**MICHAEL DEVONSHIRE
HISTORIC PRESERVATION CONSULTANT**

February 1, 2005

Re: 755-757 Greenwich St., Manhattan

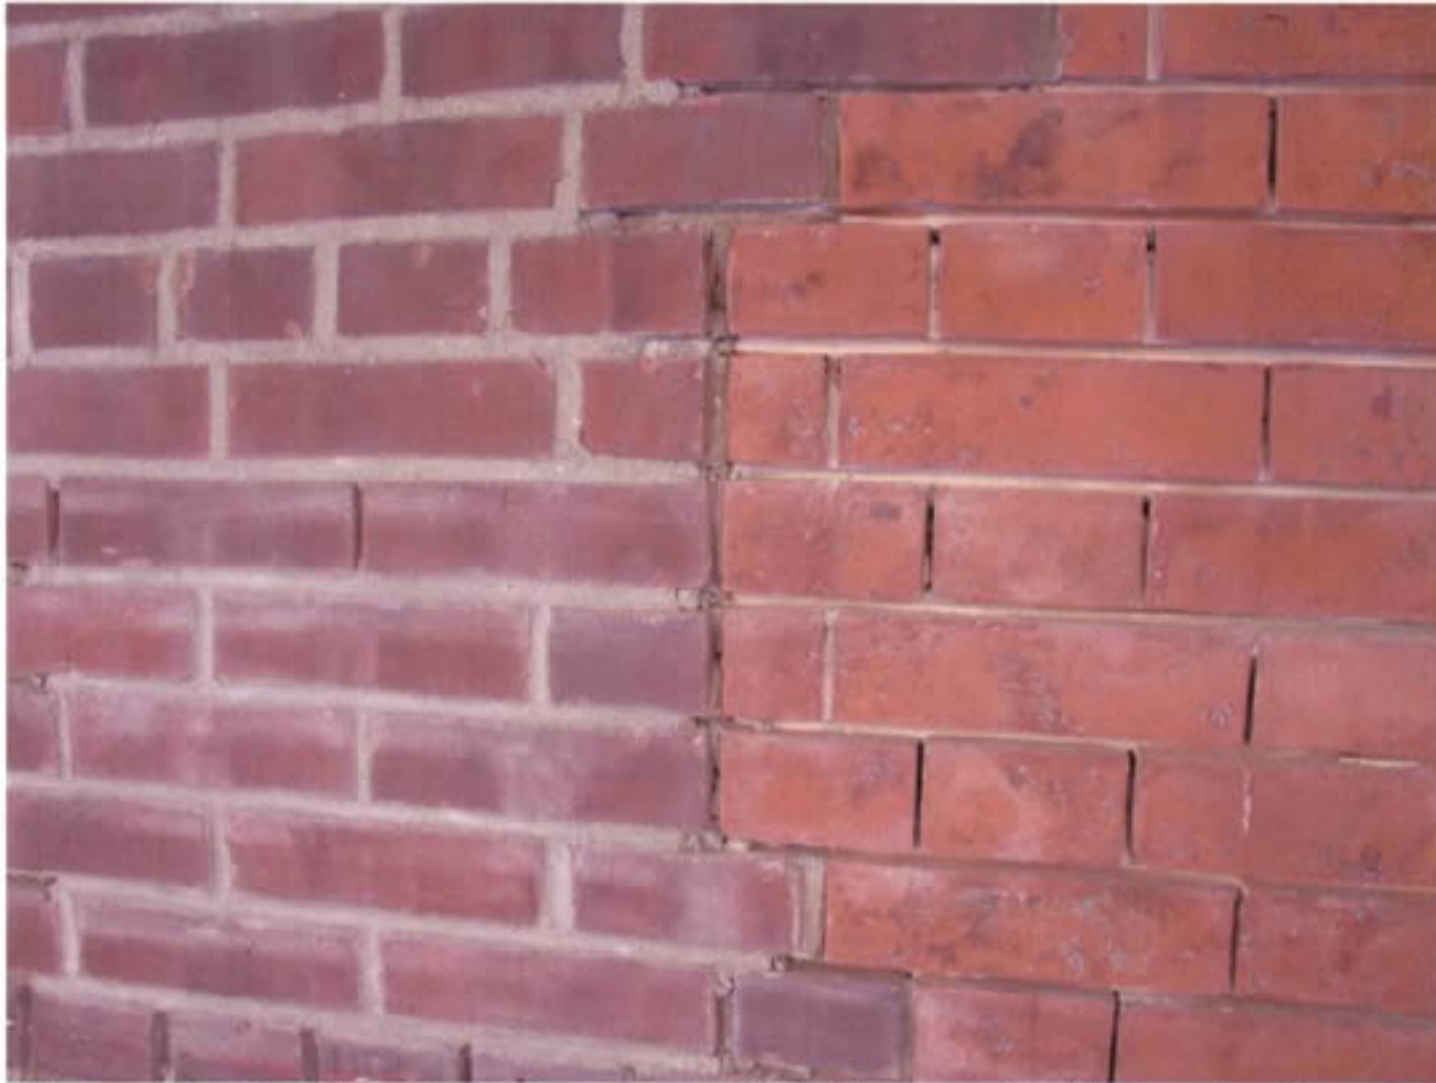
The existing original façade brick masonry has been infilled at several locations using brick which appears to be not pressed but hand struck, and of obtrusively dissimilar color (Photo 1). This has occurred not only at a large infill area on the Greenwich St. facade but also at newly cut window surrounds on the 11th St. façade. The newer brick has been laid in common bond rather than a replication of the original Flemish bond. Mortar joints on the original brick masonry system appear to have been a moderately uniform 1/8”, however, these have been cut out using a mechanical grinder. The horizontal joint cutting has been very poorly executed, and in some cases the joints are now 3/8” wide with “mistake” cuts to 1/2” at some locations, significantly and inalterably damaging original material.

Photo 1: The dissimilar color and texture of infill brick is very visually obtrusive. Coursing of the new brick masonry does not replicate the original. Mortar joints in original bricks appear to have been widened to accommodate inappropriately wide new brick joints. Note grinder marks.

Much of the unfortunate damage which has been inflicted upon the historic façade masonry (grinder damage) is irreversible although the new inappropriate bricks can be removed and replaced with units which more closely replicate the originals. The type of damage which has occurred and incongruity of architectural elements is in my opinion precisely what we as preservationists attempt assiduously to avoid when designing restoration interventions on our historic buildings. Interestingly, the LPC Permit for the work mentions specifically the building's scale, materials, design and details as being important features of the structures. Some of these have been irretrievably destroyed by the work being undertaken.

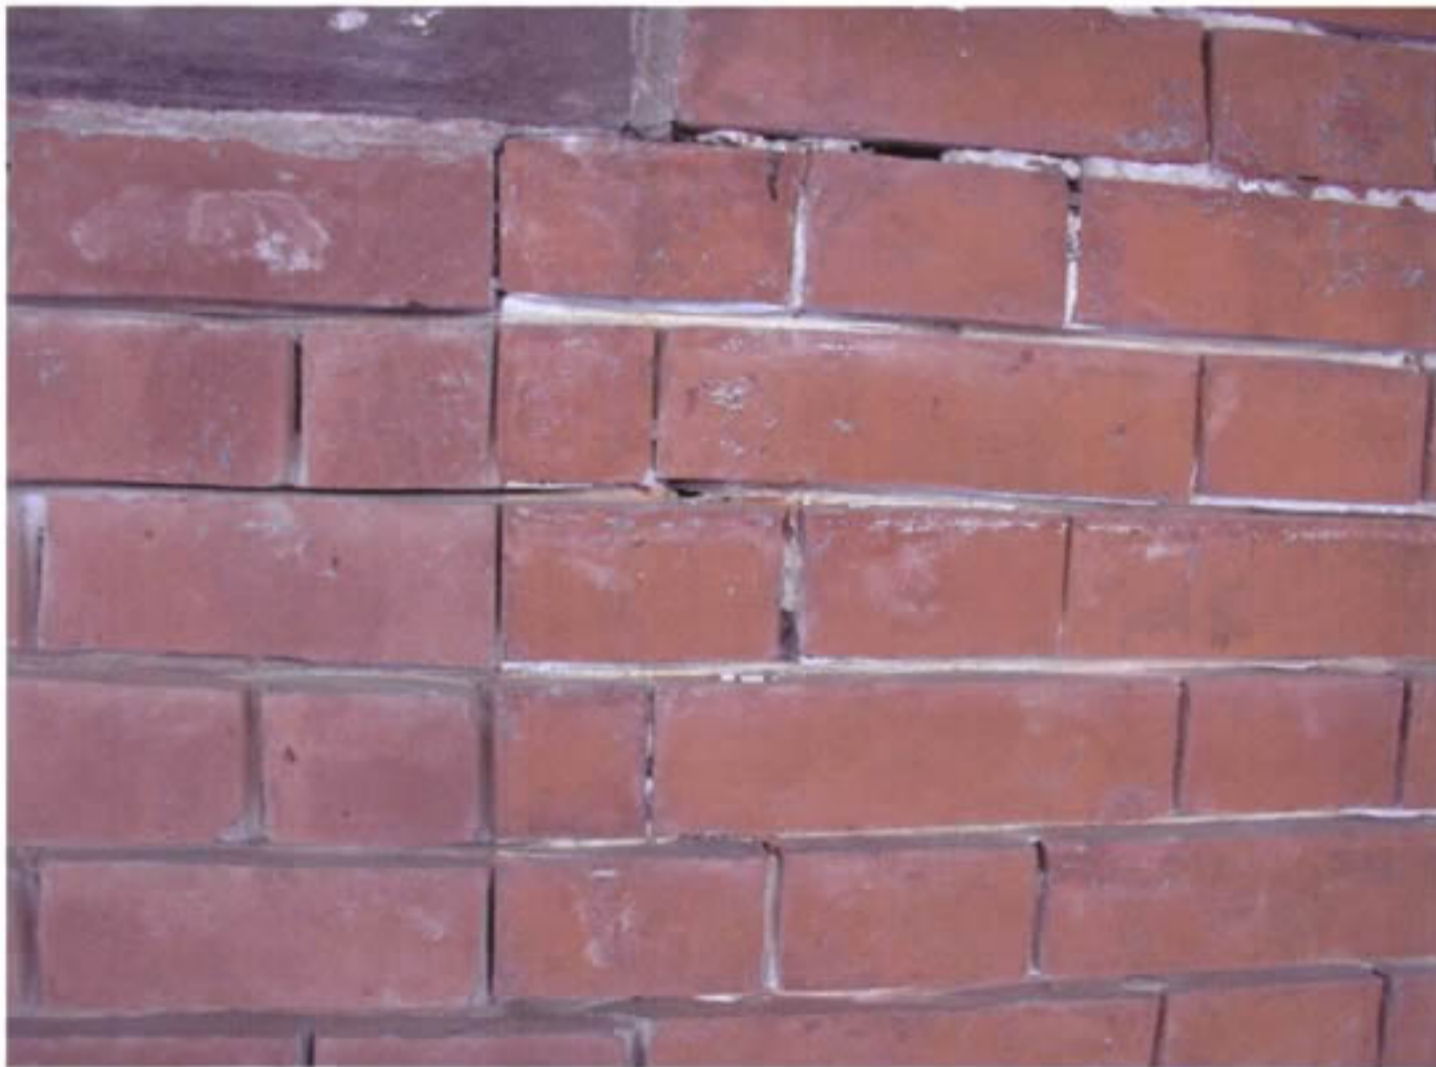
Vertical joint cutting has been somewhat better executed, but over-cuts were noted at a few locations, where original bricks were damaged by the grinder (Photo 2).

Unfortunately, the consequences of the grinder damage not only affect the visual perception of the building, but damage the protective fire skin of remaining bricks, making them more vulnerable to water and frost damage. While at some locations the grinding has revealed original lime-based mortar remaining within the joints, several of what appear to be mortar field samples have been attempted, most of which do not replicate the appearance of the original. The Greenwich St. façade exhibits what appears to be salt efflorescence due to incompletely rinsed chemical cleaning attempts, however it was not clear that the masonry has been cleaned.

Photo 2: Poorly executed cutting of mortar joints is not only unsightly, but will affect the longevity of historic bricks. Note the unevenness of the grinder cuts. Joints should have been hand-cut if mortar removal was necessary.
