# Investigation and Assessment of the Tony Dapolito Recreation Center Greenwich Village, New York, NY

## Final Report

Task 5.1  
26 October 2015

Prepared for : NYC Parks Capital Division  
Prepared by : Urbahn Architects PLLC

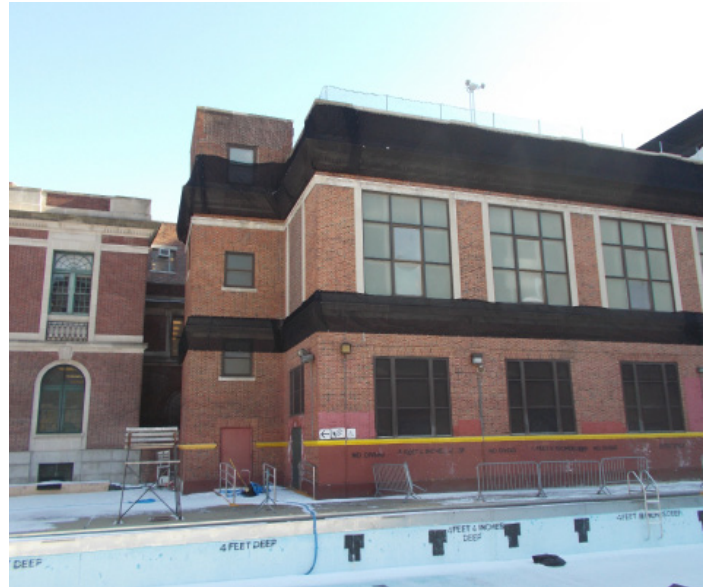
Overall the Tony Dapolito building is in fair condition, with the exception of a few localized areas. The two areas that present the highest importance for repair are stair tower 3, and the rooftop colonnade/loggia at the southwest corner of the building (1929 addition). At stair tower 3, the upper portion of the interior stair construction and the exterior wall construction is badly deteriorated and could present a safety hazard if not stabilized. At the rooftop loggia there is extensive deterioration at parapets and limestone banding. Both of these areas could present a safety hazard if not stabilized in the near future.

Repair of Stair Tower 3 is of the utmost importance due to its extremely poor condition of both the interior stair construction and the exterior masonry walls. The stair is currently closed due to the poor condition; deteriorated treads and risers at the upper level could be a danger to occupants attempting to exit the gymnasium and the roof. The tower parapets and tie-beams are deteriorating and could eventually result in masonry falling onto the outdoor pool deck three stories below. In the cost estimate and the previous reports, we evaluated repairing this stair tower compared to rebuilding the stair tower in a new configuration. As the stair is the main egress path from the public assembly gymnasium space, and as the current stair configuration is not compliant with rise and run standards in the current building codes, we recommend rebuilding the stair to comply with the current codes. (Refer to Cost Estimate - Needs Assessment Modifications/Additions item A-1.7)

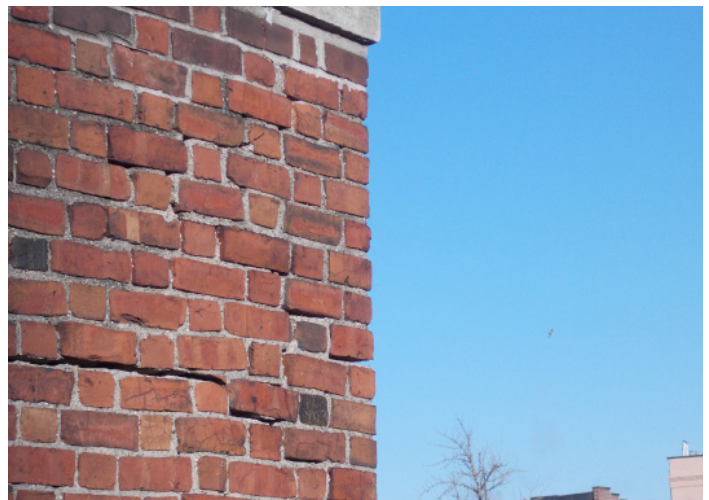
Stair Tower 3 - Separation and Cracks at Parapet Wall

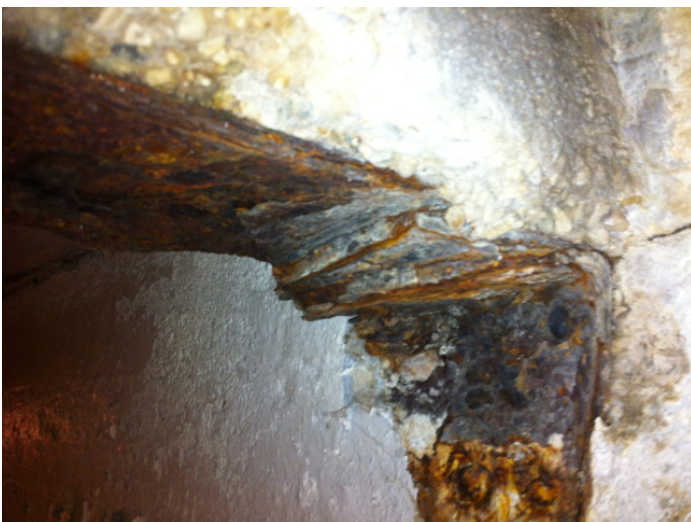
Of serious, but less critical consideration are the sidewalk vaults under Seventh Avenue and Clarkson Street, where water infiltration has caused considerable deterioration to the beams supporting the sidewalk. The condition of the main entrance ramp/stairs have contributed to the water infiltration into the vault areas due to lack of waterproofing and settlement gaps.

Deteriorated Structure at Sidewalk Vaults

In priority 2, we recommend the repair and replacement of the deteriorated structure of the sidewalk vaults under Seventh Avenue and Clarkson Street, as well as repair of the sidewalks. As the condition of the main entrance ramp/stairs significantly contribute to the deterioration of the sidewalk vault below, we also recommend rebuilding the main entrance ramp/stair. In the cost estimate and the previous reports, we evaluated rebuilding the main entrance ramp/stair in the existing location versus rebuilding it to create a new entrance

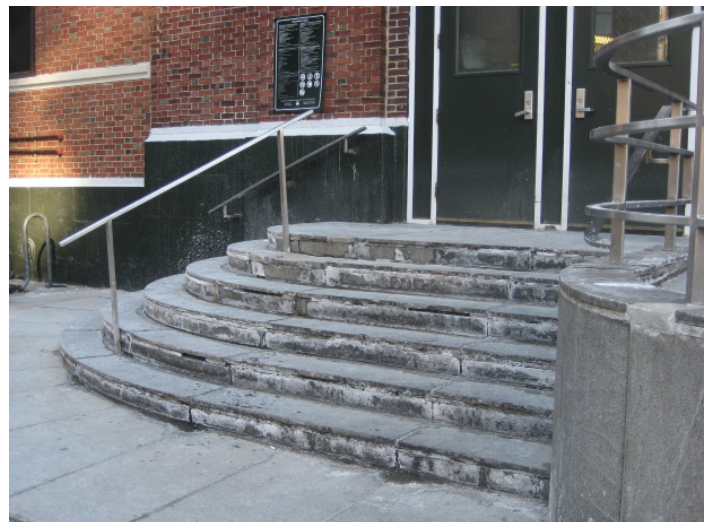
Entrance Stair / Ramp - Open Joints Allowing Water Infiltration

location on Seventh Avenue. We recommend rebuilding the stair and ramp at a new location. (Refer to Cost Estimate - Needs Assessment Modifications/Additions item C.A-1.1)

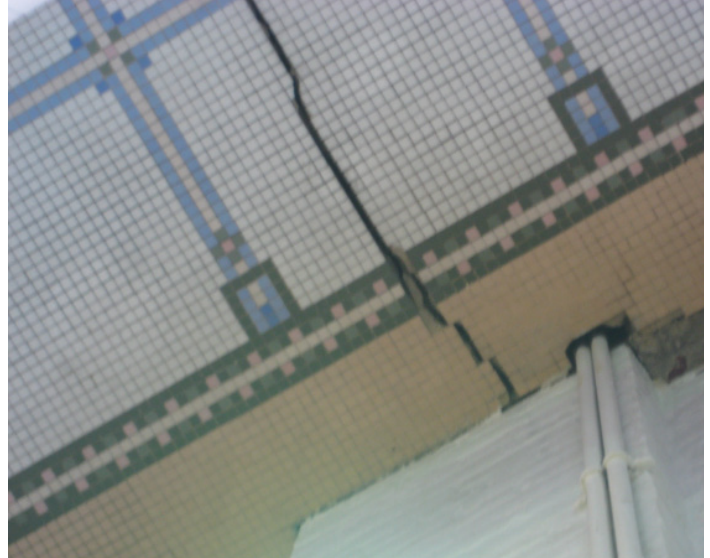
The interior of the building is worn, but in fairly good condition. There is an open joint between the original structure and the 1929 addition, where settlement has created a gap between the two structures; this is cosmetic and not a structural issue. The same can be said for a crack running transverse across the pool ceiling and the gym ceiling. These gaps are expansion related and although they are not a safety hazard at present, the tile finish may loosen and fall if the expansion joint isn't stabilized.

Gym Ceiling Expansion Crack in Tile Finish

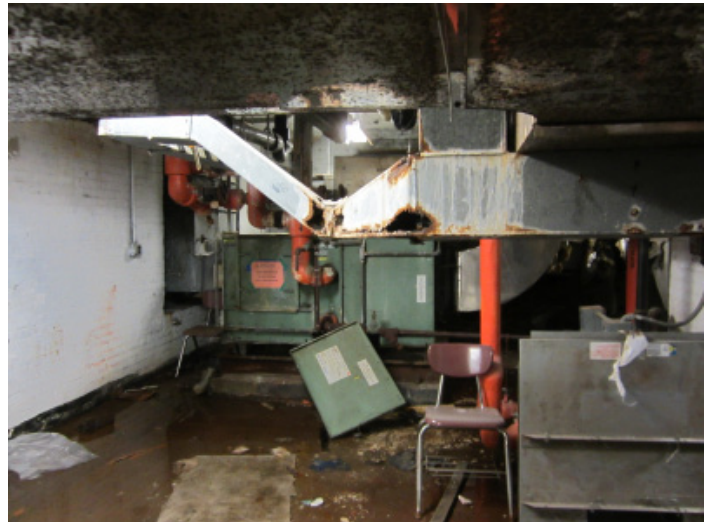
Throughout the building the mechanical systems are at the end of their useful life and therefore the code required ventilation is not being provided. The pool equipment systems are also at the end of their useful life, which causes excessive humidity in the pool as well as associated finish deterioration. The pools are not equipped with safety drain covers as required by the Virginia Graeme Baker regulation, which prevent suction entrapment and evisceration at drains. The shell construction of both the indoor and the outdoor pools have deteriorated causing numerous leaks.

Antiquated and Deteriorated Mechanical Systems

We recommend replacing the building mechanical equipment and the pool equipment in Priority 2. The equipment should be connected to the existing duct work, with the exception of the duct work at the basement level, which is included in this Priority. The equipment should be sized for future Priority 3 program upgrades, but can be installed in this phase. By including the replacement of the mechanical equipment and the sidewalk vault repairs in one phase, the contractor can sequence the work to remove and replace the mechanical equipment when there is basement access through the sidewalk. This would minimize the cost for breaking down the existing equipment for removal and installing the new equipment through temporary sidewalk openings.

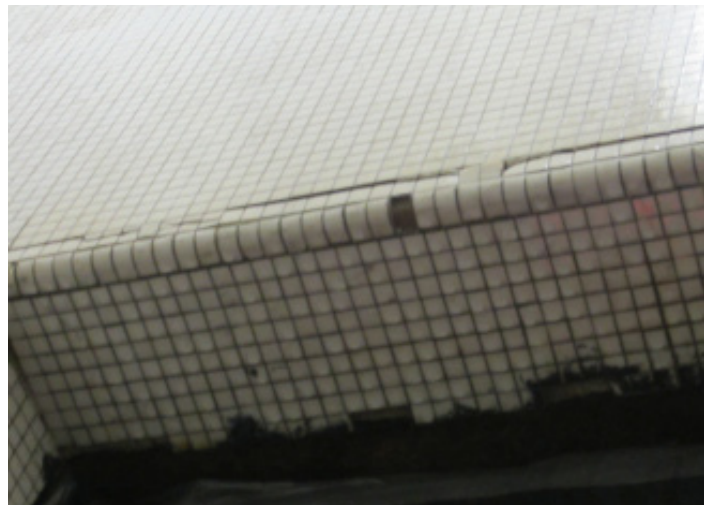
Excessive Humidity and Condensation on Pool Finishes

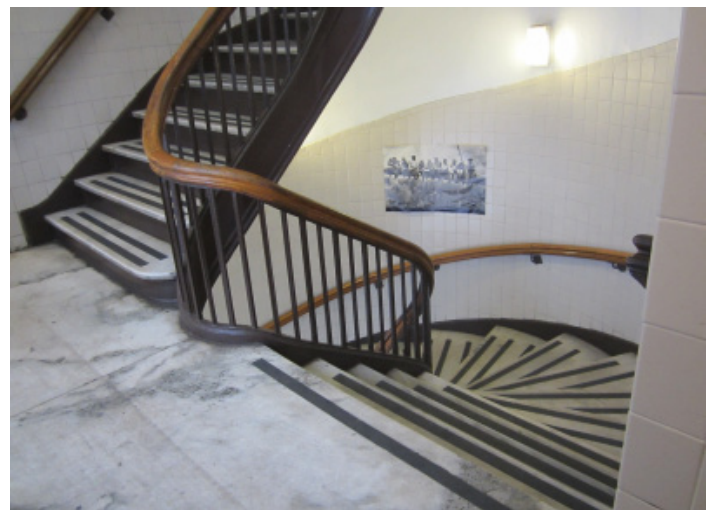
Primary Egress Stair - Non-Code Compliant Winder Stairs

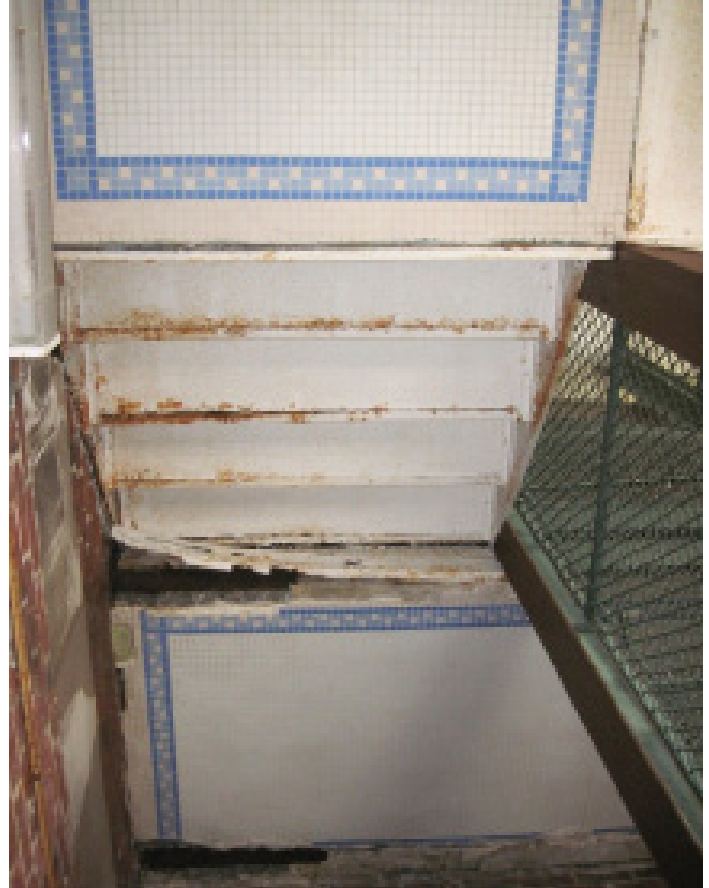
Priority 1 -Stair 3 Tower with Corroded Structure and finishes

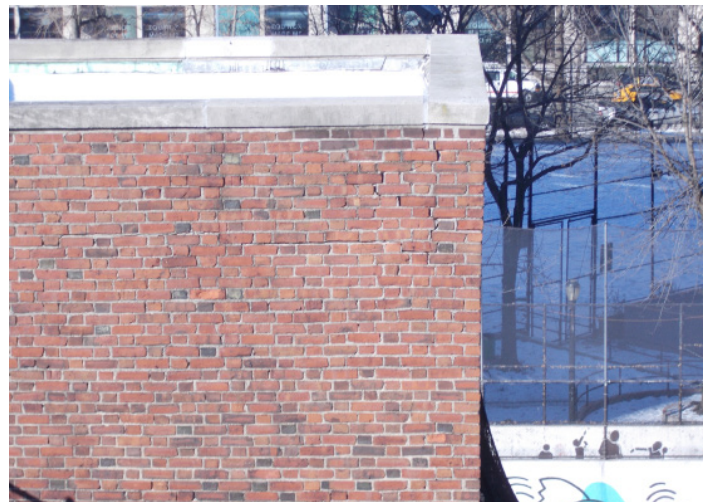
Priority 1 -Stair 3 Tower with Separating & Canting parapet

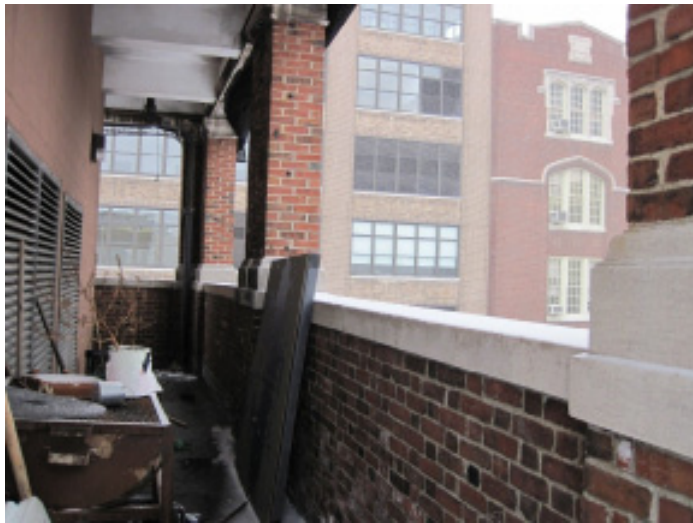
Priority 1 -Colonnade Loggia with Spalling Stucco & Open Joints

The rooftop colonnade/loggia at the southwest corner of the building (1929 addition) is the portion of the exterior envelope with the most severe deterioration. The open joints at the parapets have caused separation at the limestone banding below. As this area could present a safety hazard to anyone on the sidewalk below, we recommend repairing the parapets and resetting the limestone in the near future. (Refer to Cost Estimate - Repair and Stabilize items 3a, 4a and 4b.)

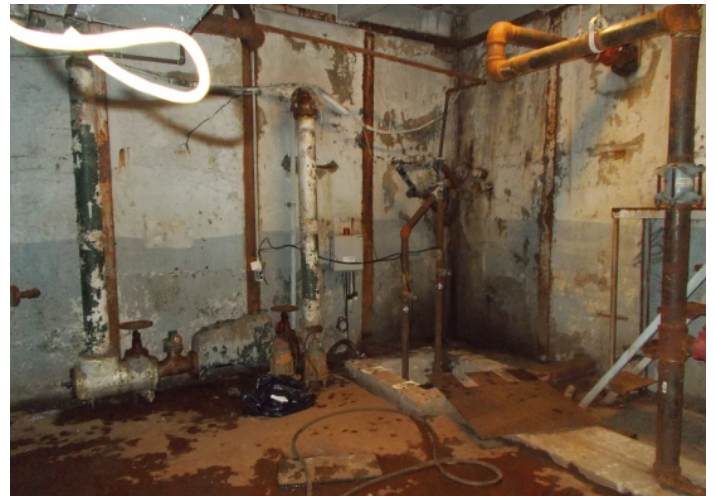
Priority 2 - Sidewalk Vault - Deteriorated Structure

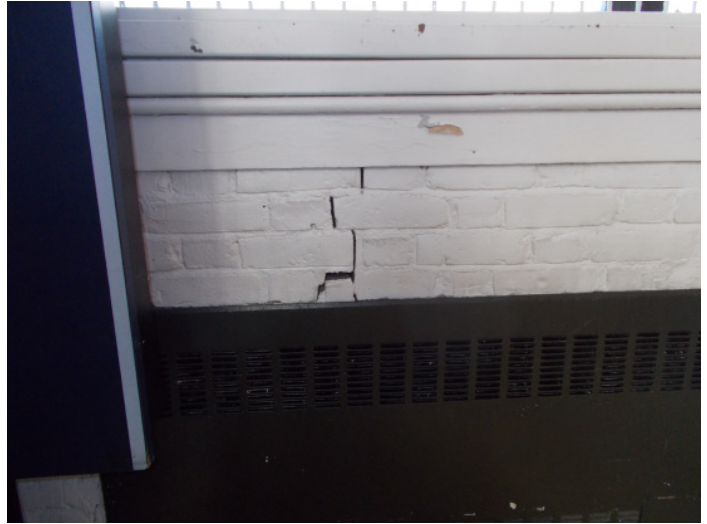
Priority 2 - Masonry Settlement Causing Window Cracking

The exterior envelope of the building, including the parapets, windows, brick and limestone bands, should be repaired in this phase. Windows should be replaced, open joints in masonry filled, localized areas of spalled or missing masonry should be patched/repared/replaced, and sections of the brick facades should be repointed. By combining the majority of the exterior envelop work into this phase, the cost for scaffolding the building will be limited to one time.

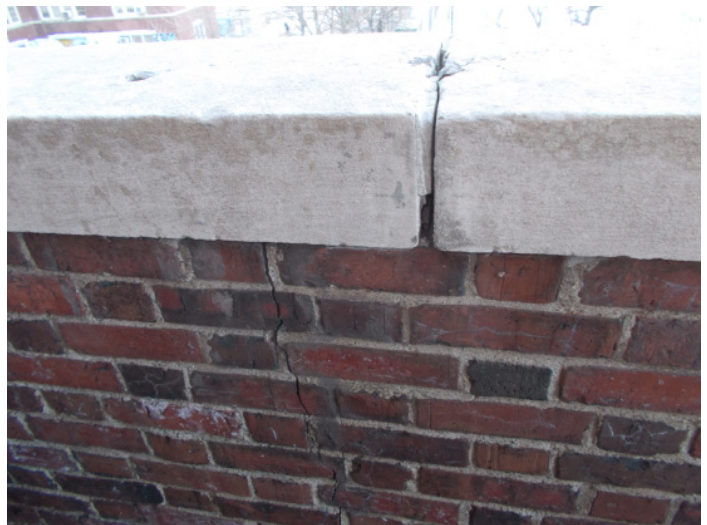
Priority 2 - Parapet and Coping Repair

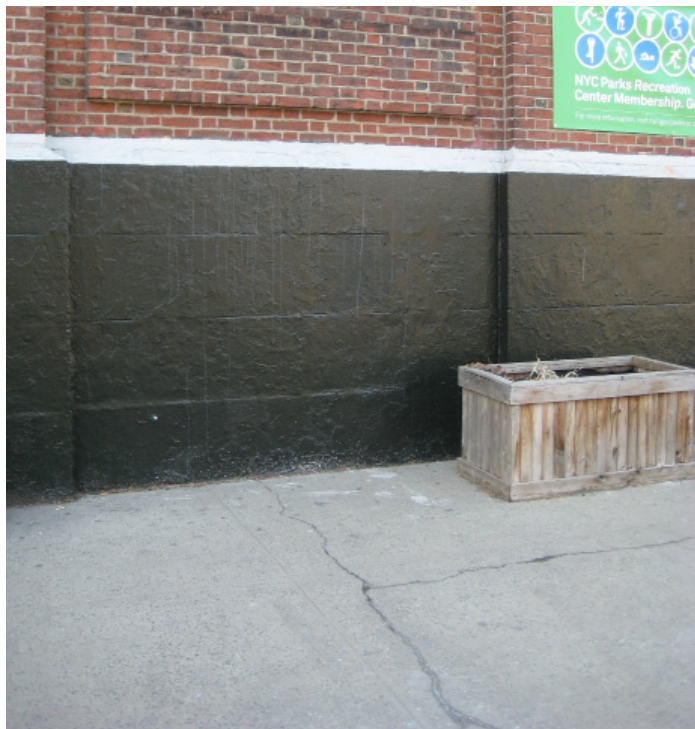
Priority 2 - Sidewalk Cracking above Deteriorated Vault Structure

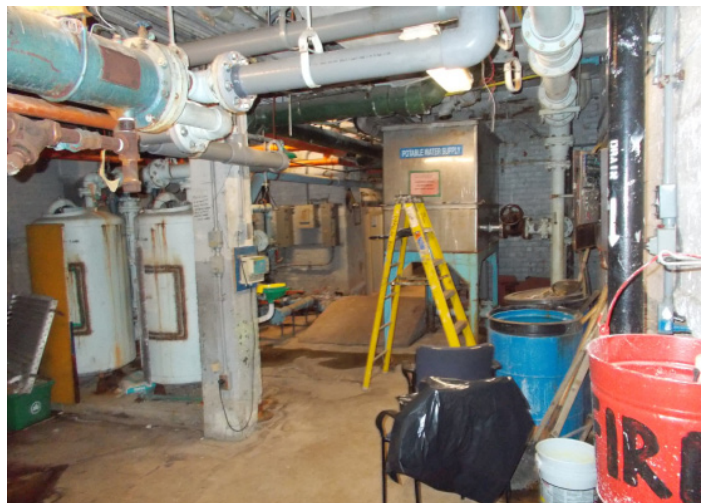
Priority 2 - Replacement of Antiquated MEP

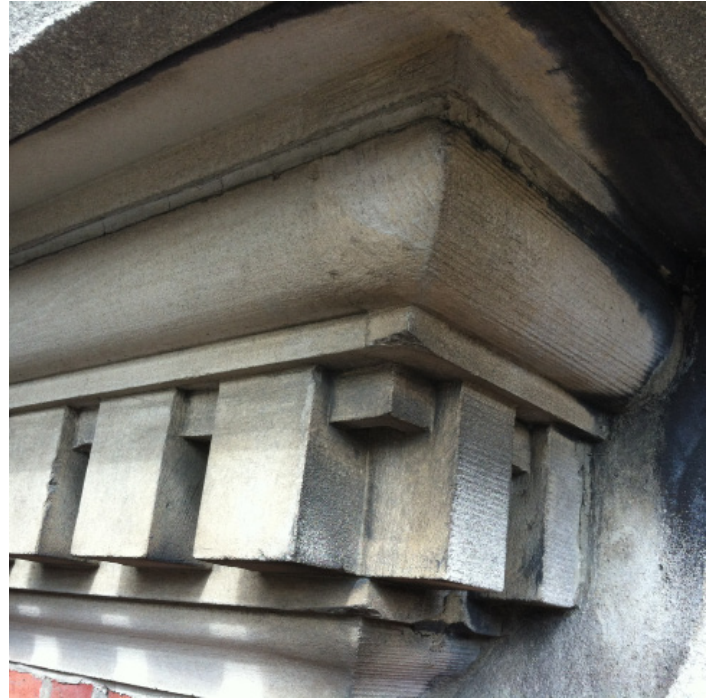
Limestone Dentil Molding at Cornice (Temp Safety Net Removal)

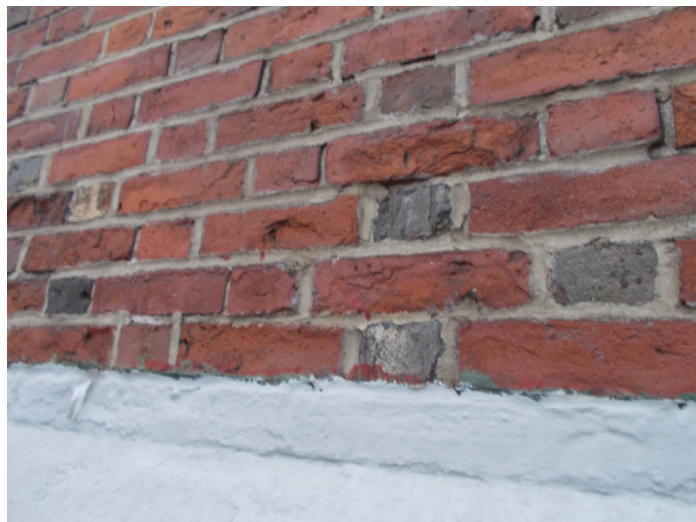
Spalling Brick due to Inappropriate Repointing Mortar

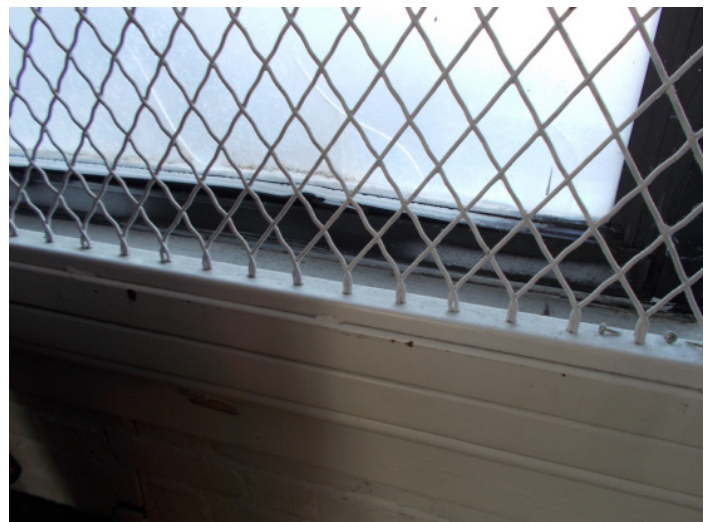
Damaged Window due to Masonry Settlement

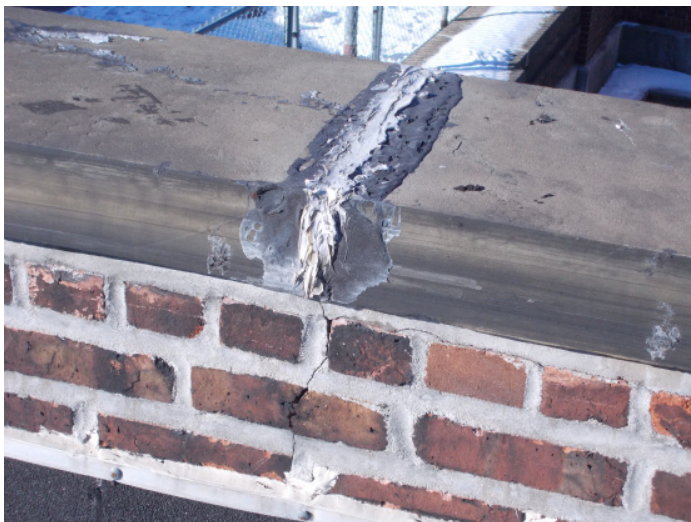
Parapet and Coping Deteriorated Joints

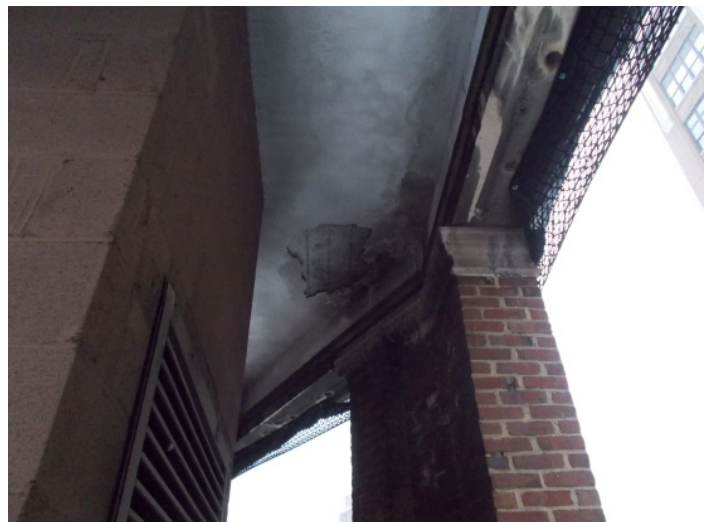
Spalling Stucco at Colonnade Loggia

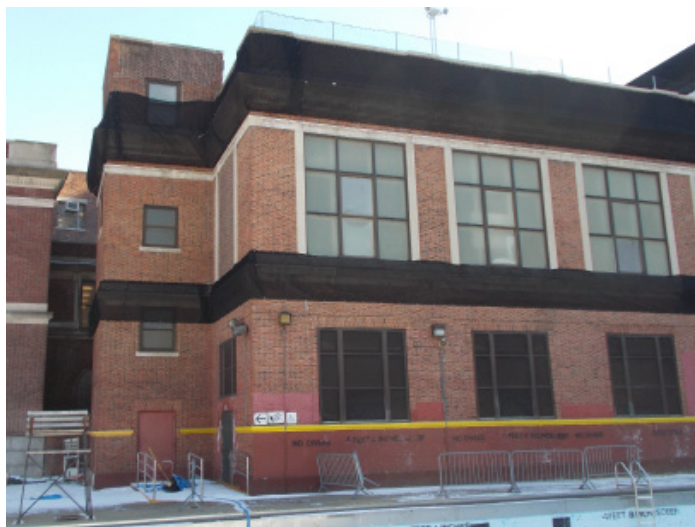
Stair 3 Tower

As noted in the architectural section, the Stair # 3 tower located at the north-west corner of building, which provides egress from all floors to the outdoor pool area, is in poor condition. The stair tower walls are constructed of 3 layers of bonded brick (12" thick), with segmented limestone banding around the tower at all the floor slab levels and at ± 3'-0" below roof level. The two limestone bands at the 3rd floor level and below the roof level do not appear to be connected to the building and there are open joints all along the band. The brick walls and parapets above this band (segmented prefabricated concrete tie-beams) are in poor condition. There is severe spalling and cracking, and the parapet is splayed outward. The metal stairs run around a center core and are supported by four vertical steel angles at this center core and along the exterior walls. The metal stairs from the 2nd floor level to the roof are in poor condition, with corroded stringers and cracks in the treads and landings.

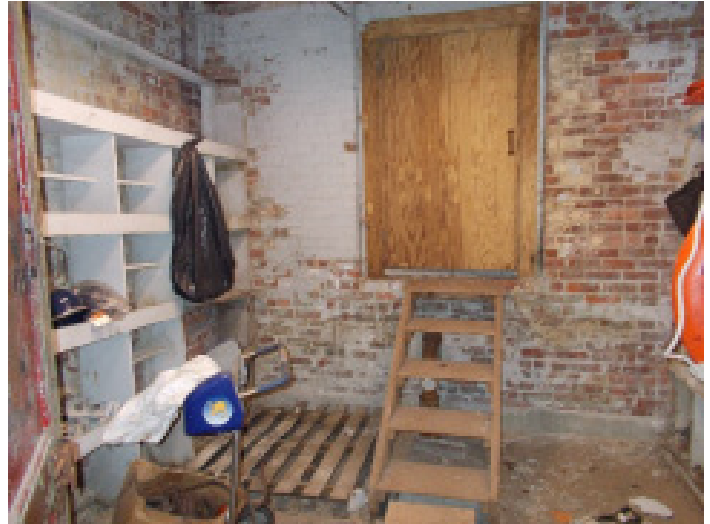
Basement Level Plywood Door at Second Means of Egress

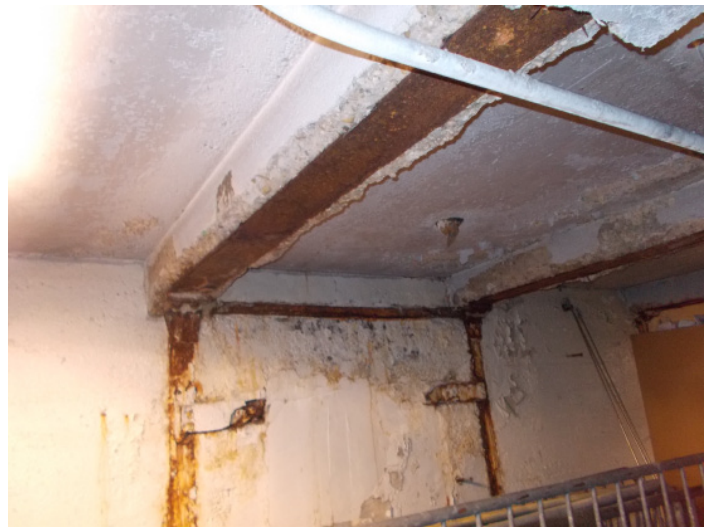
Sidewalk Vault Deteriorated Structure

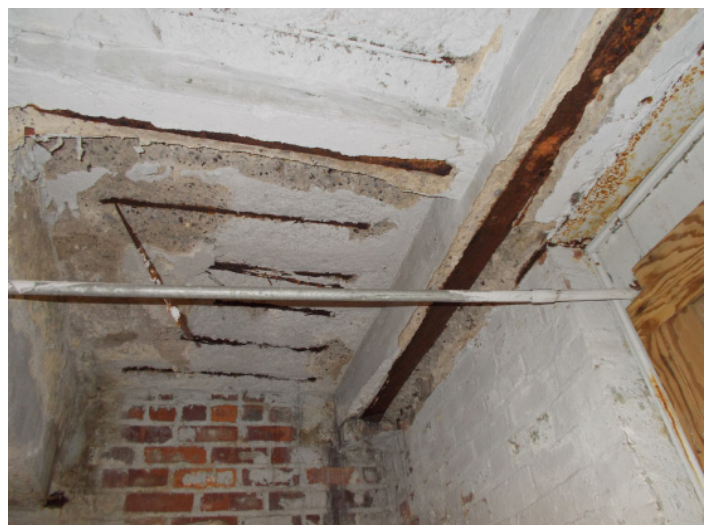
Basement Level Exposed Rebar

At the ceiling slab of the vaults, there is spalled concrete with exposed reinforcement, primarily at the Sump Pit Room and in the Seventh Avenue sidewalk vault. The reinforcement is rusted due to leaks and moisture causing the concrete to spall. The deteriorated portions of the ceiling slab should be stabi-

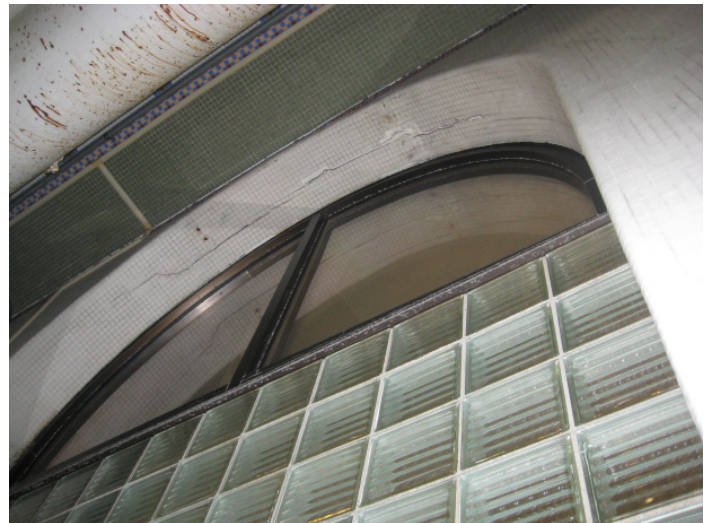
Pool - Cracks at Window Arch

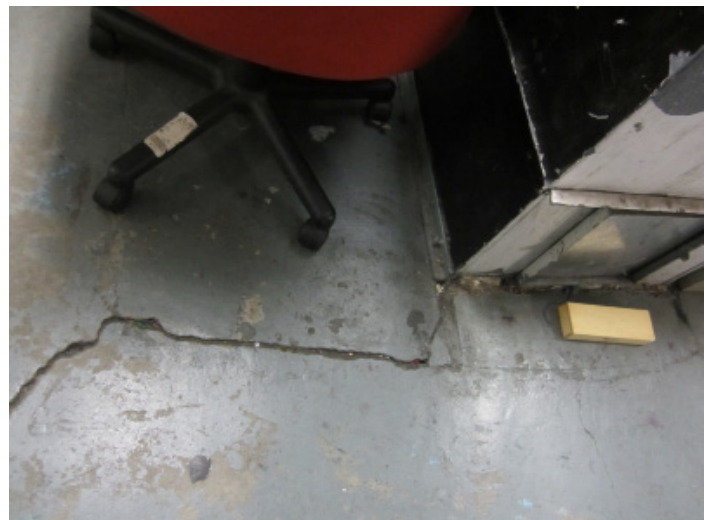
Crack in Floor of Third Floor Mechanical Room

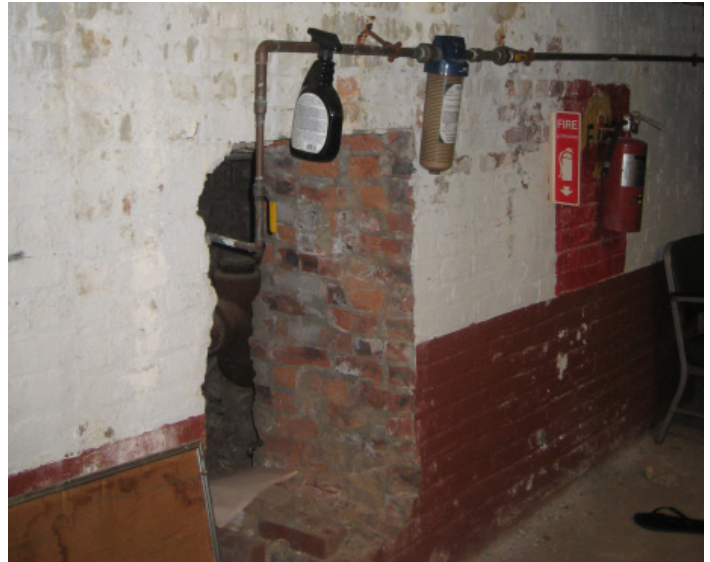
- At the Seventh Avenue sidewalk vault the lintels at the coal chute openings are in poor condition.
- Water infiltrates the building via the coal chutes.
- The outdoor pool walls are displaying efflorescence and calcification.
- An approximately 30"W by 36"H opening was cut through the 1922 foundation into the vault area without a lintel to support the 24" thick masonry, making the foundation wall above the opening vulnerable to failure.

Unsupported Opening in Bearing Foundation Wall

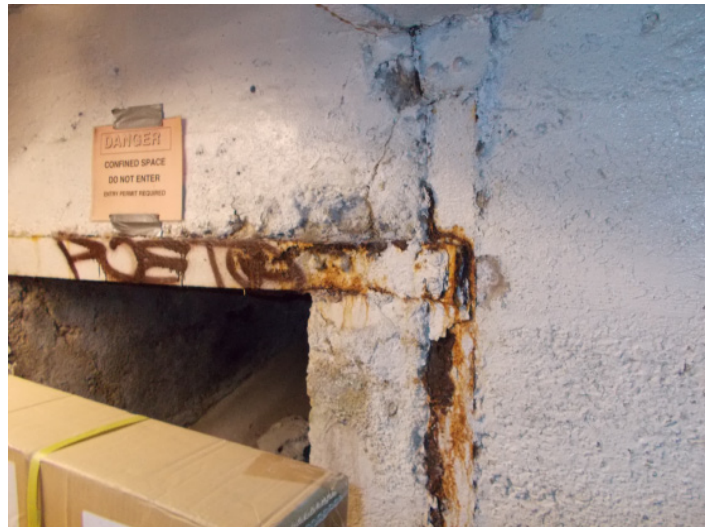
Abandoned Coal Chute with Deteriorated Lintel

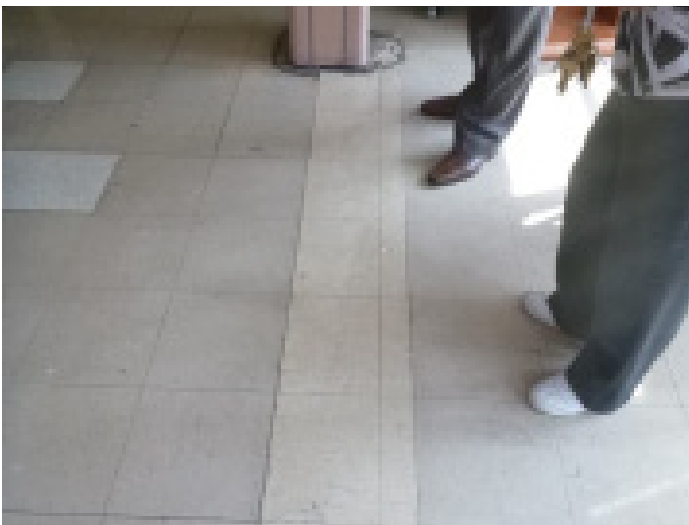
1908 / 1929 Expansion Crack at Multipurpose Room Floor

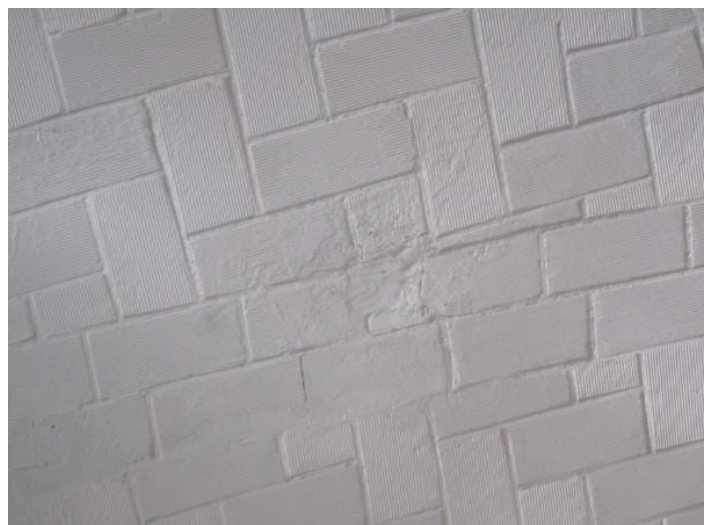
Patch at Guastivino Ceiling

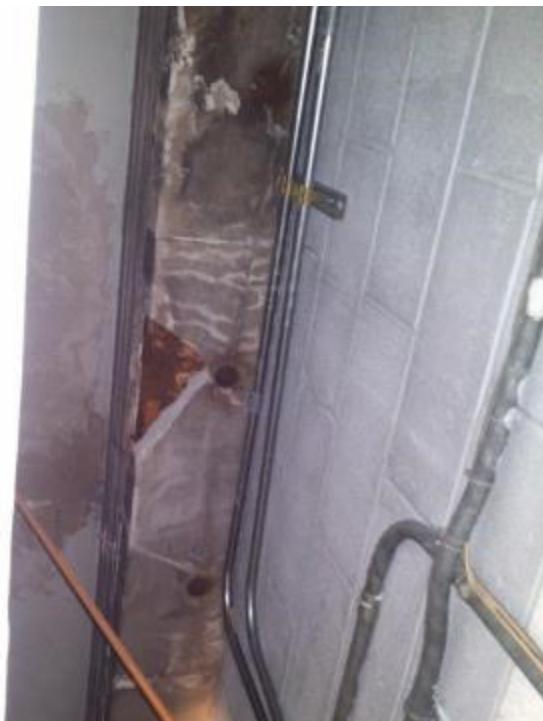
Falling Limestone at 3rd Floor Mechanical Room

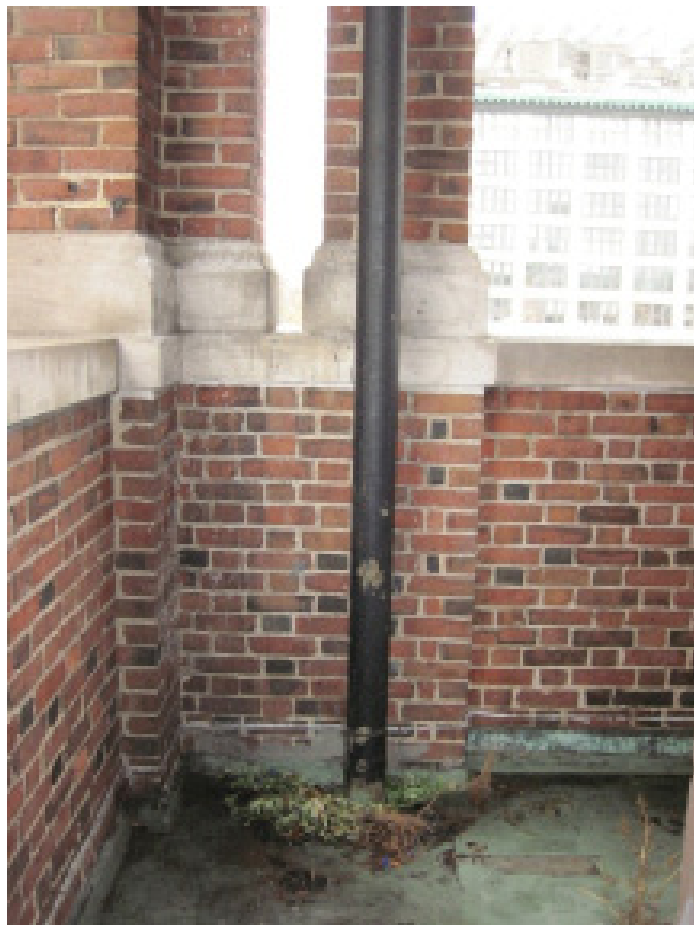
Deteriorated Roof Leader at Colonnade Loggia w/ plant growth

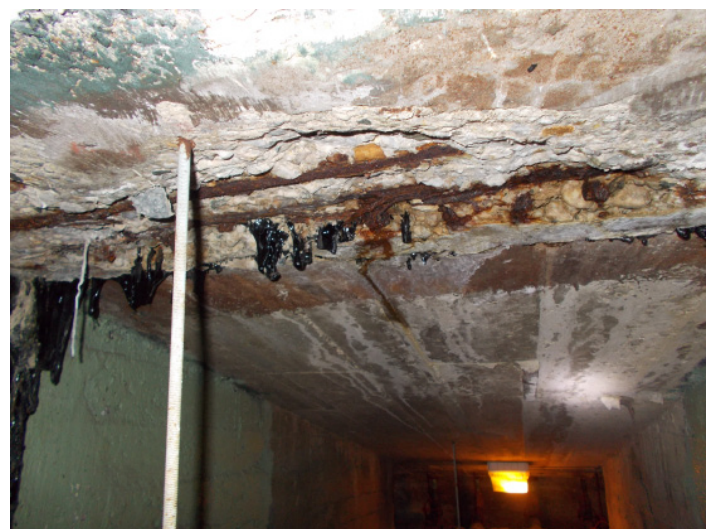
Leaks in Pool Shell

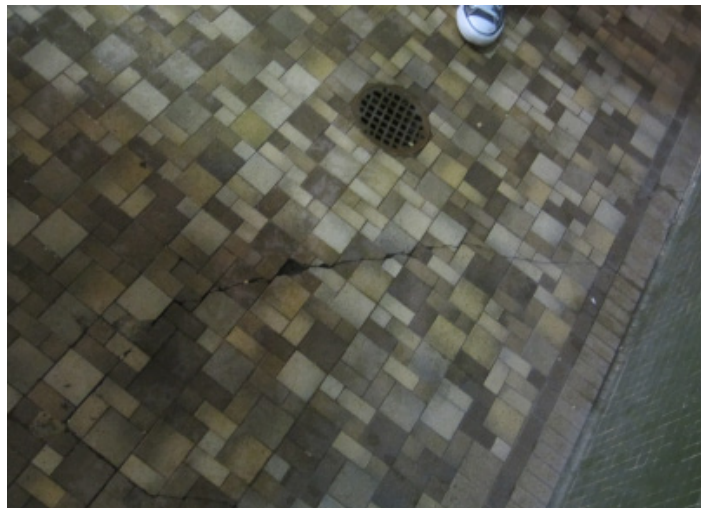
Indoor Pool - Crack in Deck by Drain

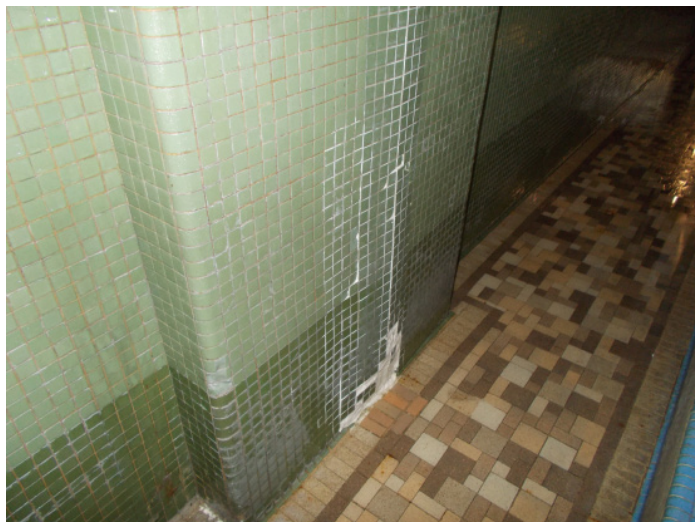
Pool Finishes Exhibiting Moisture Damage

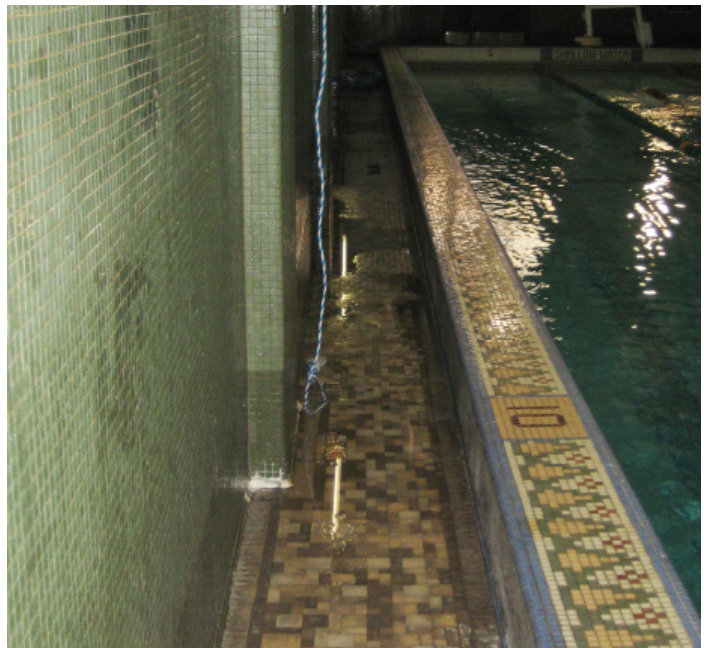
Indoor Pool Deck - Narrow Clearance

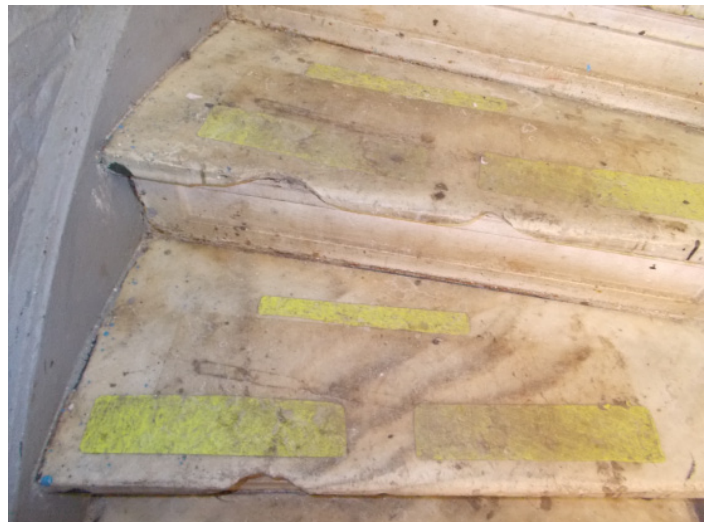
Winder Stair with Broken Treads

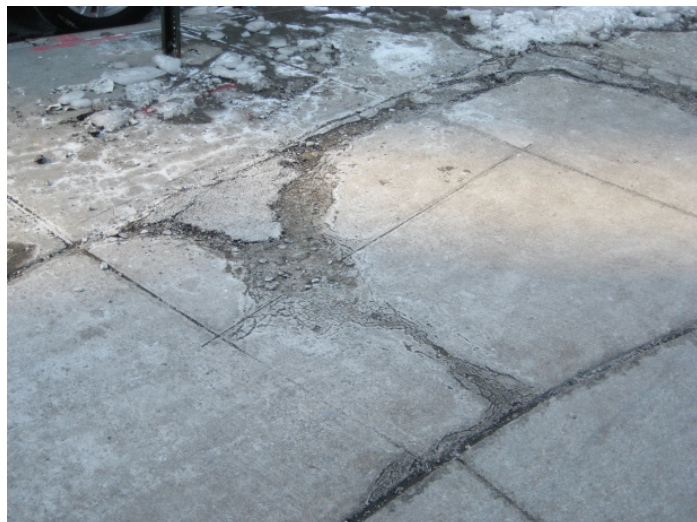
Spalls in Public Sidewalk

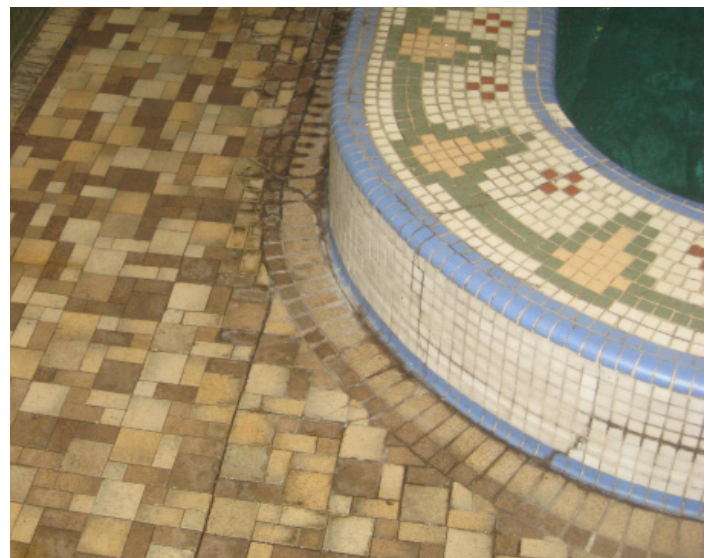
Cracked Tile at Indoor Pool
