Educational Building

70 Fifth Avenue

Landmarks Committee Hearing

I. Introduction & Existing Conditions

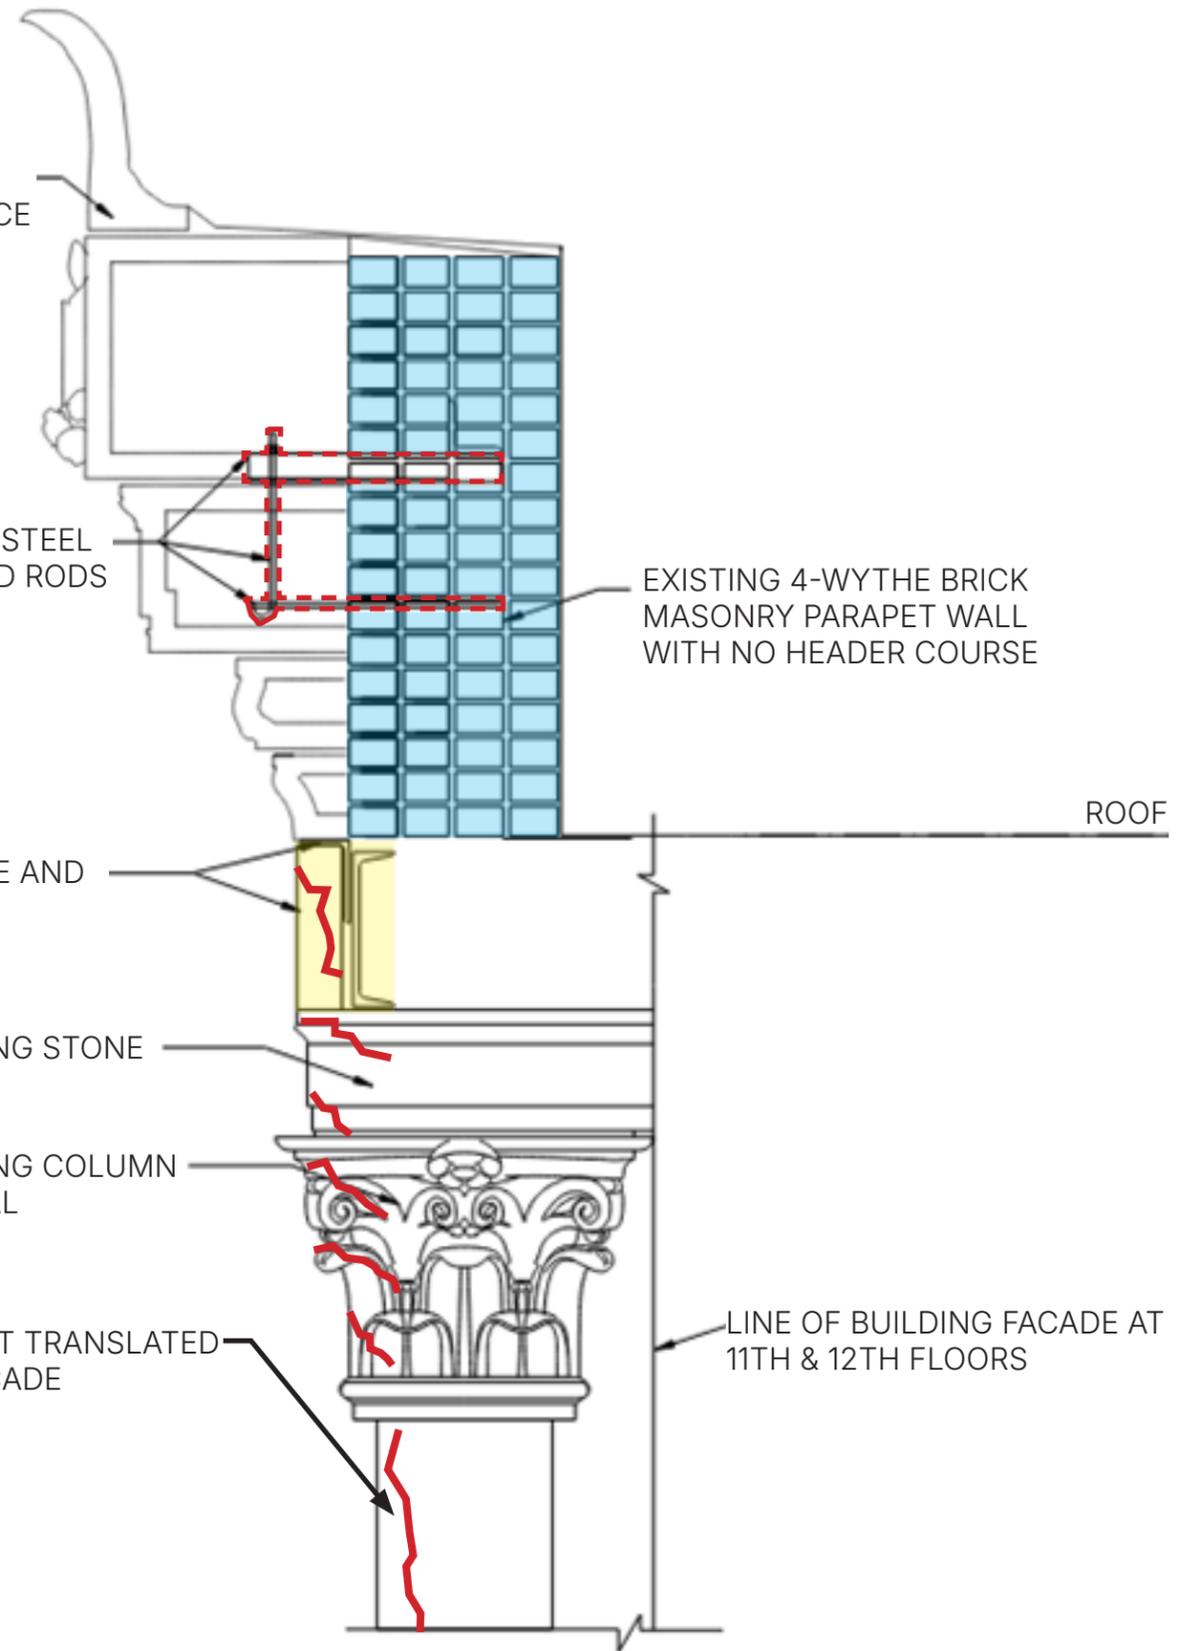
Structural Components of Cornice Parapet

EXISTING CRACKING
TERRACOTTA CORNICE

HEAVILY CORRODED STEEL
TIE-BACK ANGLE AND RODS

EXISTING LIMESTONE AND
STEEL ANGEL

WEIGHT TRANSLATED
TO FACADE

EXISTING 4-WYTHE BRICK
MASONRY PARAPET WALL
WITH NO HEADER COURSE

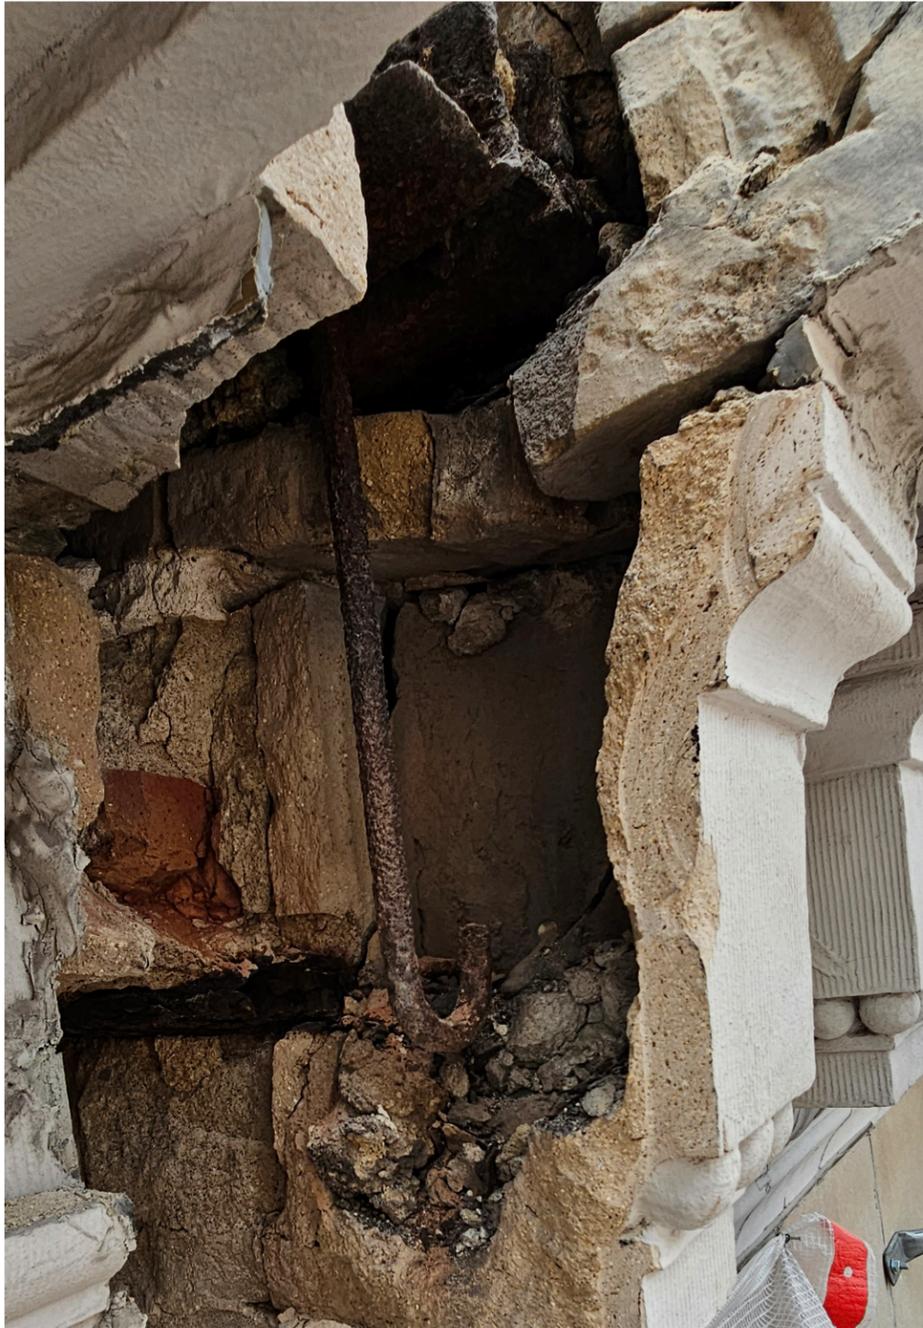
Deterioration of steel anchor embedments

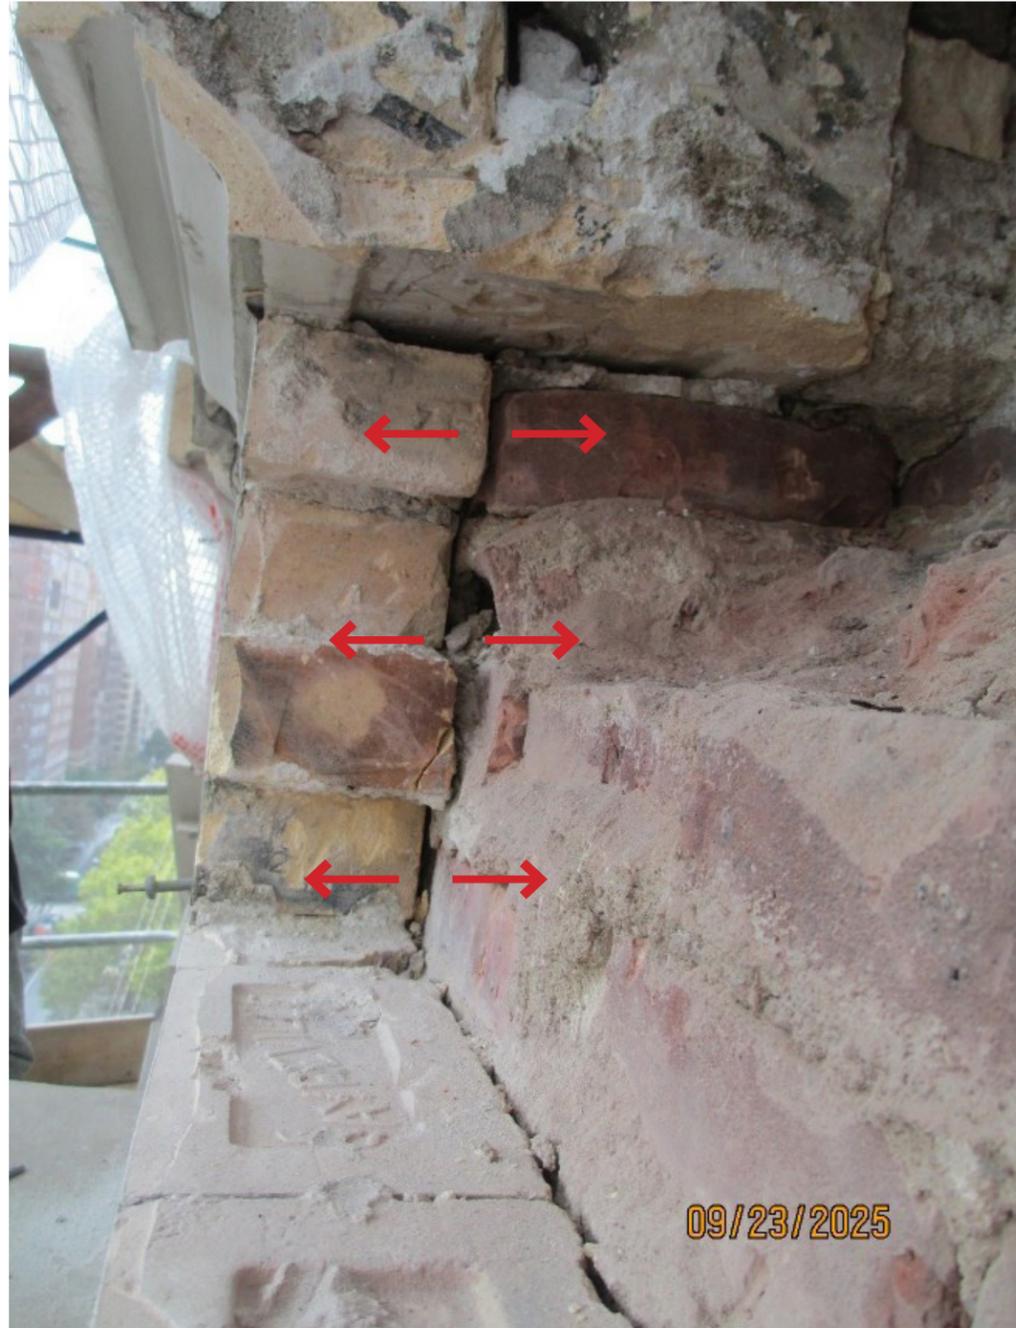
Separation between face brick and back-up brick masonry back up wall due to lack of header course

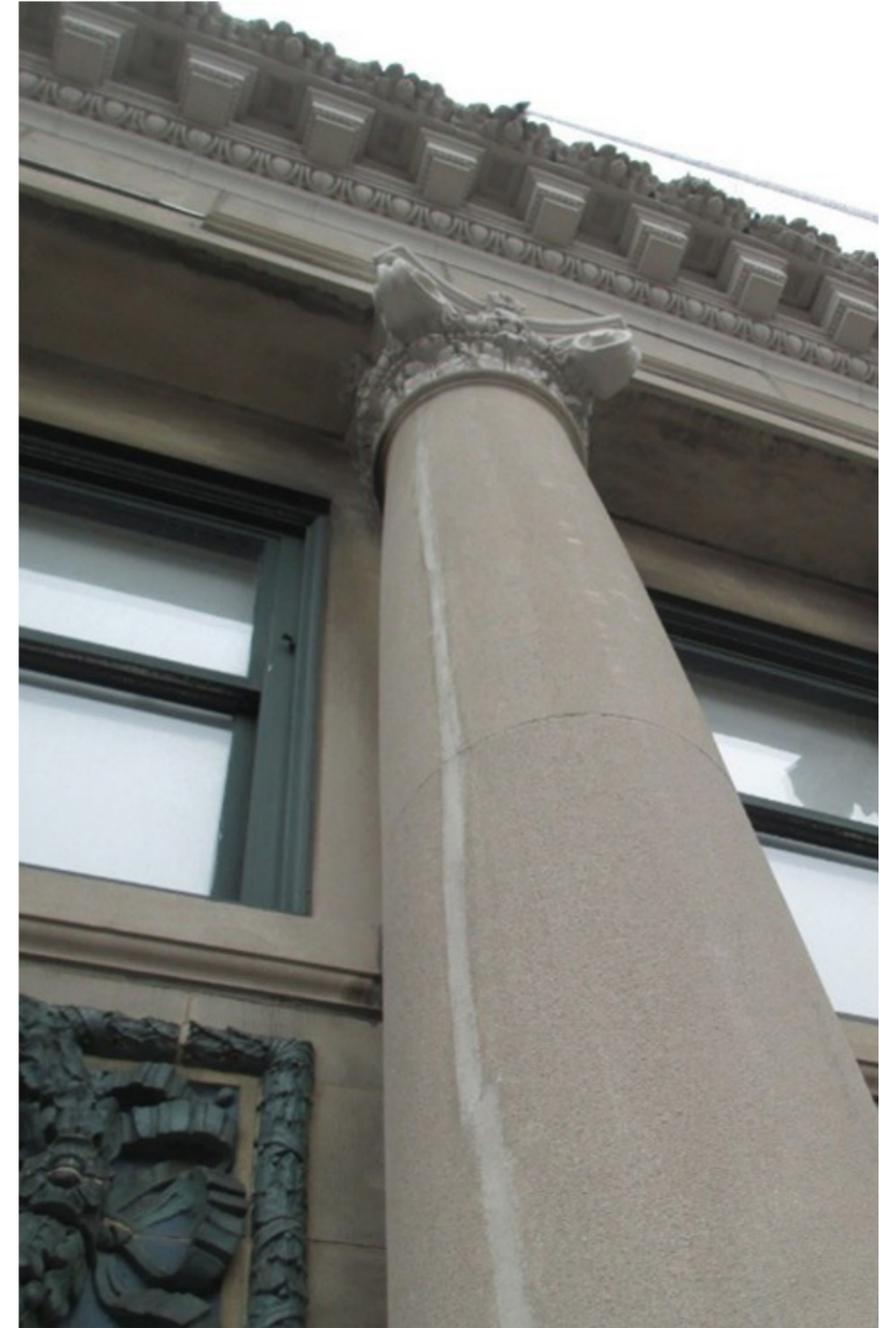
Continuous vertical cracking at limestone due to compression forces

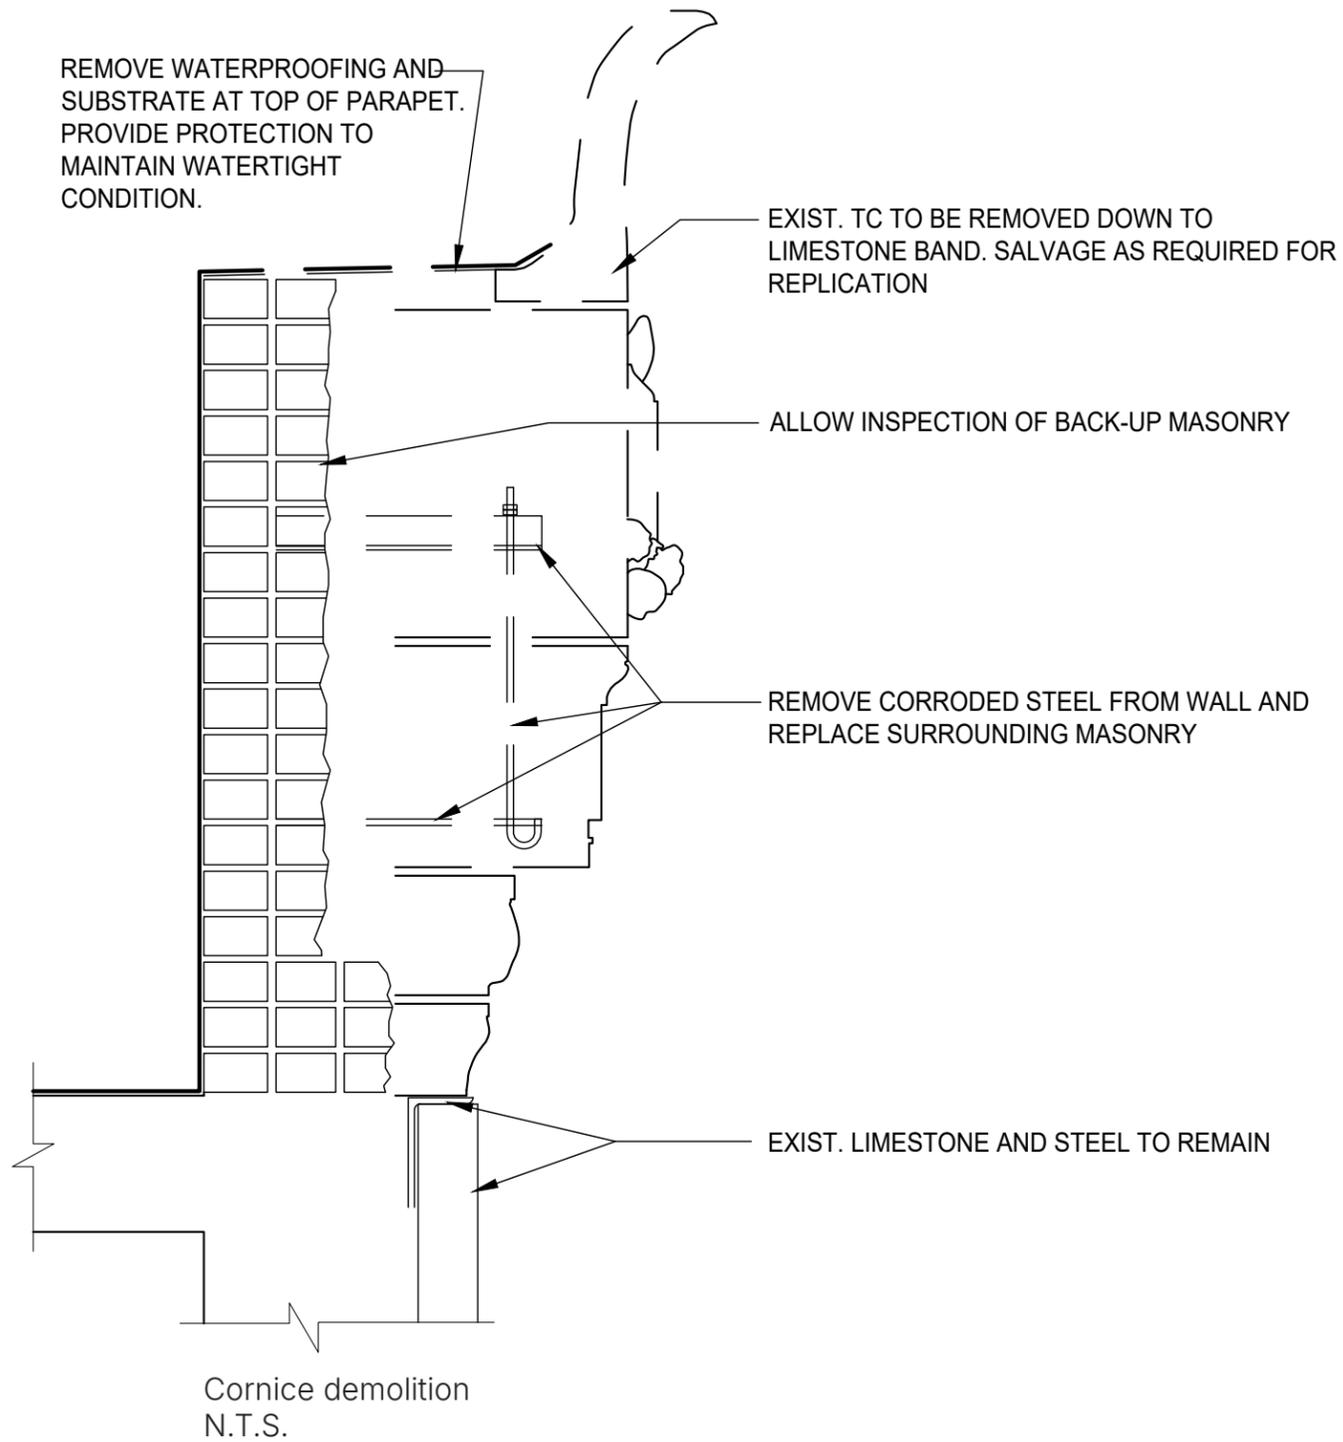
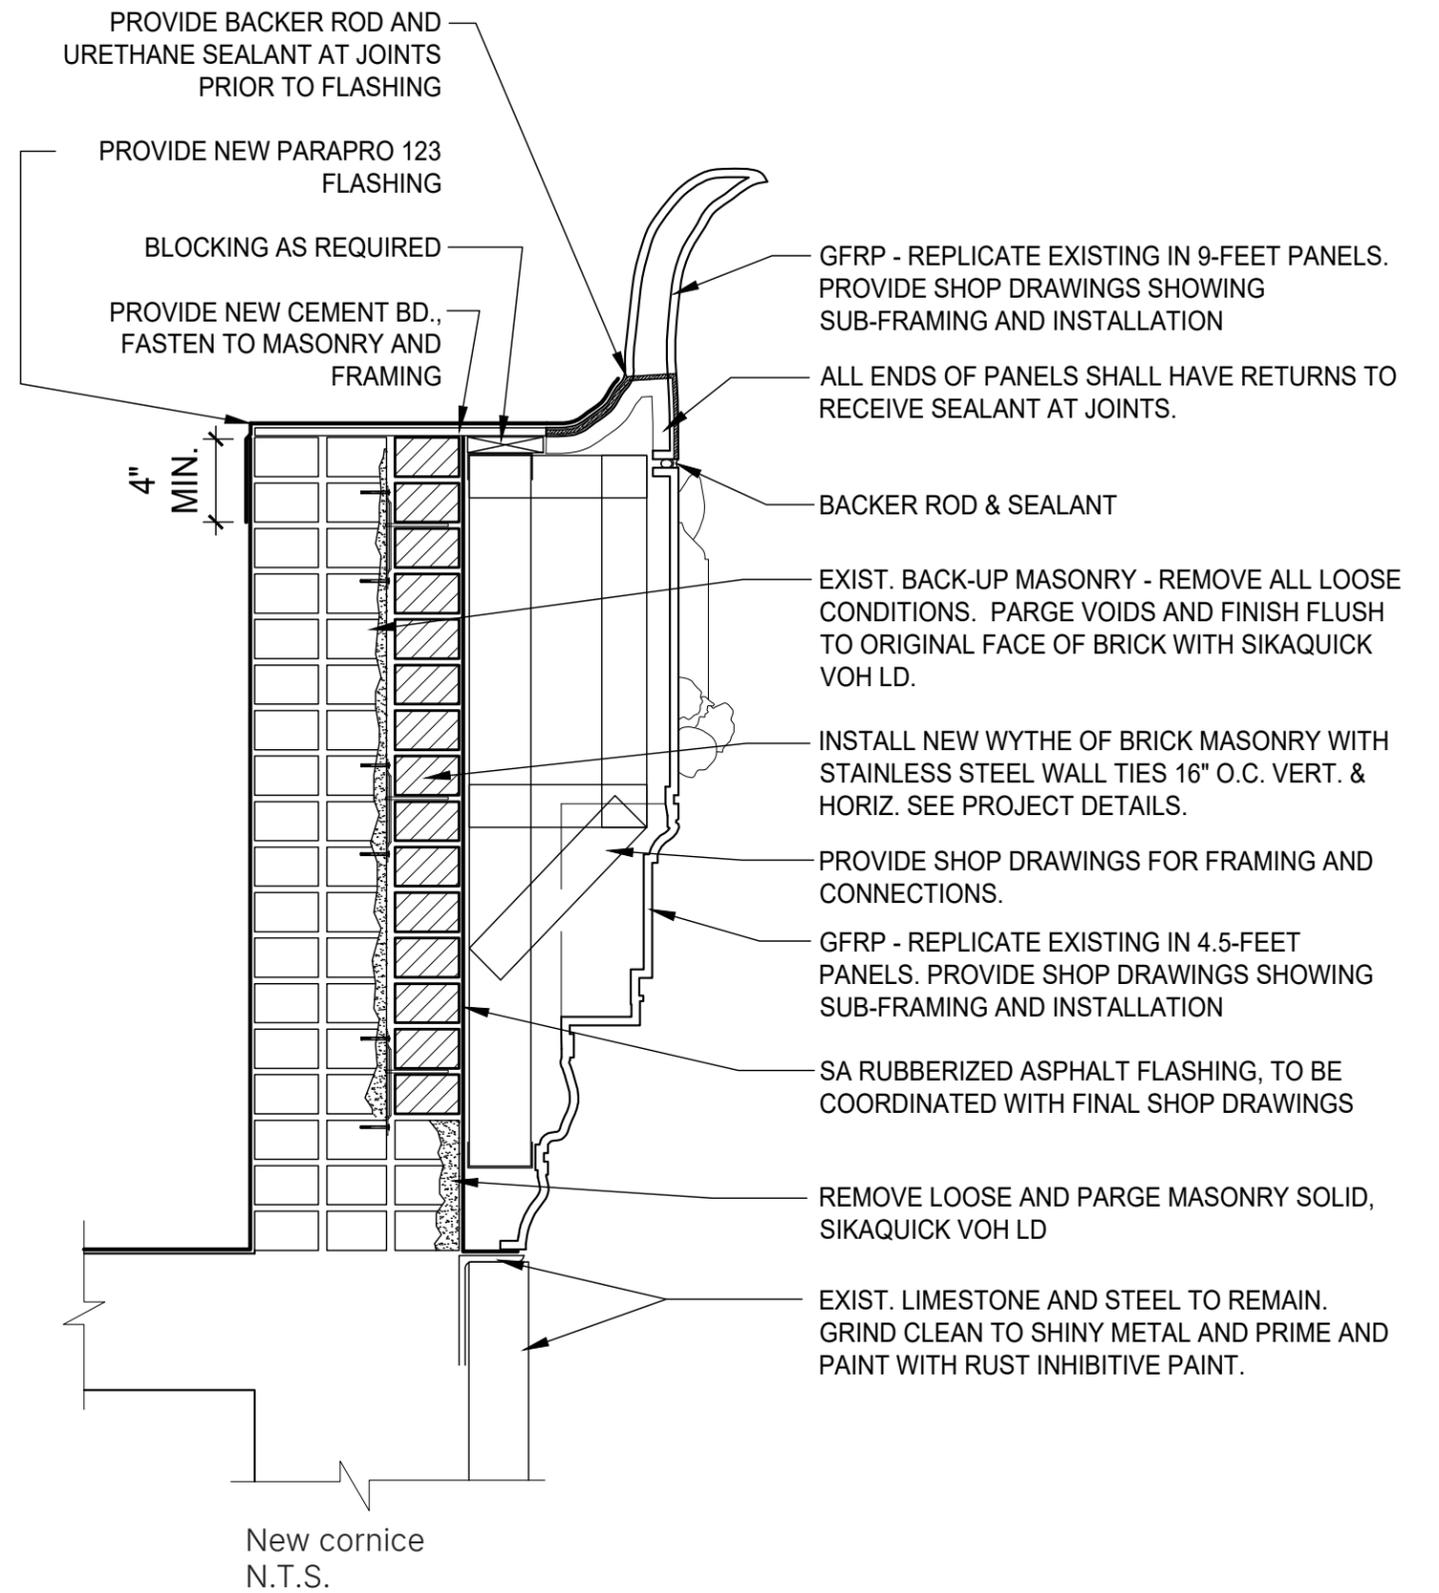
Proposed Cornice Replacement

1. Existing cornice cannot be supported by parapet.
2. Parapet can support alternate material cornice.
3. Alternate material eliminates load transferred to facade.

NOTE: Existing Terracotta at 70 Fifth Ave is coated, new GFRP shall be similarly coated
