Educational Building

70 Fifth Avenue

Landmarks Preservation Commission
Public Hearing

I. Introduction & Existing Conditions

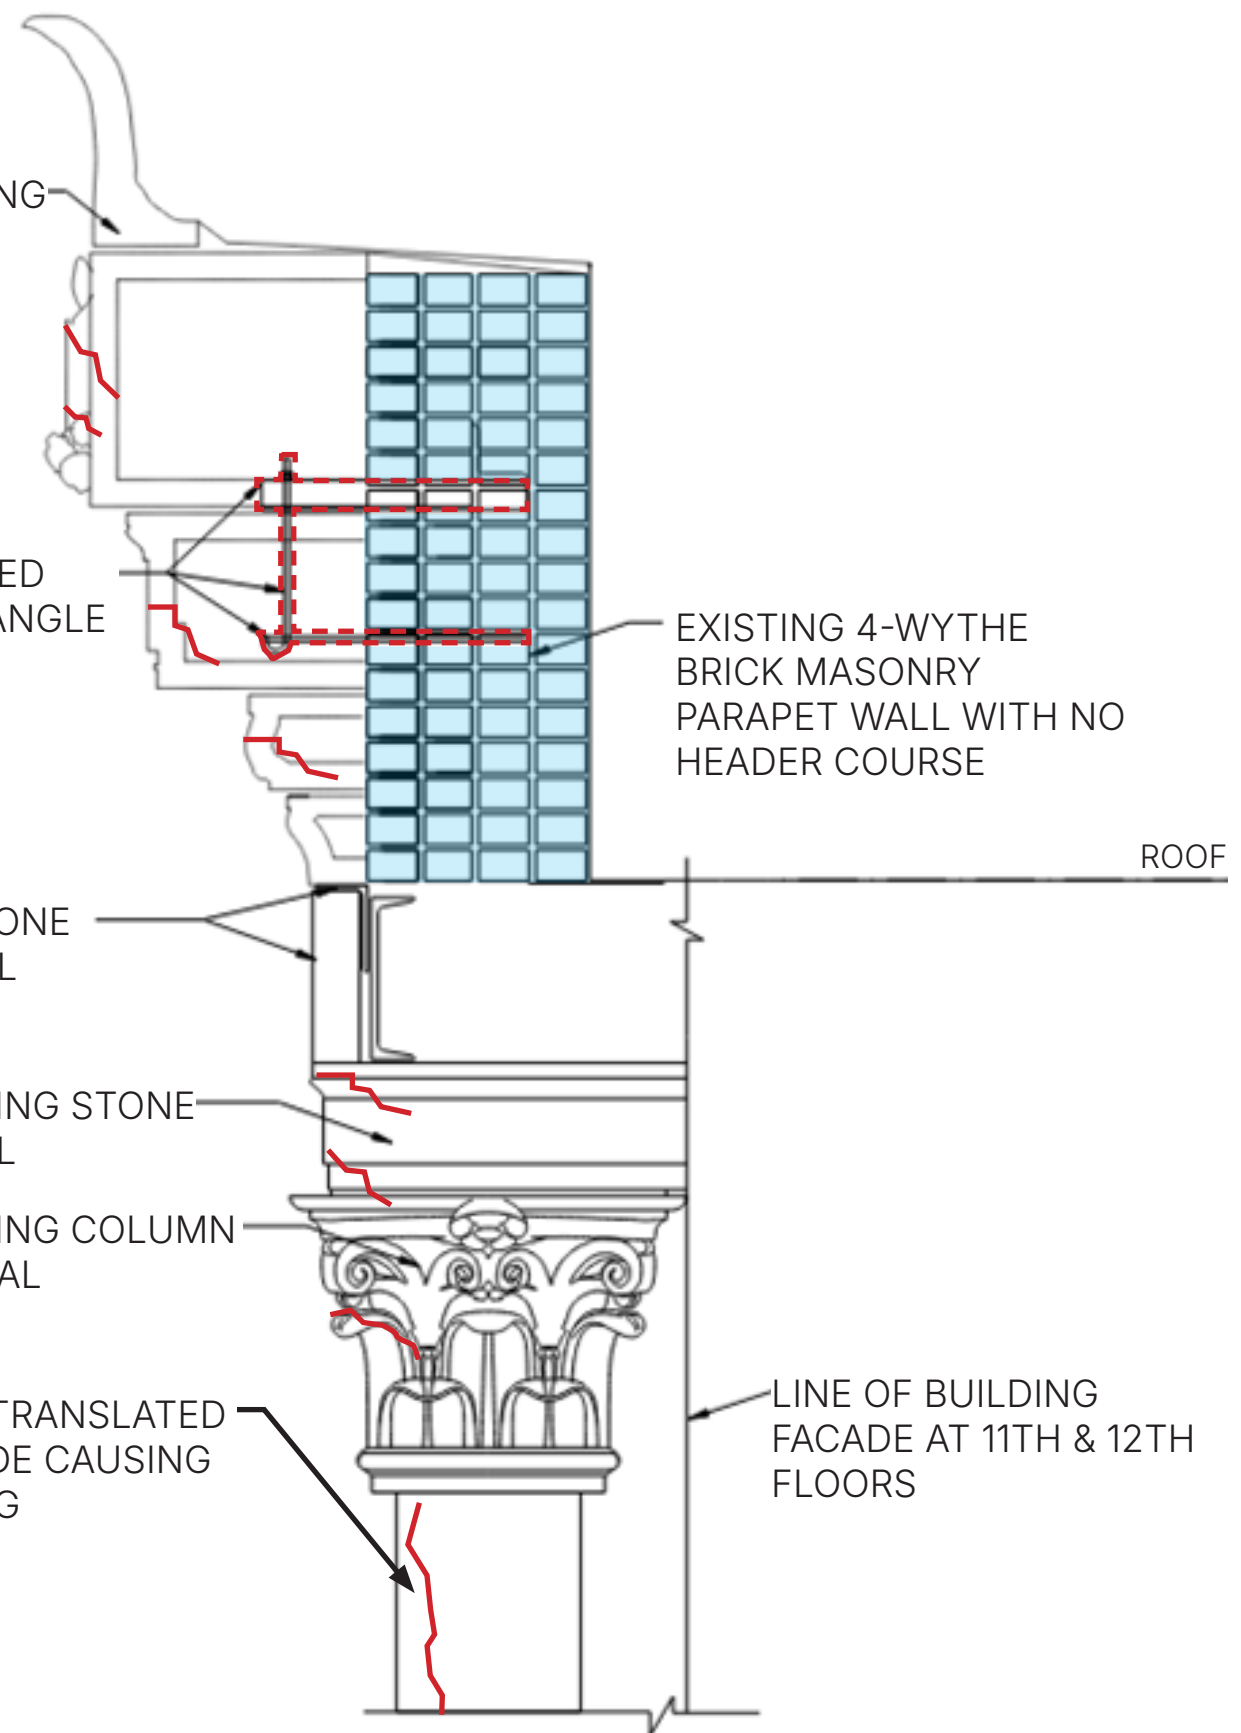
Structural Components of Cornice Parapet

EXISTING CRACKING
TERRACOTTA
CORNICE

HEAVILY CORRODED
STEEL TIE-BACK ANGLE
AND RODS

EXISTING LIMESTONE
AND STEEL ANGEL

EXISTING STONE
LINTEL

EXISTING COLUMN
CAPITAL

WEIGHT TRANSLATED
TO FACADE CAUSING
CRACKING

EXISTING 4-WYTHE
BRICK MASONRY
PARAPET WALL WITH NO
HEADER COURSE

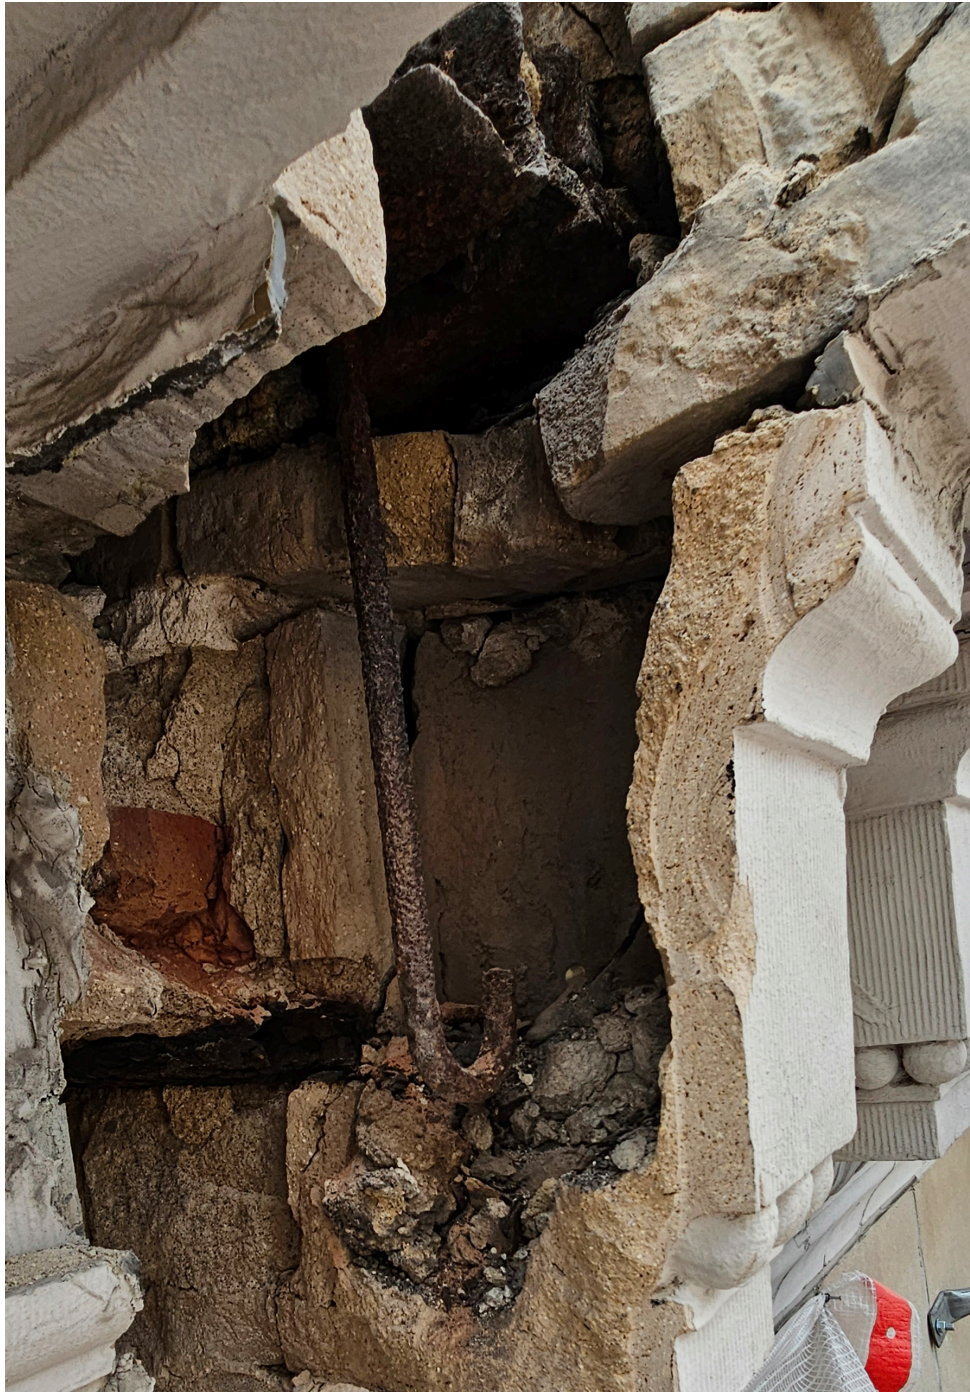
Deterioration of steel anchor embedments

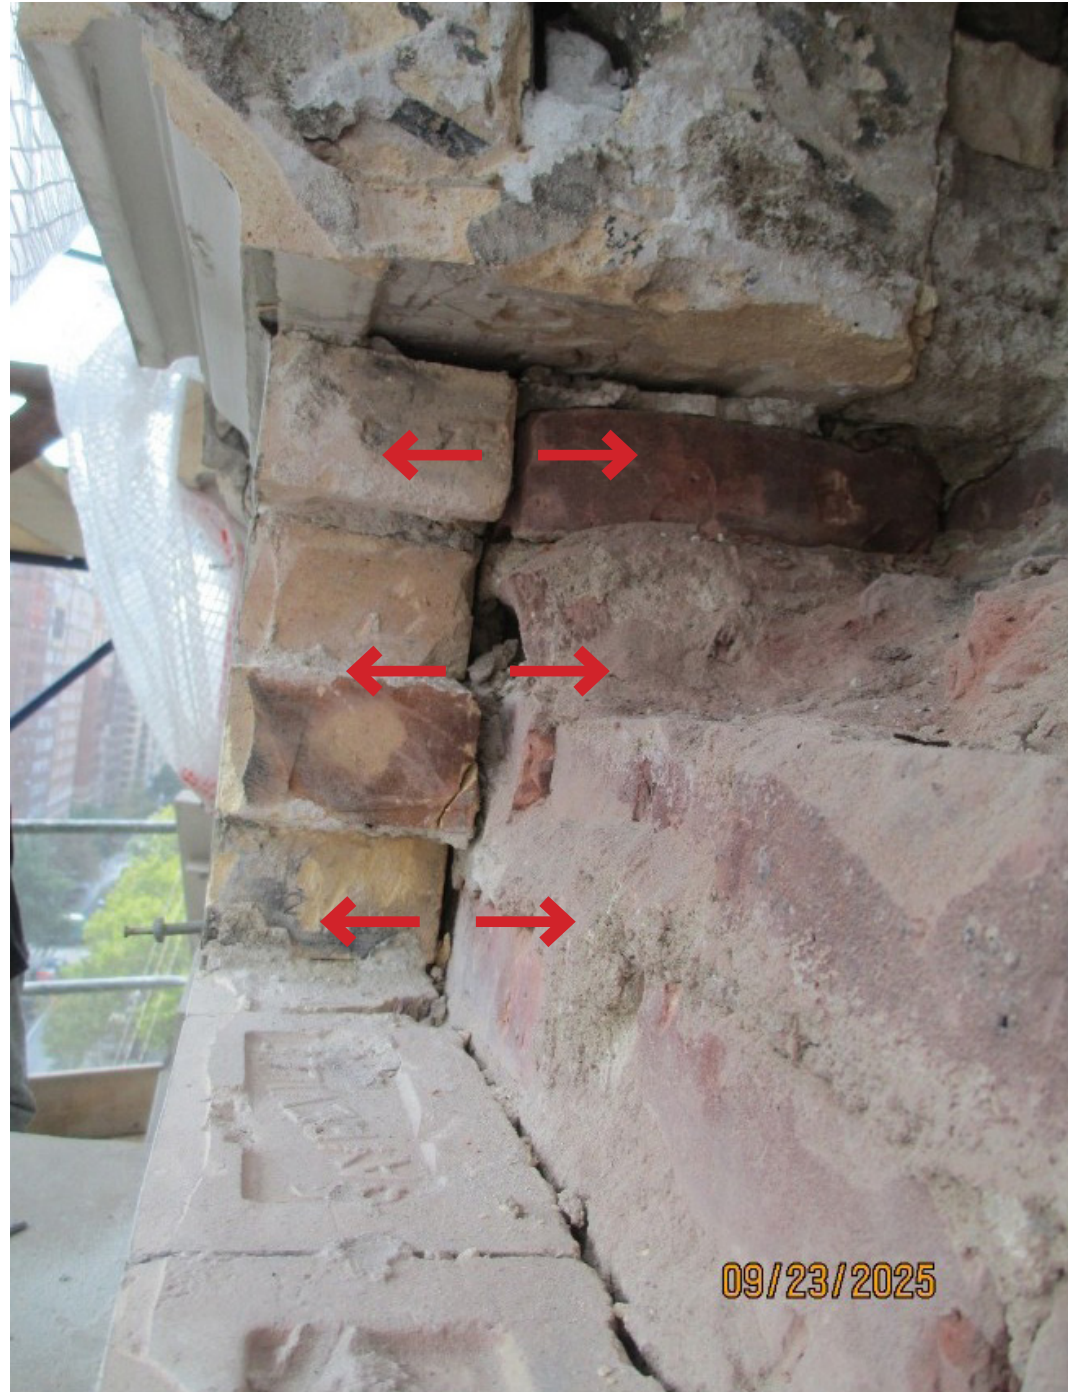
Separation between face brick and back-up brick masonry back up wall due to lack of header course

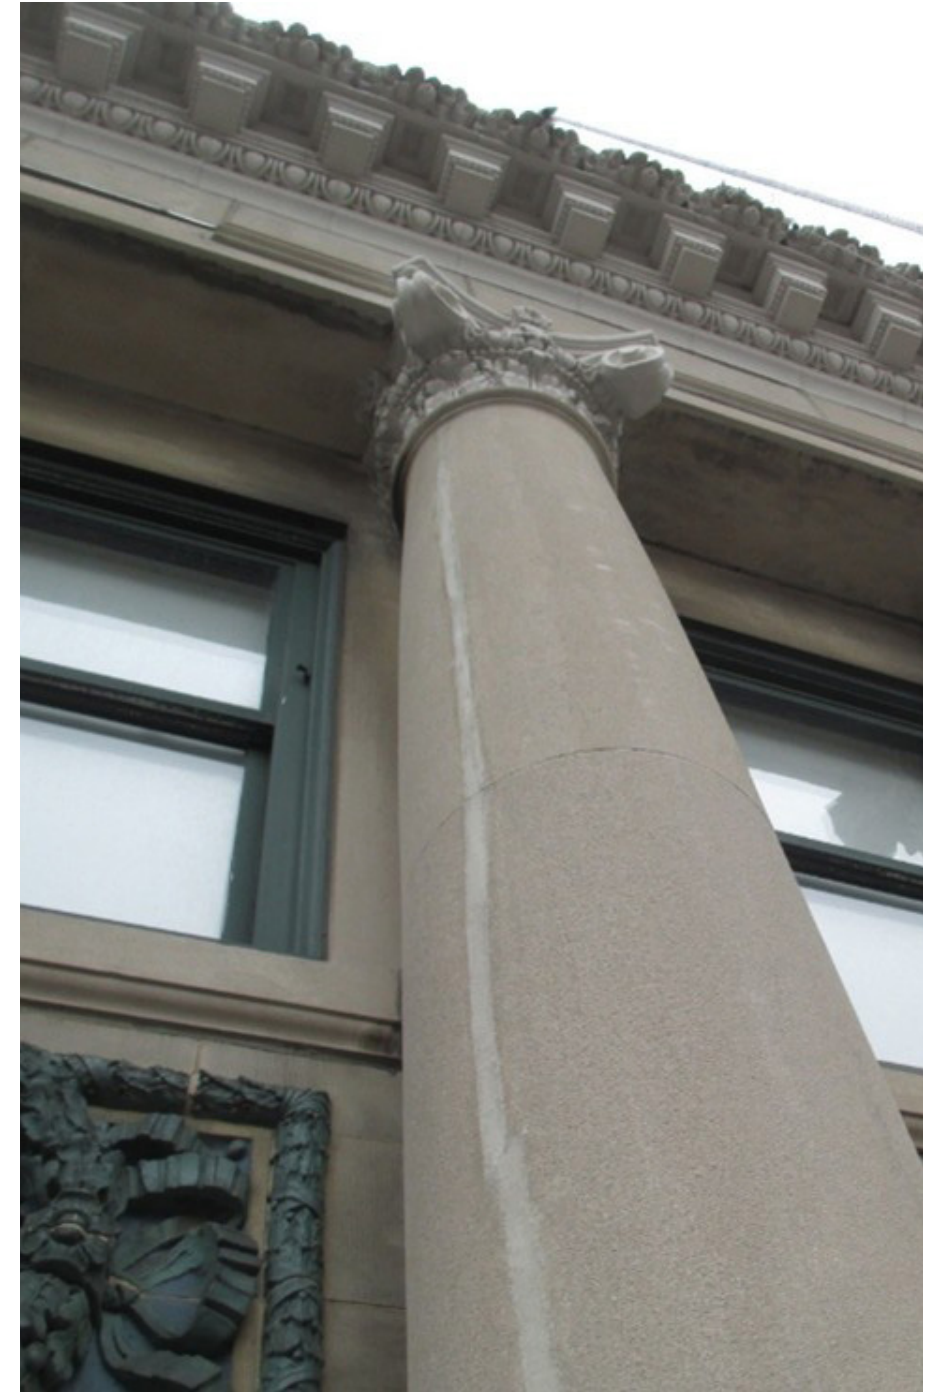
Continuous vertical cracking at limestone due to compression forces

1. Existing parapet does not have sufficient capacity to support the terracotta cornice, causing the load to be transferred to the building facade.
2. Reducing the cornice load allows the parapet to adequately support the remaining loads.
3. Removing compressive forces from the facade reduces stress, assisting in preventing future cracking to preserve the building.

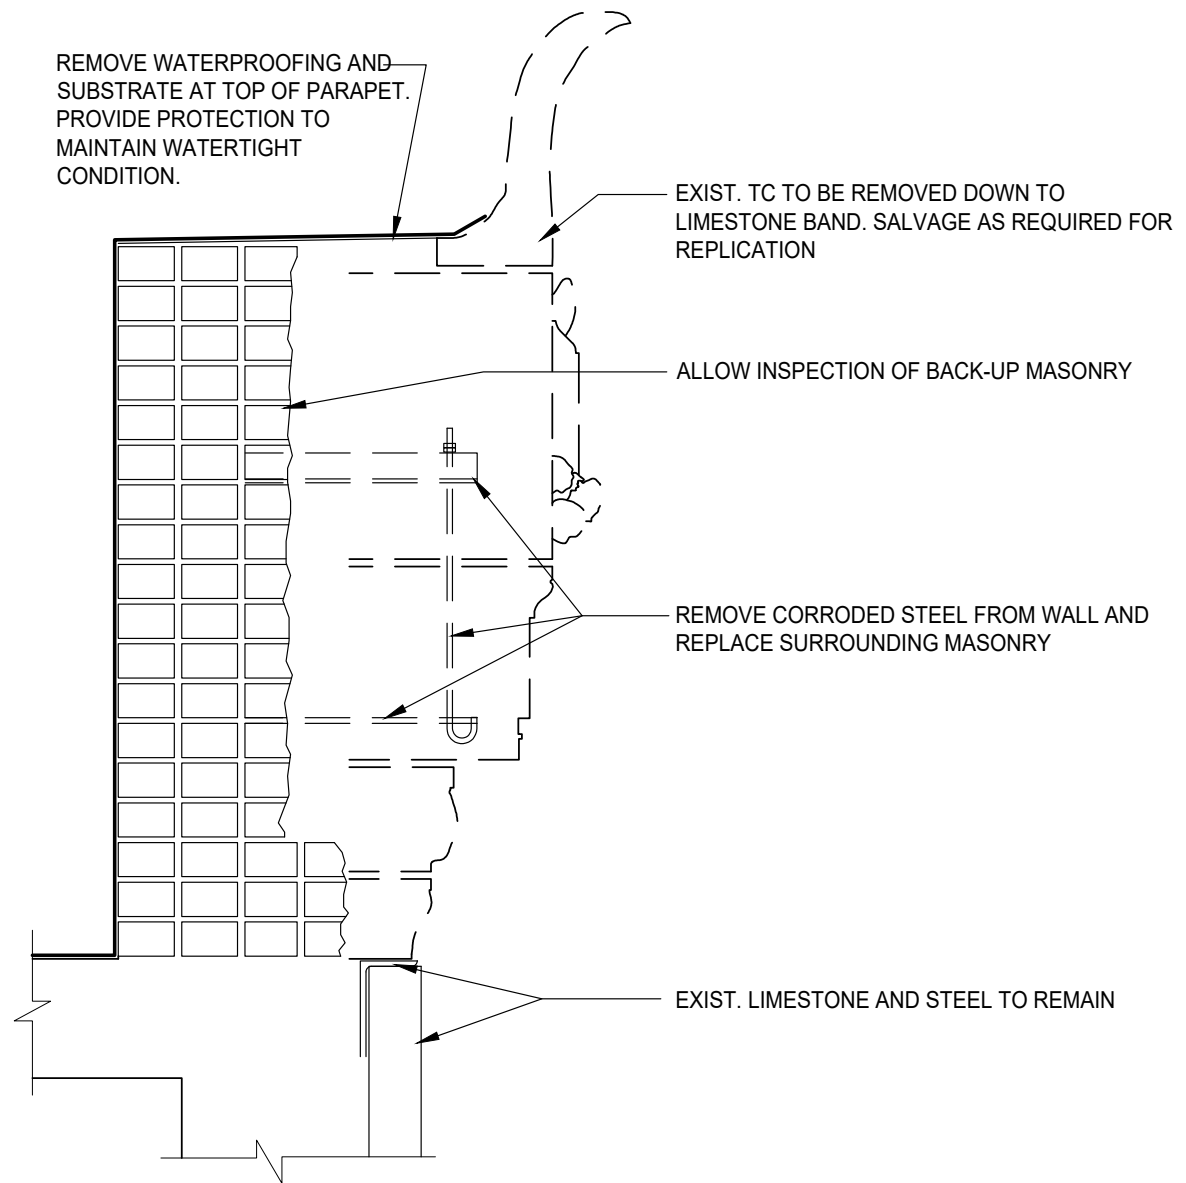
Cornice demolition

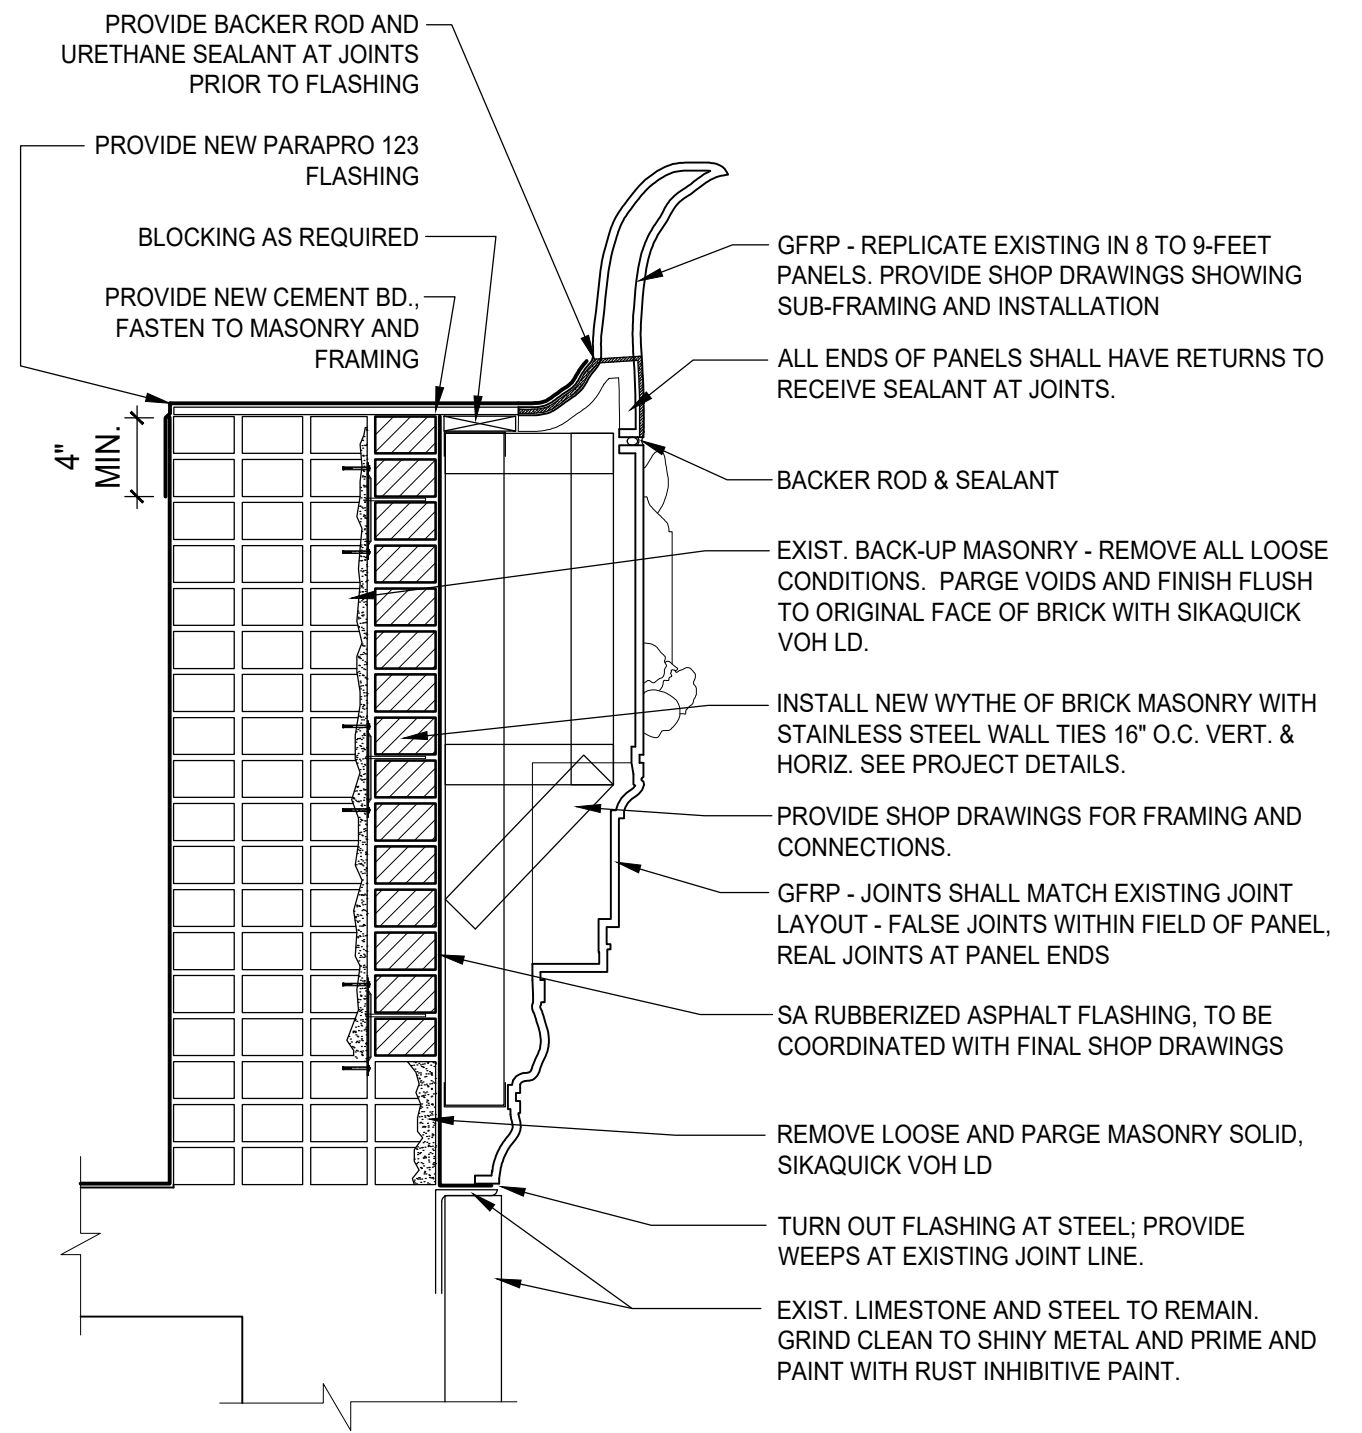
New cornice

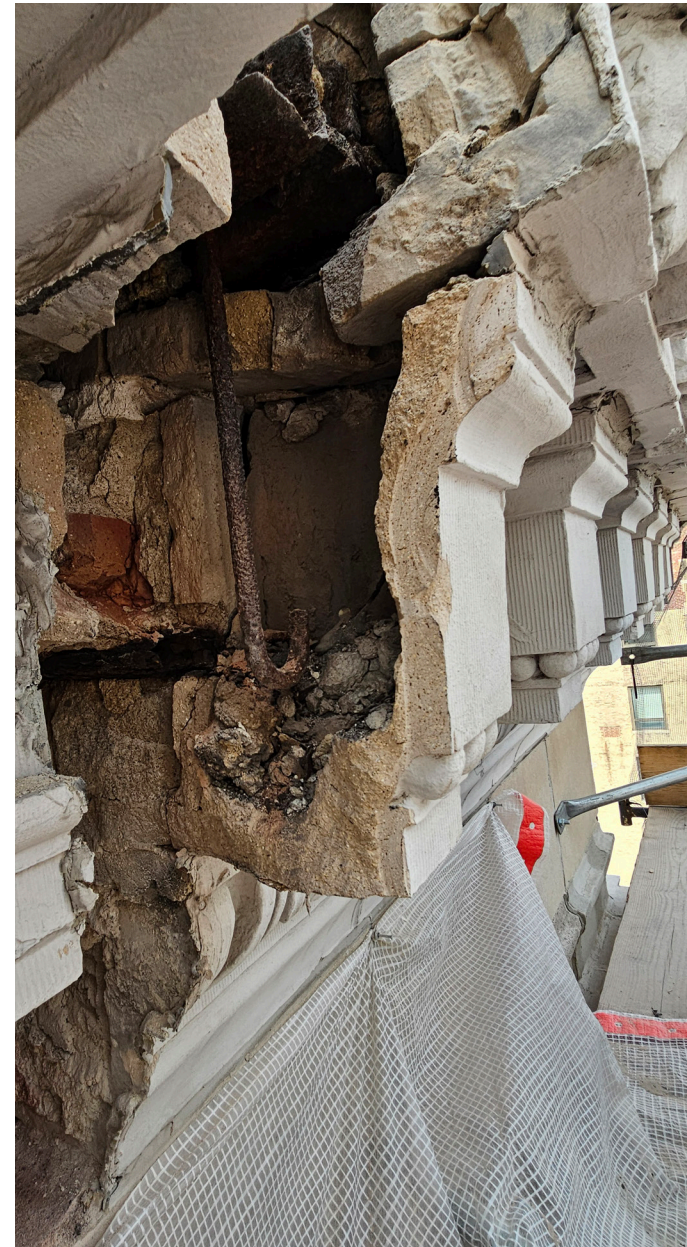
Terracotta cornice probes

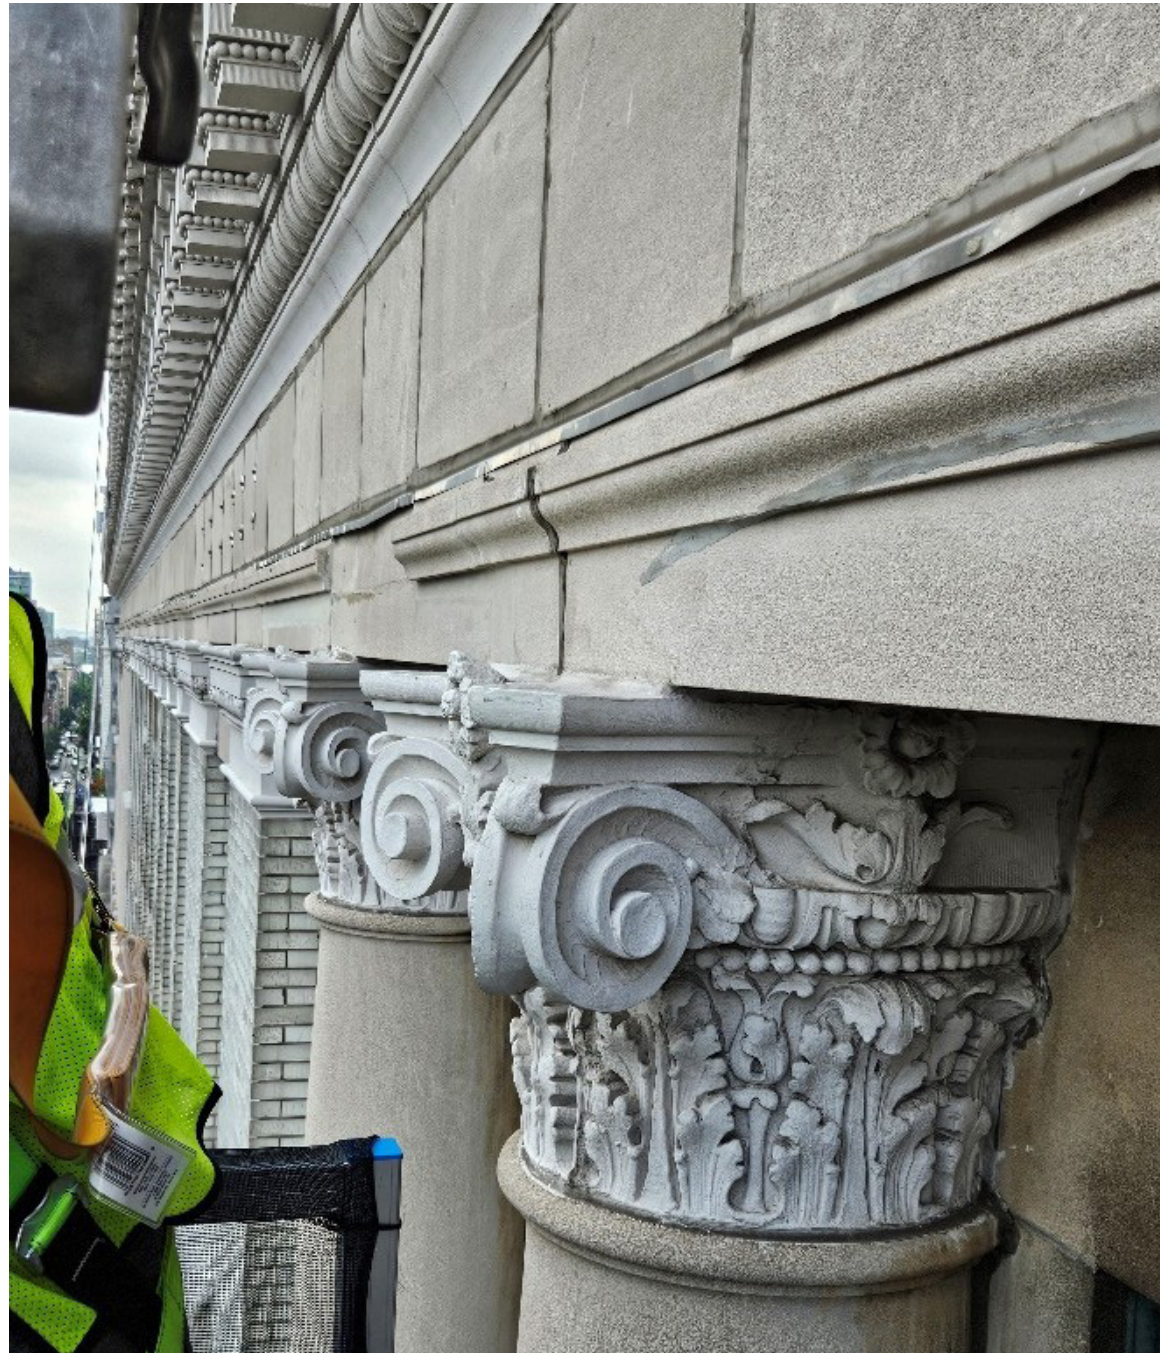
Painted column capital

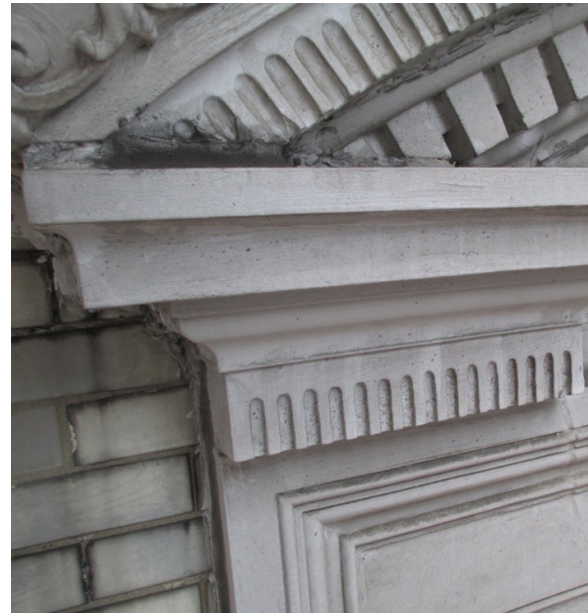
Painted window surrounds

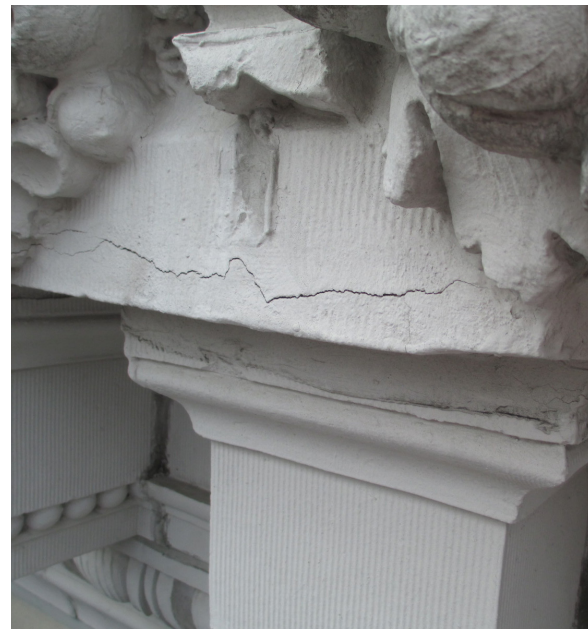
Painted cornice

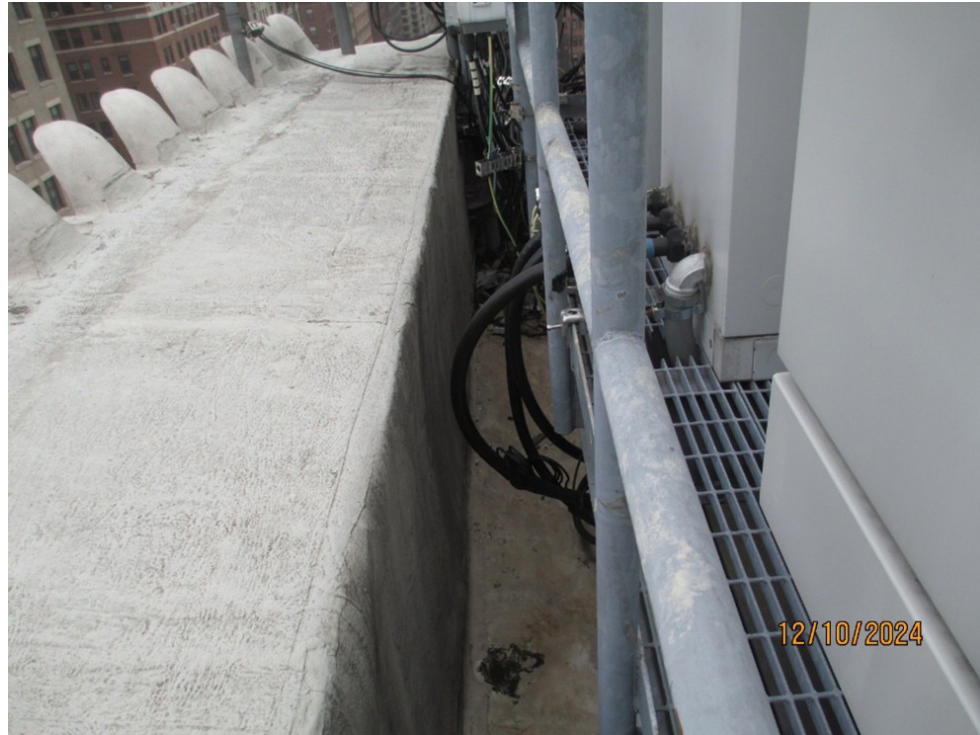
East parapet roof dunnage

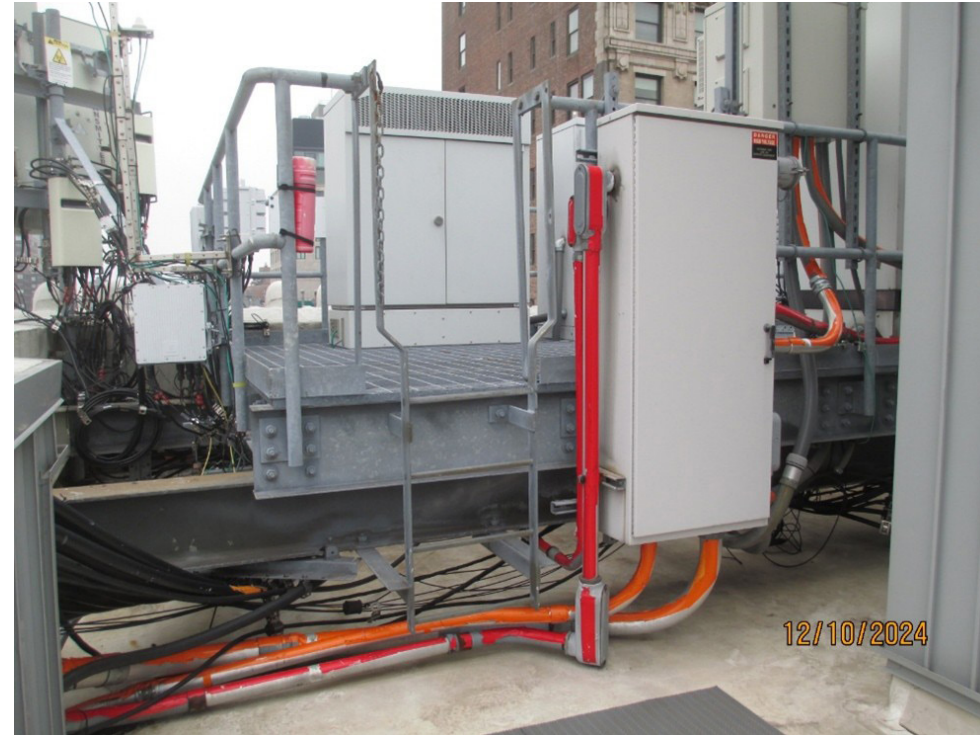
East parapet roof dunnage

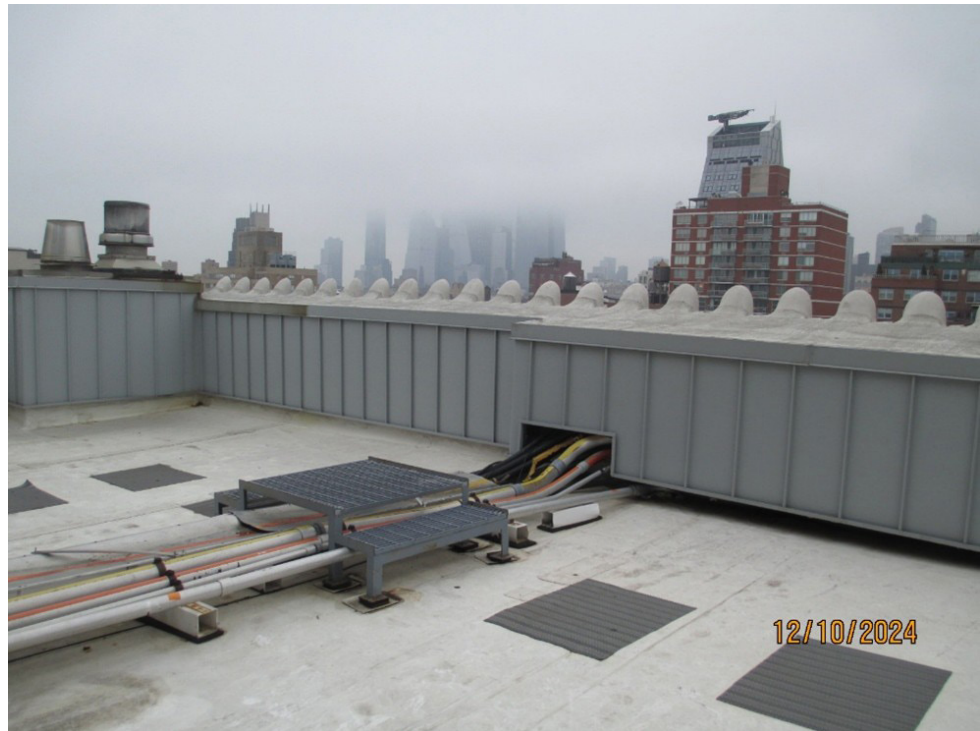
North parapet conduit chase

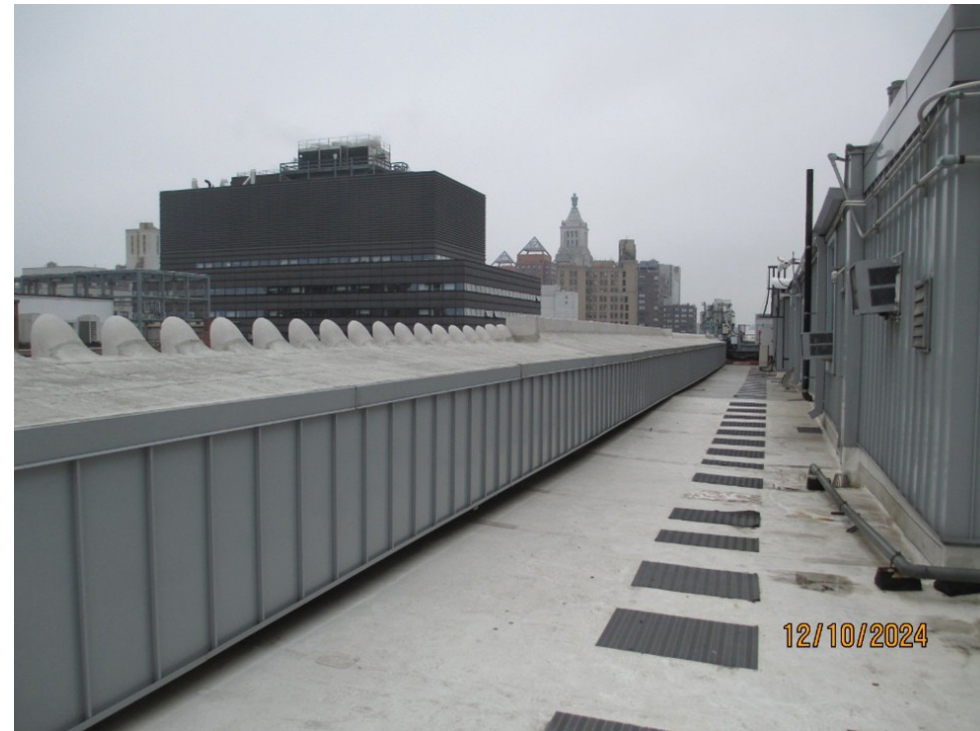
North parapet conduit chase
