139 Thompson Street
Landmark Preservation Commission Public Hearing Presentation
March 17, 2026

Table of Contents

1. History of building up to repair work
2. Required stabilization and intervention
3. Observations & Analysis undertaken
4. CCD1 and its ramifications
5. New configuration and compliance
6. Facade conditions and assessment
7. Proposed reconstruction

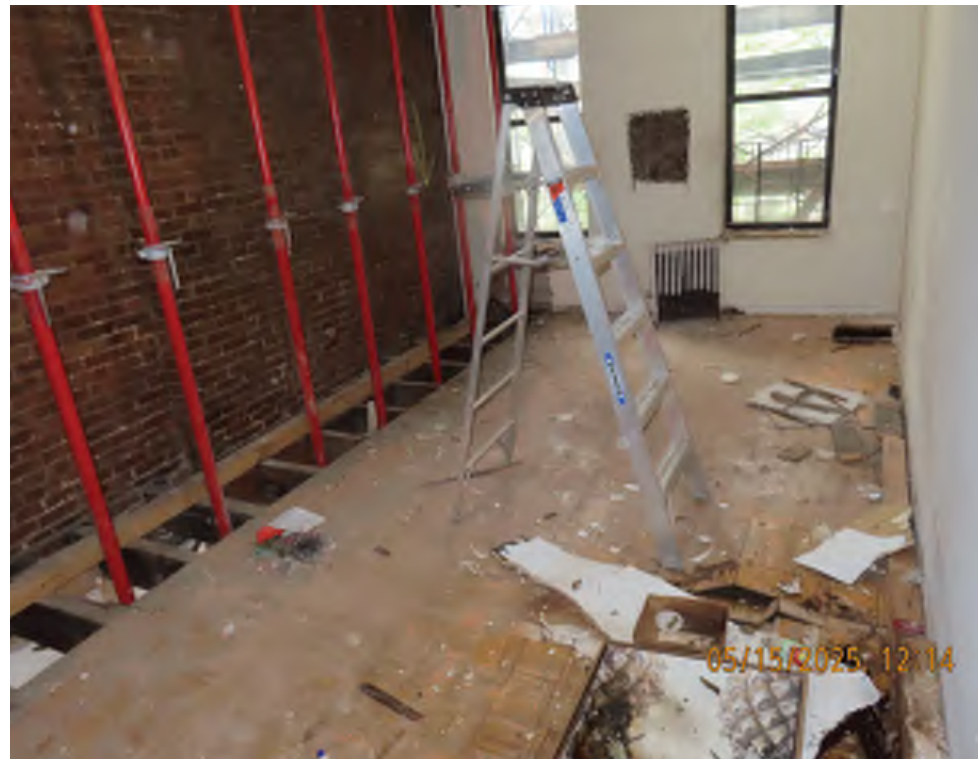
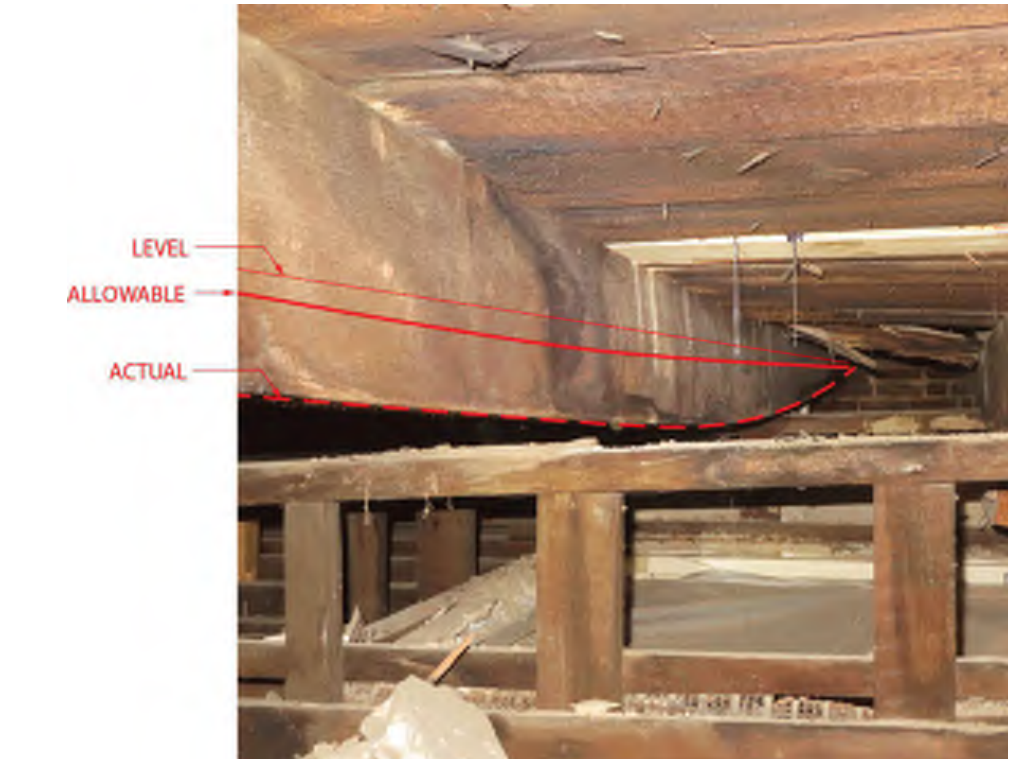
TILTED STAIRS DUE TO EXCESSIVE FLOOR JOIST DEFLECTIONS

FLOOR JOIST DEFLECTION

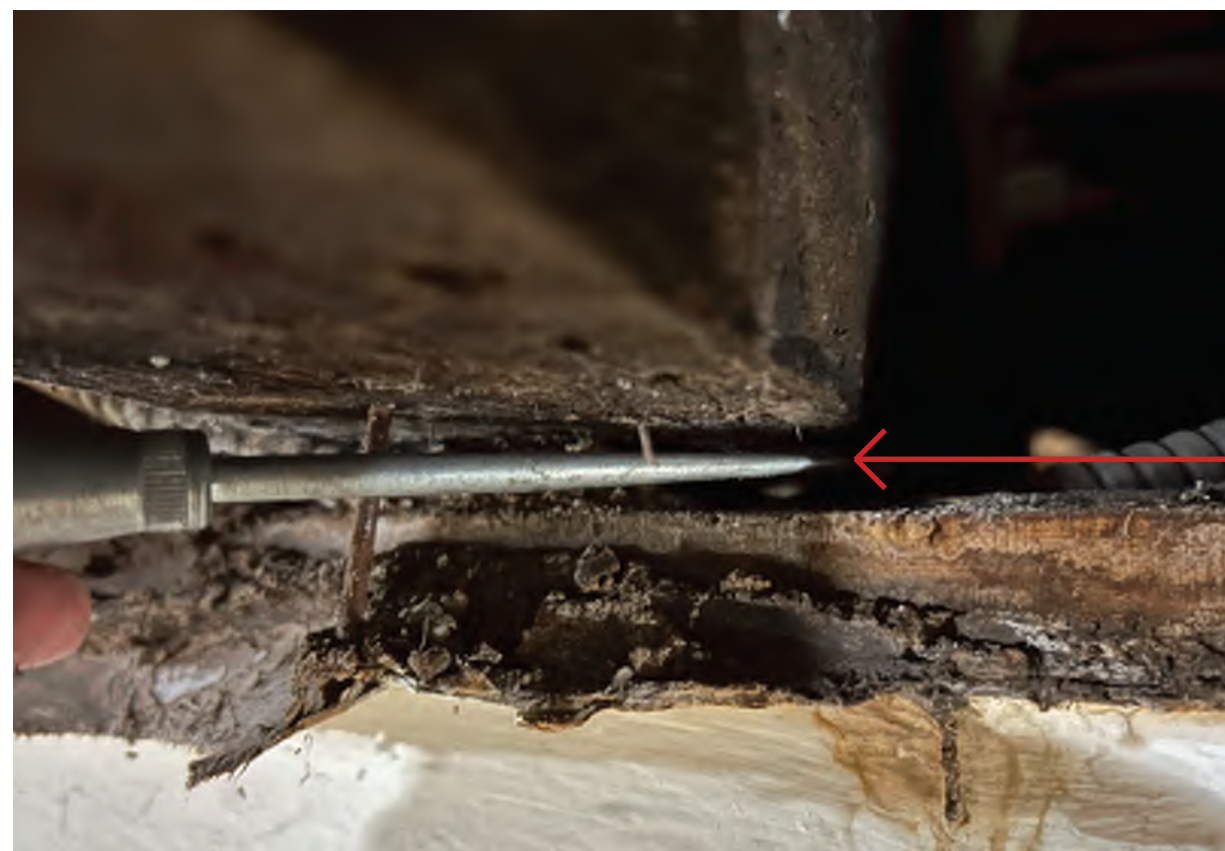
JOIST NOT BEARING ON CENTER WALLS

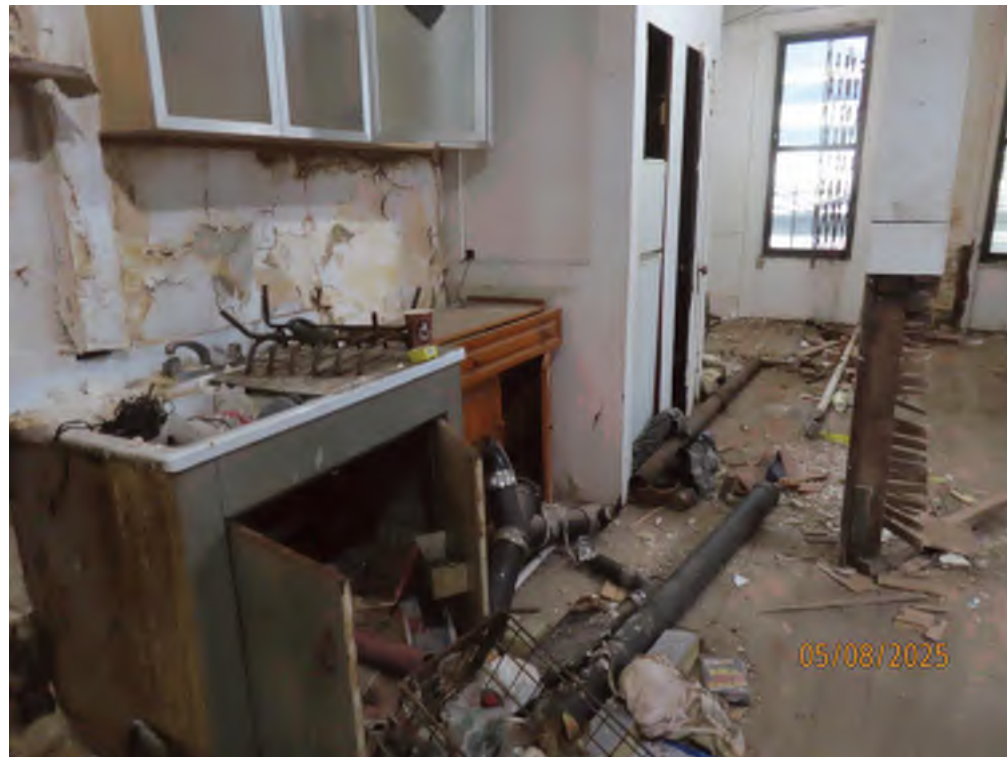
CURRENT CONDITION OF INTERIOR (TYPICAL)

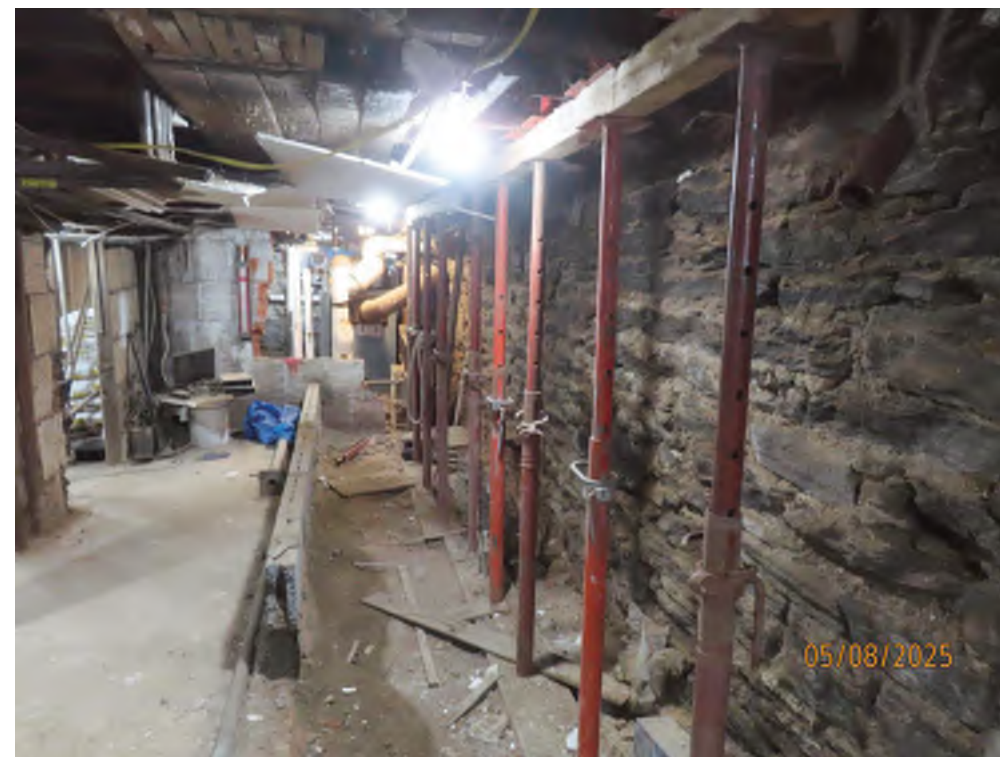
CURRENT CONDITION AT CELLAR

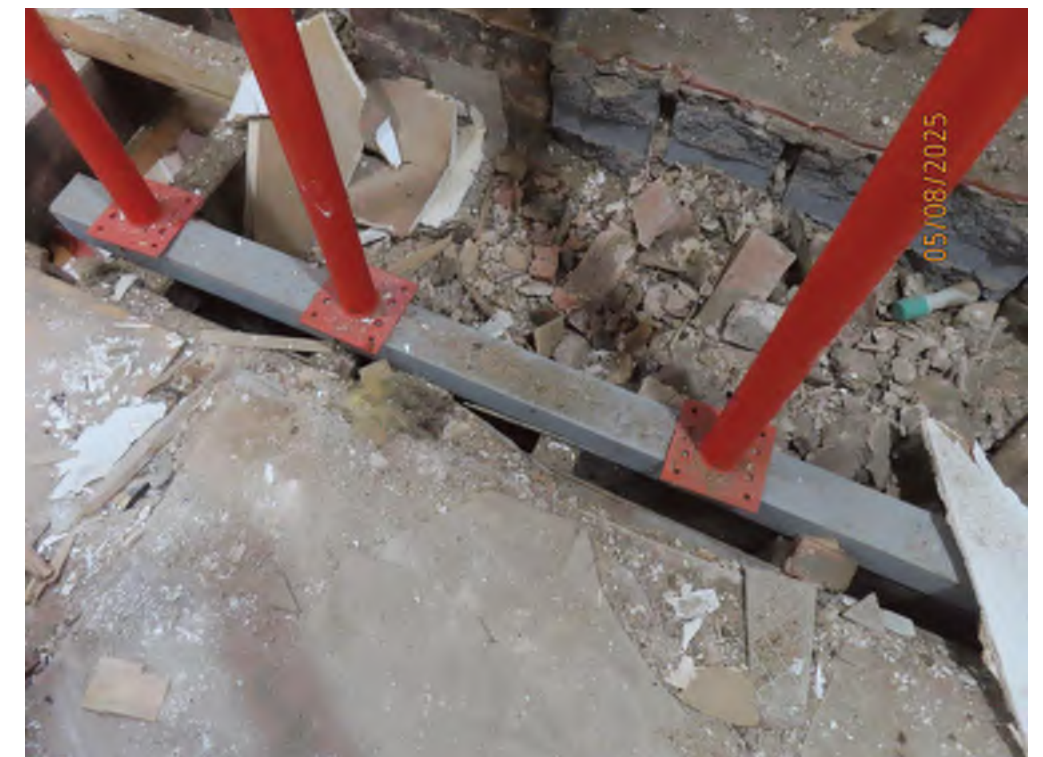
SHORING JACKS (DETAIL)

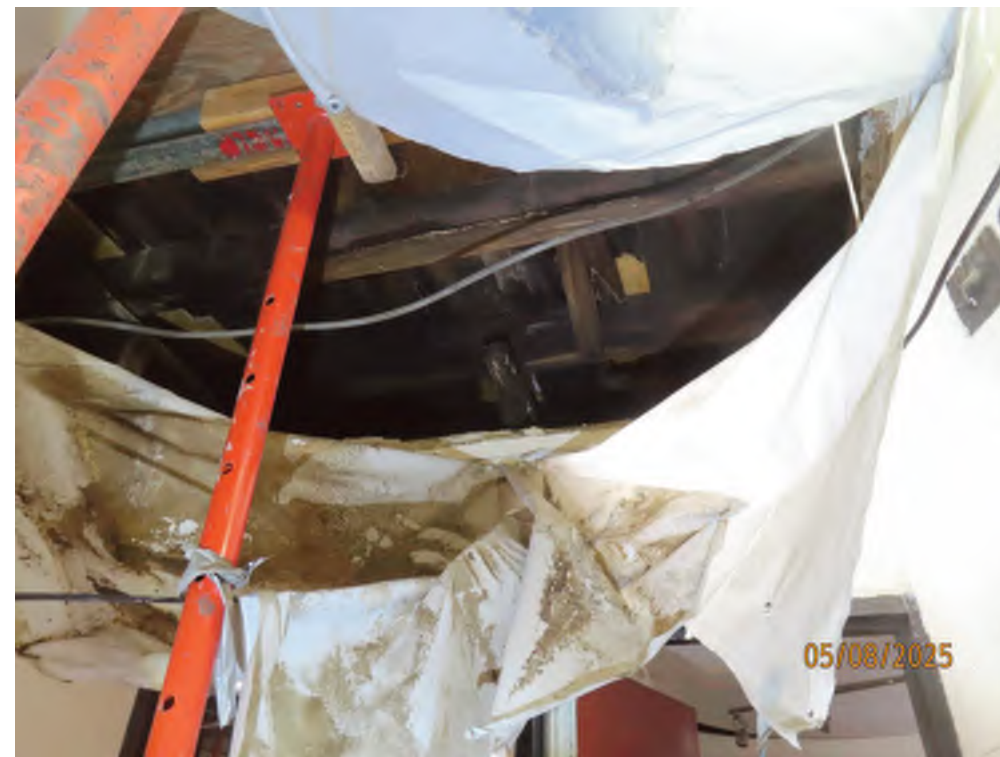
TYPICAL OVERHEAD CONDITION WITH SHORING JACK IN PLACE

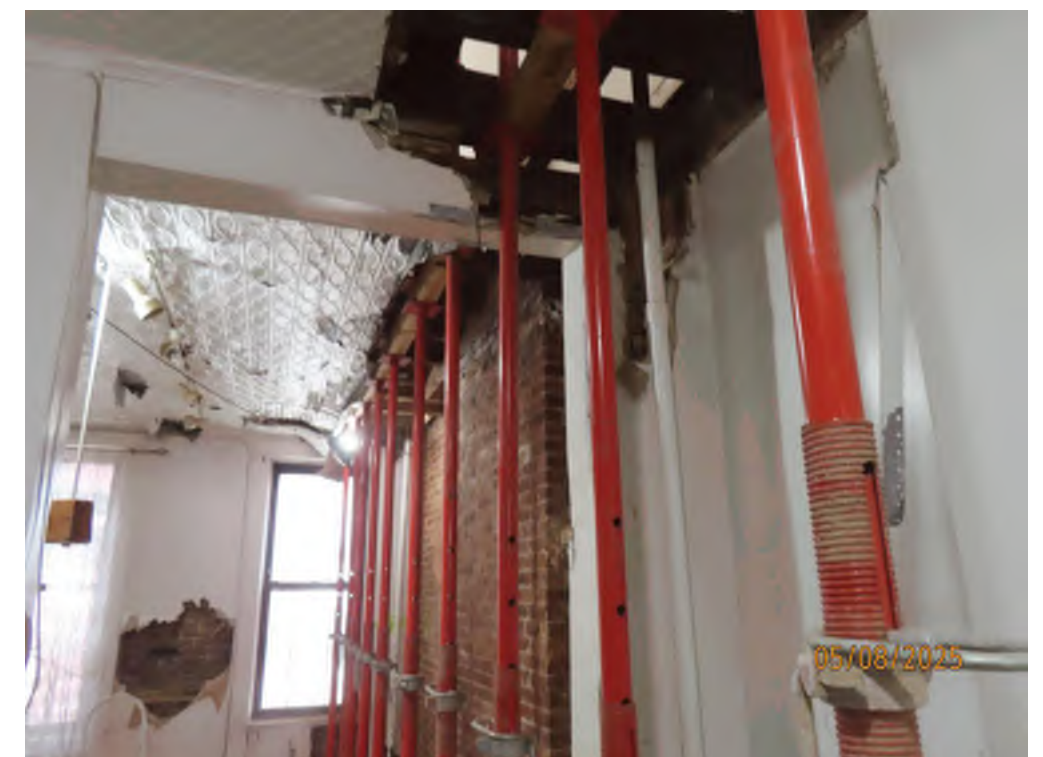
TYPICAL PERIMETER CONDITION AT INTERIOR

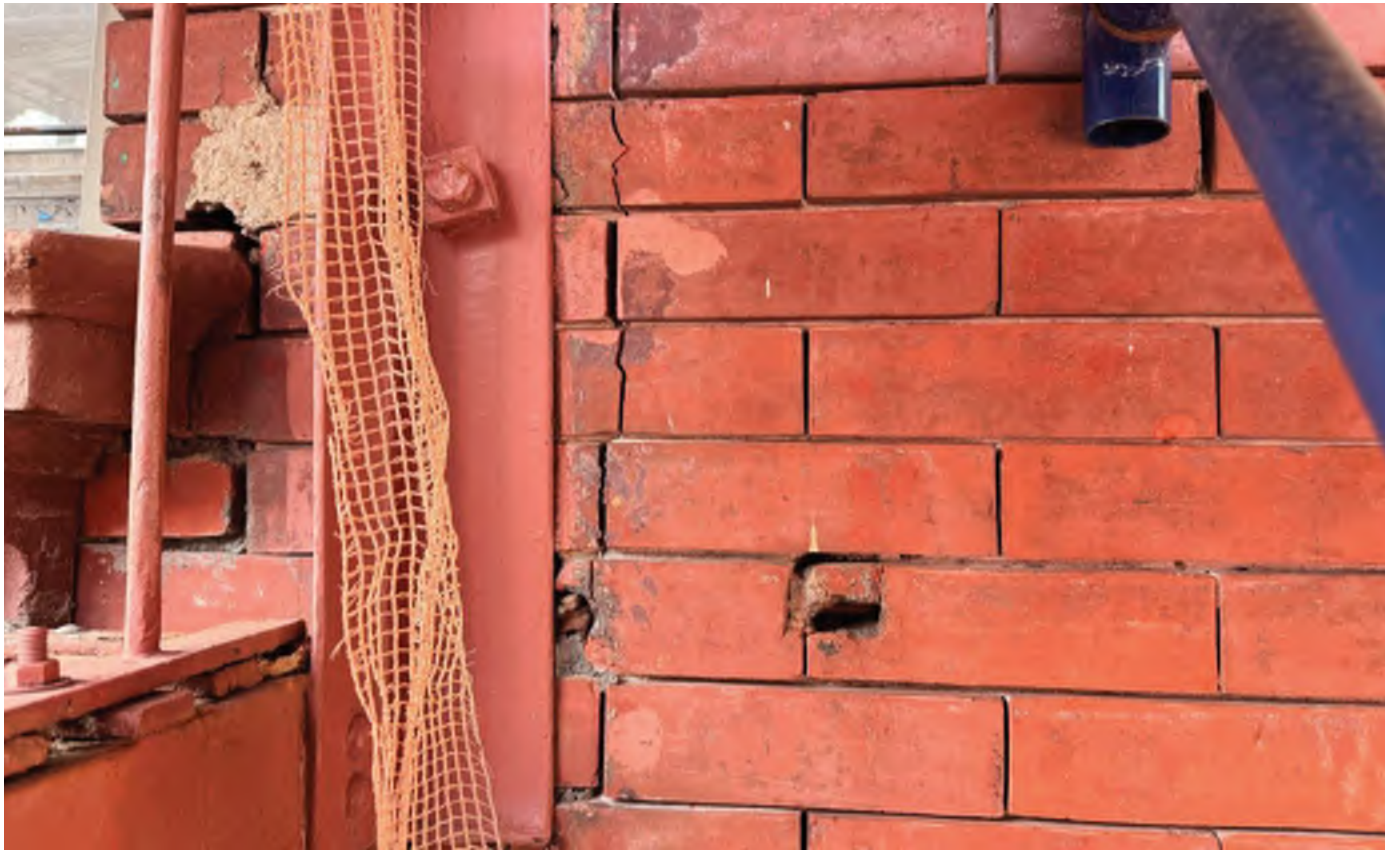
5 Vertical Brick Crack

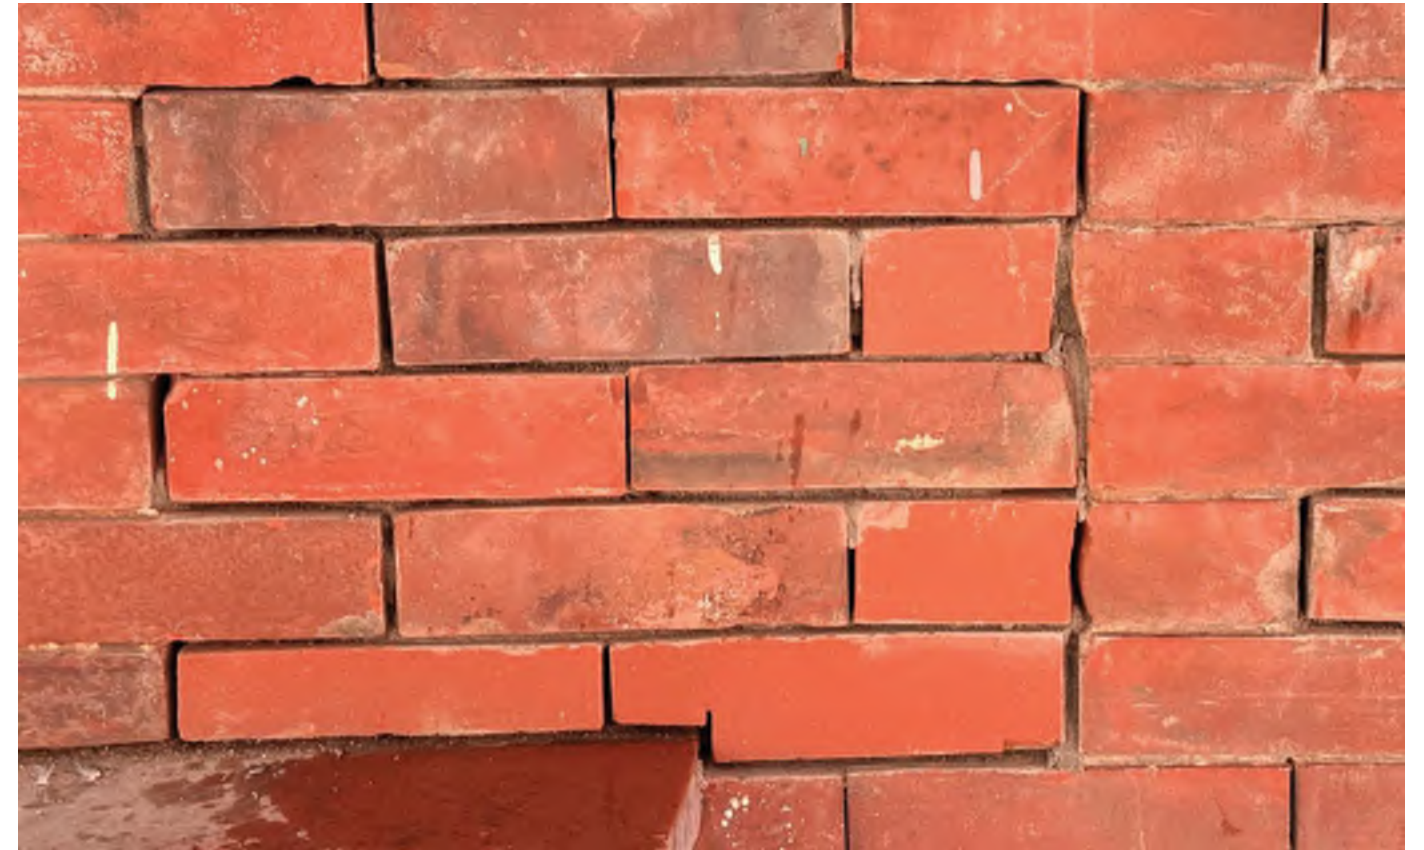
6 Discoloration/Non-Original Brick

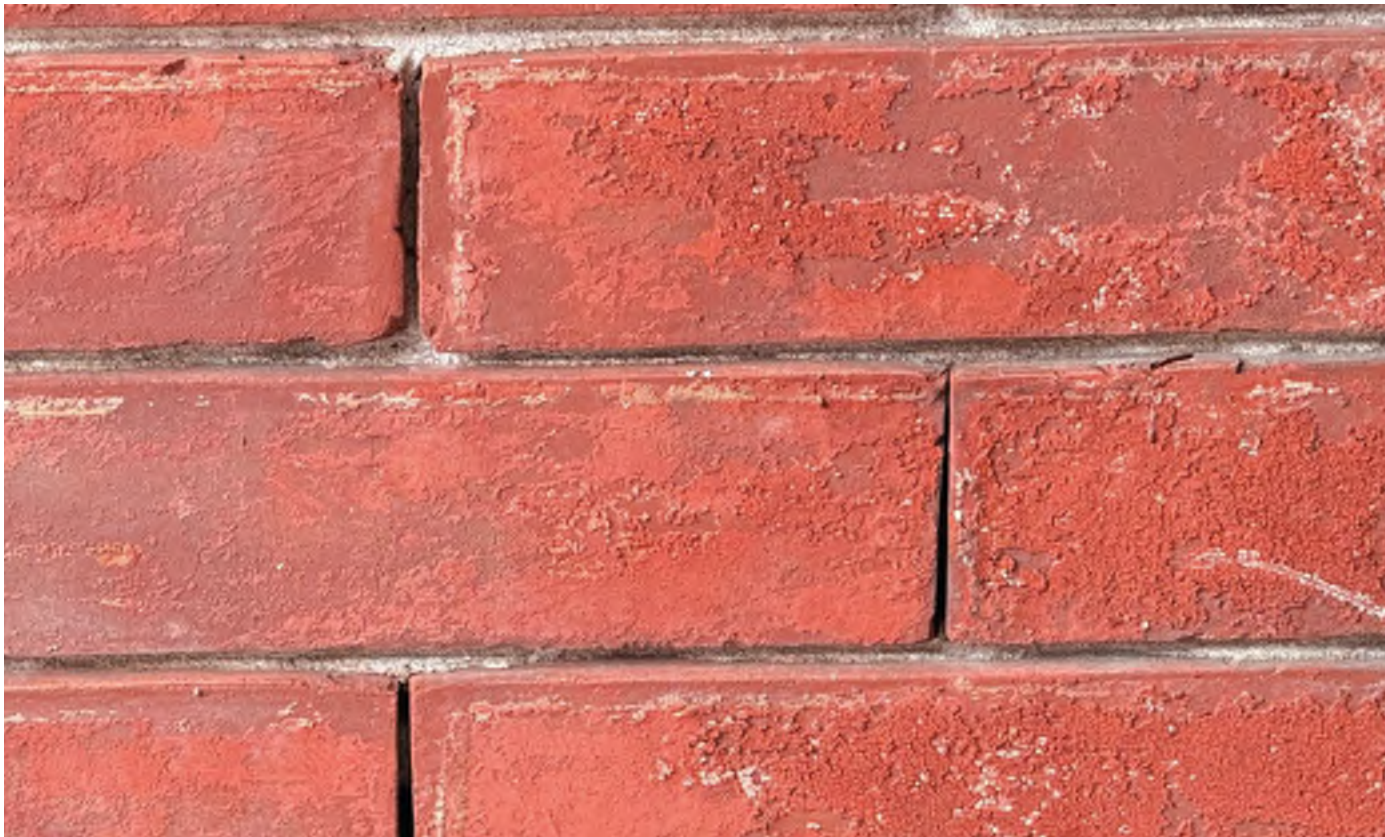
7 Former Coating Damage

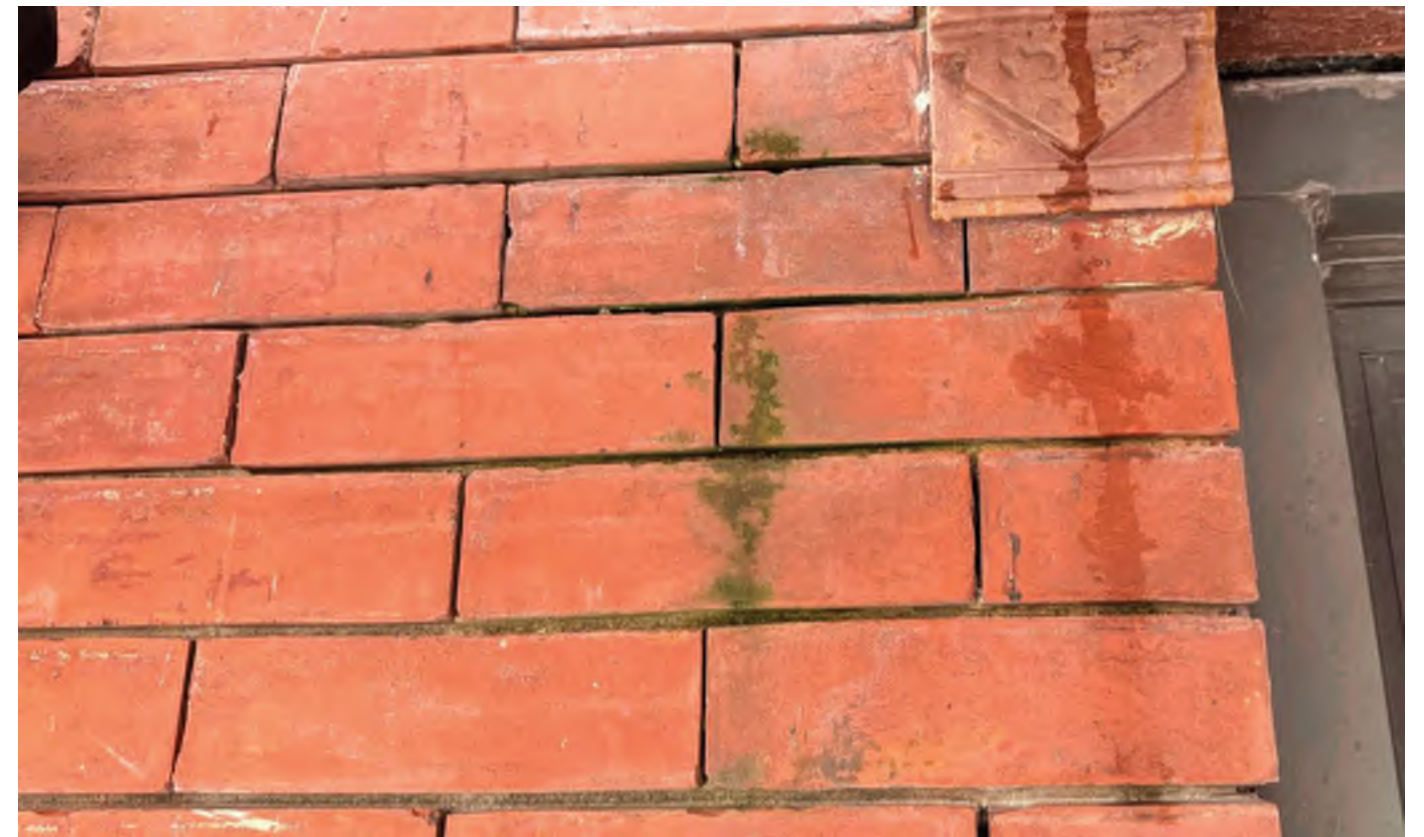
8 Organic Growth

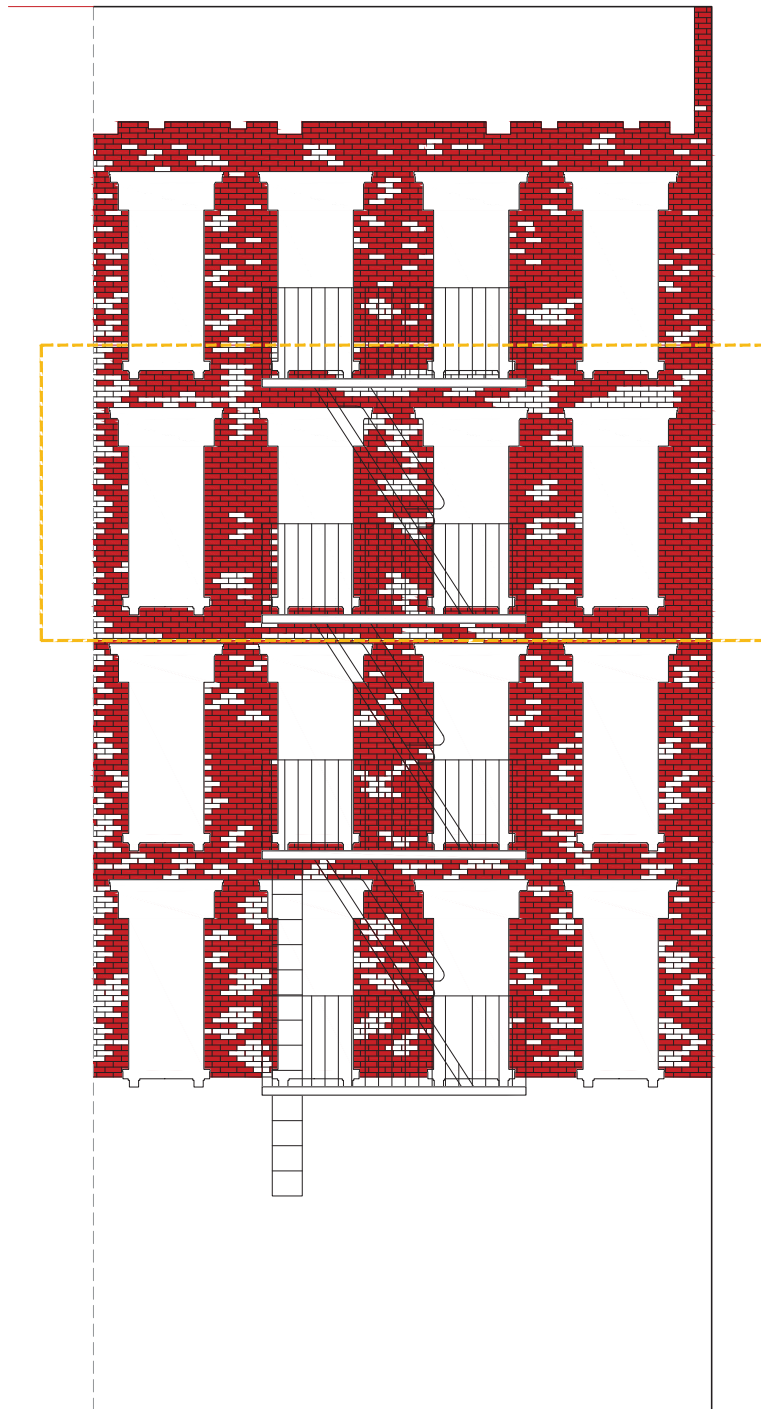
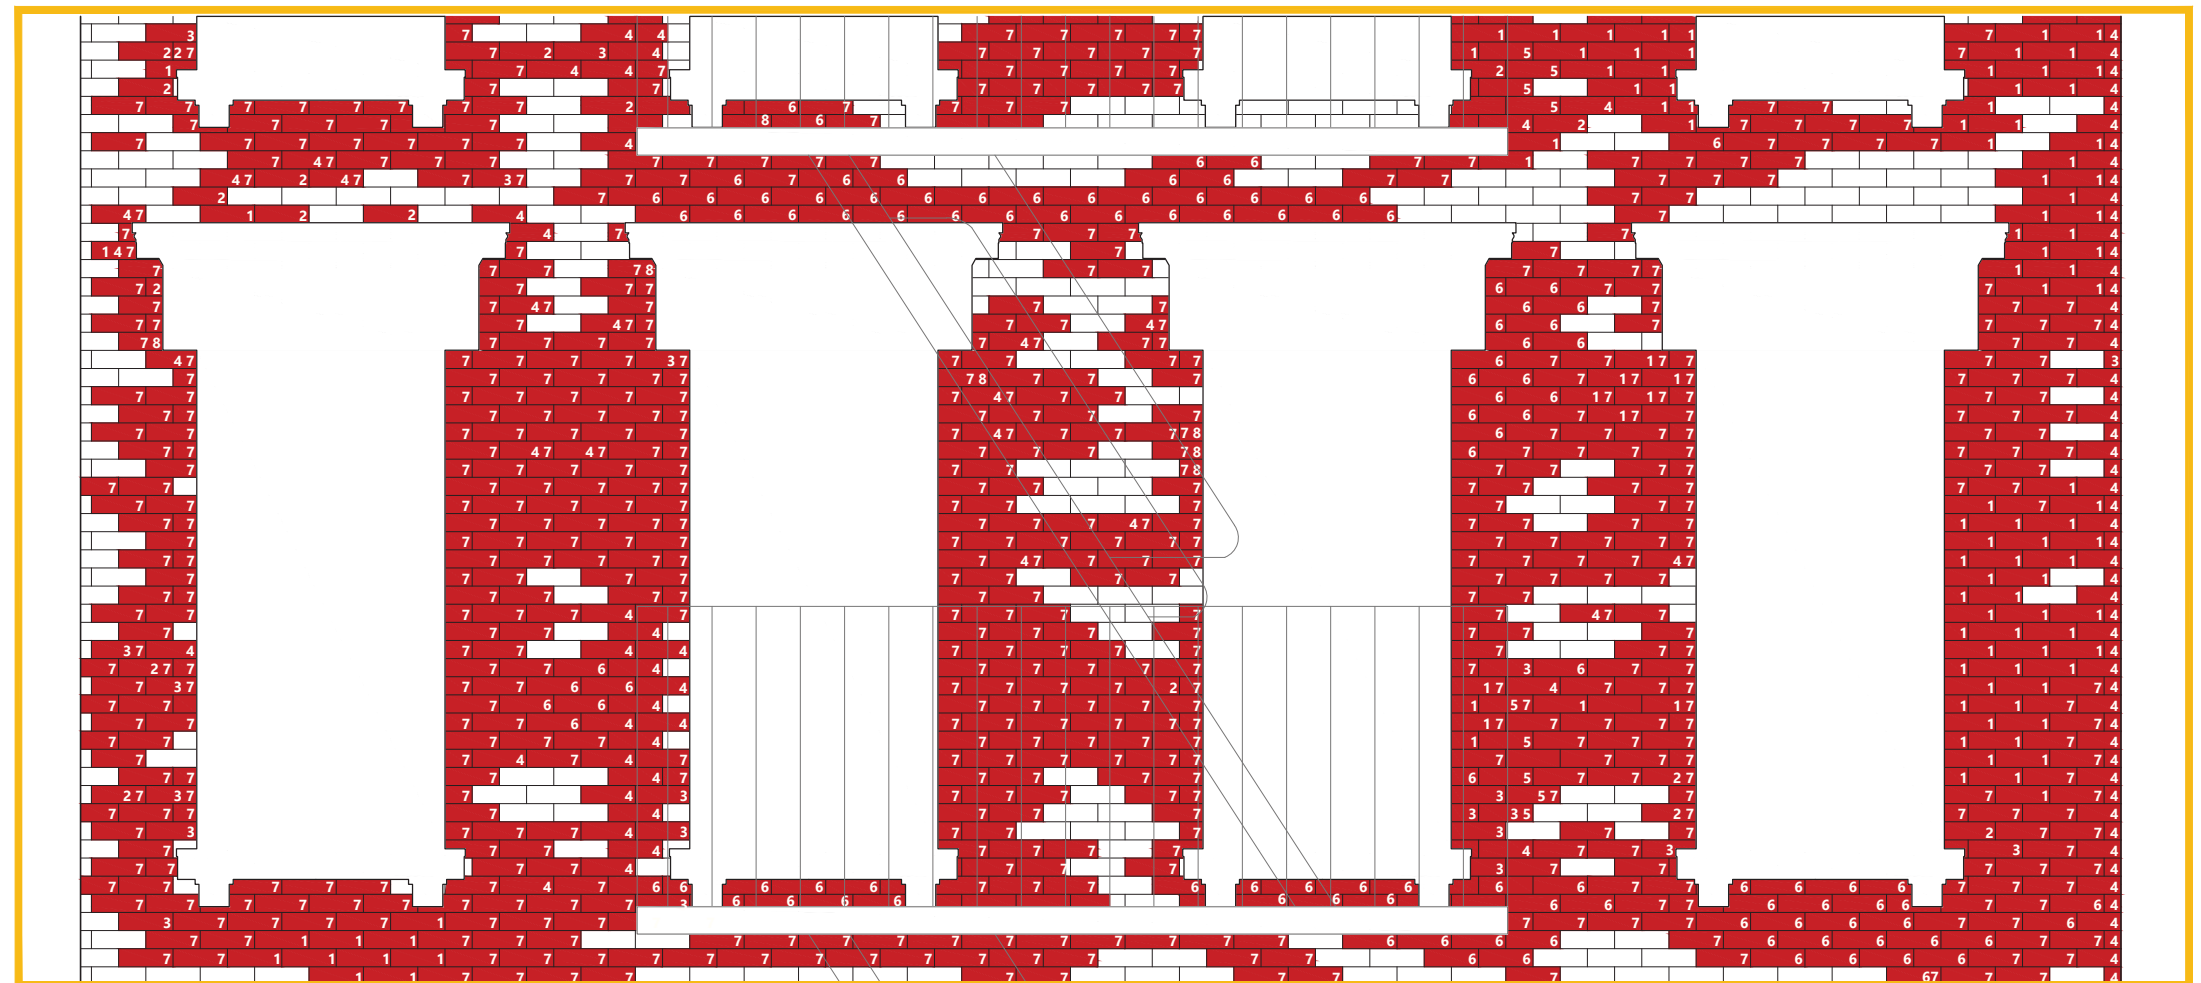
Front Facade Inspection - Bricks

ID No.	Condition	% of Total Damaged	# Bricks
1	Heavy Crazing	27.00%	816.48
2	Brick Spall	5.00%	151.2
3	Cracked Brick	5.00%	151.2
4	Missing/Damaged Brick	6.00%	181.44
5	Vertical Brick Crack	1.50%	45.36
6	Discolor/Non-Original Brick	4.25%	128.52
7	Former Coating Damage	51.00%	1542.24
8	Organic Growth	0.25%	7.56

±	3024	Damaged Bricks
	3780	Total Bricks
	80%	% of Total Bricks
