FACADE REPAIRS & STAIRWELL REINFORCING

139 THOMPSON STREET
 NEW YORK, NY

Front Facade Inspection

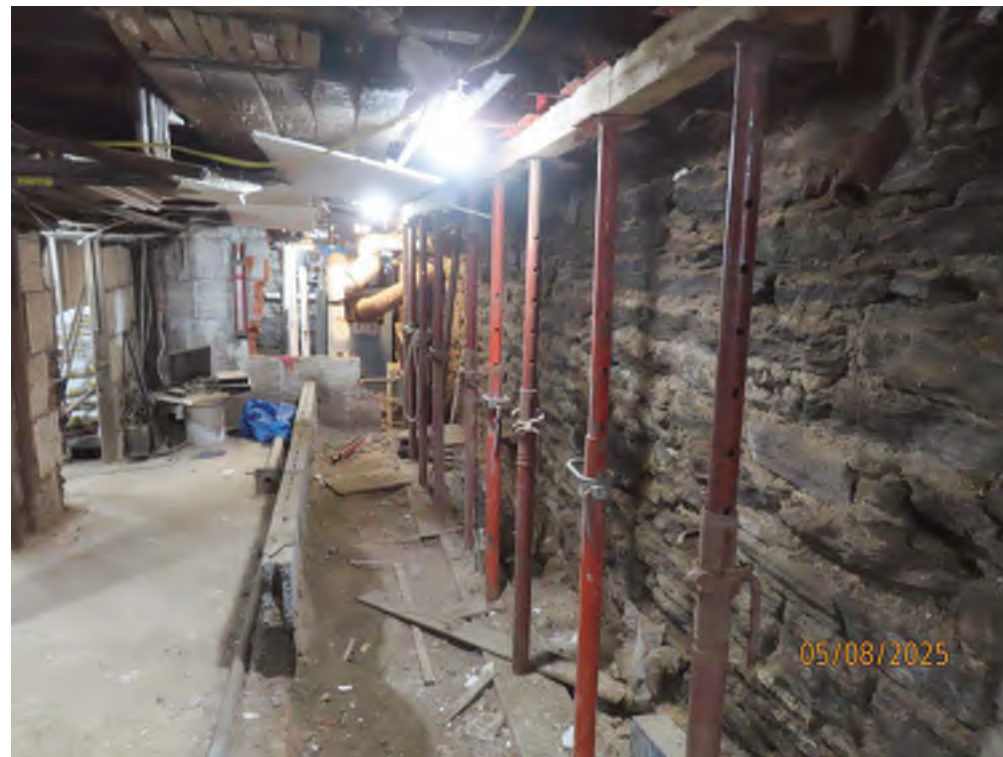
CURRENT CONDITION AT CELLAR

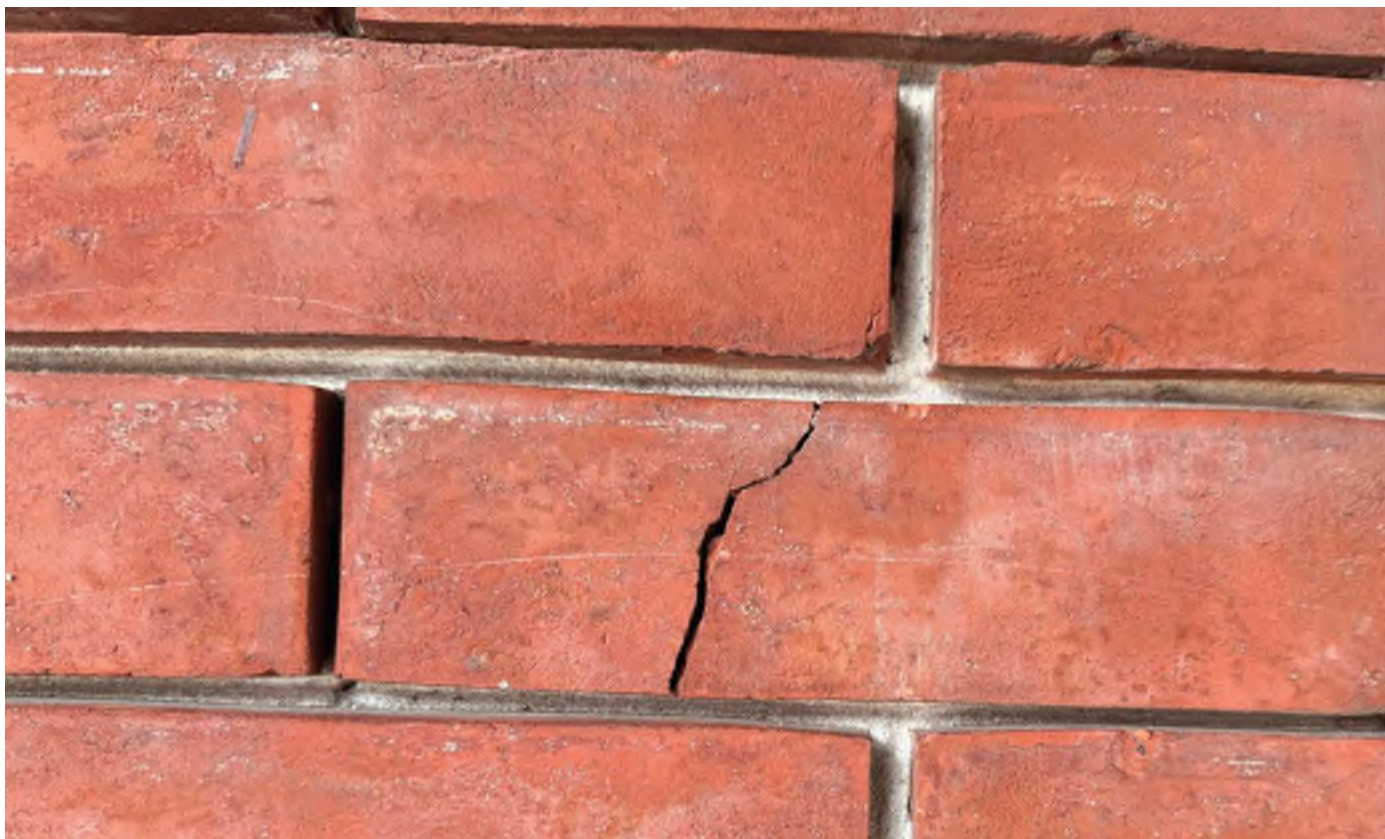
2 Brick Spall

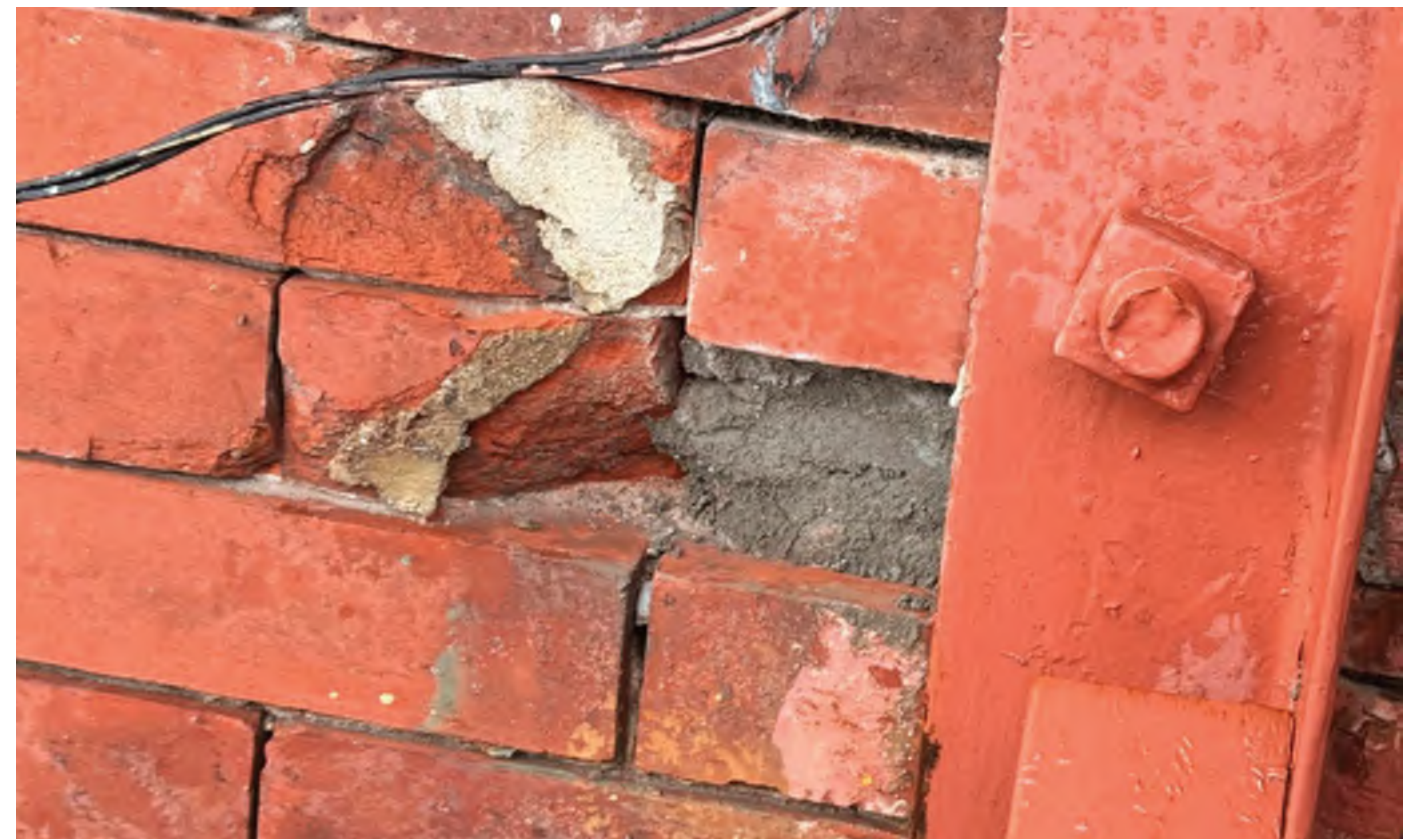
3 Brick Crack

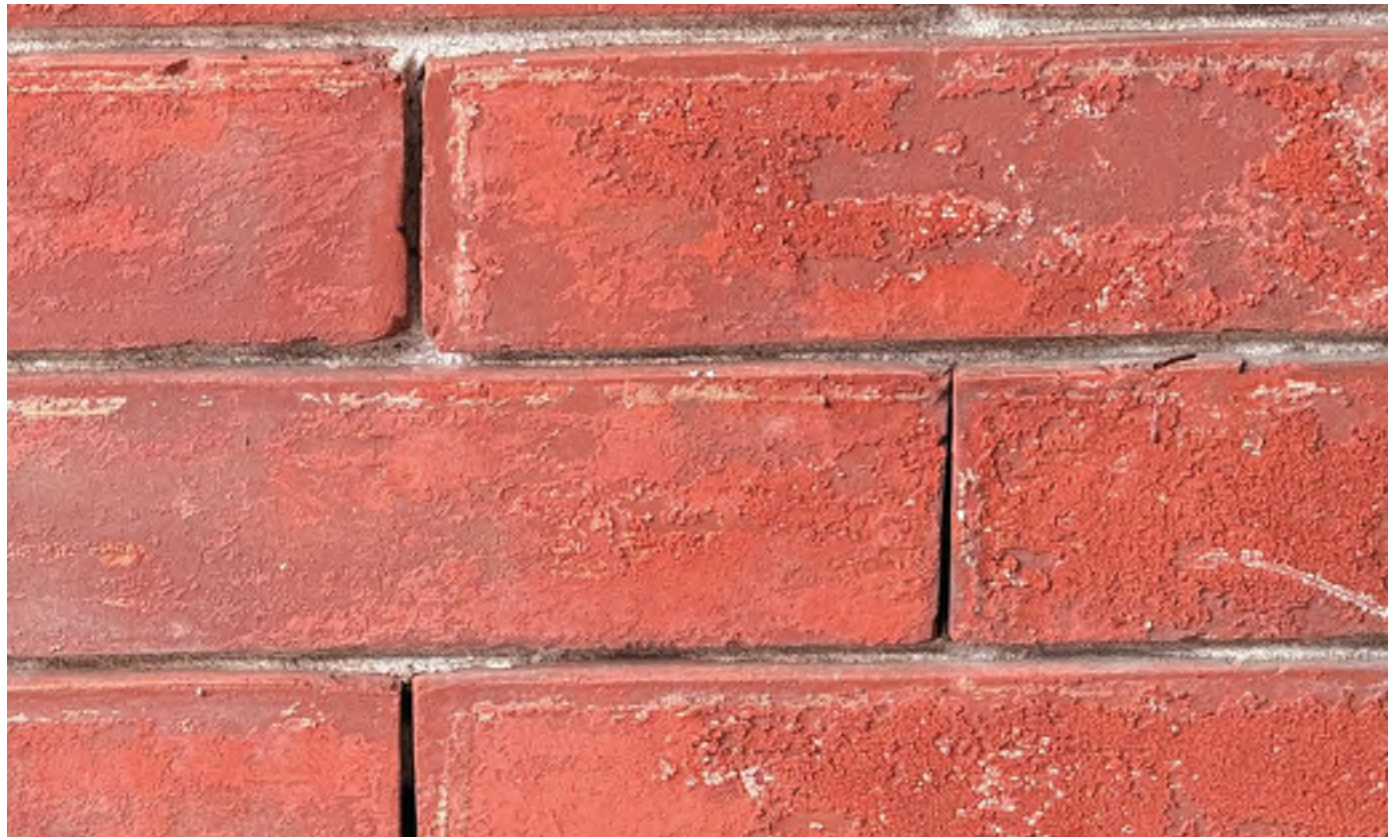
6 Discoloration/Non-Original Brick

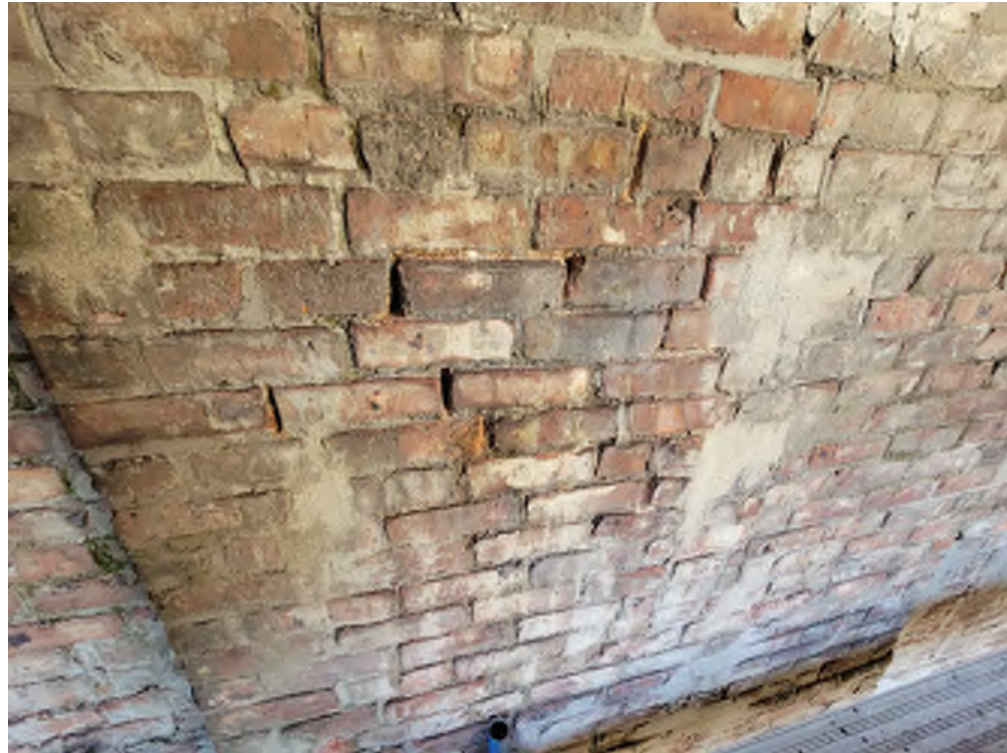
DEGRADATION OF FACADE BRICK (VISIBLE FROM SCAFFOLD)

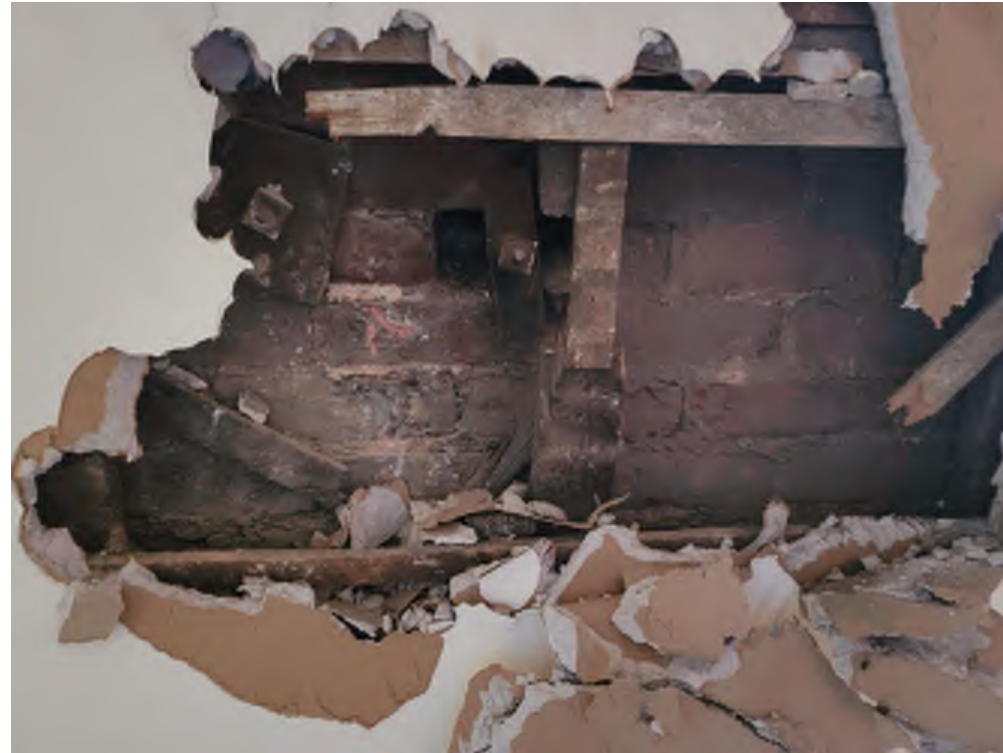
PROBE AT INTERIOR OF FACADE

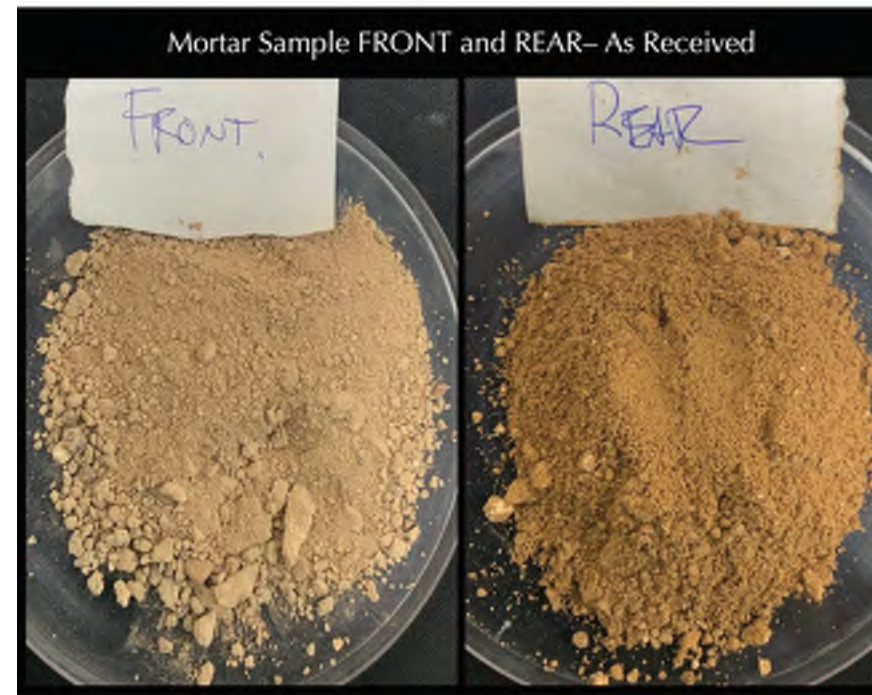
Figure 1: Mortar samples in severely disintegrated, powdery conditions. FRONT and REAR samples are total 1/2 and 1/6 grams in weights, respectively where the largest fragment found in each sample is approximately 10 mm in maximum lateral dimension.

As mentioned, both mortars were received in severely disintegrated, entirely powdery form, tan-colored, moderately damp conditions.
