# St. Mark's Church in-the-Bowery

75-42  
Continuing  
Maintenance Plan

21 JULY 2026

**BEYER  
BLINDER  
BELLE**

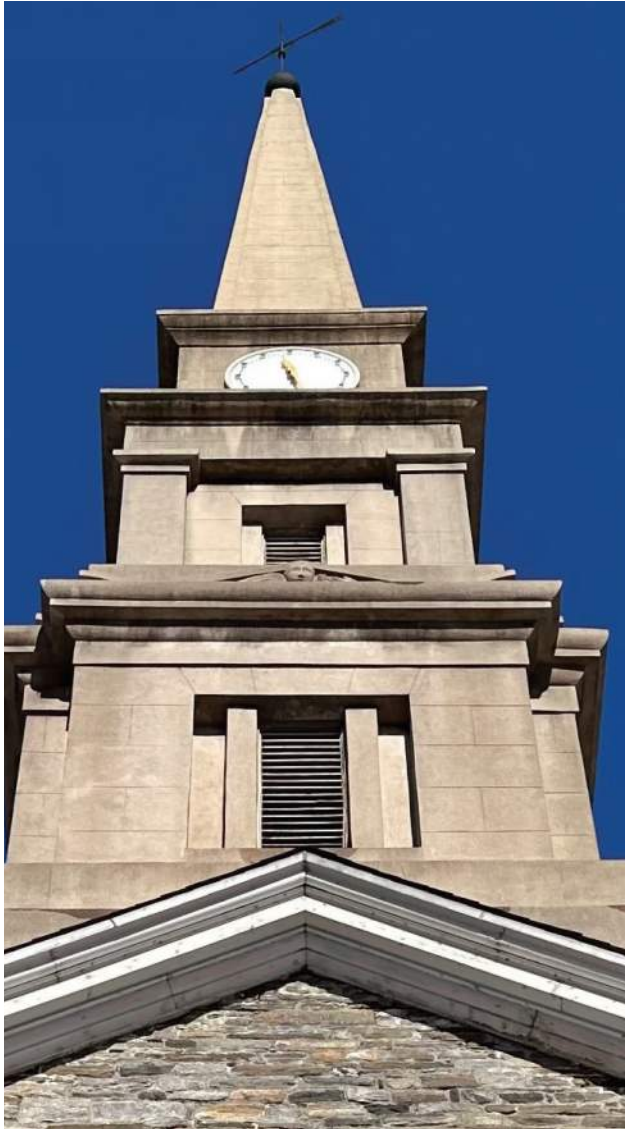
#### BELL TOWER & STEEPLE

Stucco generally sound and in good condition from the ground.

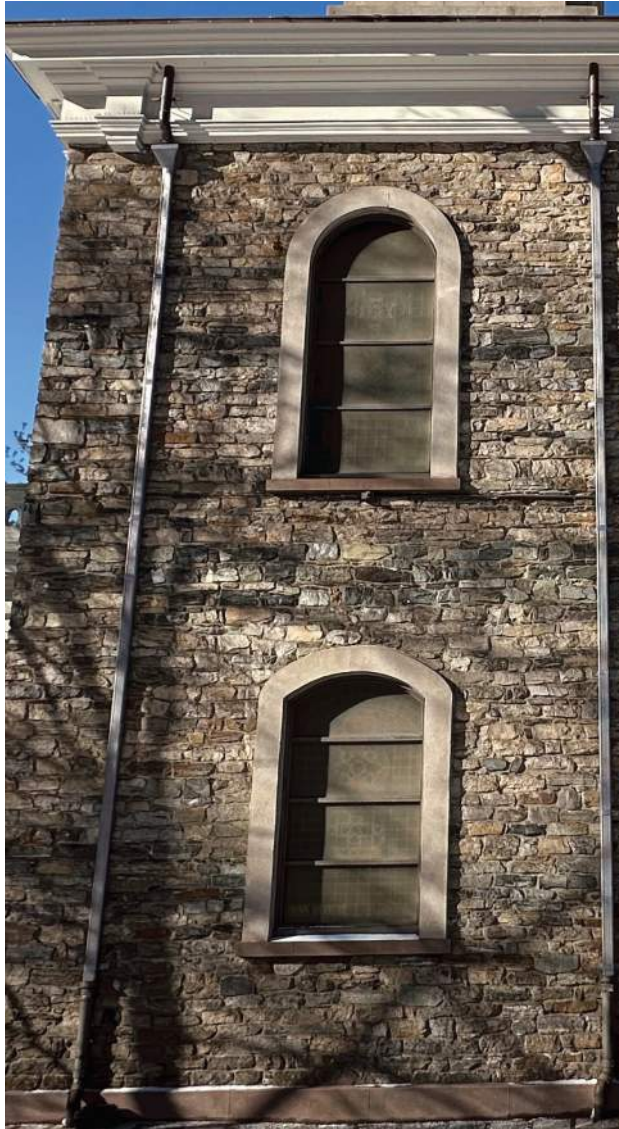
#### EXTERIOR WALLS

All four walls of the Church are made of mass stone masonry, and are in good condition.

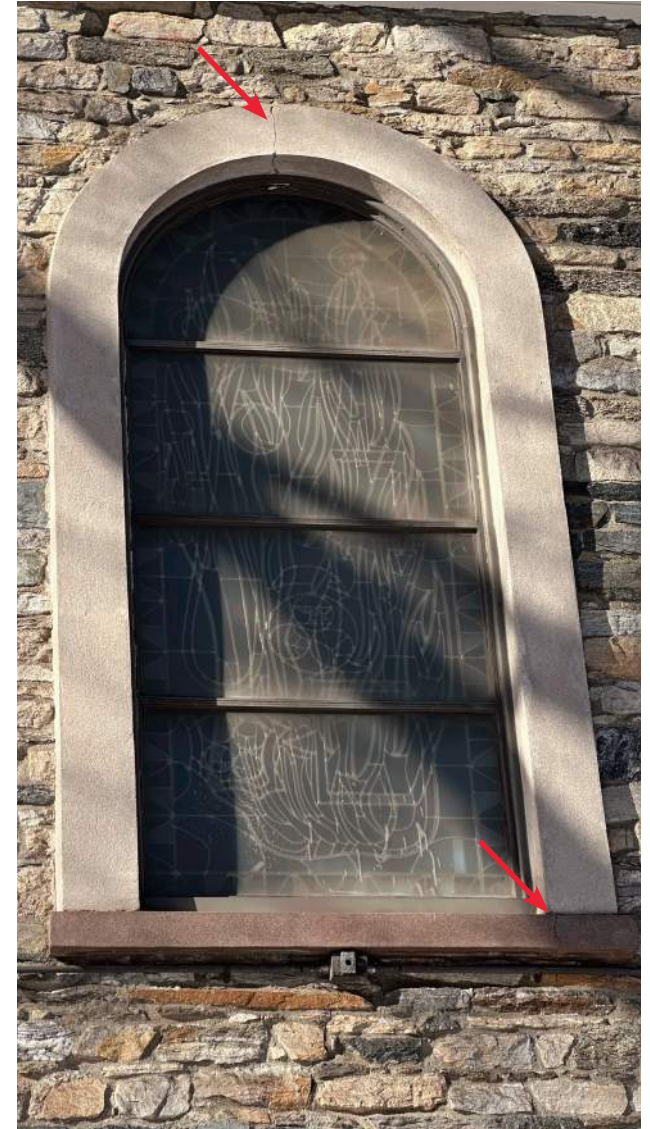
#### WINDOW SURROUNDS

Surrounds have typically cracked at the top of the arch, and horizontally cracked at sills, at both nave and mezzanine level windows.

**A11-1** - REPAIR CRACKS AT STONE MASONRY  
AND AT WINDOW SURROUNDS

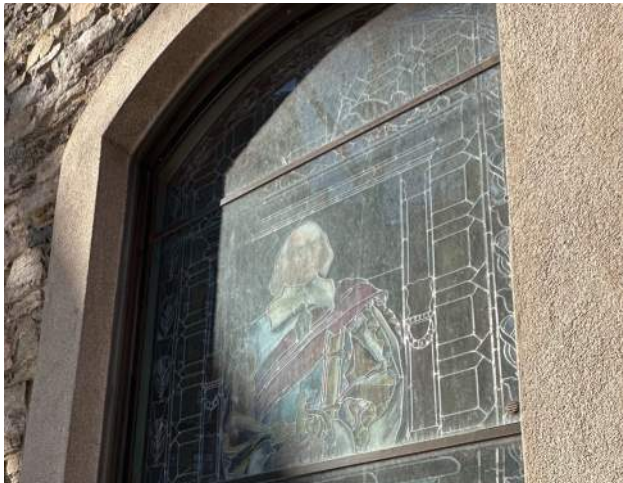
#### PROTECTIVE GLAZING

One contemporary unit of clear glass in an aluminum frame is installed outside of the memorial window to Peter Stuyvesant. It has small vents to allow passage of vapor.

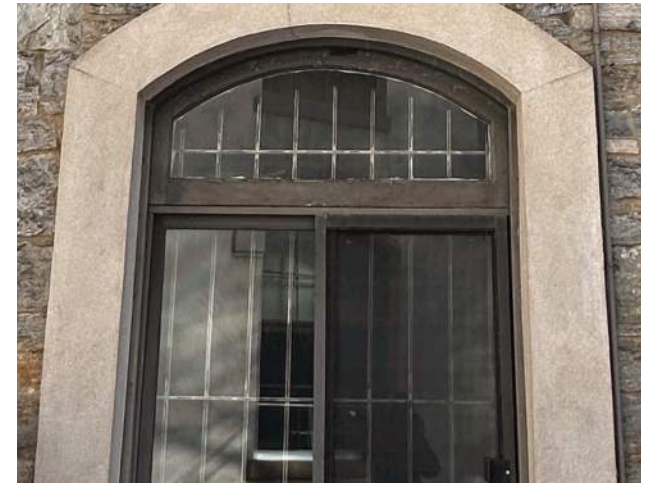
#### ALUMINUM WINDOWS

Sliding windows at the 1FL are in poor condition and their operation is hindered by interior bars.

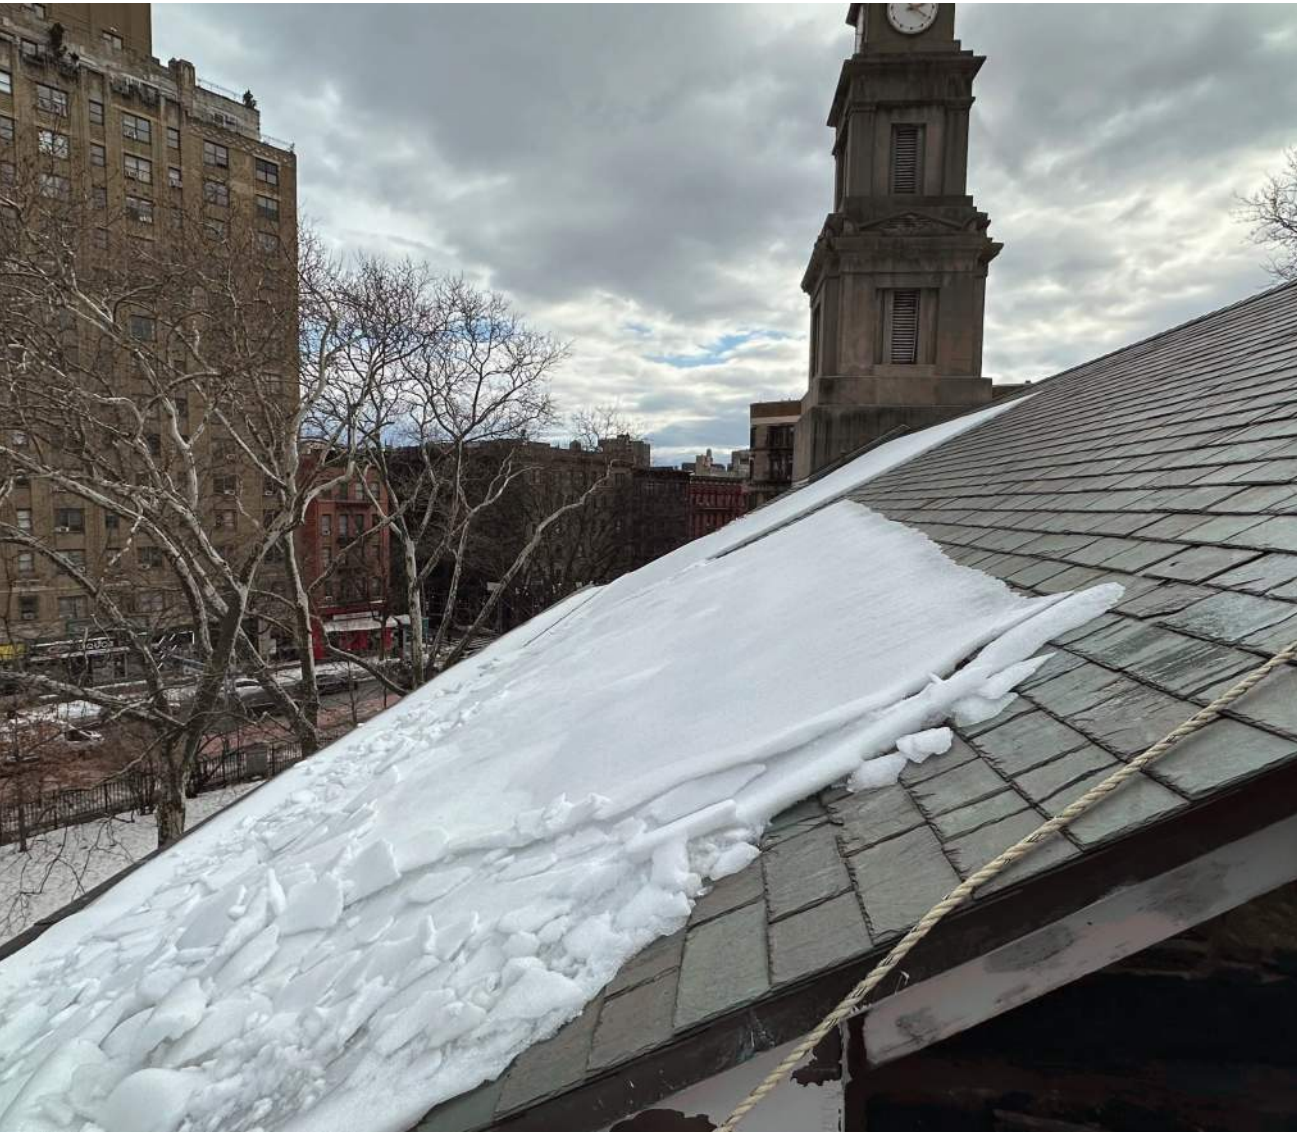
**ROOFING**

The slate roof of the church is in fair condition, and active leaks were not observed in the attic below. The Church has attic stock tiles and completes repairs periodically as needed.

**A34** - REPLACE SLATE ROOFS

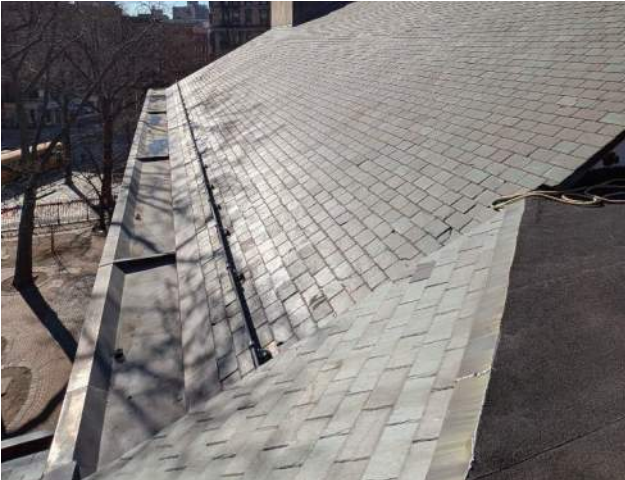
**GUTTERS**

Gutters were installed in 2023 and are in excellent condition. Drains were reported to be blocked with debris in past years, and should be cleaned bi-annually.

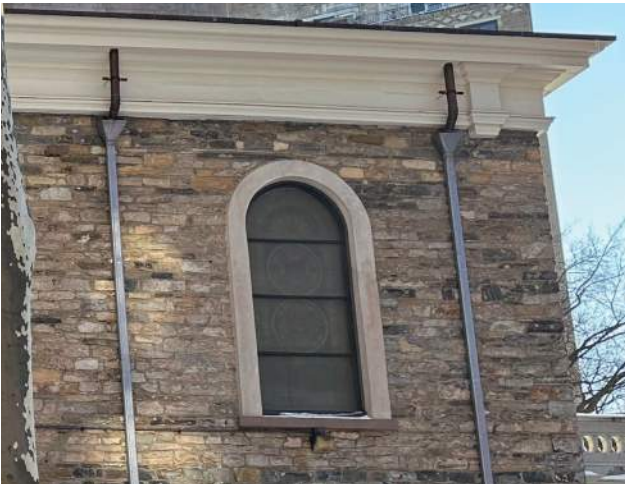
**LEADERS**

Copper downspouts were replaced with the gutter restoration project in 2023. External leaders extend to drainage boots below but are frequently stolen.

**A01 - RECONNECT ROOF DRAIN LEADERS**

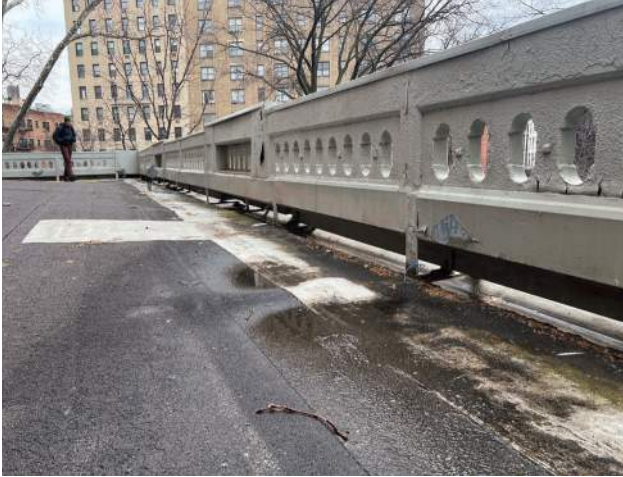
#### PORTICO ROOF

The roof membrane appears to have been in place before the parapet and base flashings were repaired, before 2017, but is in sound condition.

**A36** - REPLACE PORTICO ROOF MEMBRANE

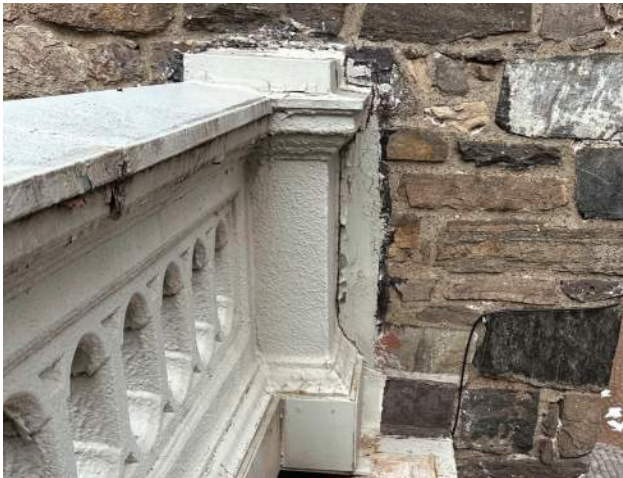
#### PORTICO FLASHING

Iron posts of the parapet are flashed into the stone wall with galvanized sheet metal that has been overpainted. The end flashings are in poor condition.

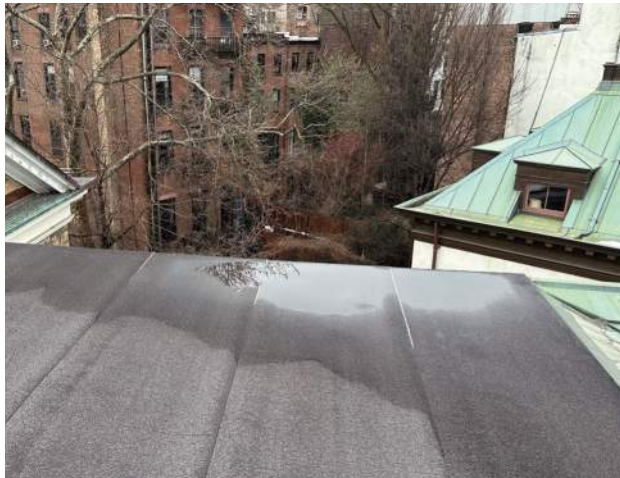
#### LOW-SLOPE ROOF

Open seams or other defects were not observed in the low slope membrane, however, water collected at edges and did not have scuppers to direct runoff.

**A15-1** - REPLACE PARISH HALL ROOFING MEMBRANE AT FLAT ROOF

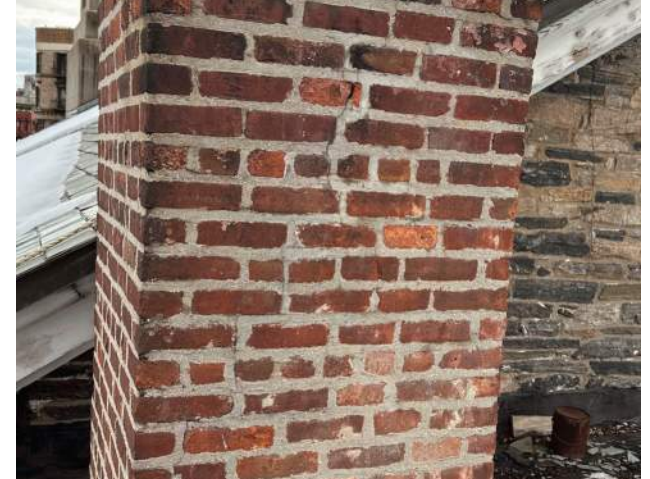
#### CHIMNEYS

Chimney masonry shows cracked bricks and loose mortar.

**A15-3 - INSTALL WEATHER-RESISTANT CHIMNEY CAPS**

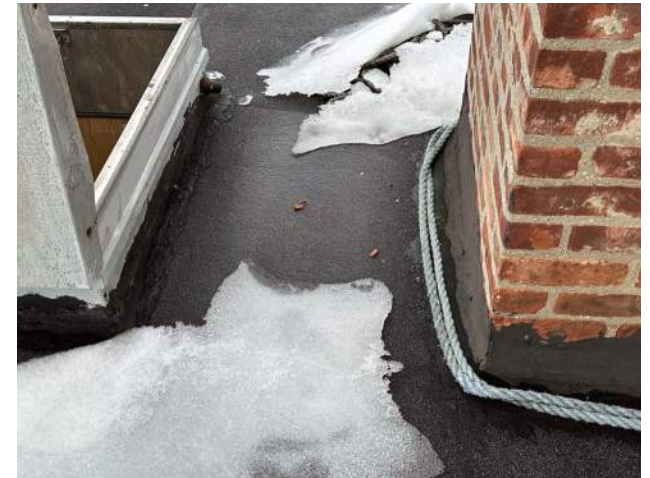
#### BASE FLASHINGS

Typical base flashings on low-slope roofs are sheet membranes, but here are only applied tar.
