PROJECT LOCATION
829 Greenwich St
Manhattan

LPC DISTRICT
Greenwich Village
Historic District

EXISTING CONDITIONS

BUILDING ENCLOSURE PROPOSED SCOPE

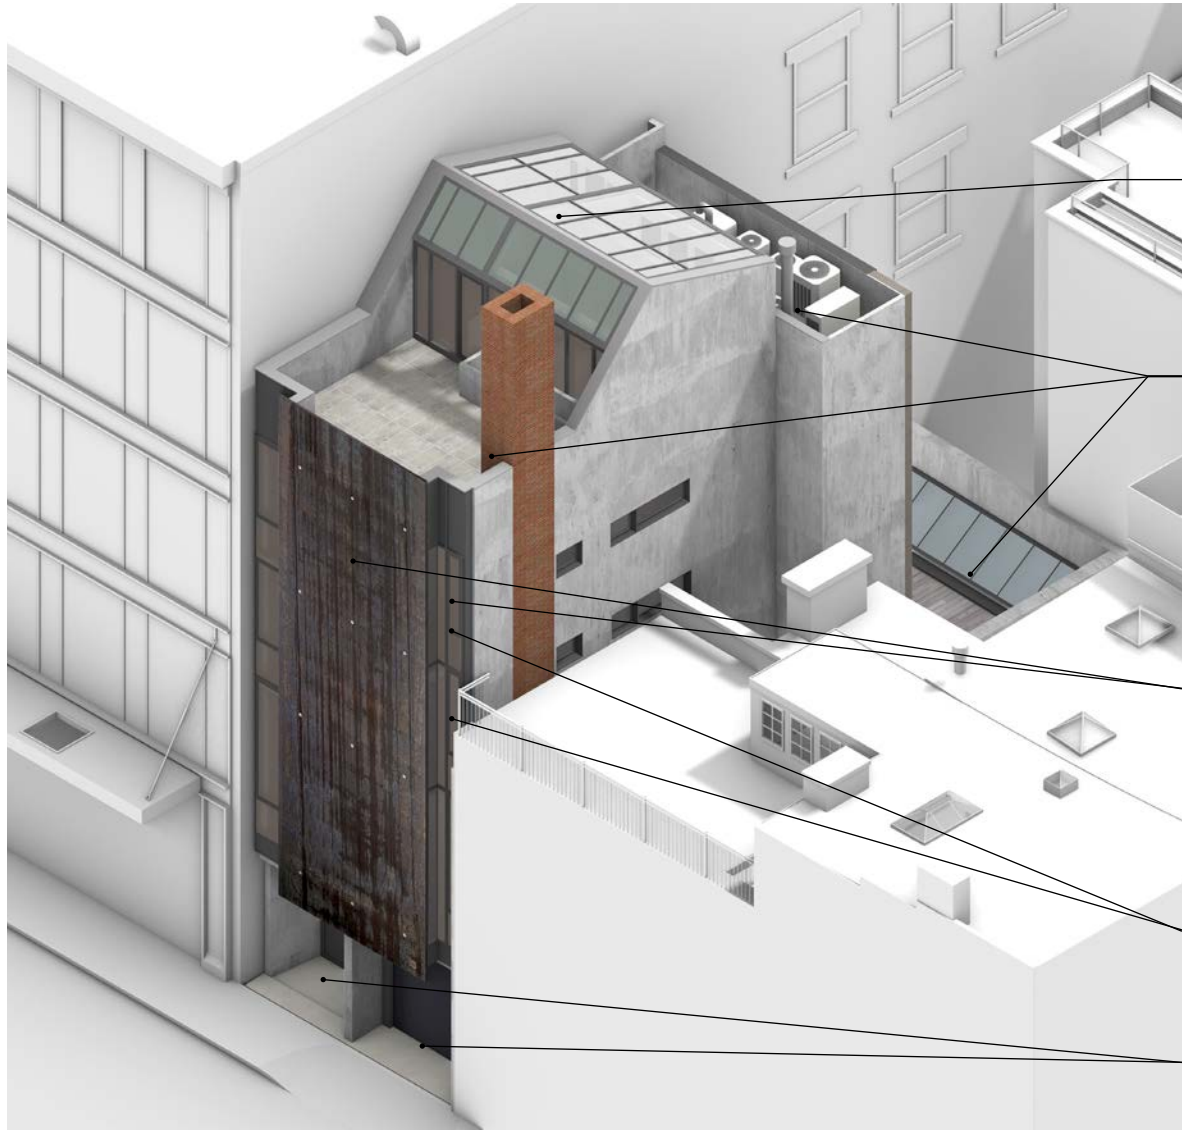
FRONT / SIDE AERIAL VIEW

Excessive solar heat gain through large bulkhead skylight

Water leakage through skylights, roof terraces, curtain walls, and around steel plate caused mold which made the family ill

Thermal bridging through curtain walls, failed IGUs, and uninsulated portions of steel plate

Inadequate natural light in front rooms

Very deep recesses at ground level

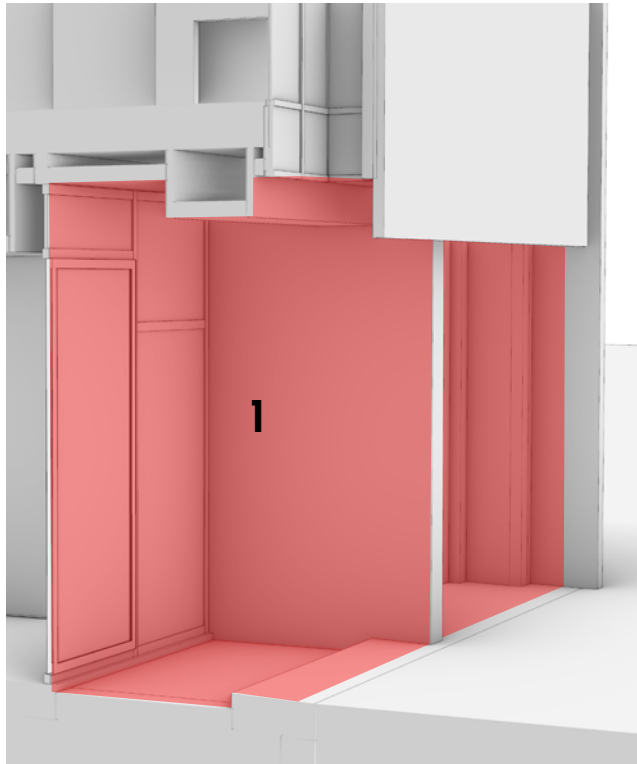
1
 Recessed spaces at the entry door
 and garage door on the ground level
 of the front facade are deep enough
 to be used as shelters for transient
 individuals, creating a safety hazard

Move boundary of entry and garage door out towards street to reduce exterior overhang

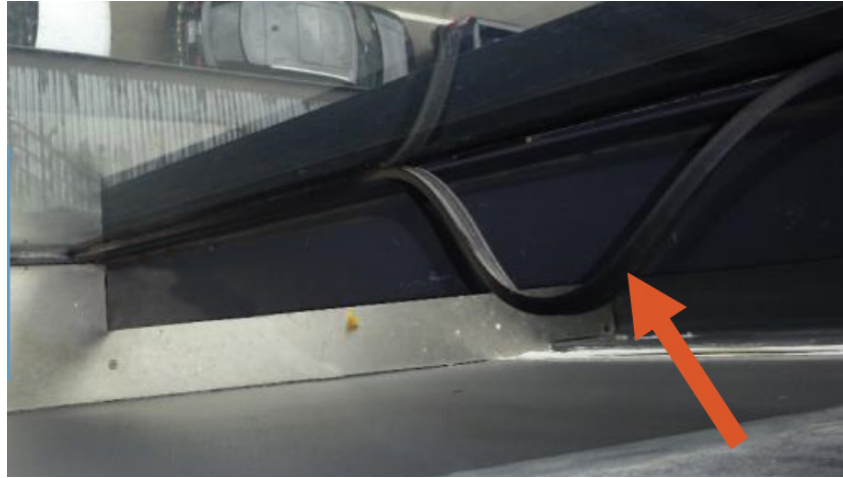
1

Displaced gasket

Staining at IGU edge and on trim

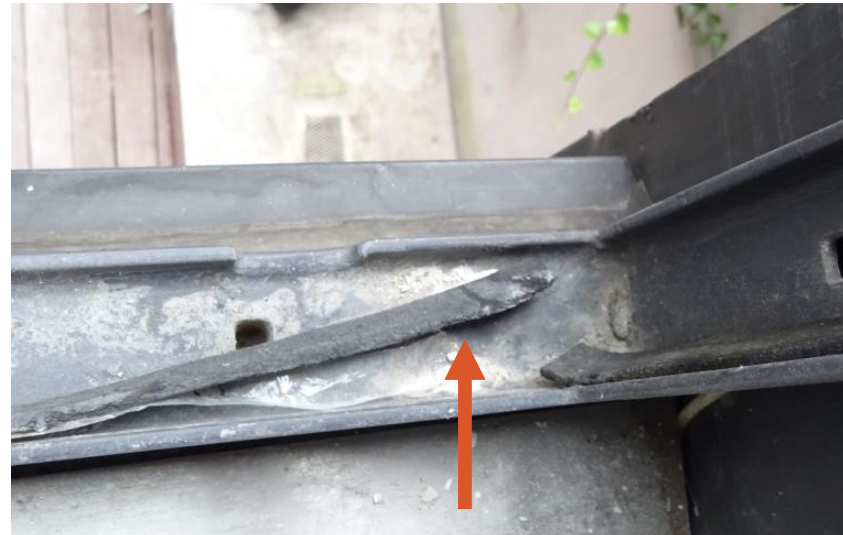
2

Displaced IGU spacers

Deteriorated gaskets at operable vents

Water leaks throughout entire building envelope caused mold growth on majority of building interior, which needed to be professionally abated

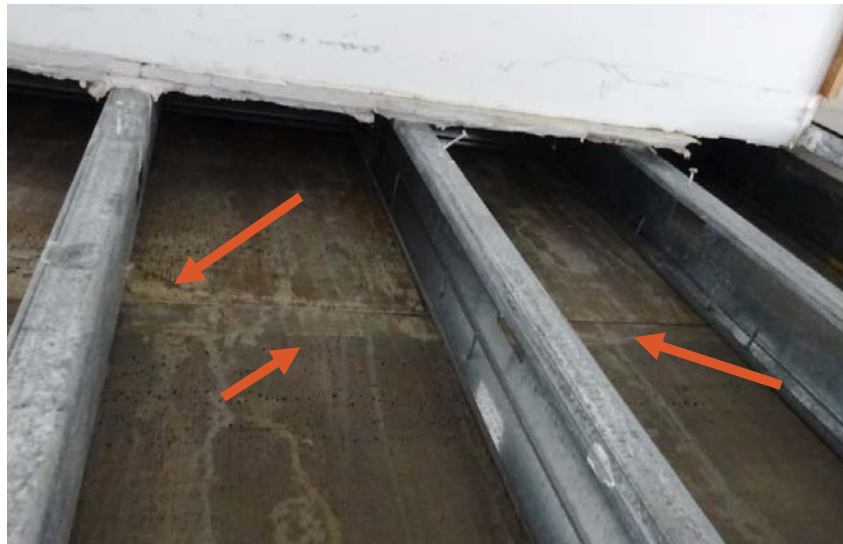
3

Steel plate, XPS insulation, self-adhered membrane waterproofing

Interior surface of exterior sheathing-staining and deterioration

Steel plate has water leaks, thermal bridges, and poor thermal performance

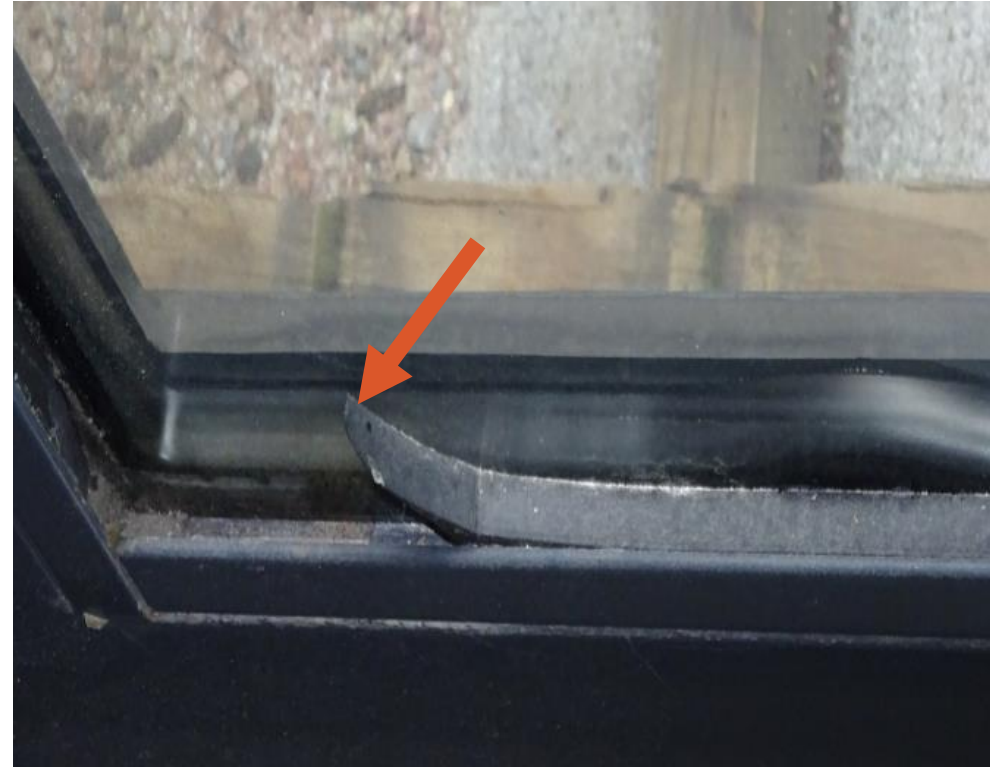
1

Deteriorated gaskets at operable vents

Discontinuous gasket

Water stain

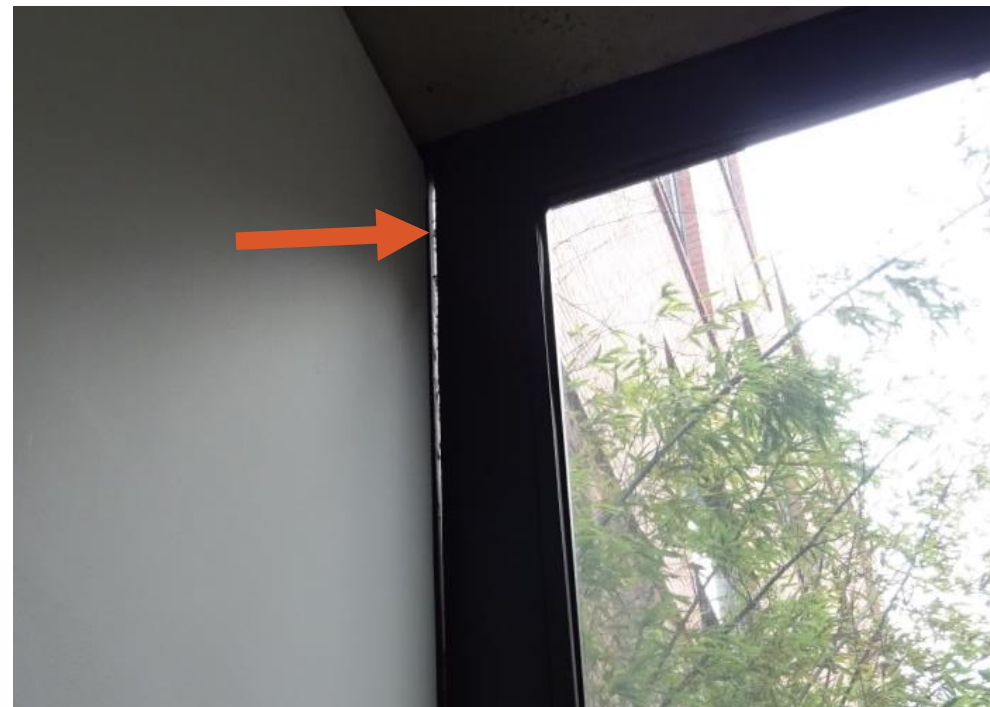
2

Misalignment / lack of gasket compression at bi-fold door

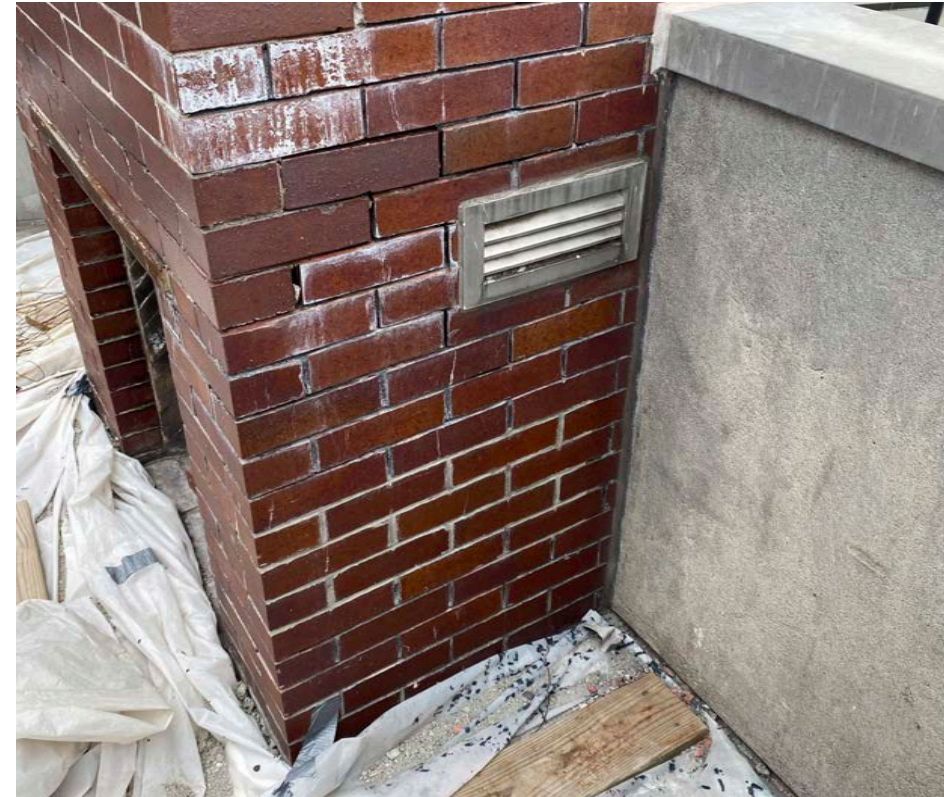
1
Deteriorated mortar at brick masonry chimney

1. Provide interior drainage system at cellar walls
2. Perform negative-side waterproofing repairs
3. Provide blind-side waterproofing at new foundation slab
4. Clad chimney

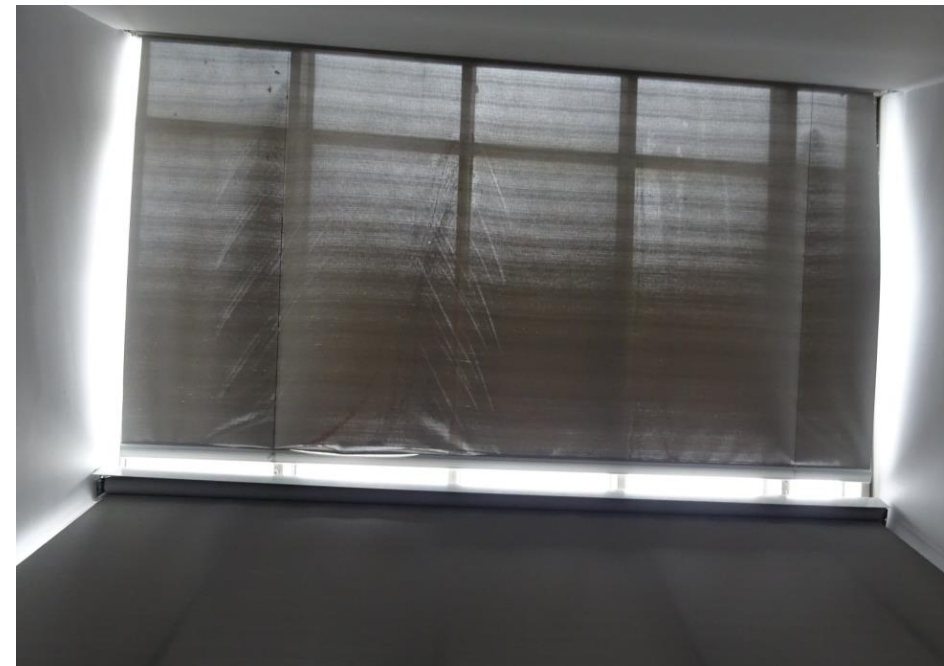
2
Excessive solar heat gain from roof skylight (shade installed to reduce heat gain)

Large skylight and bulkhead has air leaks, condensation at frames, and contributes to excessive solar heat gain

1. Provide additional insulation at main roof.
2. Provide waterproofing and insulation (if necessary) at main roof ducts
3. Replace parlor level terrace roofing with waterproofing system
4. Replace stucco and waterproofing at planters
5. Replace skylights with thermally-broken skylight system with condensation gutters

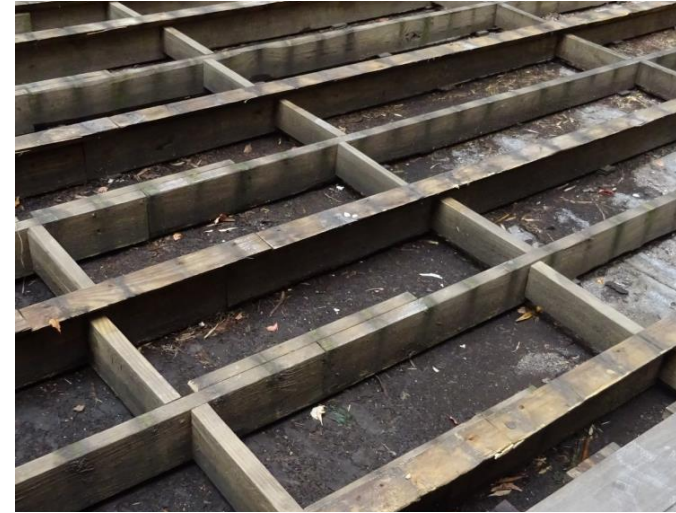
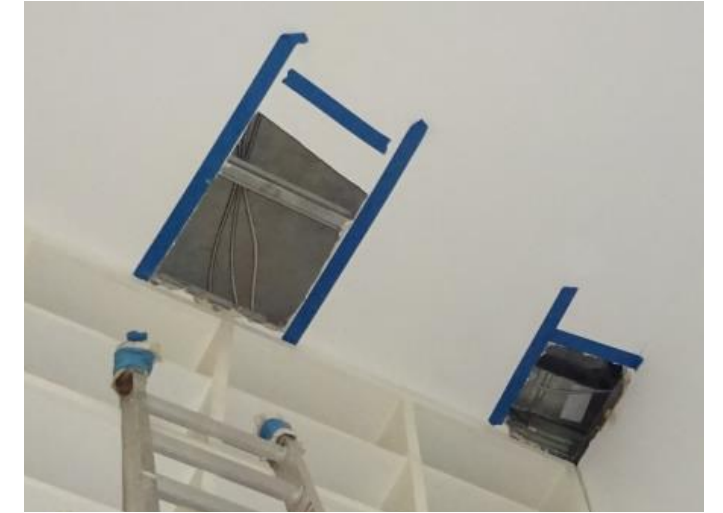
1

Existing roofing

Water below and within roofing assembly

Ceiling repairs at area of reported water leakage

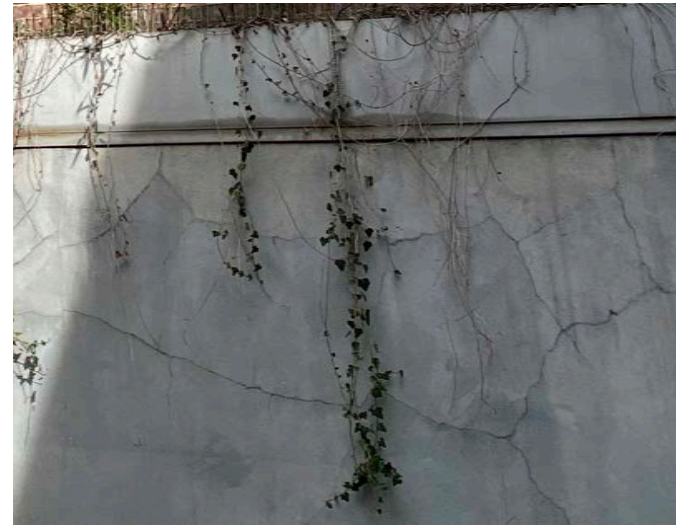
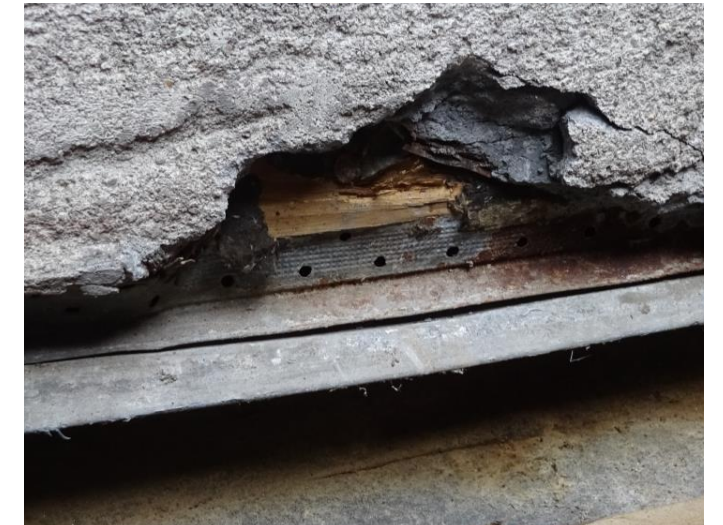
2

Cracked stucco and corroded flashing

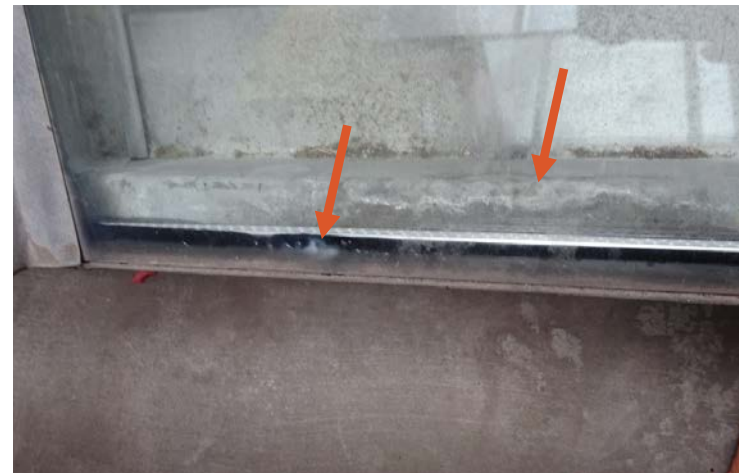
3

Staining and mineral deposits on framing at sill
Discoloration at IGU edge
