83-85 SULLIVAN STREET

PRESENTATION TO:
LANDMARKS PRESERVATION COMMISSION

Existing Conditions: Sullivan Street Facade

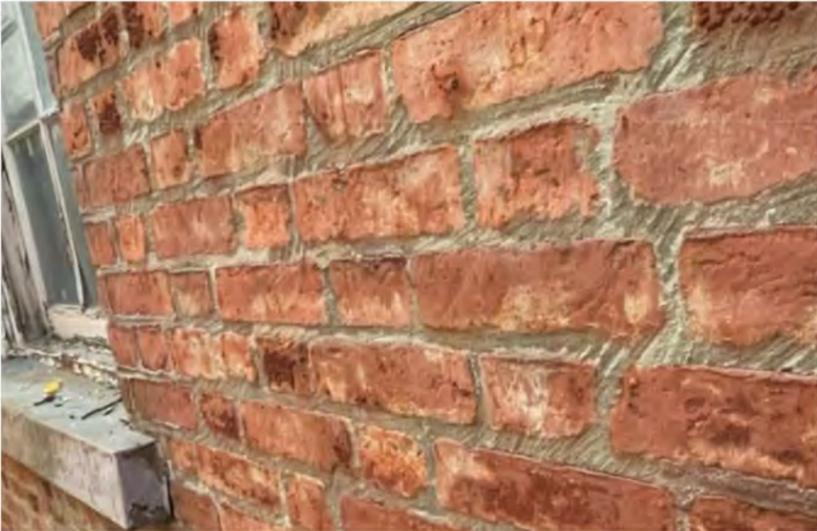
Mechanically Scraped Bricks

Flaking Paint Residue

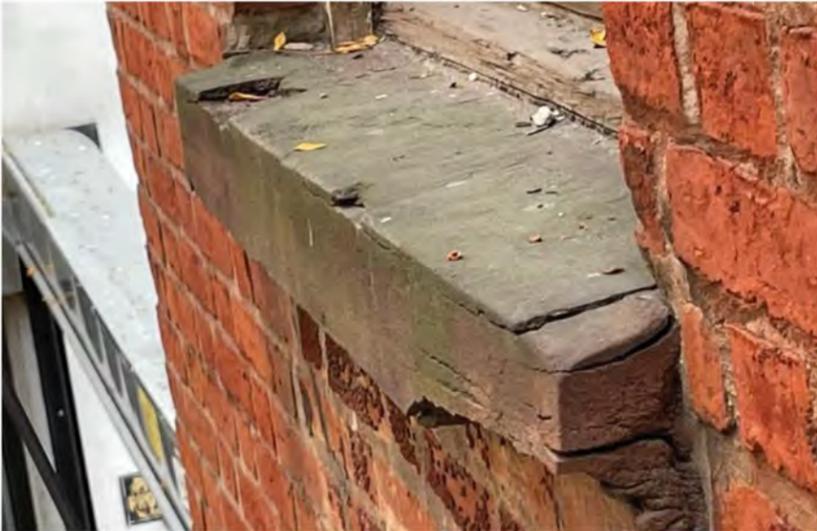
Stone Sill Deterioration

- SL
PATCH SPALLED BROWNSTONE LINTEL/SILL USING COMPATIBLE REPAIR MORTAR. PROVIDE ACCESS FOR ARCHITECT TO ASSES BROWNSTONE CONDITIONS AFTER AREA HAS BEEN CLEARED OF SPALLED AREAS AND IS BEING PREPARED FOR APPLICATION OF PATCHING MATERIAL.

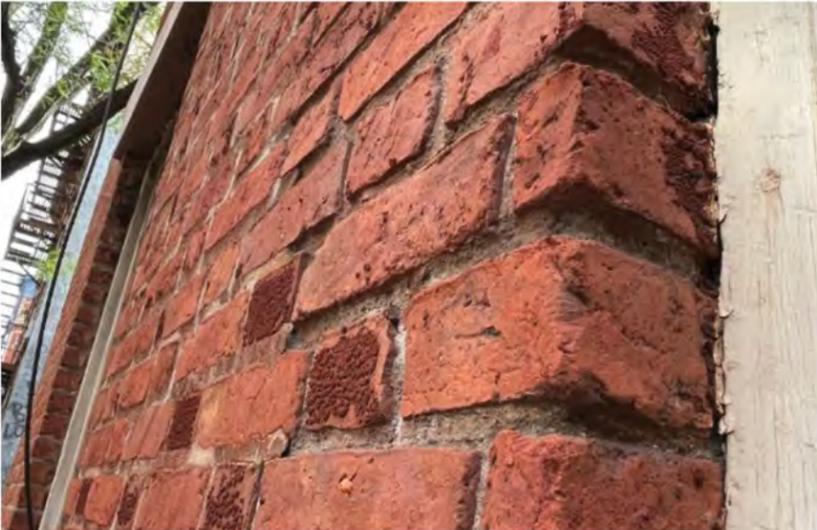
Mortar Erosion

- R100
RAKE OUT ALL LOOSE MORTAR AND REPOINT 100% OF JOINTS. TOOL MORTAR. MATCH EXISTING HISTORIC MORTAR TO ORIGINAL MORTAR LAB COMPOSITION RESULTS.
- MC
REMOVE EXISTING METAL COPINGS OVER BROWNSTONE SILLS AND LINTELS. PROVIDE ACCESS FOR ARCHITECT TO ASSESS UNDERLYING BROWNSTONE CONDITIONS. REPLACE WITH NEW PRECAST UNITS TO MATCH EXISTING LINTEL/SILLS IN COLOR, LAYOUT & SIZE.

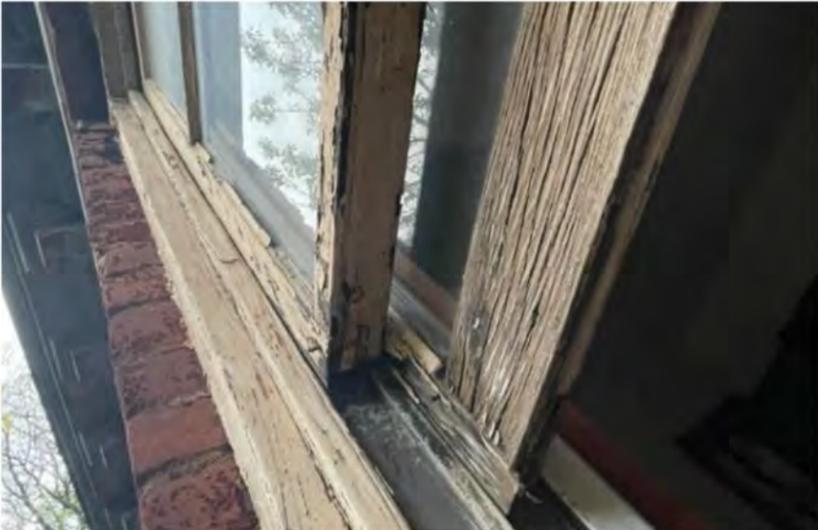
Severe Window Frame Deterioration

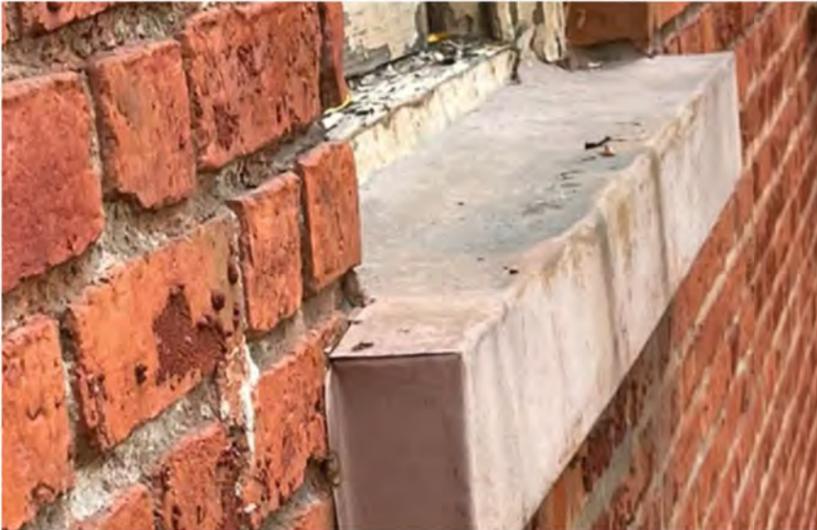
Sill Covered in Break Metal

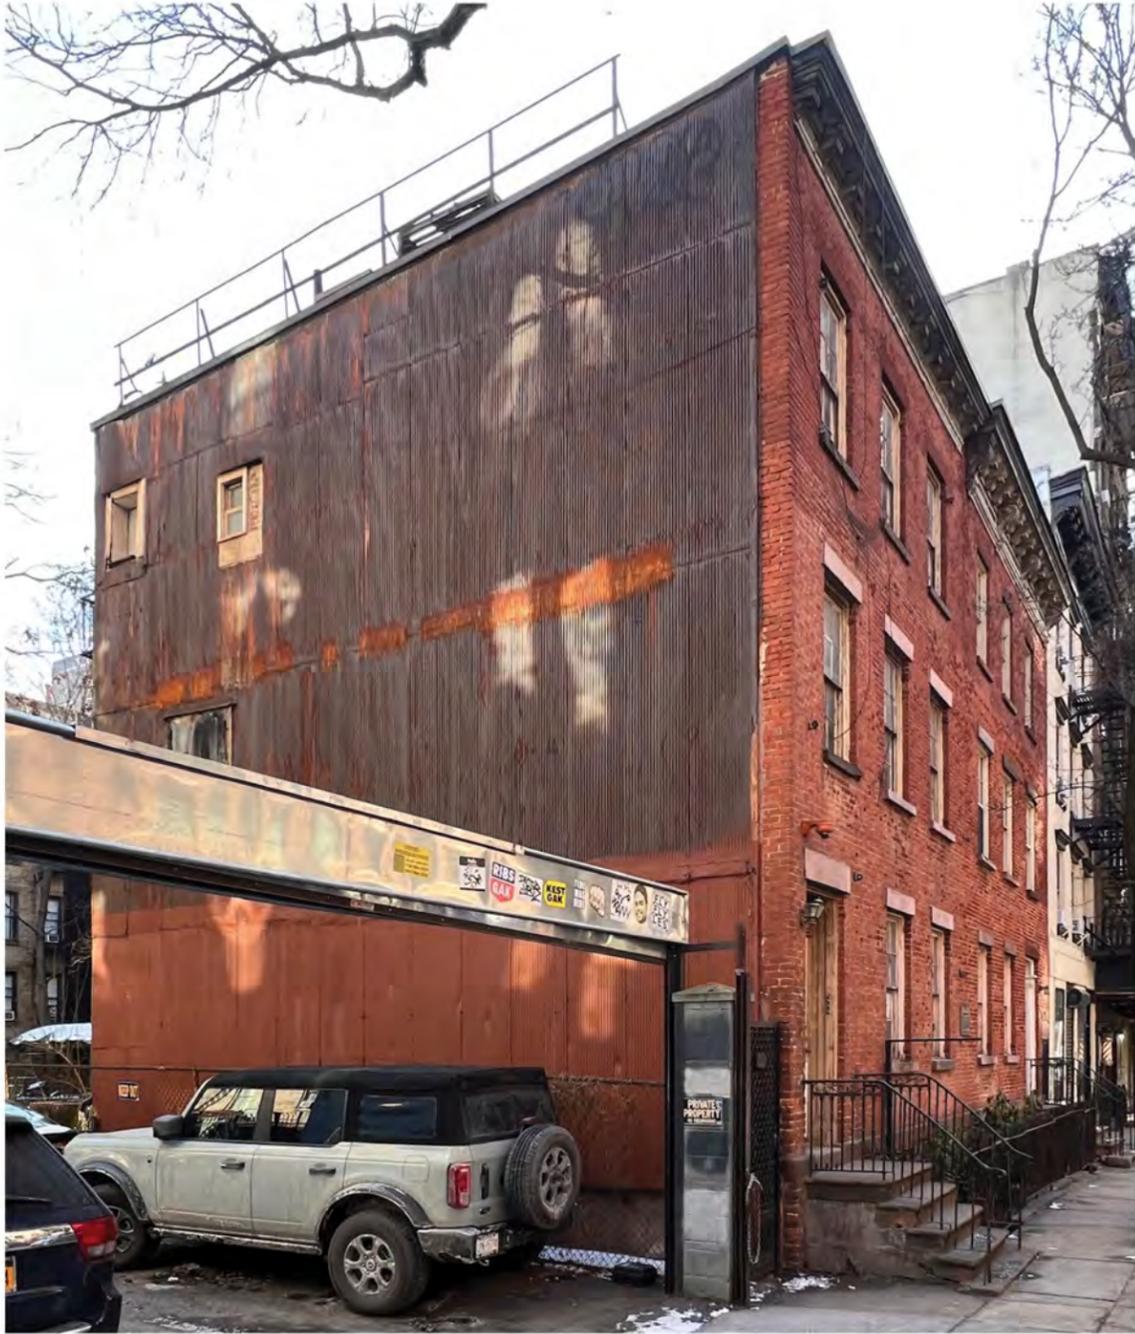
85 Sullivan Street North Facade
Current photograph, deteriorated metal cladding, installed in 1930s

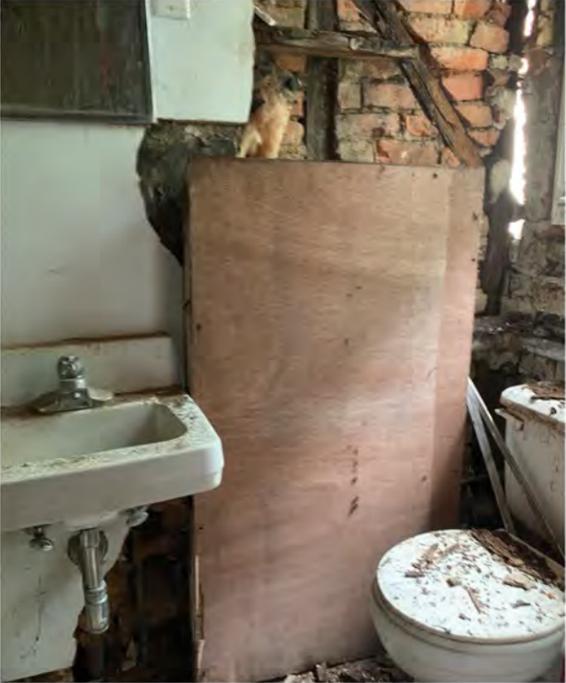
Interior deterioration due to weather infiltration at open exterior corner

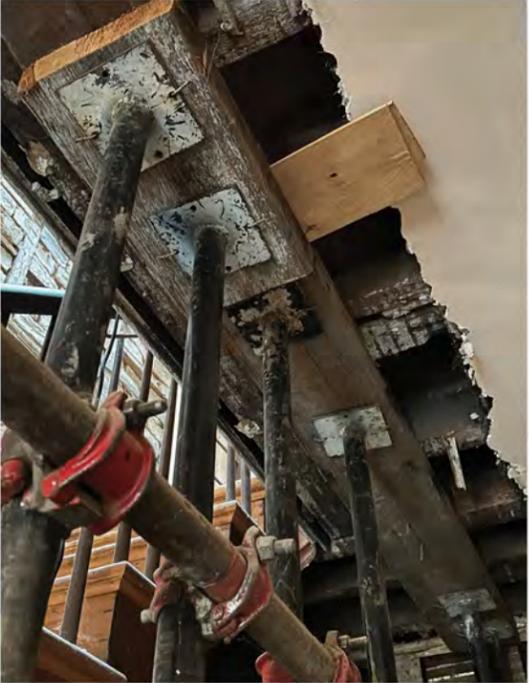
Structural shoring, installed in 2009 to prevent building collapse

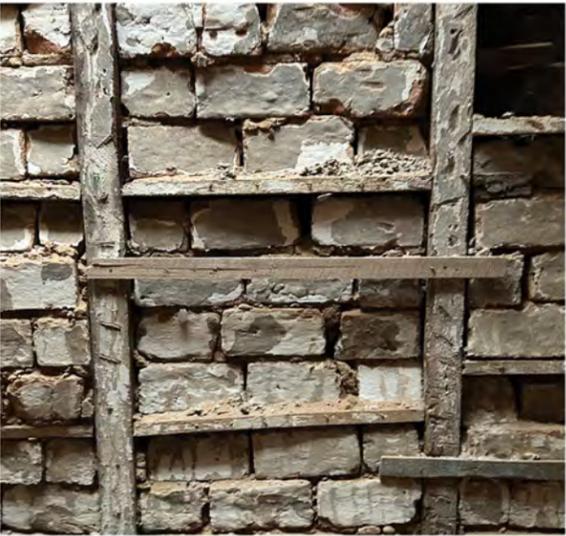
Decay of brick nogging wall, including loose brick and rot at original structural timbers

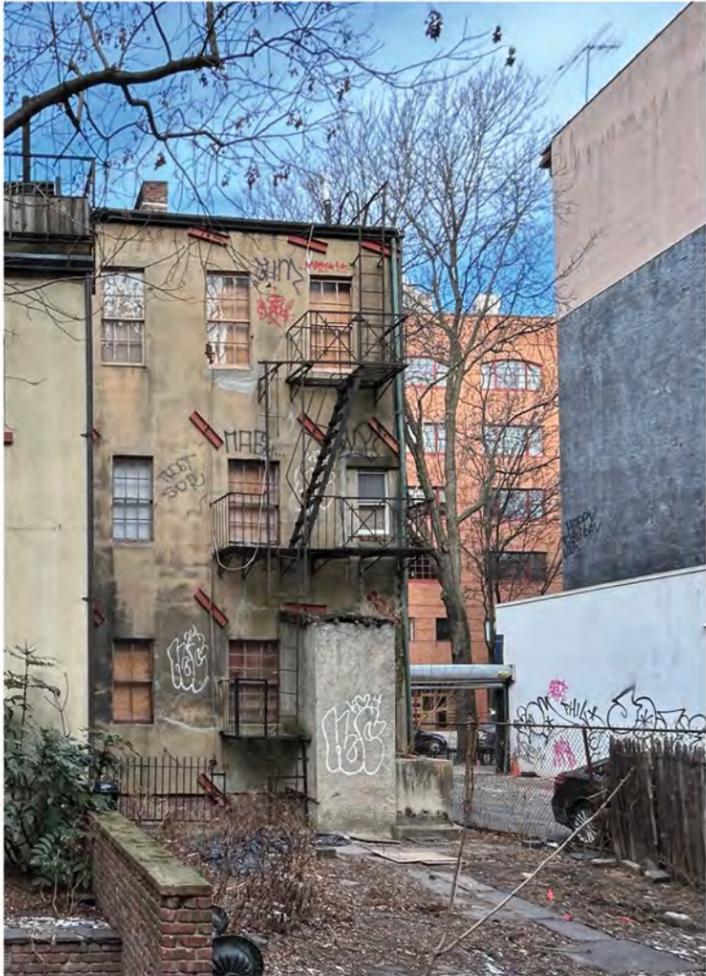
Rear Facade
Structural tie-backs to secure unstable wall, weather infiltration at missing windows

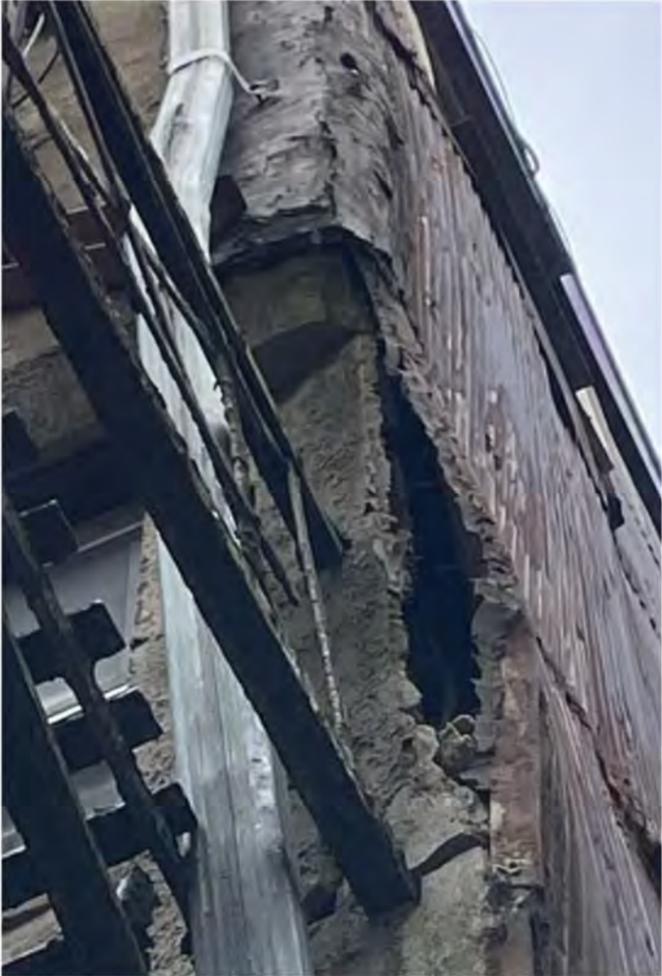
Buckling Wall
Separation of the north and east wall, source of considerable water infiltration

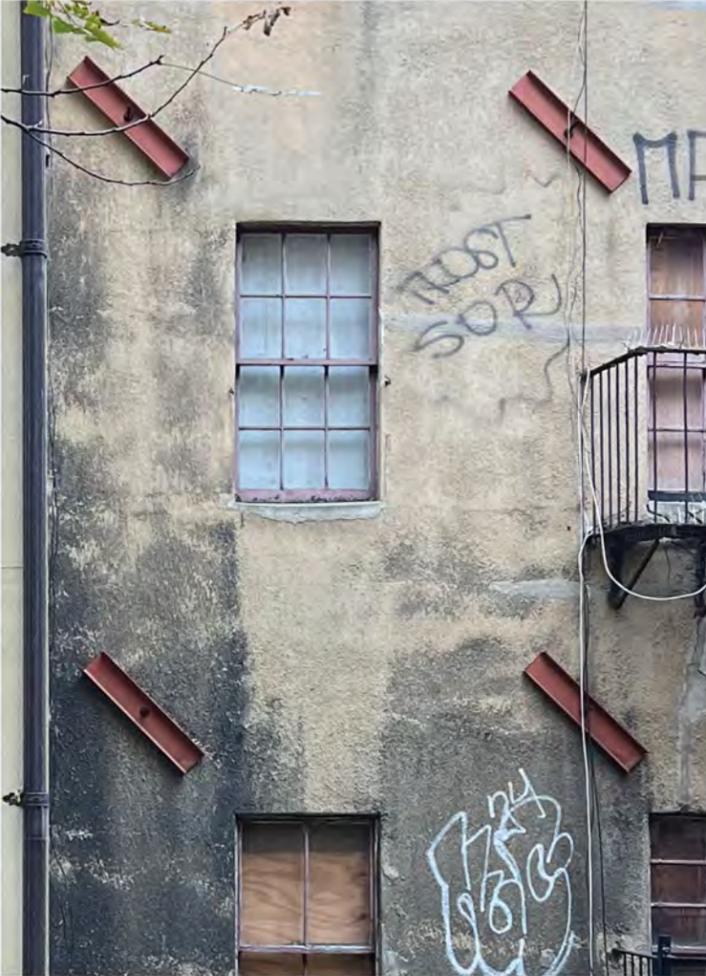
Exposed Structural Tie-Backs
Installed in 2009 to help stabilize the building and prevent further separation of the facade
