A-0 HISTORIC IMAGES AND DISTRICT MAP

A-7 PROPOSED WORK AT EXISTING SIDEWALK

A-3 PROPOSED PERSPECTIVE AT FIFTH AVE. & 9TH ST.

24 Fifth Avenue
Proposed Façade Renovation
Submission for NYC Landmarks Preservation Commission
10 October 2013

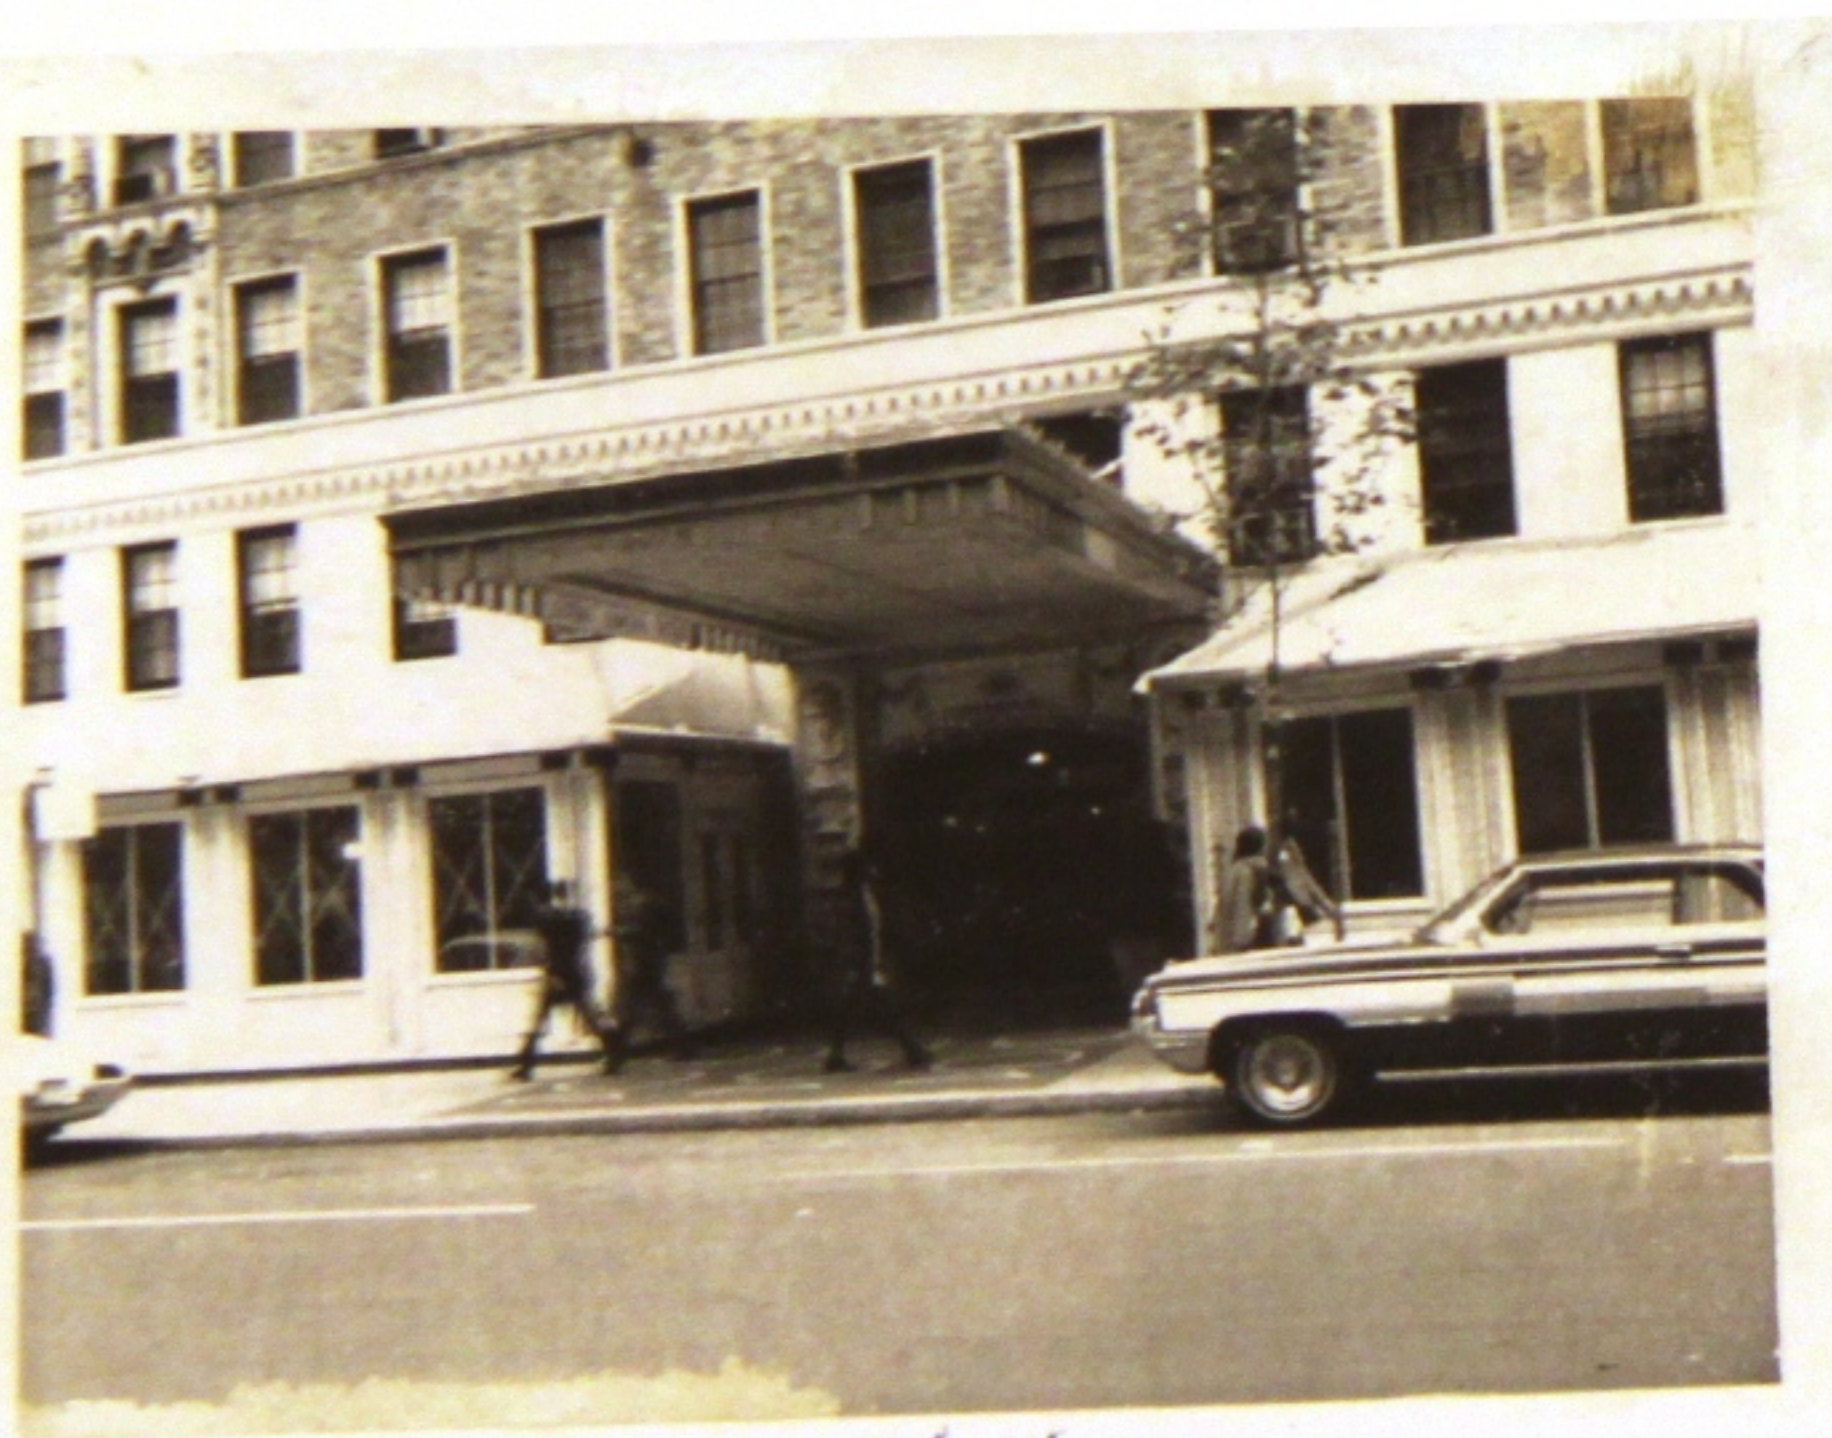
03 1971 PHOTOGRAPH [AFTER INSTALLATION OF SIDEWALK ENCLOSURE] PHOTOGRAPH

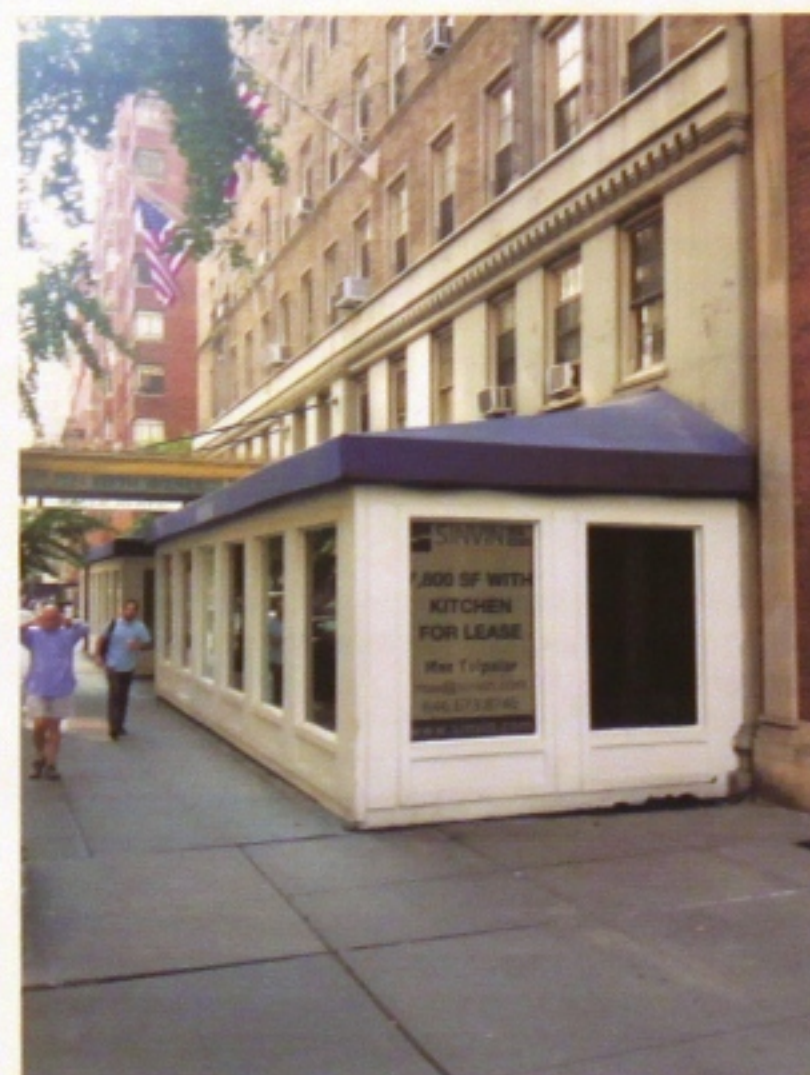
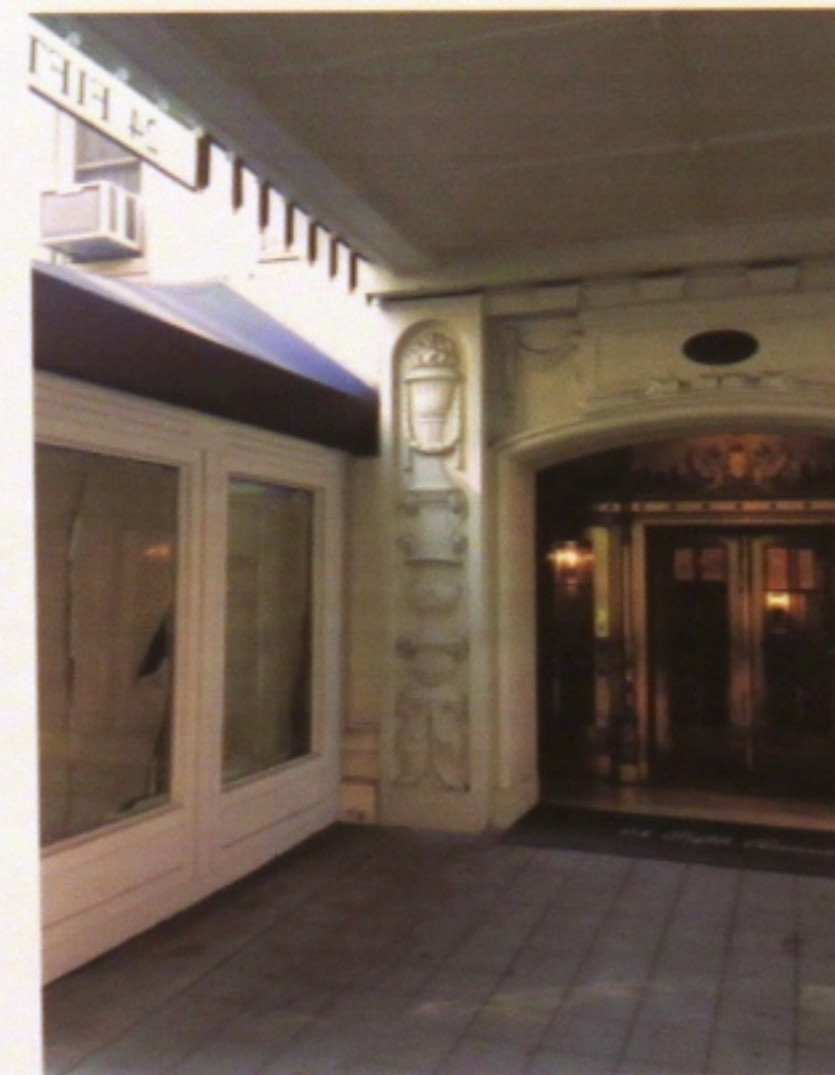
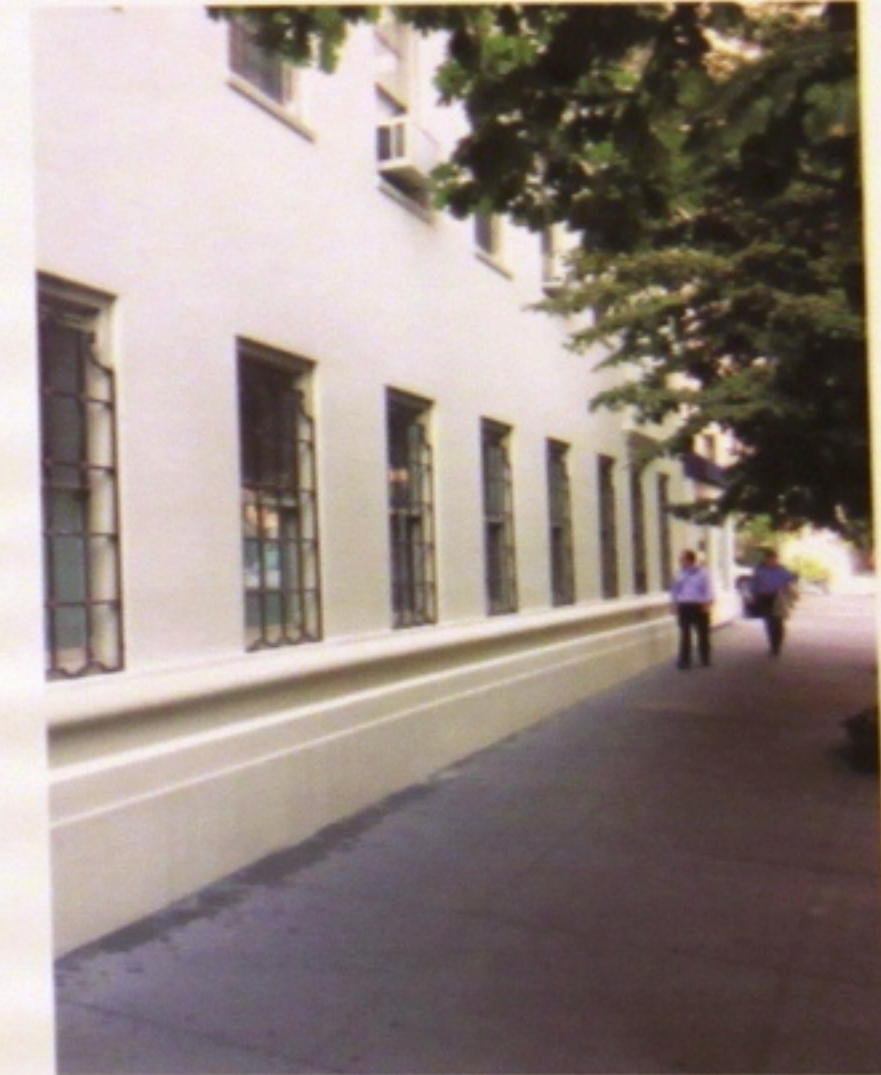
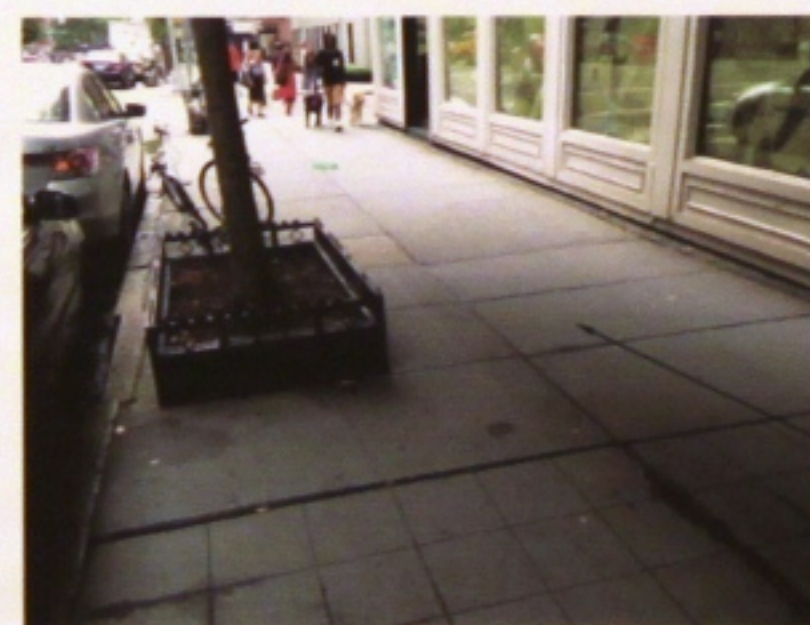
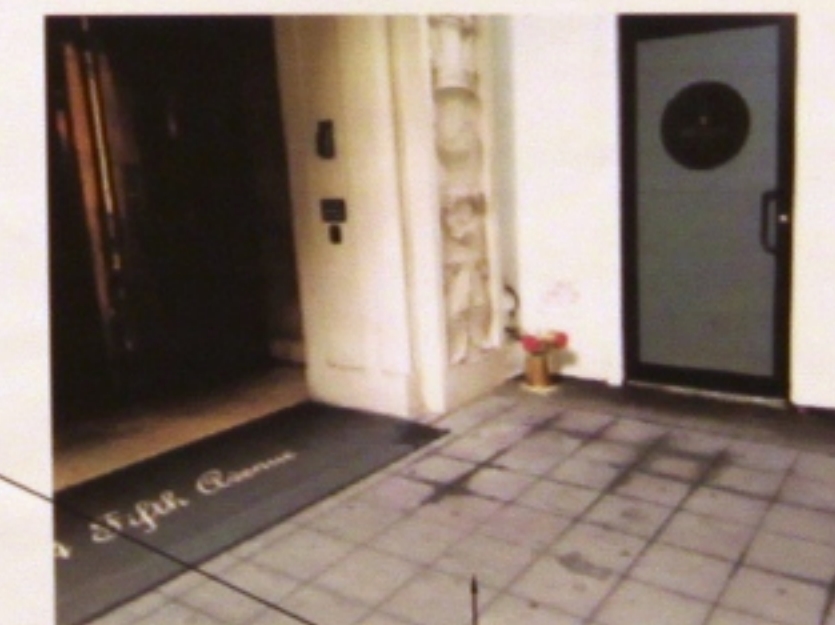
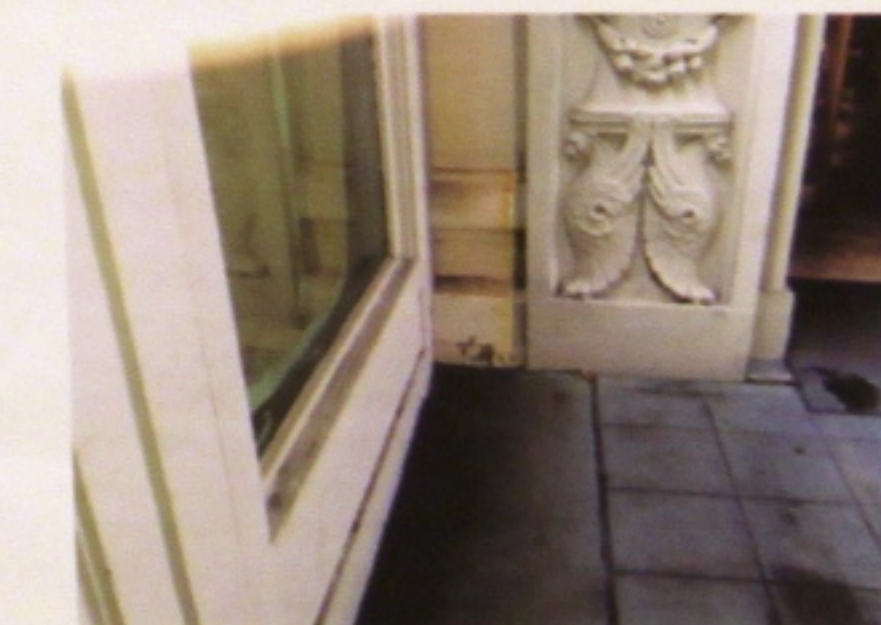
03 EXISTING SIDEWALK CONDITION
PHOTOGRAPHS

EXISTG SIDEWALK PATTERN: NEW SIDEWALK JOINT PATTERN TO MATCH EXISTING

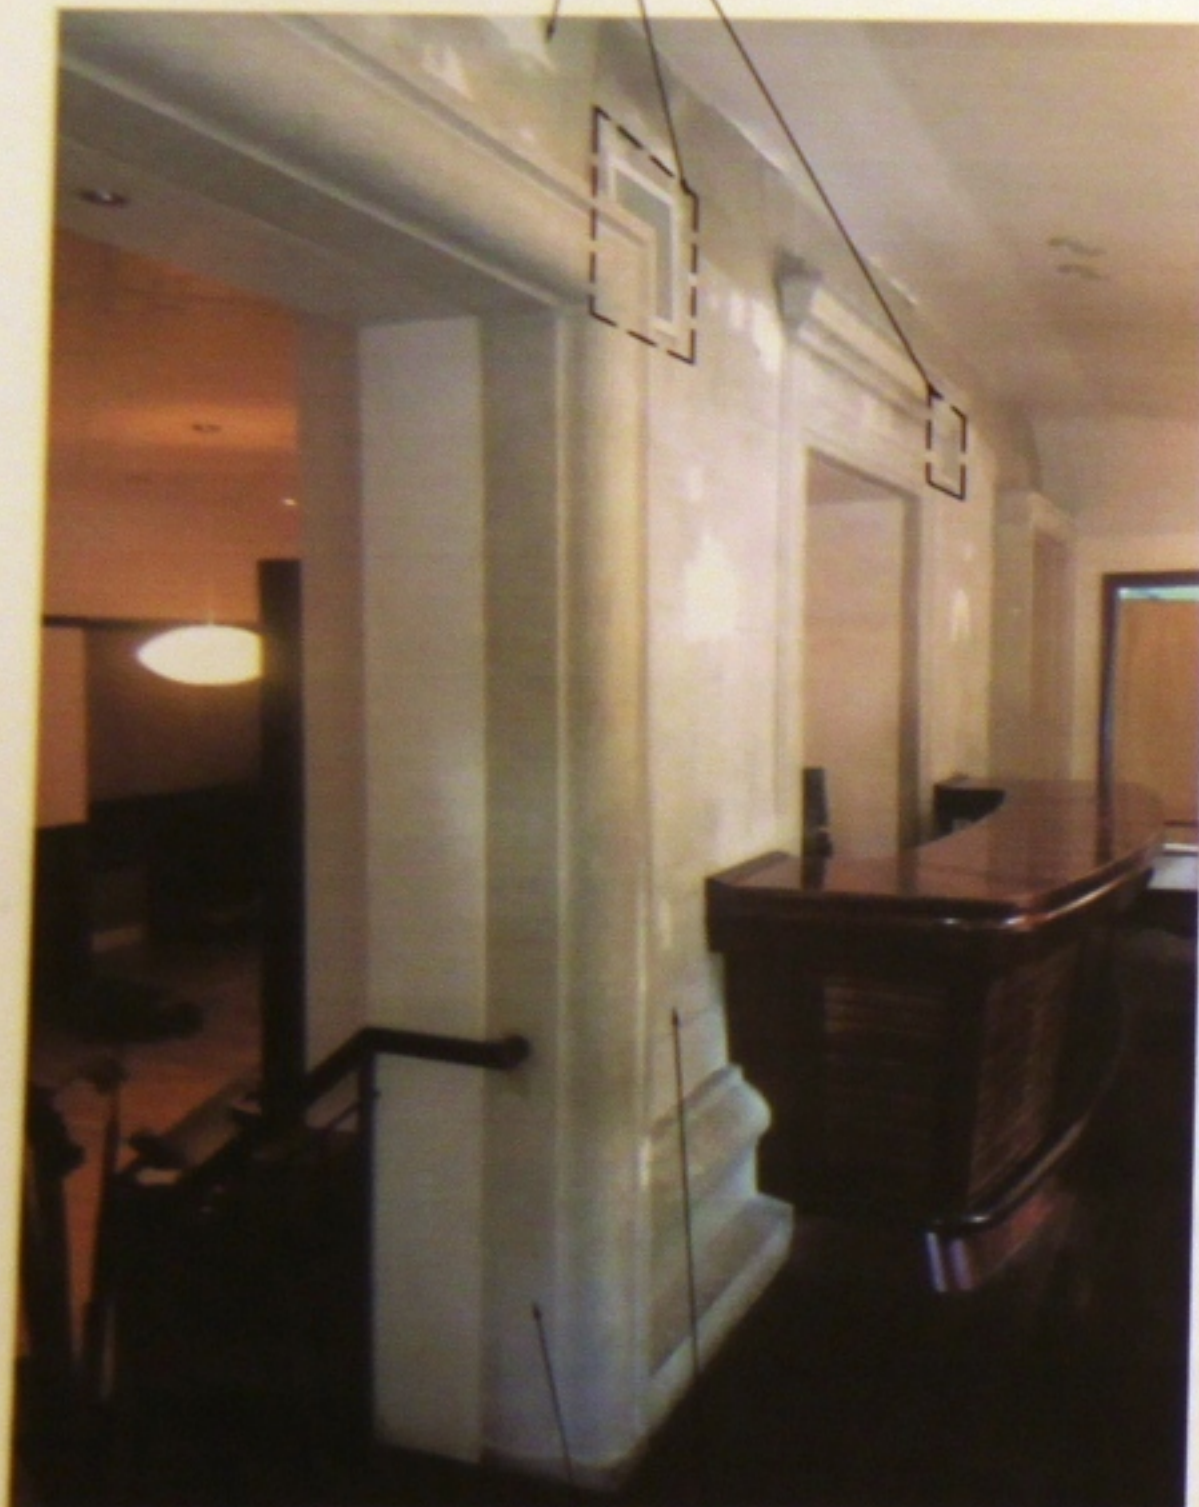
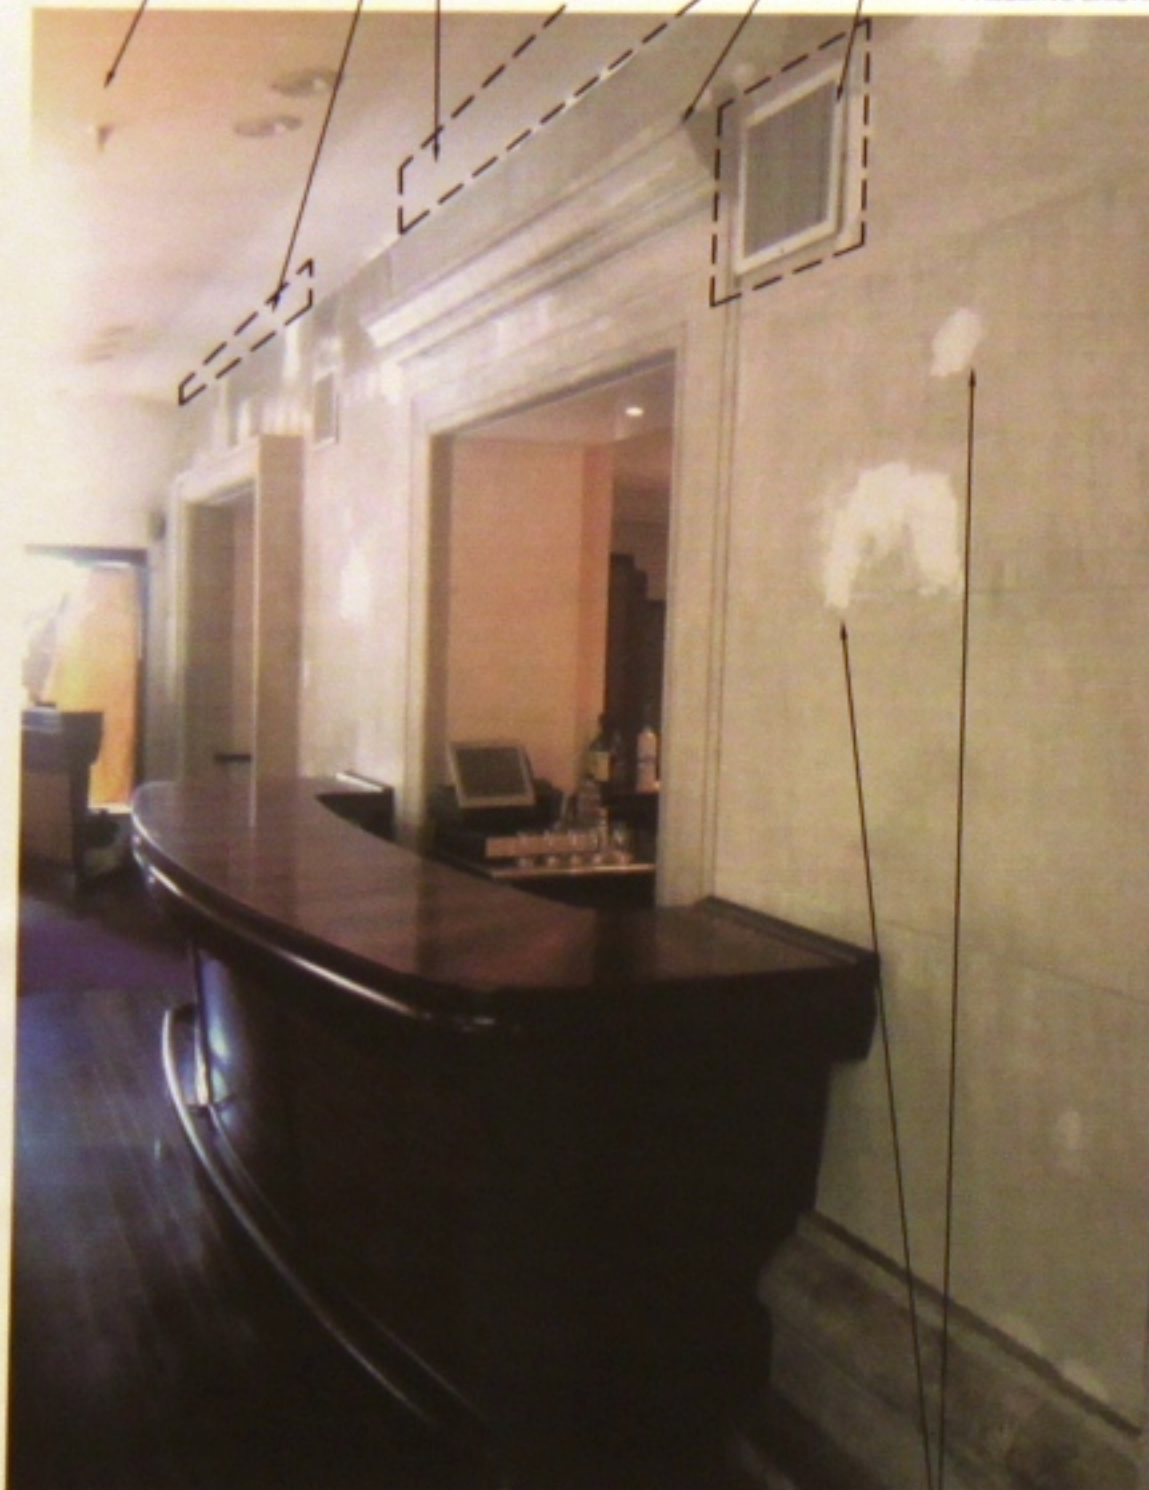
01 EXISTING PHOTOS AT FIFTH AVE WALL, SOUTH ENCLOSURE PHOTOGRAPHS

EXISTING MECHANICAL GRILLES TO BE REMOVED AT EXTERIOR WALLS. TO BE REPAIRED W/ LIMESTONE DUTCHMAN KEYED TO ADJACENT MASONRY. PRESERVE EXISTING JOINT LINES

REMOVE EXISTING PLASTER REPAIRS ON LIMESTONE

EXISTING SIDEWALK ENCLOSURE (WALLS, WINDOWS, CEILING, ROOF AND FLOORING) TO BE REMOVED. PATCH AND REPAIR WALLS AND SIDEWALK TO MATCH EXISTING ADJACENT. TYP.

LOCATION OF PROPOSED AWNING INSTALLATION. SEE ELEVATIONS AND DETAILS

RESTORE EXISTING MISSING LIMESTONE MOLDING ABOVE DOOR

- ALL REPAIRS TO BE REVIEWED / APPROVED BY BUILDING ARCHITECT (WALTER B. MELVIN)
 - MASONRY AREAS LARGER THAN 25 SQ. INCHES TO BE REPAIRED W/ LIMESTONE DUTCHMAN KEYED TO ADJACENT MASONRY
 - REPAIRS TO PRESERVE EXISTING JOINT LINES

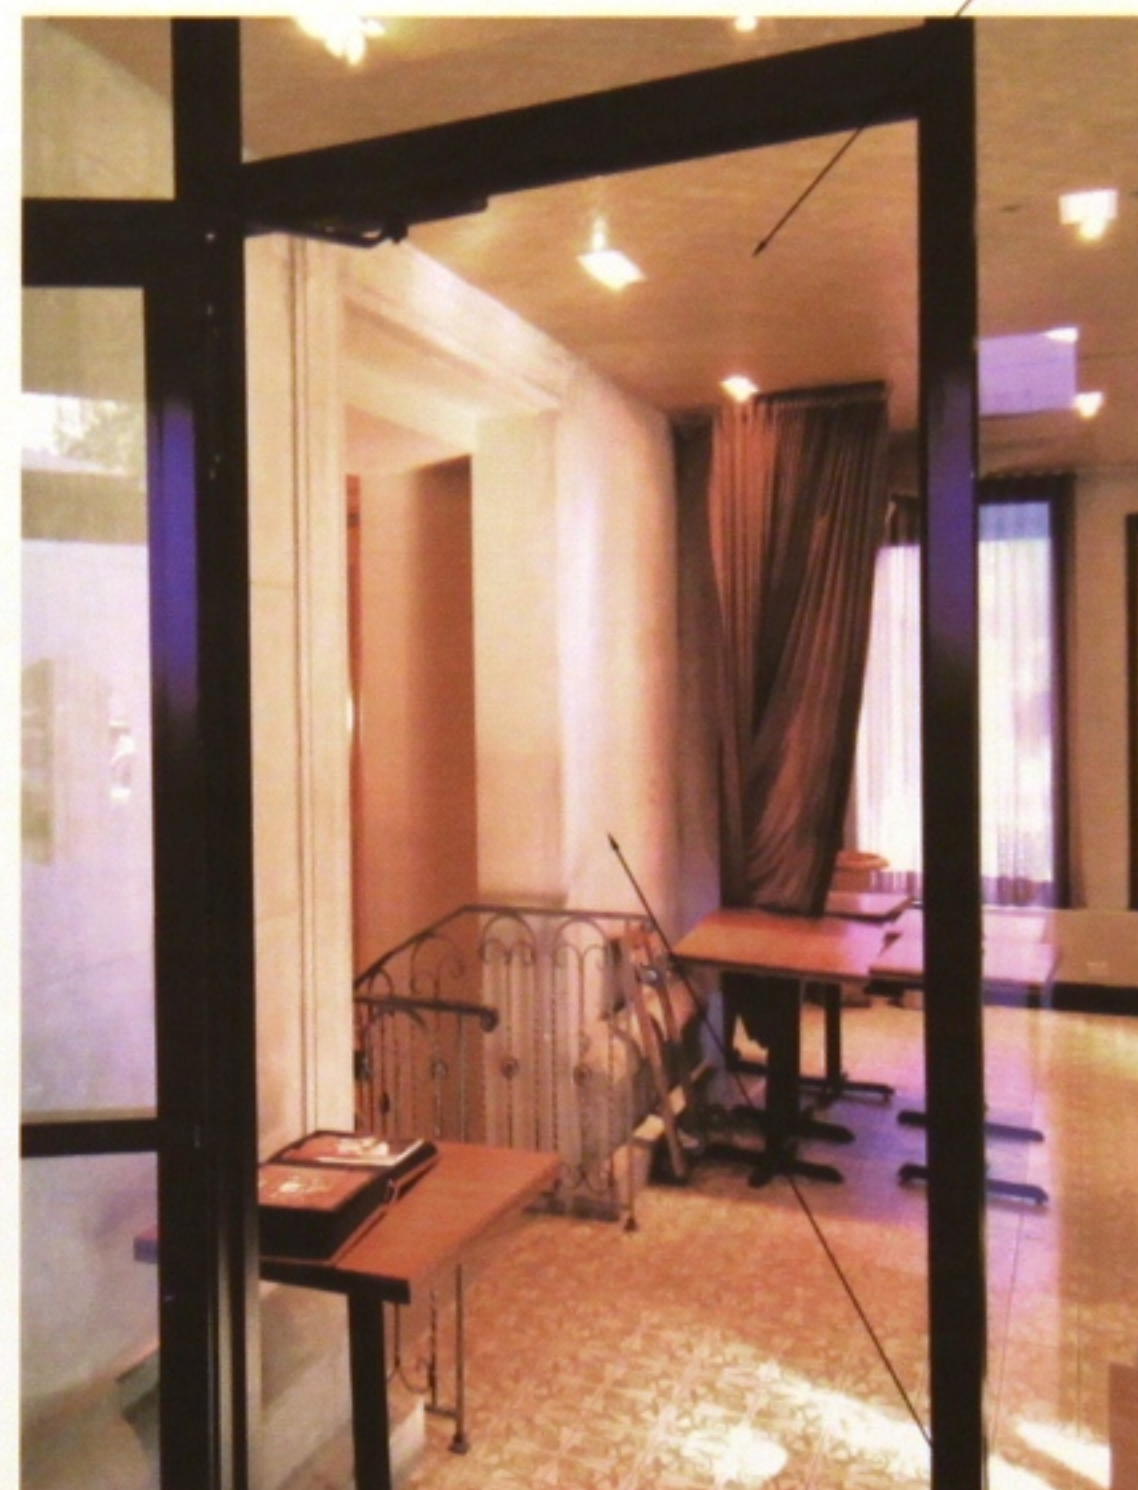
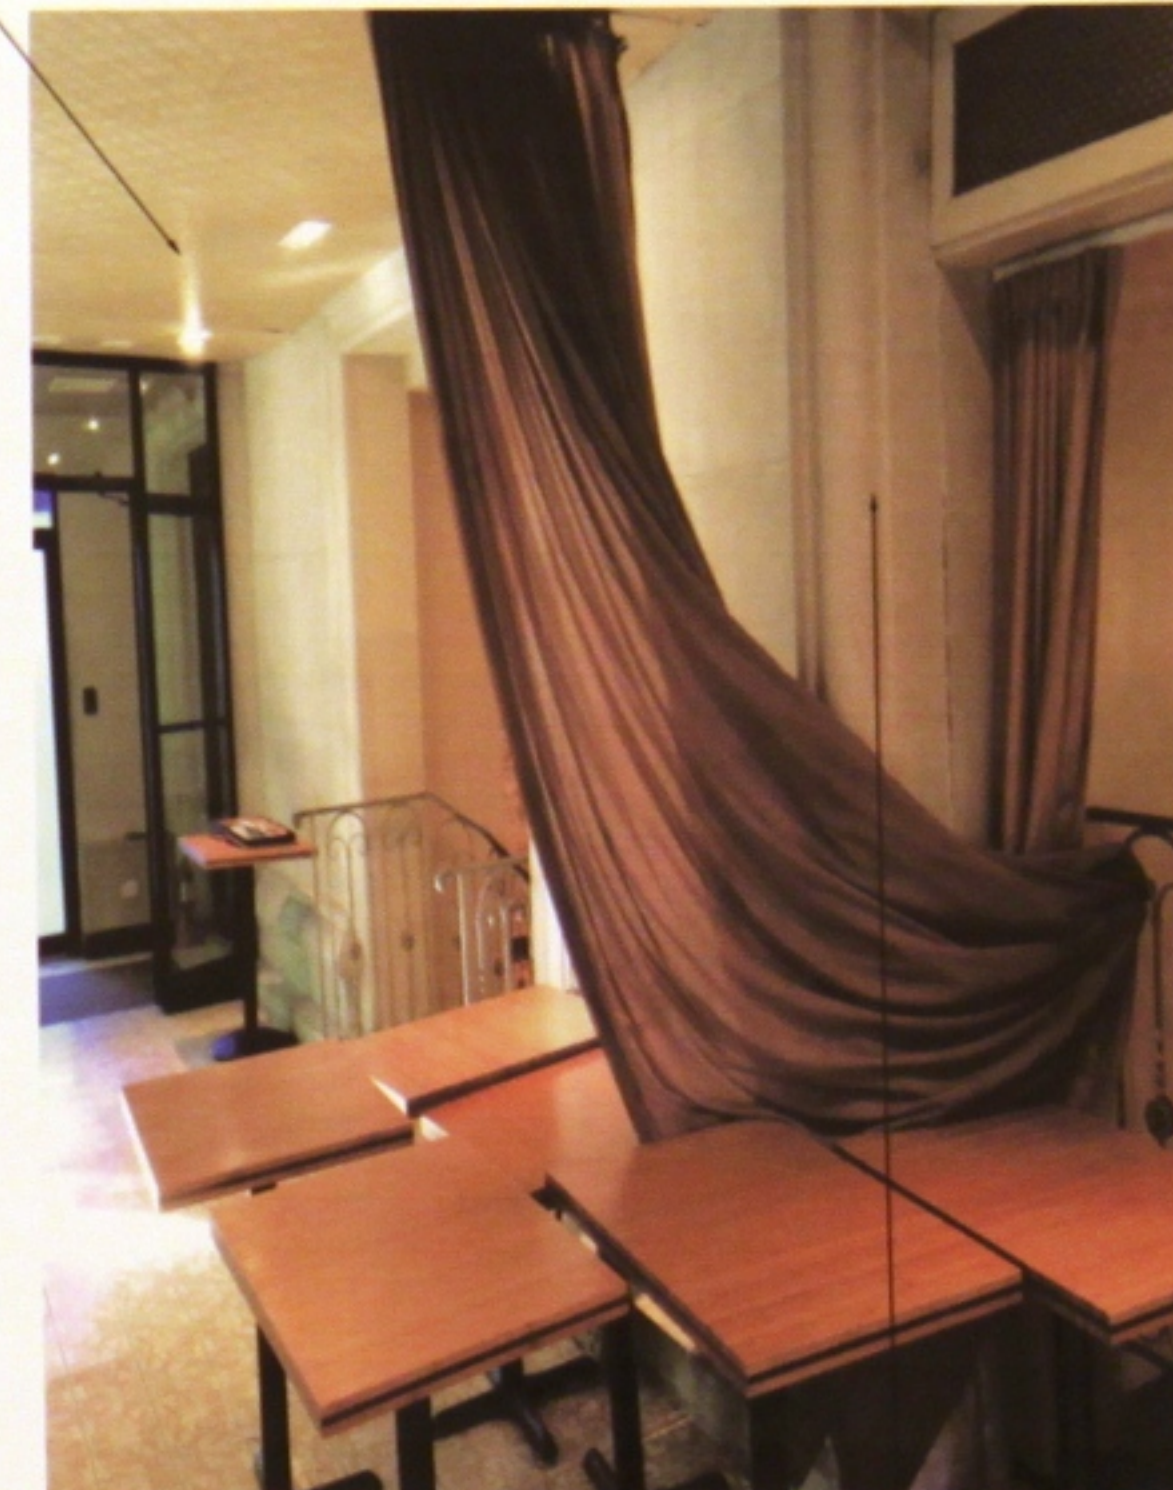
02 EXISTING PHOTOS AT FIFTH AVE WALL, NORTH ENCLOSURE PHOTOGRAPHS

REMOVE EXISTING PLASTER REPAIRS ON LIMESTONE

EXISTING LIMESTONE FACADE TO BE PATCHED, REPAIRED AND PAINTED TO MATCH EXISTING ADJACENT. TYP.

EXISTING FRAMED LIMESTONE OPENINGS AT FACADE TO REMAIN. PATCH AND REPAIR AS REQUIRED. PAINT TO MATCH EXISTING ADJACENT. NEW DOORS TO BE INSTALLED AT EXISTING OPENINGS. SEE ELEVATIONS

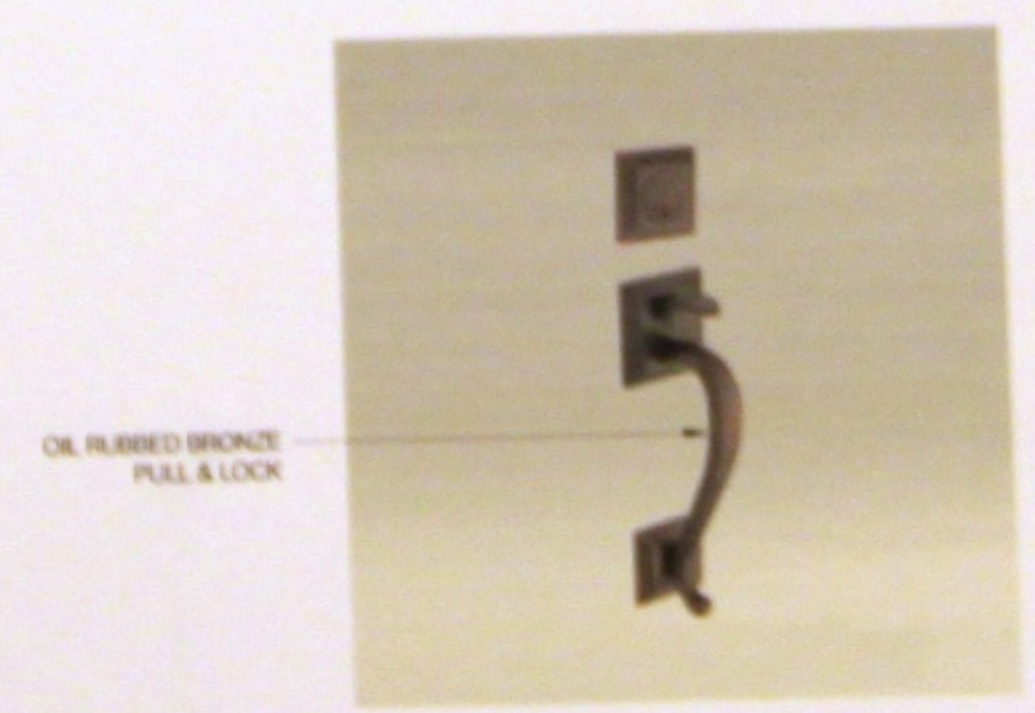
08 PROPOSED EXTERIOR DOOR HARDWARE
SCALE: N.T.S.
