83-85 SULLIVAN STREET

PRESENTATION TO:
LANDMARKS PRESERVATION COMMISSION

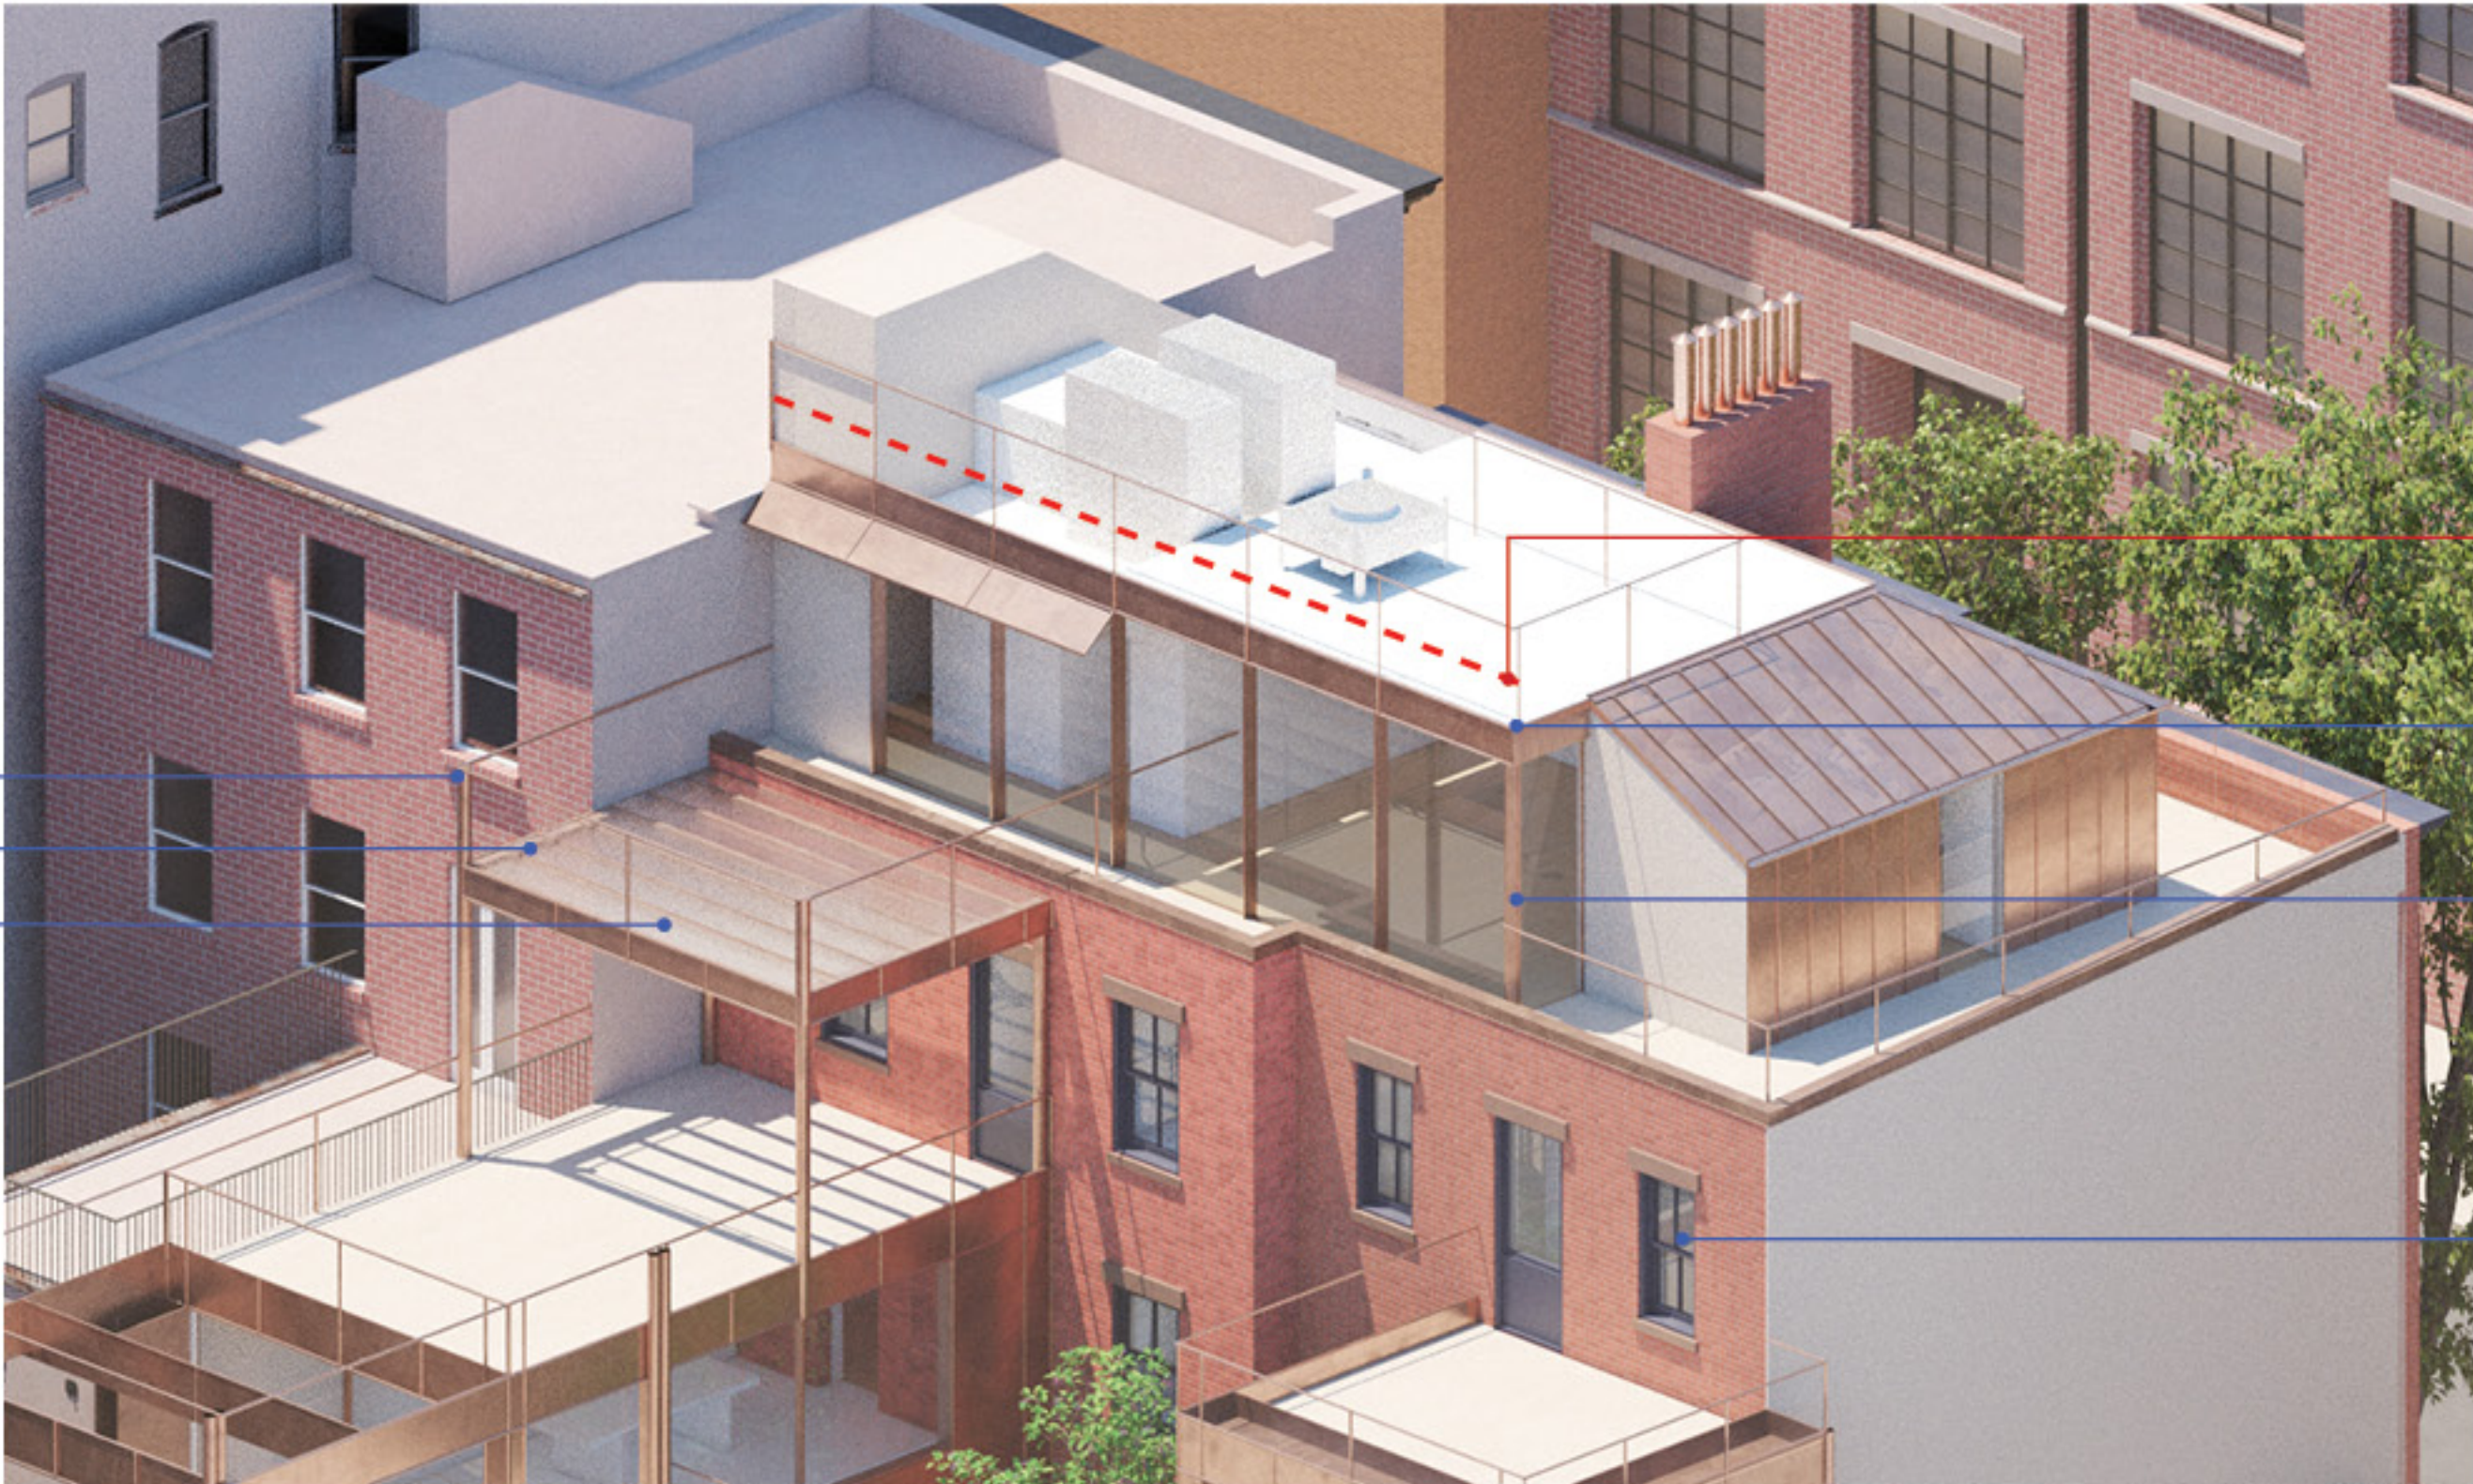
Currently Proposed Addition

Third floor addition at 83 Sullivan replaced with open porch with reduced footprint.

Reduced depth of fascia to increase visibility of continuous roof line at rear of historic mass.

Roof of open porch detailed with walkable glass surface for increased light at restored rear facade.

Roof addition ceiling height reduced by 1'-0". Depth of fascia further reduced to decrease overall appearance.

Vertical fins reduced to emphasize continuous historic roof line.

Windows at restored rear facade detailed to match the historic 2-over-2 windows at the front facade. Doors detailed to match window proportions.

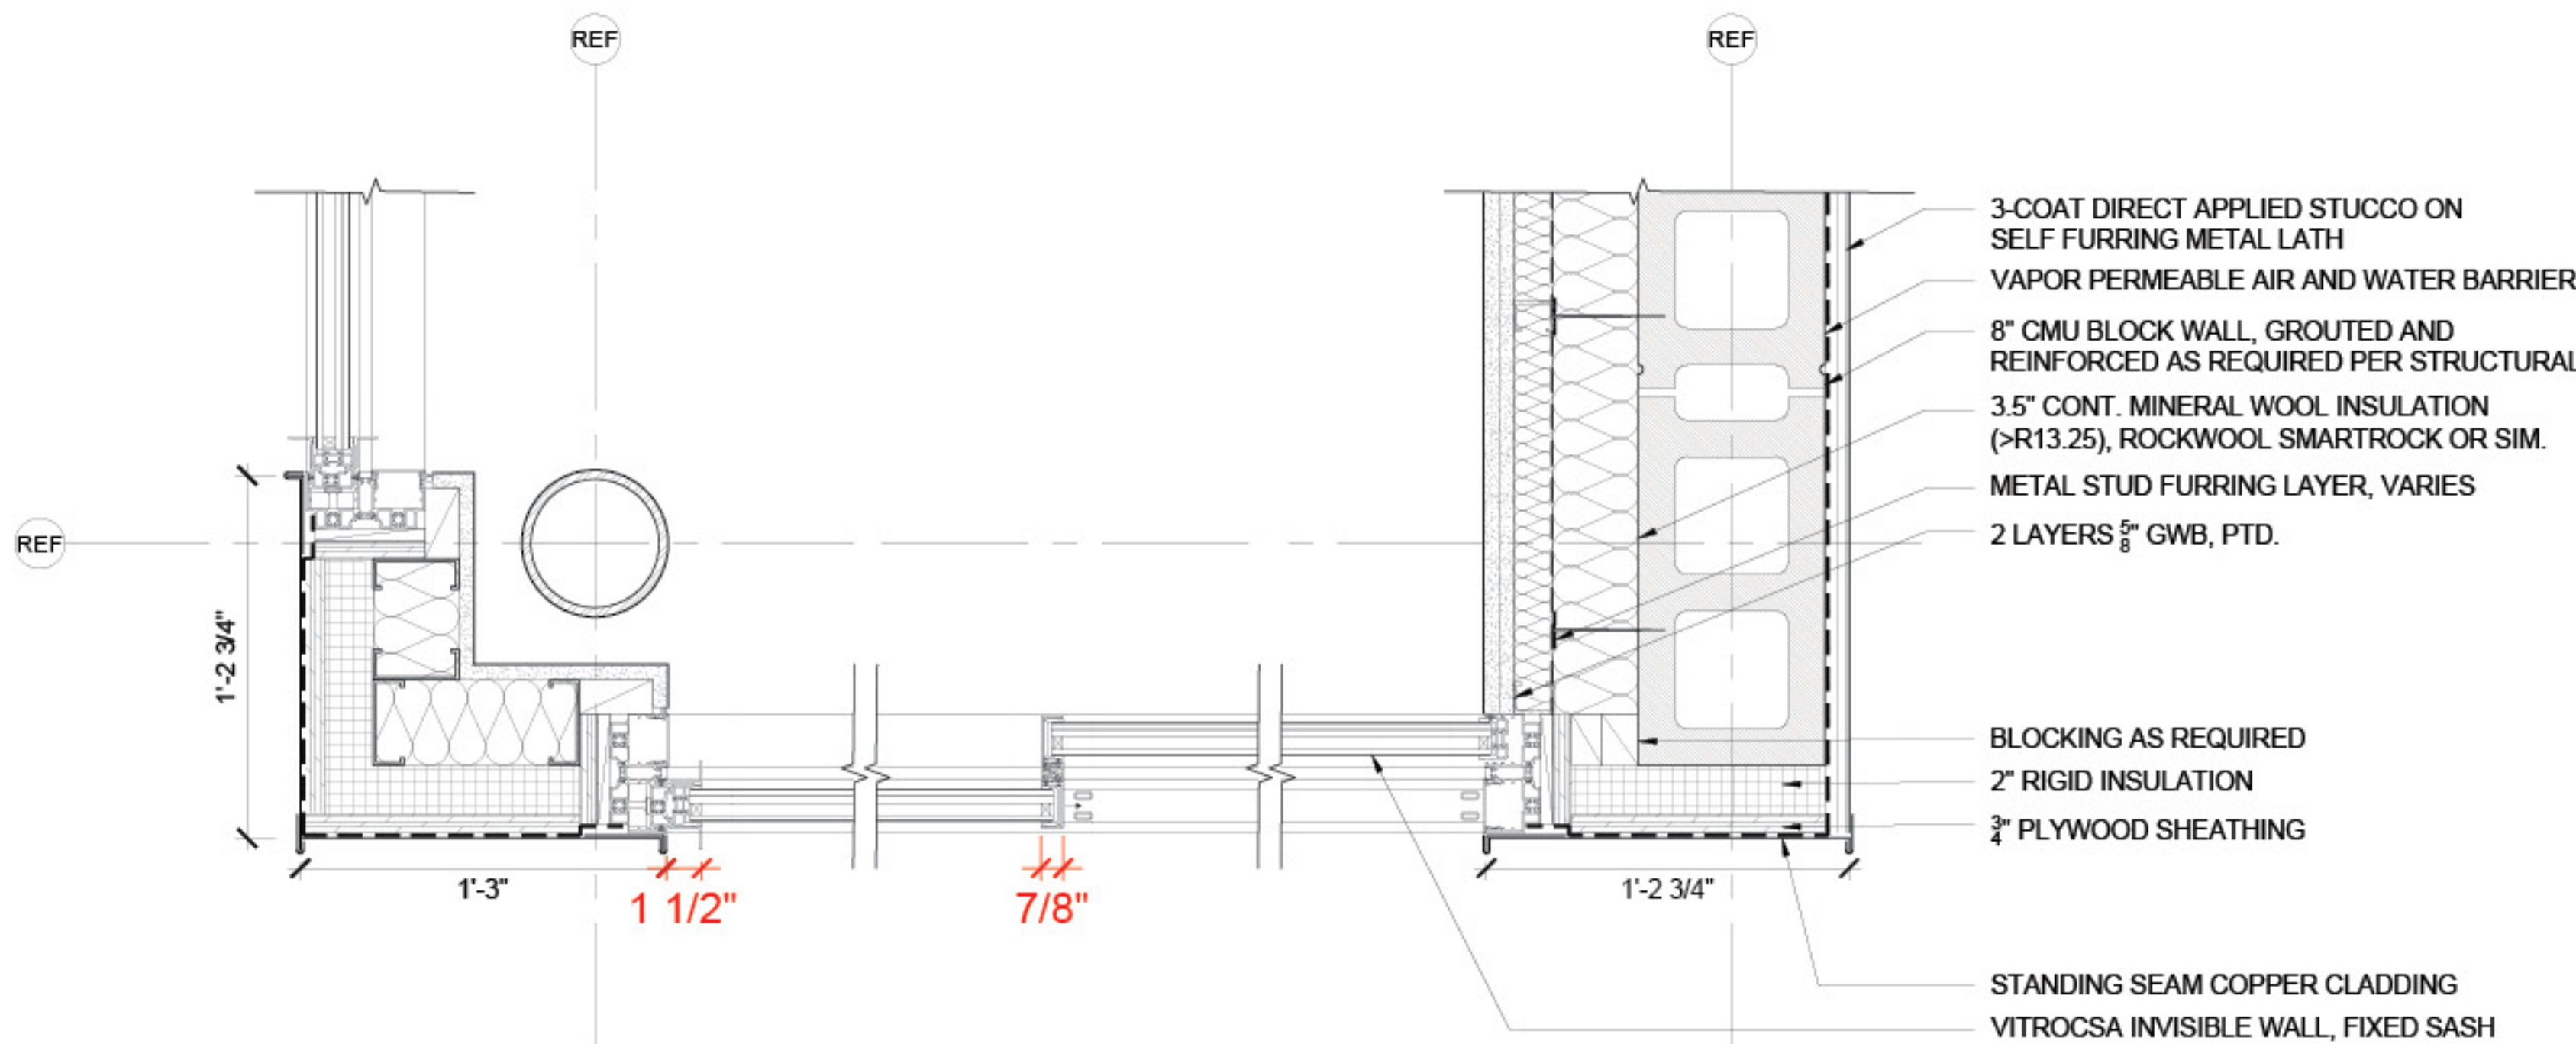
Large-Scale Glazing System at 83 and 85 Sullivan Additions

Vitrocsa Sliding Door and Window System Specifications:
 Full Frame Depth: 2-5/16" (concealed)
 Visible Frame Dimensions:
 Fixed Jamb: 1/4"
 Operable Jamb: 1-7/16"
 Vertical Mullion: 7/8"
 Head, Sill: 5/8"
 Max. Panel Size: 26'-0" x 10'-6"
 Max. Proposed Panel Size: 13'-2" x 9'-2"

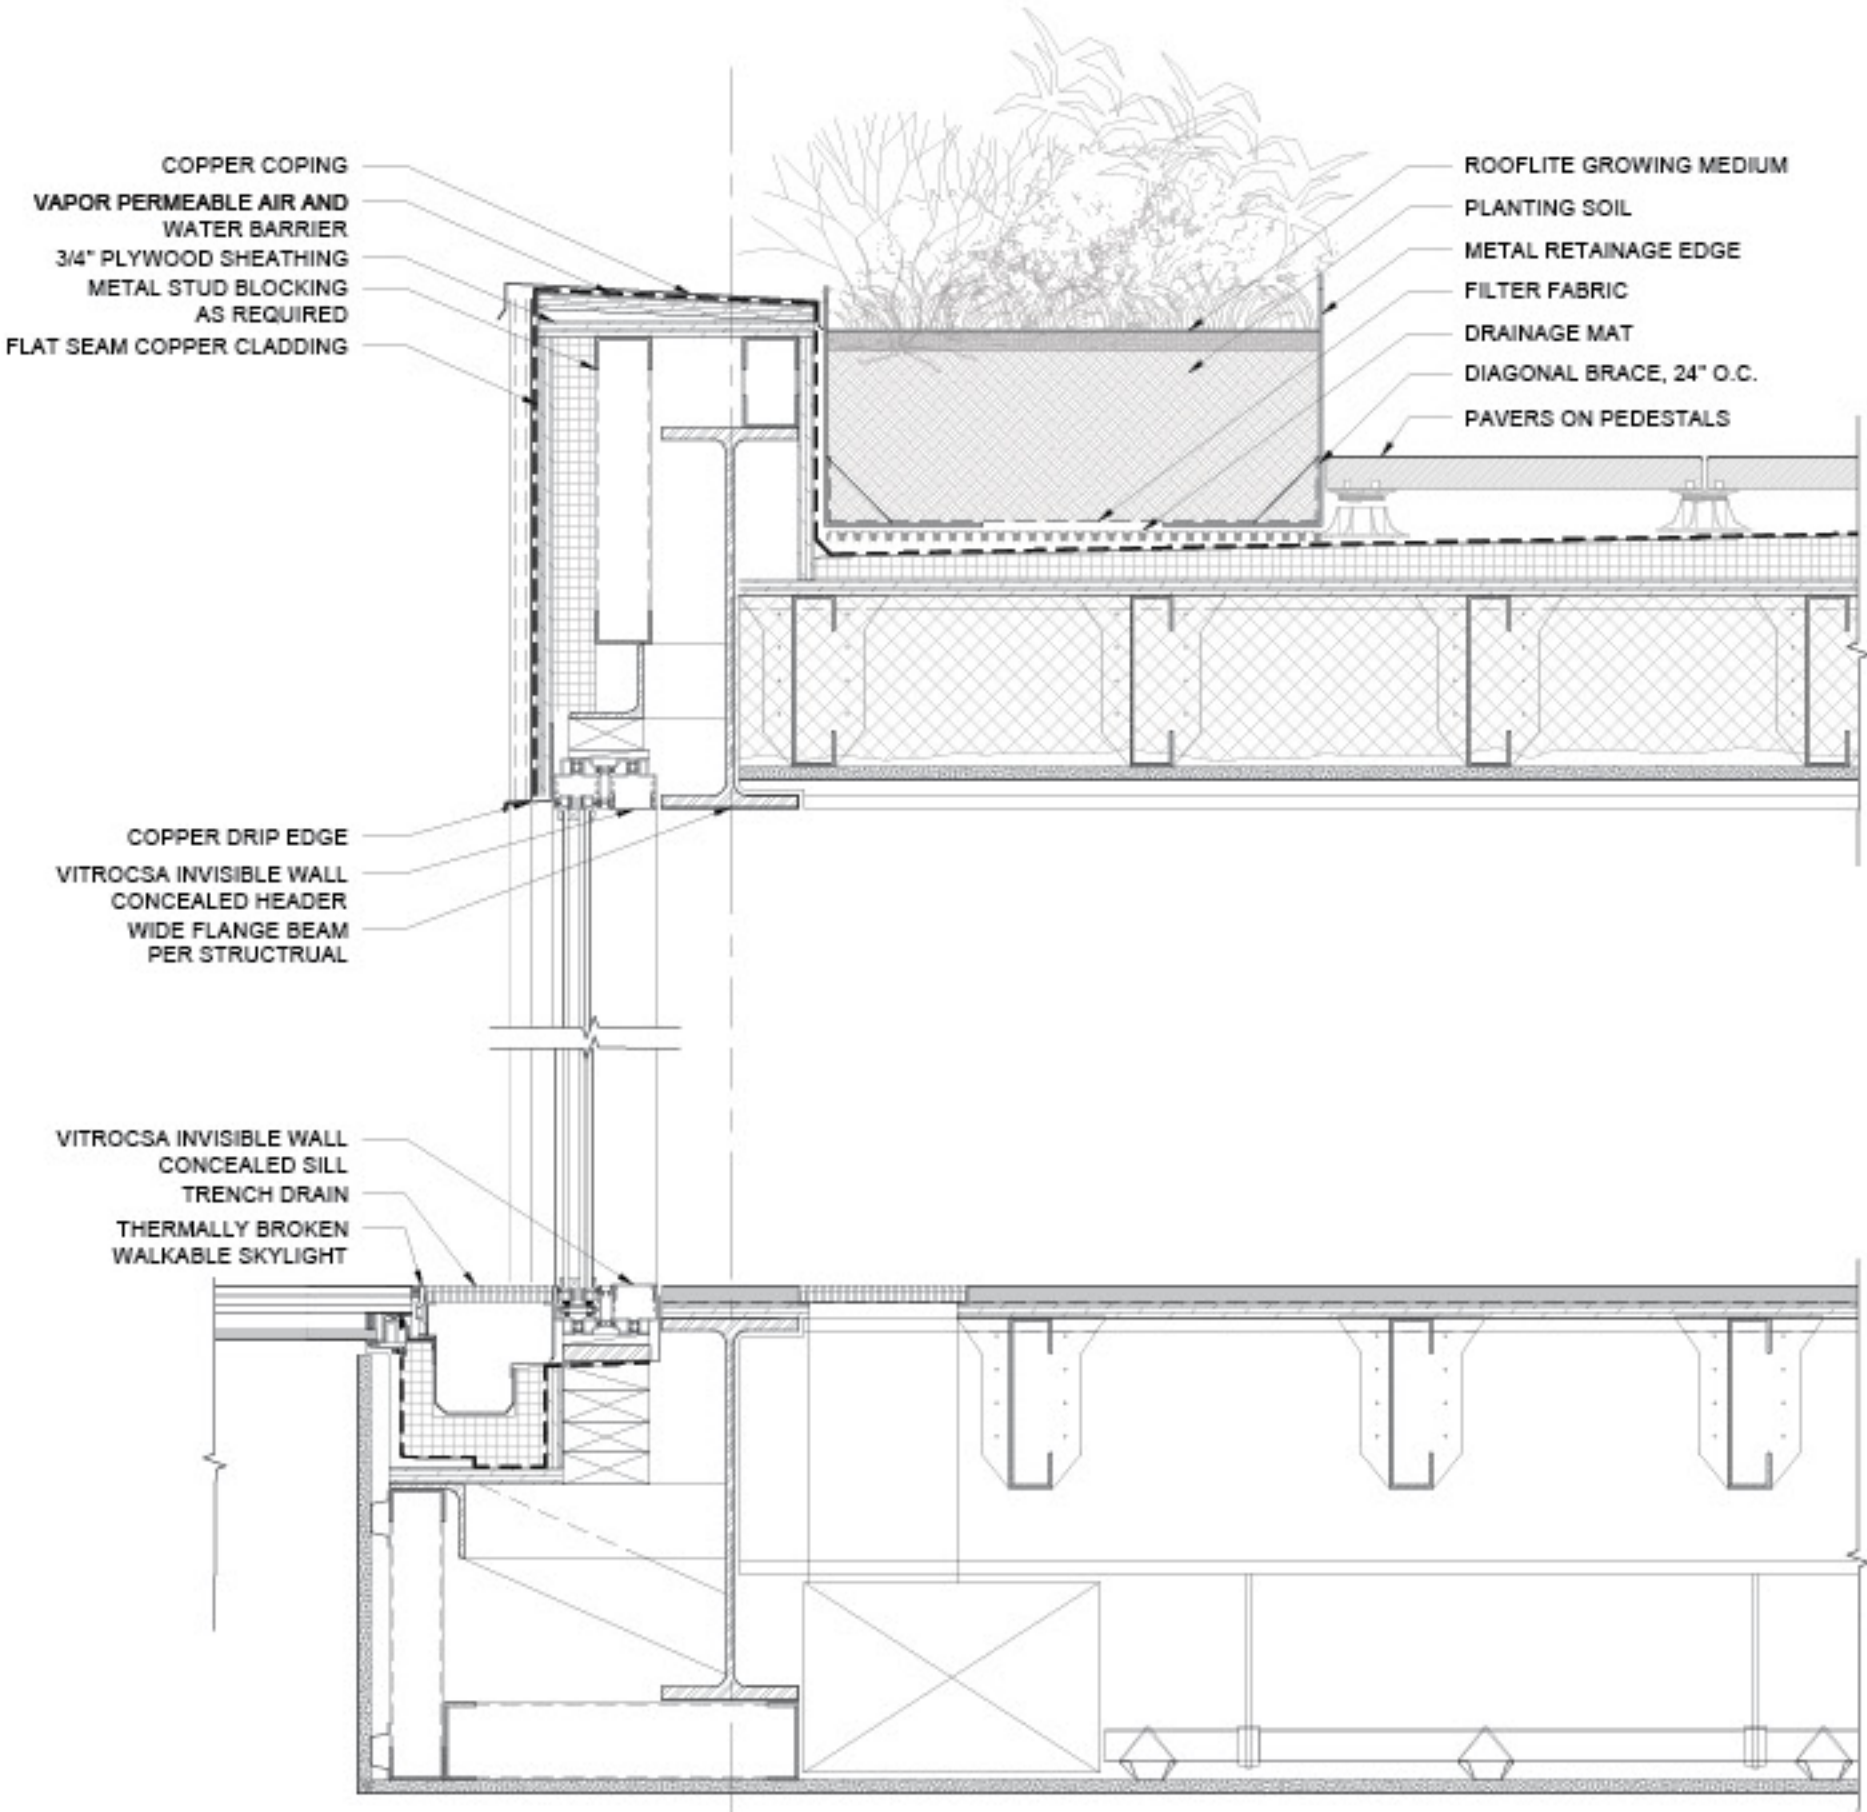
Typical Head, Sill, Deck, and Planter Details

Exterior Deck with Integrated Planters

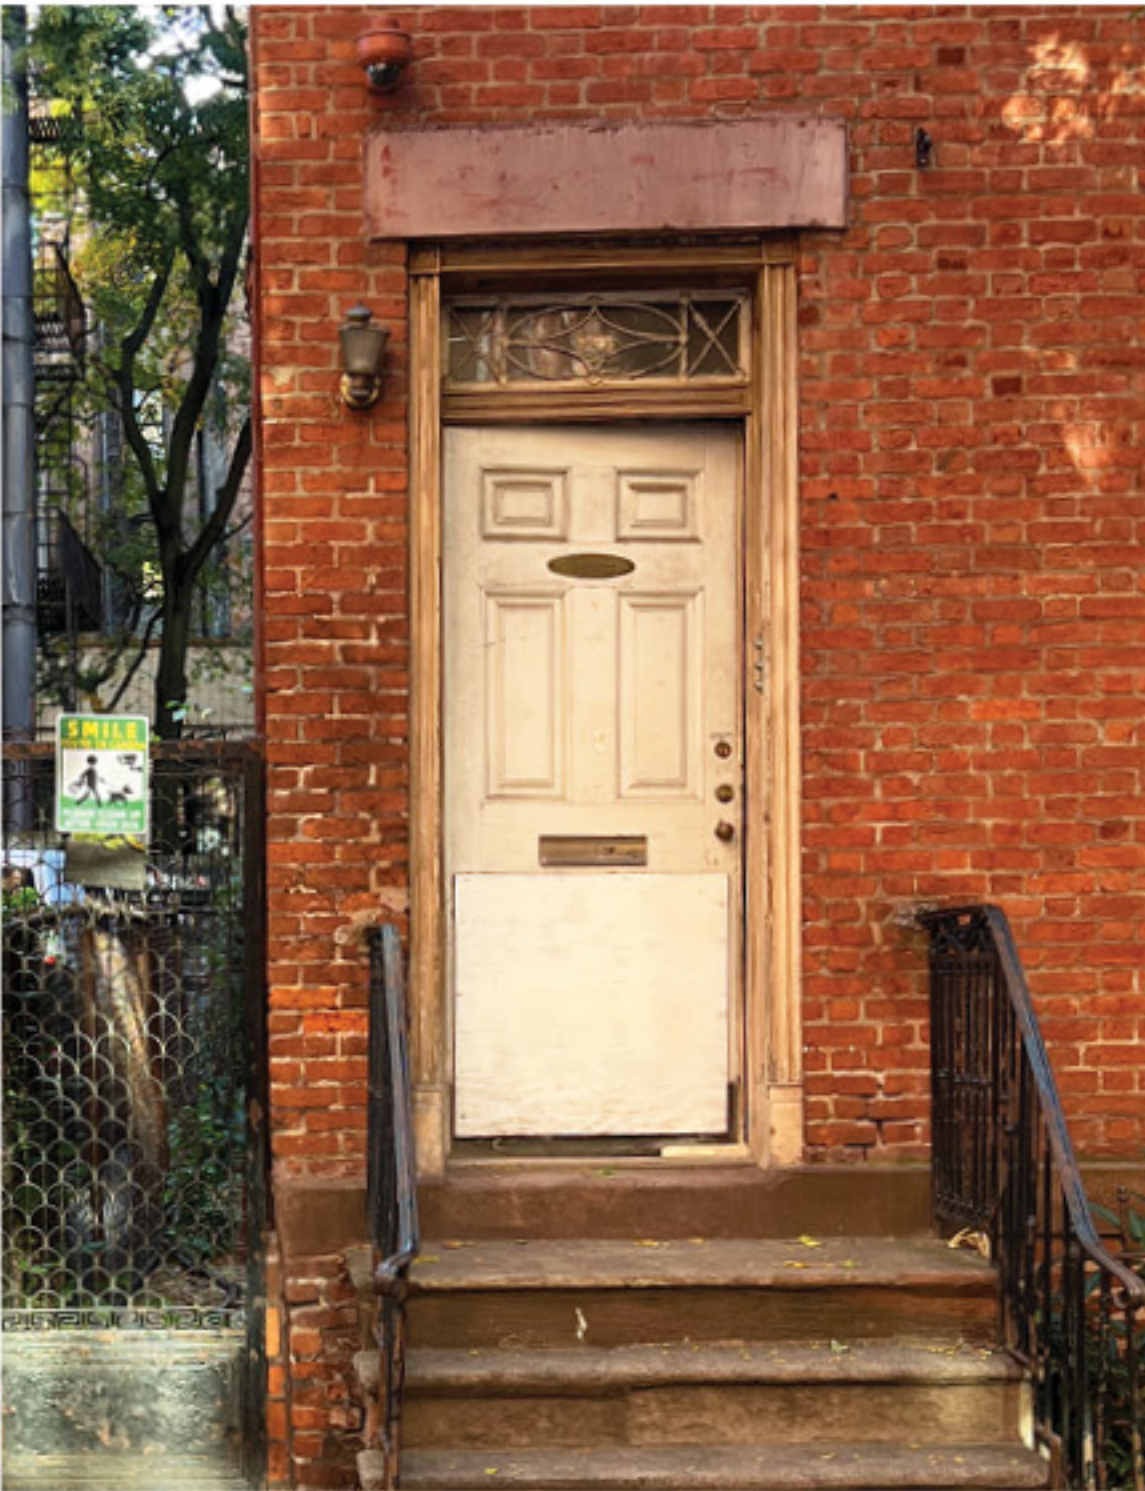
Existing Conditions: Facade Features

85 Sullivan Doorway (surround to remain)

83 Sullivan Doorway (surround to remain)

Cornice (to remain)

Ironwork (surround to remain)

Original, historic door surrounds and transoms to be preserved at both addresses.

Non-original doors to be replaced with new doors to match historic doors w/ lites as shown in the 1940's tax photos.

Original, historic cornices and wrought-iron railings to be preserved.

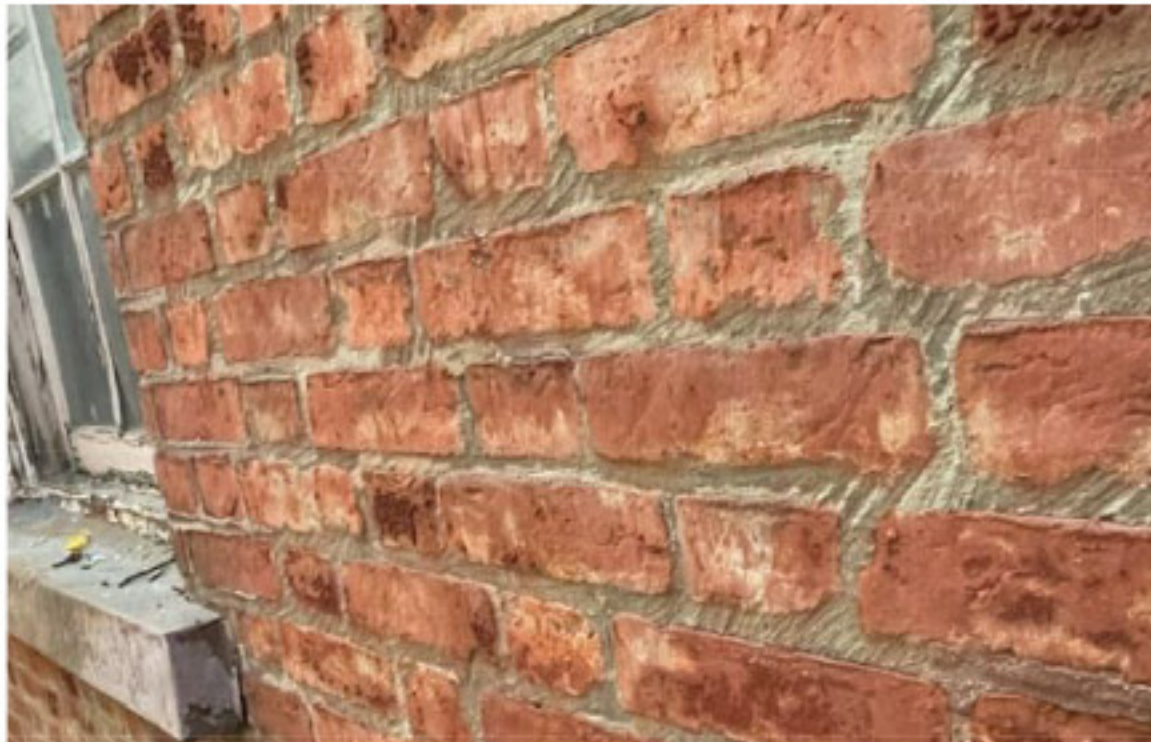
Mechanically Scraped Bricks

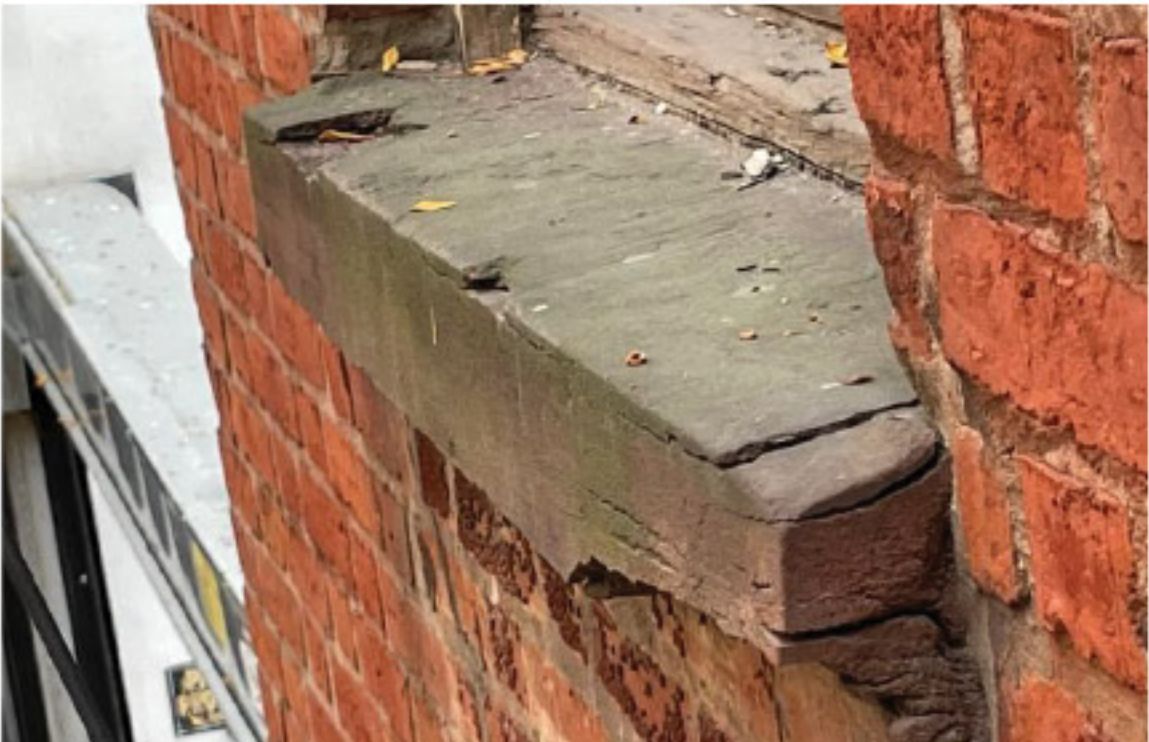
Stone Sill Deterioration

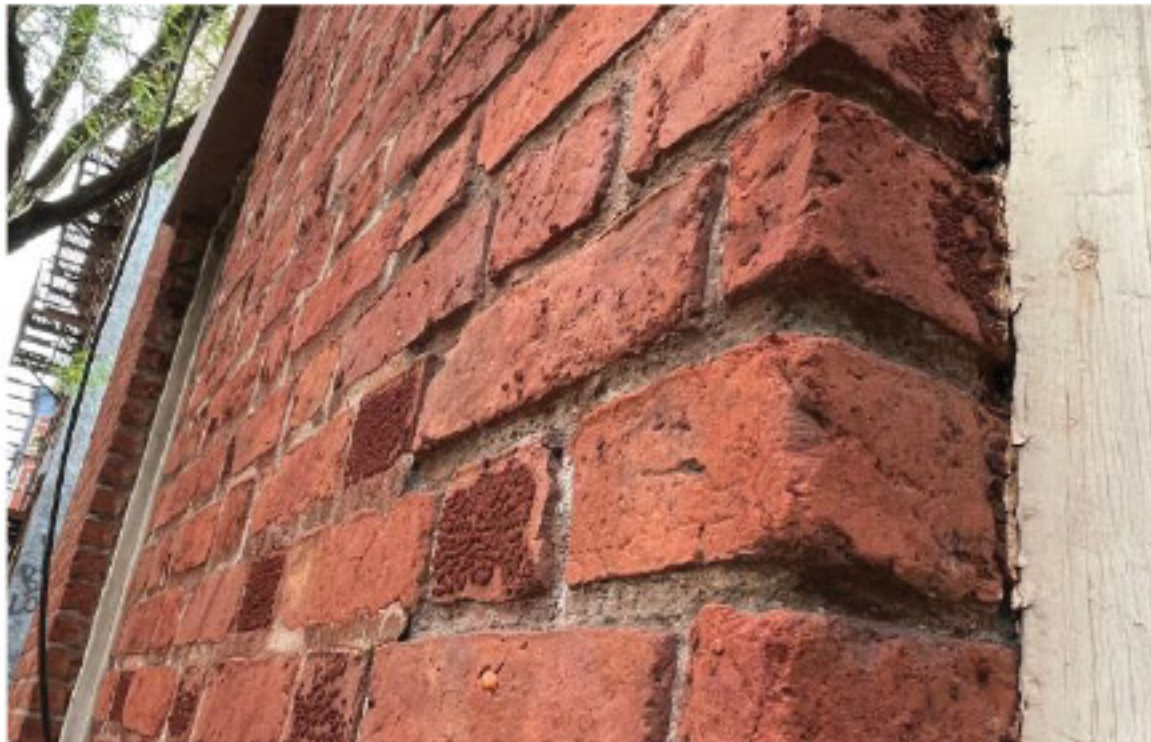
Mortar Erosion

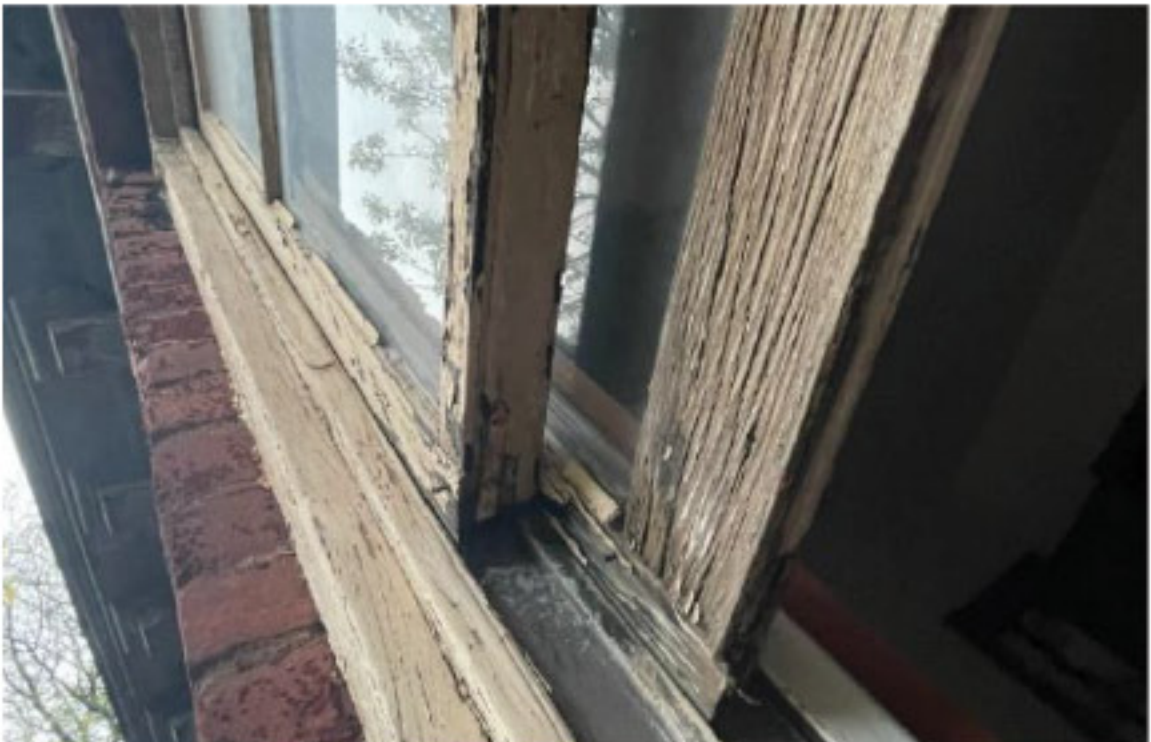
Severe Window Frame Deterioration

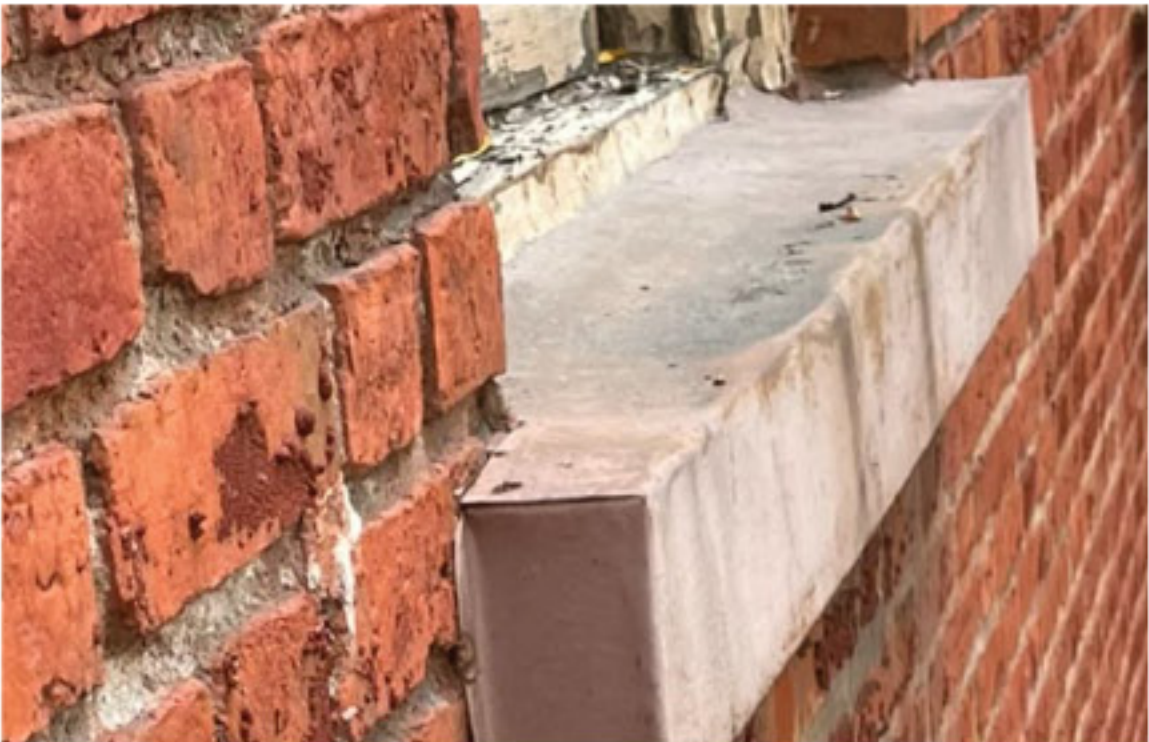
Sill Covered in Break Metal

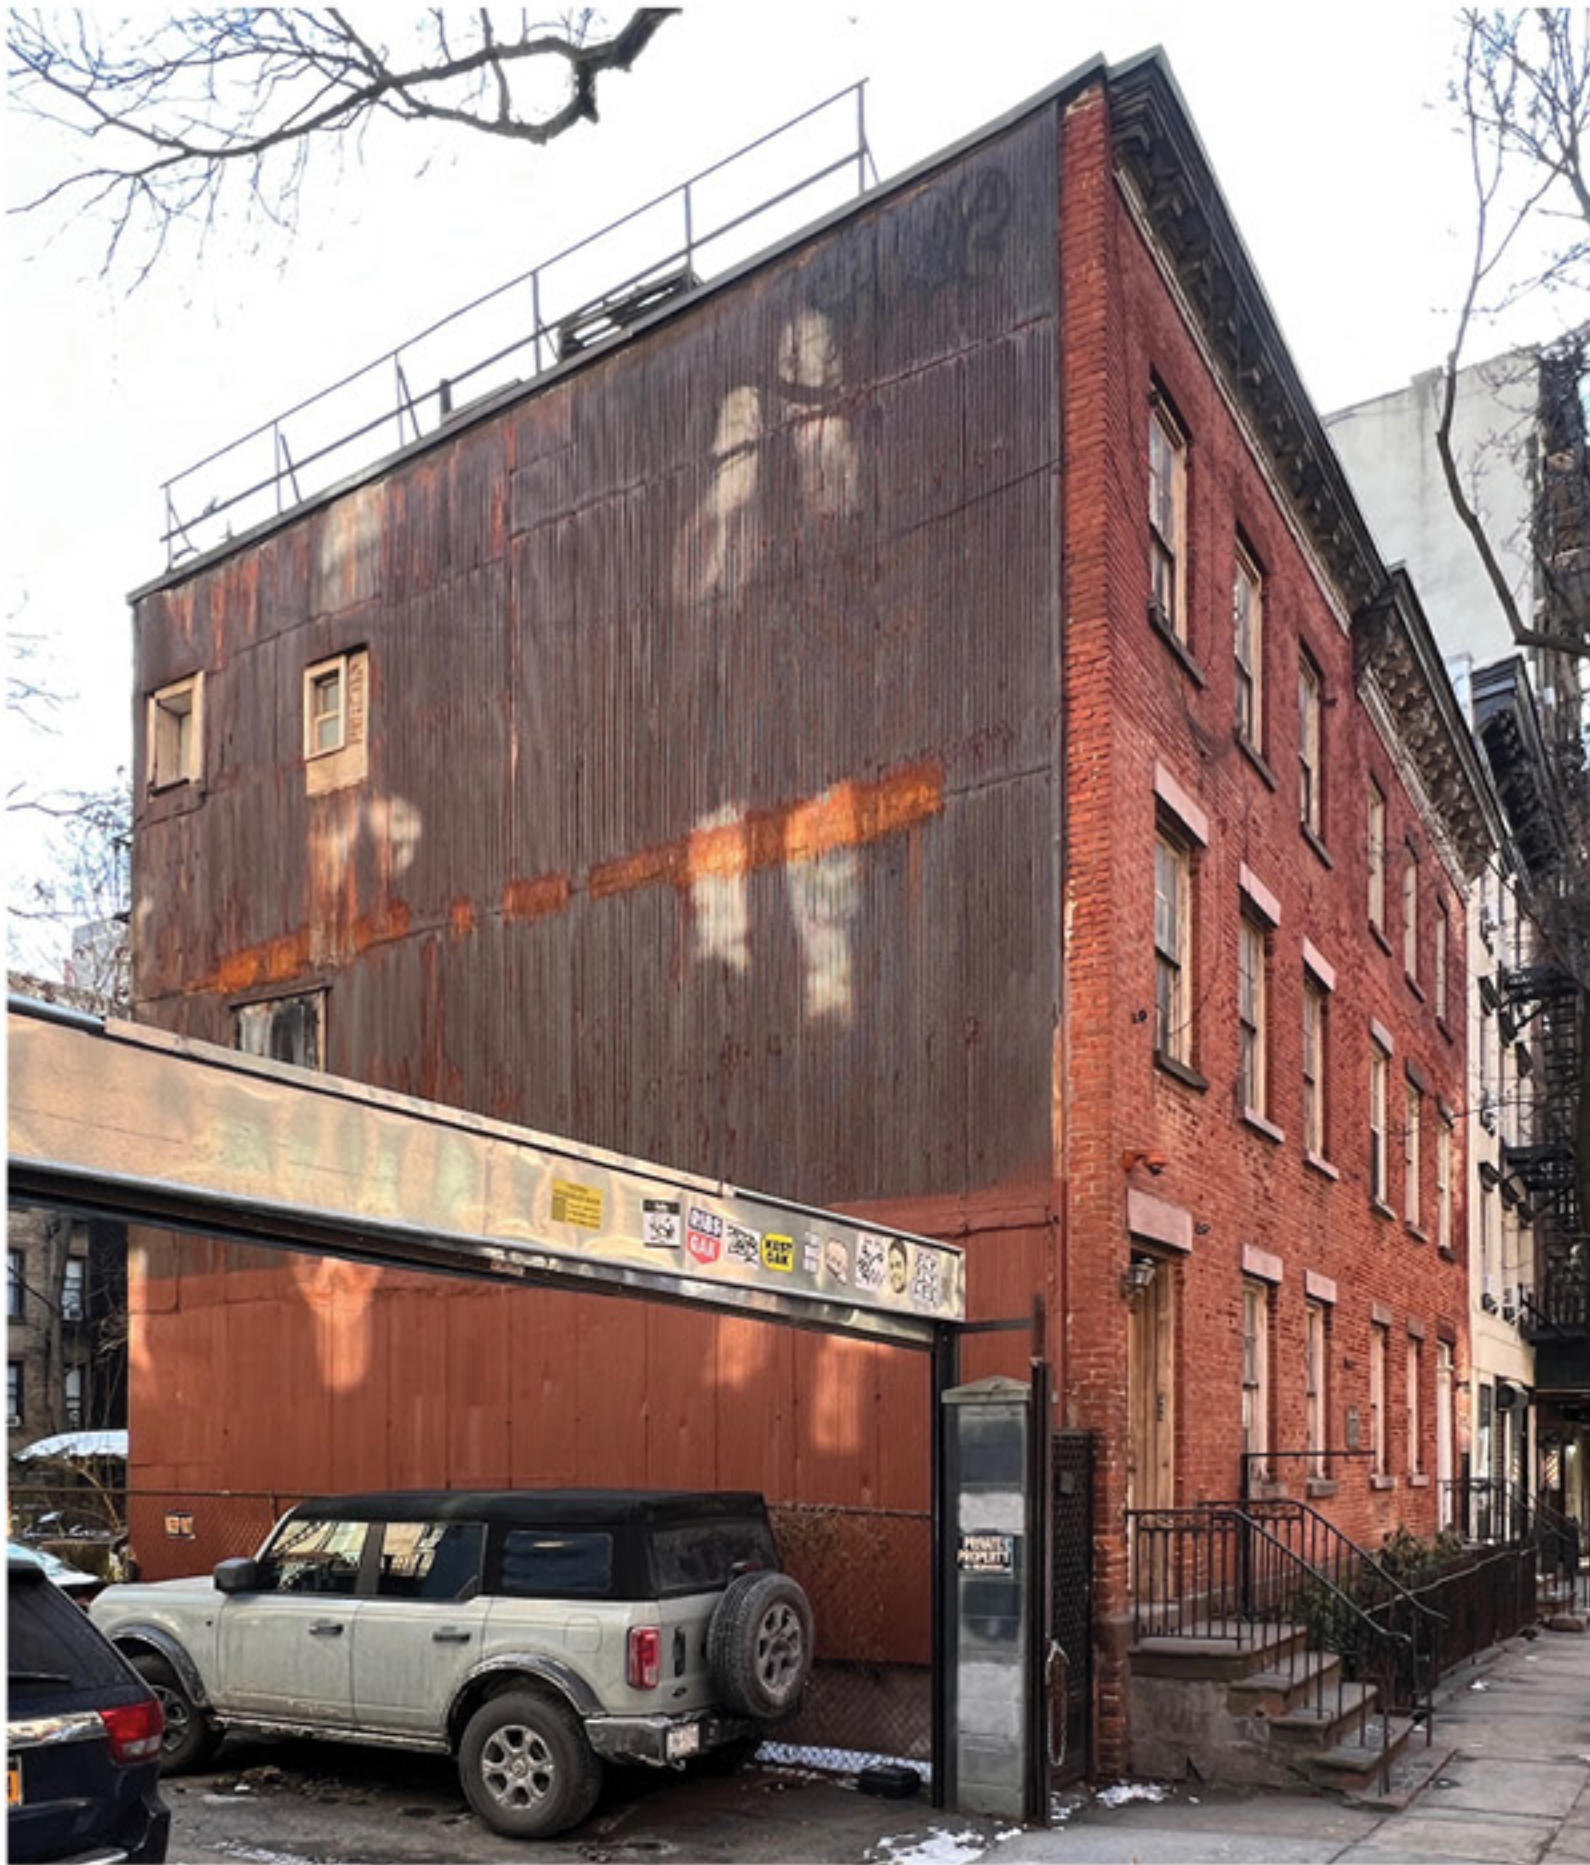
85 Sullivan Street North Facade
Current photograph, deteriorated metal cladding, installed in 1930s

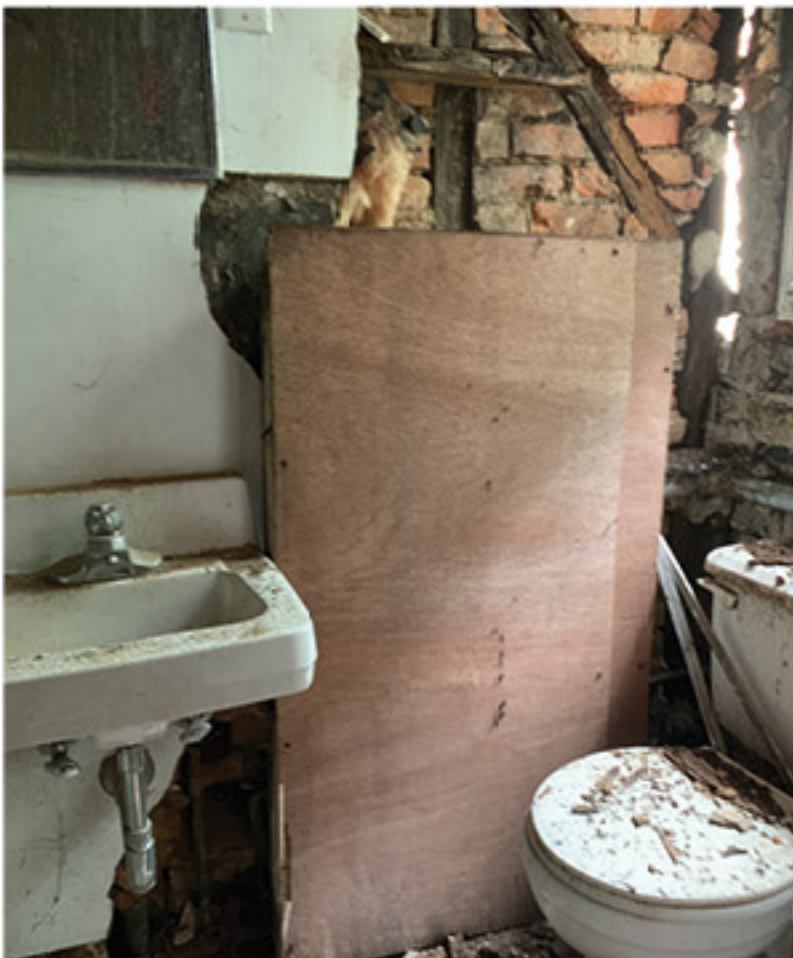
Interior deterioration due to weather infiltration at open exterior corner

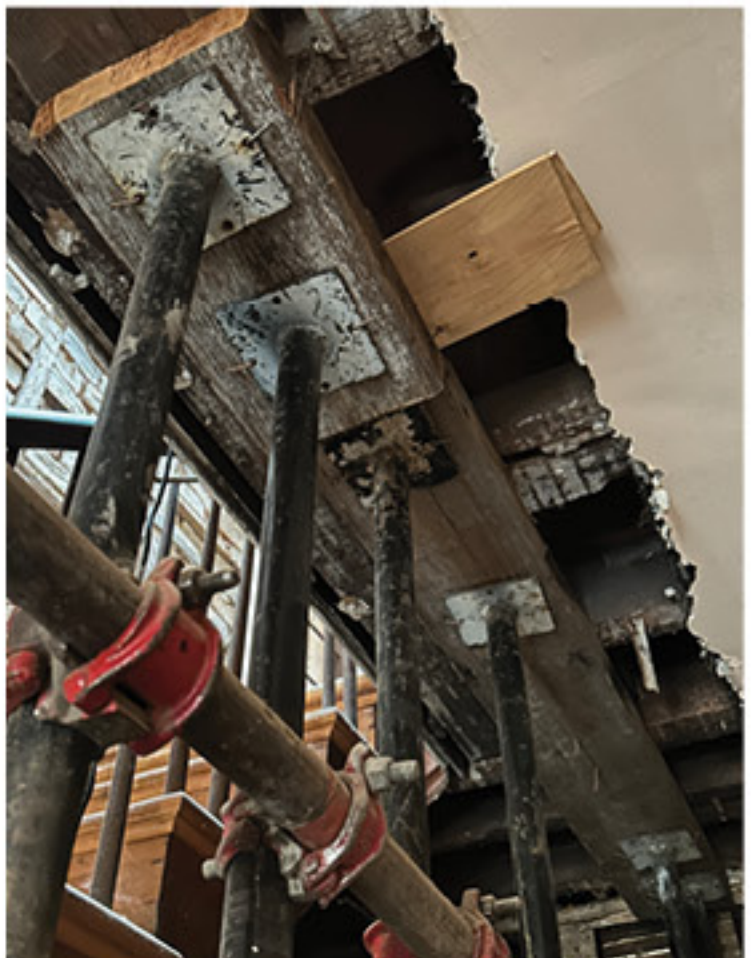
Structural shoring, installed in 2009 to prevent building collapse

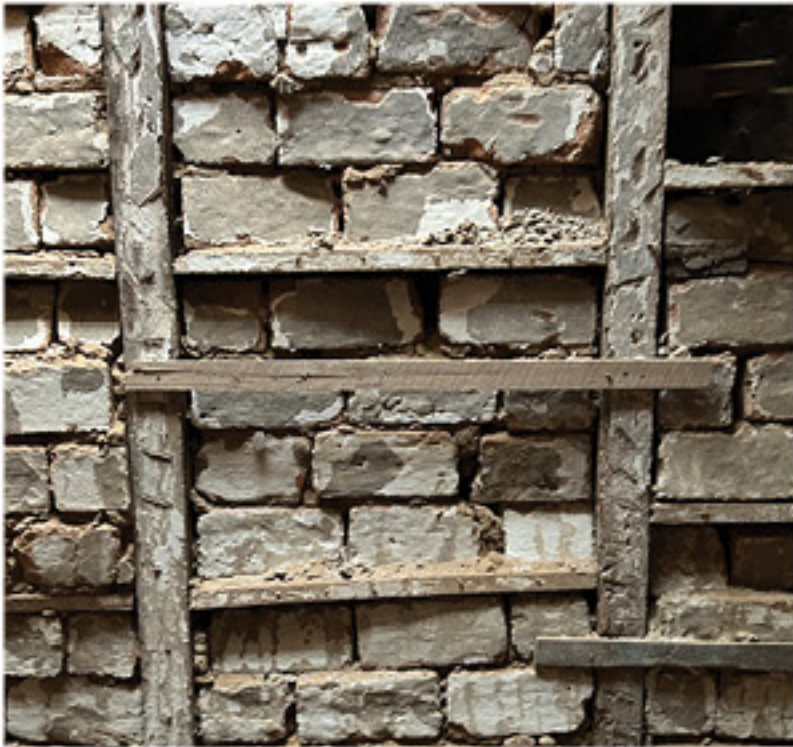
Decay of brick nogging wall, including loose brick and rot at original structural timbers

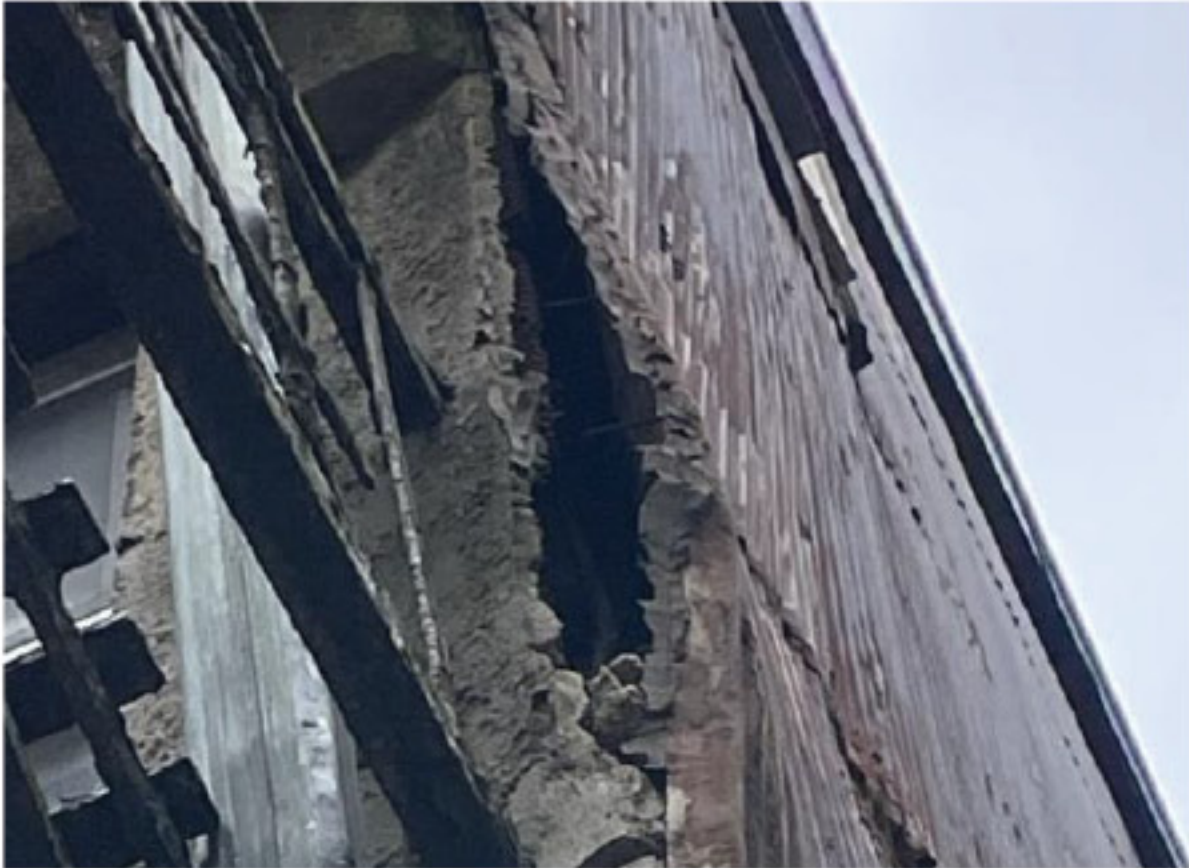
Buckling Wall
Separation of the north and east wall,
source of considerable water infiltration

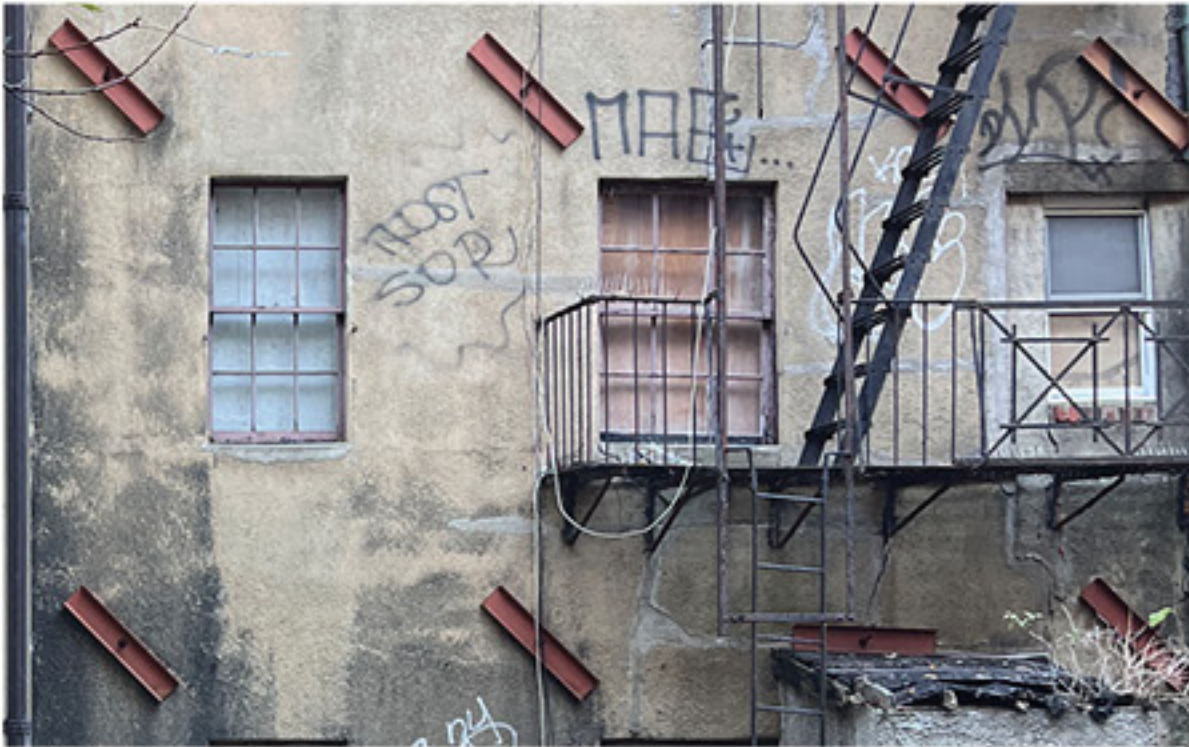
Exposed Structural Tie-Backs
Installed in 2009 to help stabilize the building
and prevent further separation of the facade
