83-85 SULLIVAN STREET

PRESENTATION TO:
LANDMARKS PRESERVATION COMMISSION

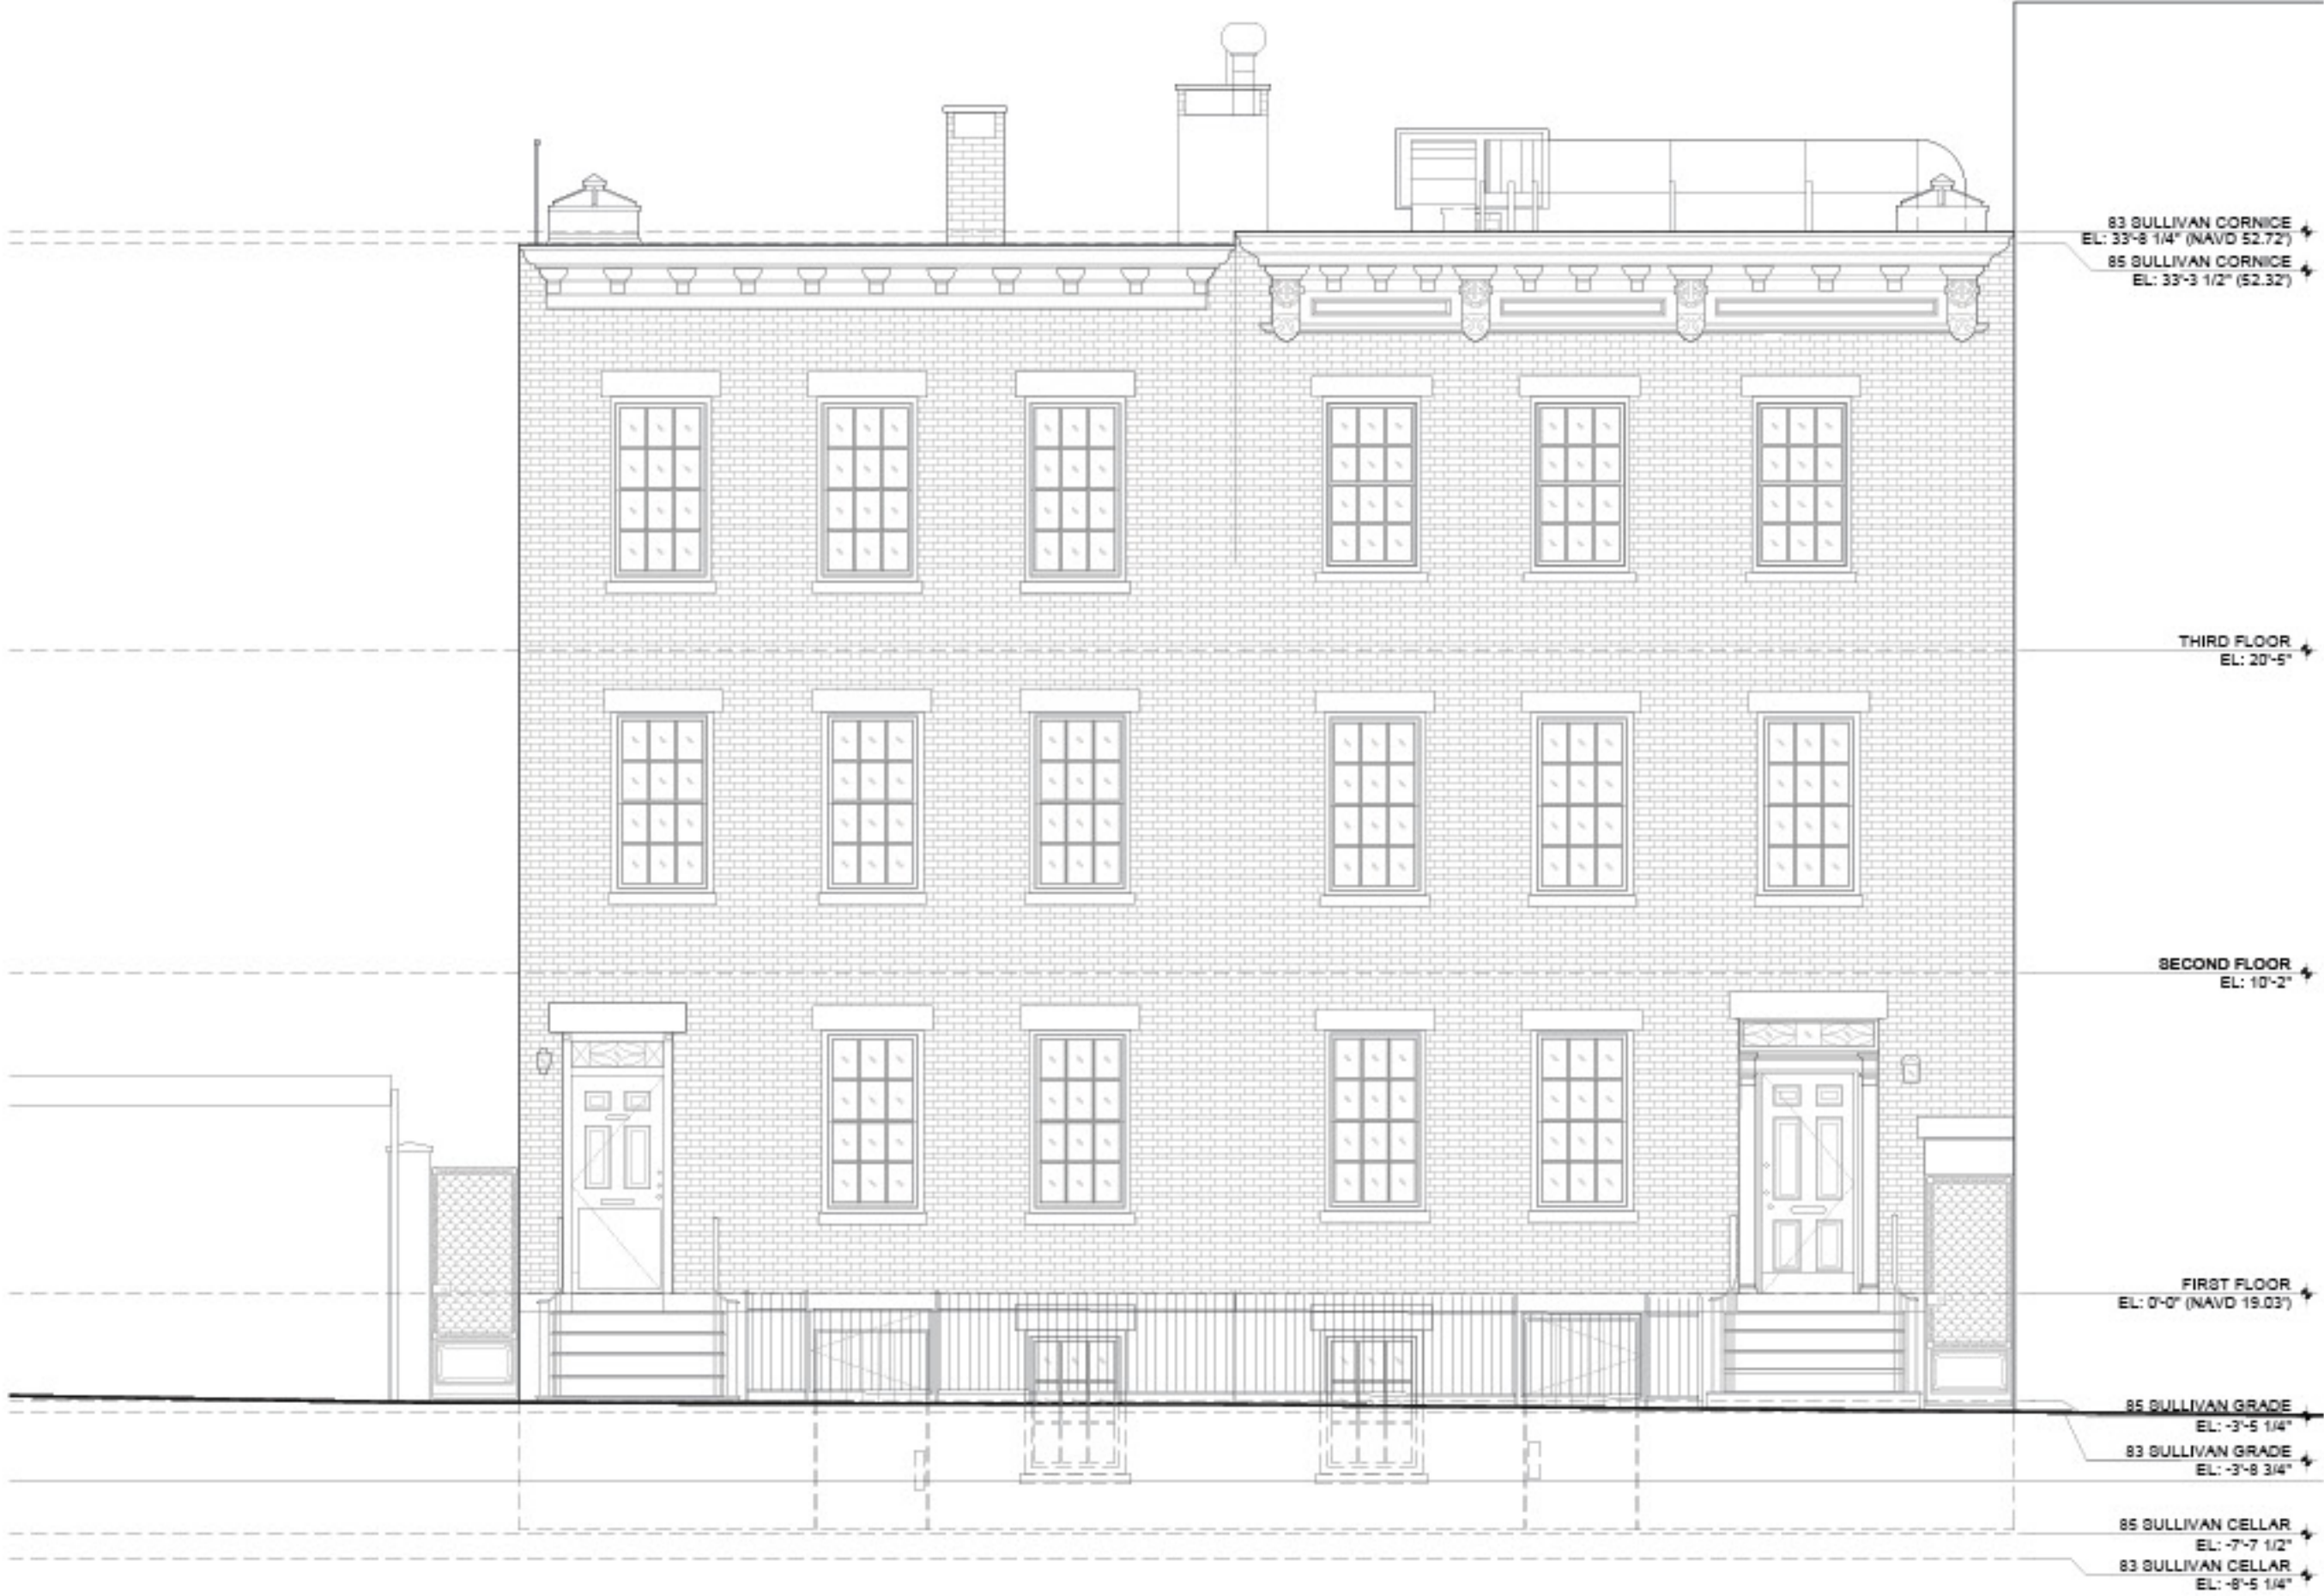
Existing Conditions - Sullivan Street Elevation

RAKE OUT ALL LOOSE MORTAR AND REPOINT 100% OF JOINTS. TOOL MORTAR. MATCH EXISTING HISTORIC MORTAR TO ORIGINAL MORTAR LAB COMPOSITION RESULTS.

REMOVE EXISTING METAL COPINGS OVER BROWNSTONE SILLS AND LINTELS. PROVIDE ACCESS FOR ARCHITECT TO ASSESS UNDERLYING BROWNSTONE CONDITIONS. REPLACE WITH NEW PRECAST UNITS TO MATCH EXISTING LINTEL/SILLS IN COLOR, LAYOUT & SIZE.

REMOVE AND REPLACE CRACKED BRICK UNITS. KEY NEW UNITS INTO EXISTING. NEW BRICK TO MATCH EXISTING IN SIZE, COLOR, AND LAYOUT. PROVIDE SAMPLES FOR ARCHITECT APPROVAL.

PATCH SPALLED BROWNSTONE LINTEL/SILL USING COMPATIBLE REPAIR MORTAR. PROVIDE ACCESS FOR ARCHITECT TO ASSES BROWNSTONE CONDITIONS AFTER AREA HAS BEEN CLEARED OF SPALLED AREAS AND IS BEING PREPARED FOR APPLICATION OF PATCHING MATERIAL.

REPOINT BRICK MORTAR JOINTS AT JAMBS DOOR MASONRY OPENINGS.

REPOINT ISOLATED OPEN MORTAR JOINTS.

SCRAPE, PRIME AND PAINT EXISTING METAL CORNICE.

SEAL EXISTING JOINT BETWEEN BUILDINGS. APPLY SEALANT RECESSED IN THE JOINT TO ALLOW CONCEALING IT WITH MORTAR.
