PROJECT LOCATION
829 Greenwich St
Manhattan

LPC DISTRICT
Greenwich Village
Historic District

EXISTING CONDITIONS

BUILDING ENCLOSURE PROPOSED SCOPE

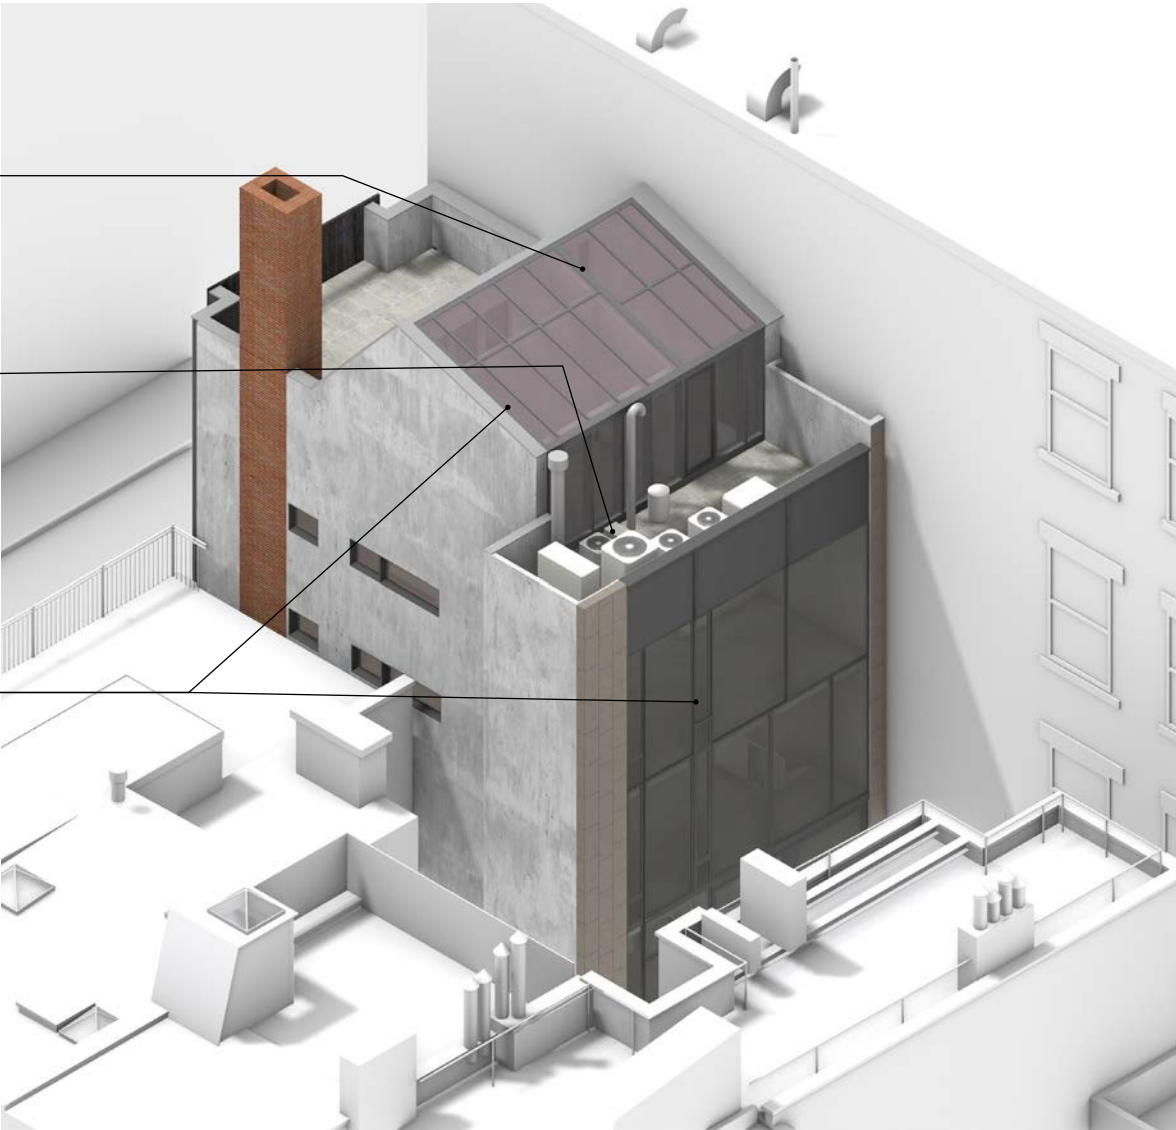
REAR / SIDE AERIAL VIEW

Excessive solar heat gain through large bulkhead skylight

Water leakage through skylights, roof terraces, curtain walls, and around steel plate caused mold which made the family ill

Thermal bridging through curtain walls, failed IGUs, and uninsulated portions of steel plate

Inadequate natural light in front rooms

Very deep recesses at ground level

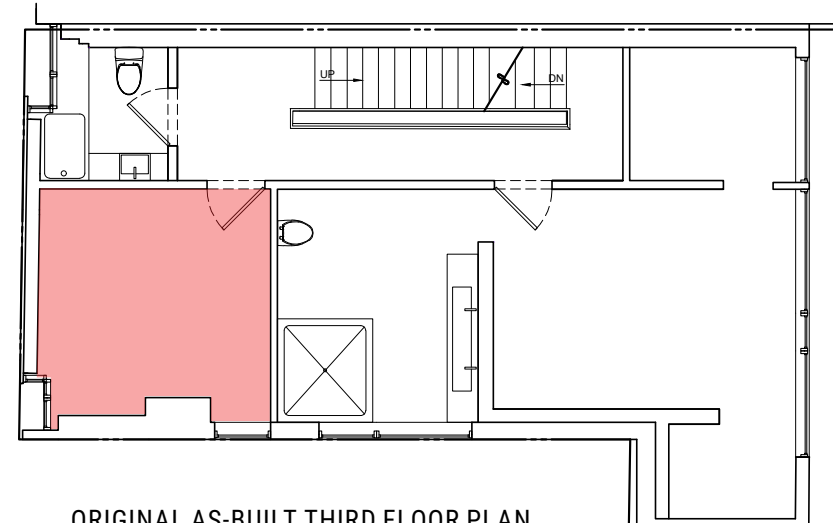
ORIGINAL AS-BUILT THIRD FLOOR PLAN

Original third floor front bedroom glazing area does not comply with code requirements

Floor area = 123 SF
Required light (10%) = 12.3 SF
Provided light = 8.2 SF

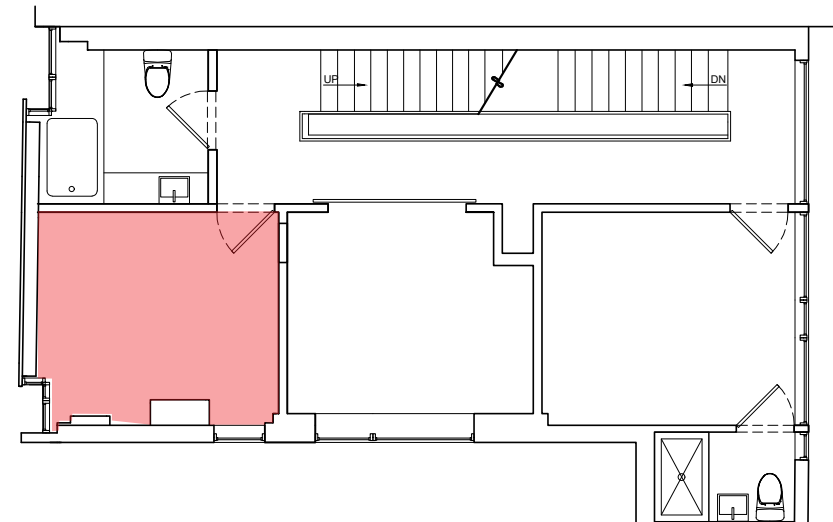
ORIGINAL AS-BUILT SECOND FLOOR PLAN

Original second floor front bedroom glazing area does not comply with code requirements

Floor area = 120 SF
Required light (10%) = 12.0 SF
Provided light = 7.4 SF

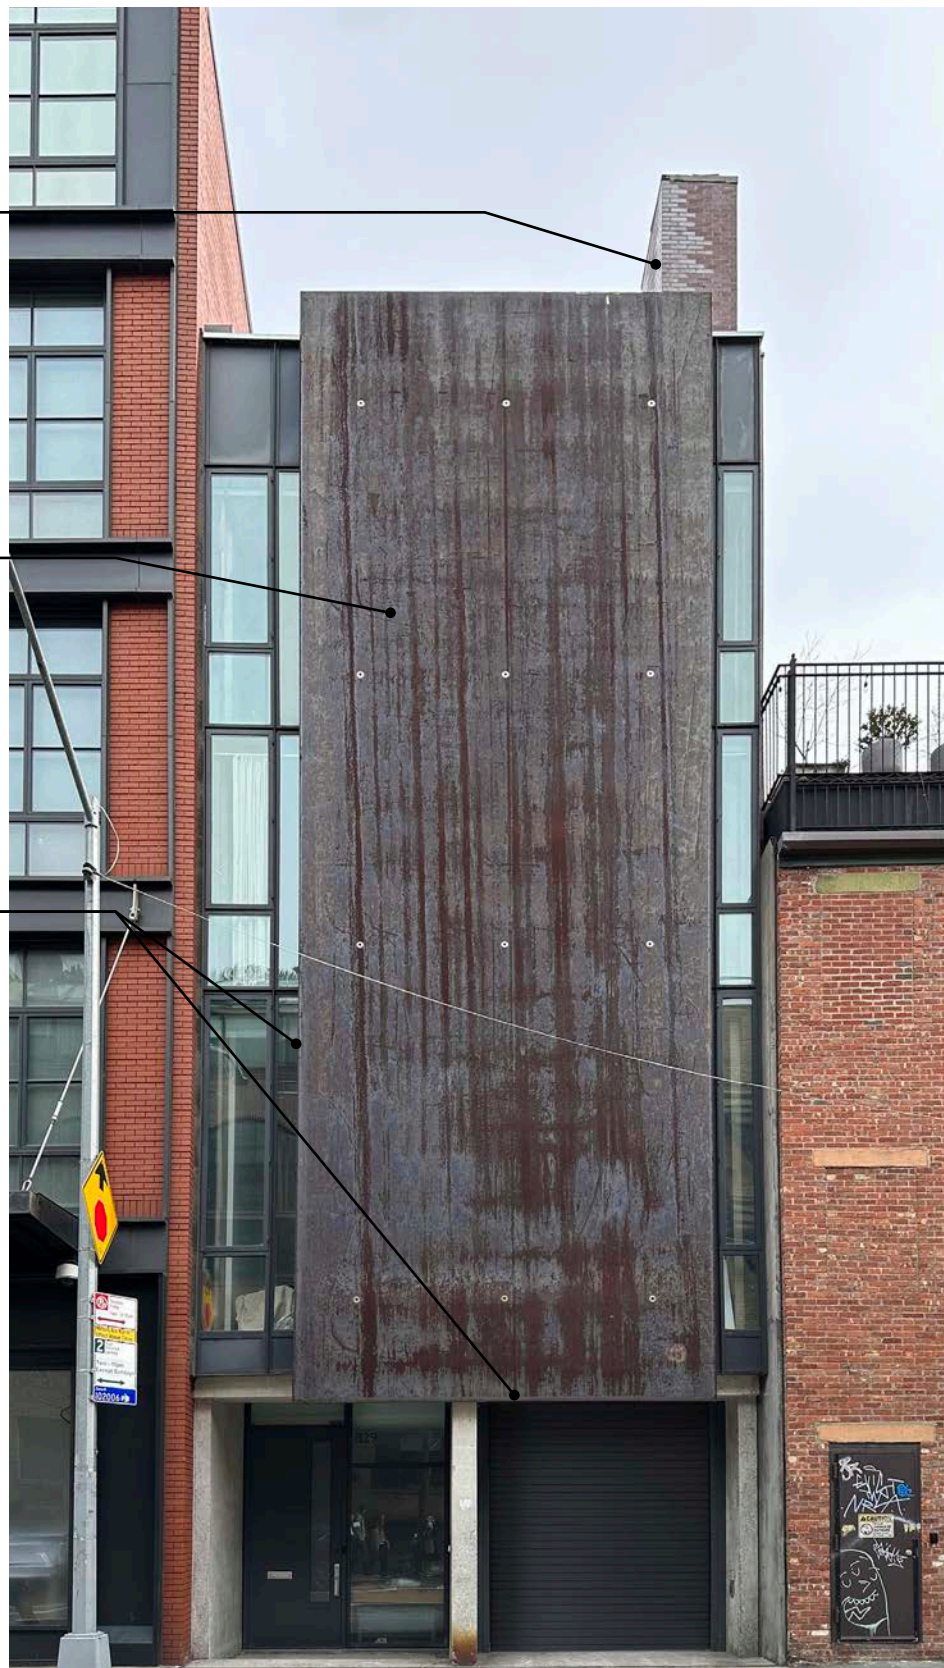
EXISTING

The steel plate was designed to match the proportion of a townhouse facade.

The steel plate was designed to 'float' independently in front of the glass curtain wall and supporting concrete columns and beam. The plate makes no alignments with the curtain wall and concrete structure behind it. Layers are absolutely clear and distinct.

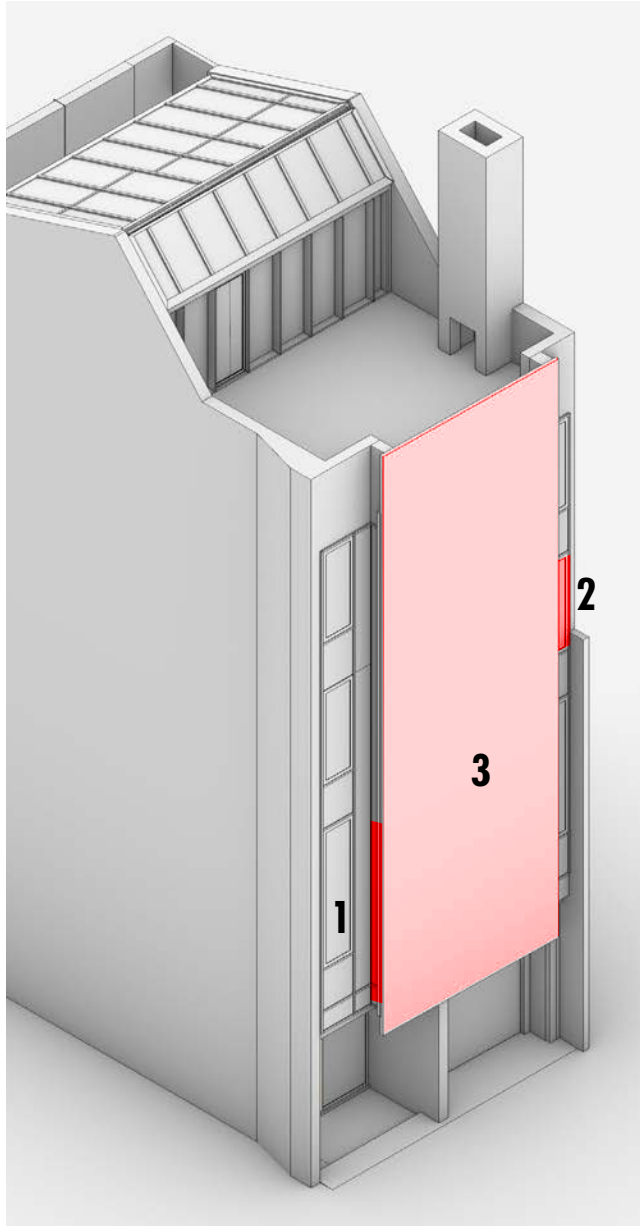
1

Displaced gasket

Staining at IGU edge and on trim

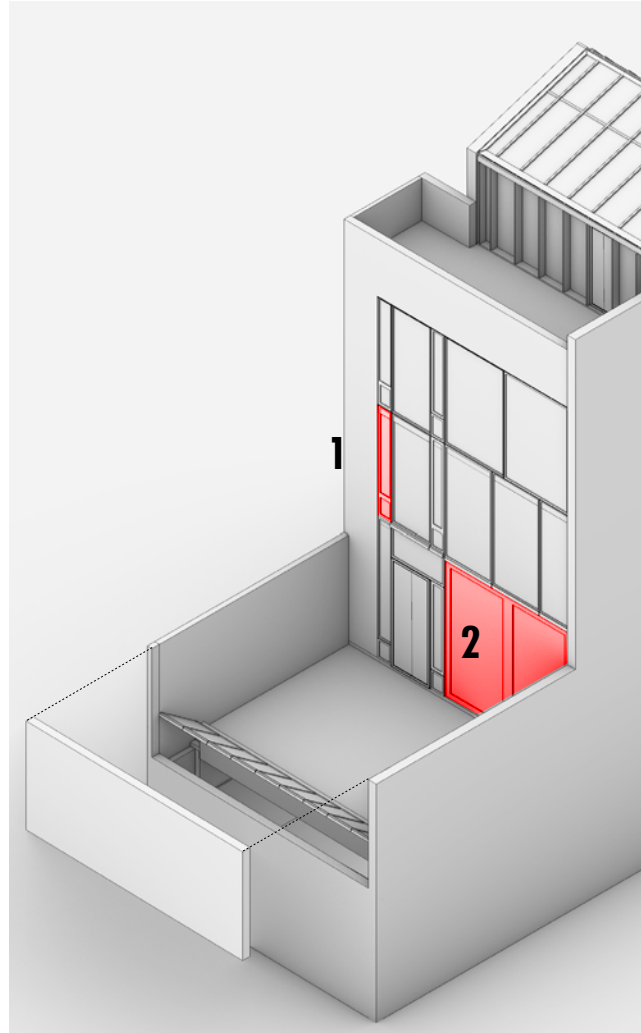
1

Deteriorated gaskets at operable vents

Discontinuous gasket

Water stain

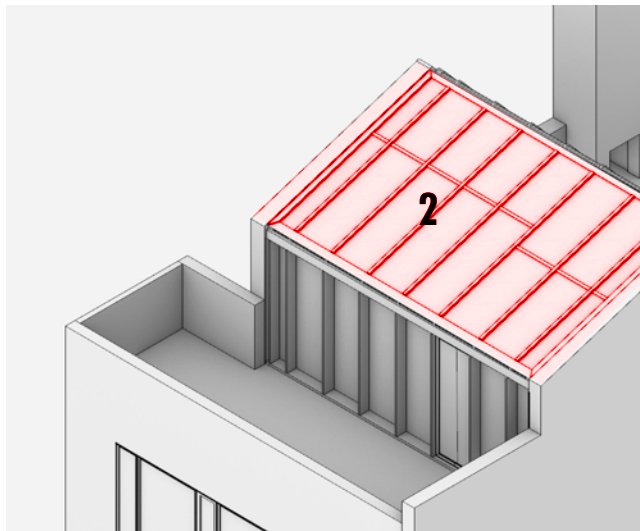
2
Excessive solar heat gain from roof skylight (shade installed to reduce heat gain)

Large skylight and bulkhead has air leaks, condensation at frames, and contributes to excessive solar heat gain

1. Provide additional insulation at main roof.
2. Provide waterproofing and insulation (if necessary) at main roof ducts
3. Replace parlor level terrace roofing with waterproofing system
4. Replace stucco and waterproofing at planters
5. Replace skylights with thermally-broken skylight system with condensation gutters

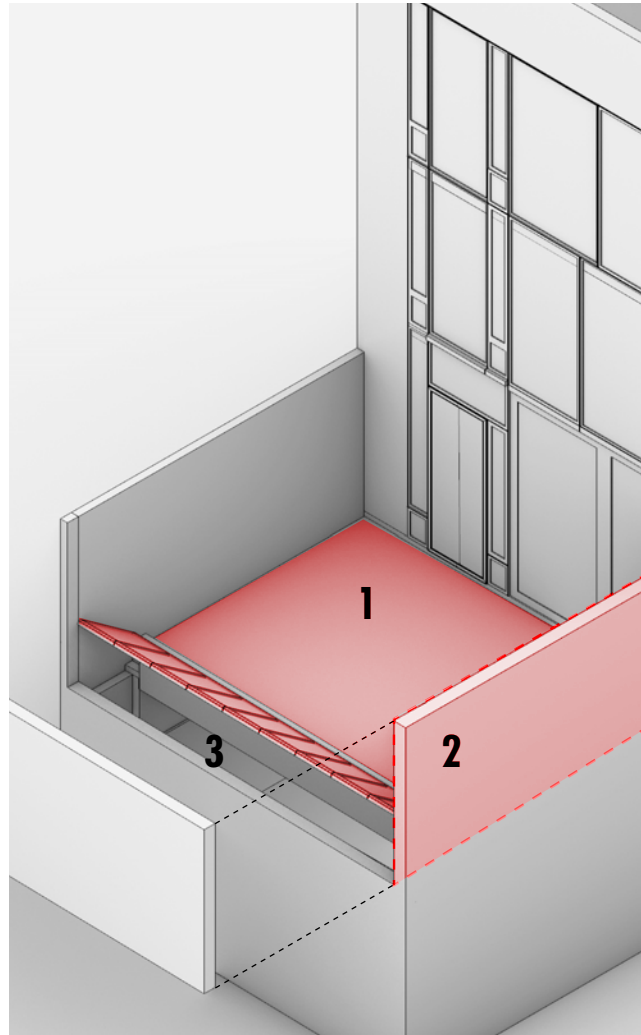
1

Existing roofing

Water below and within roofing assembly

Ceiling repairs at area of reported water leakage

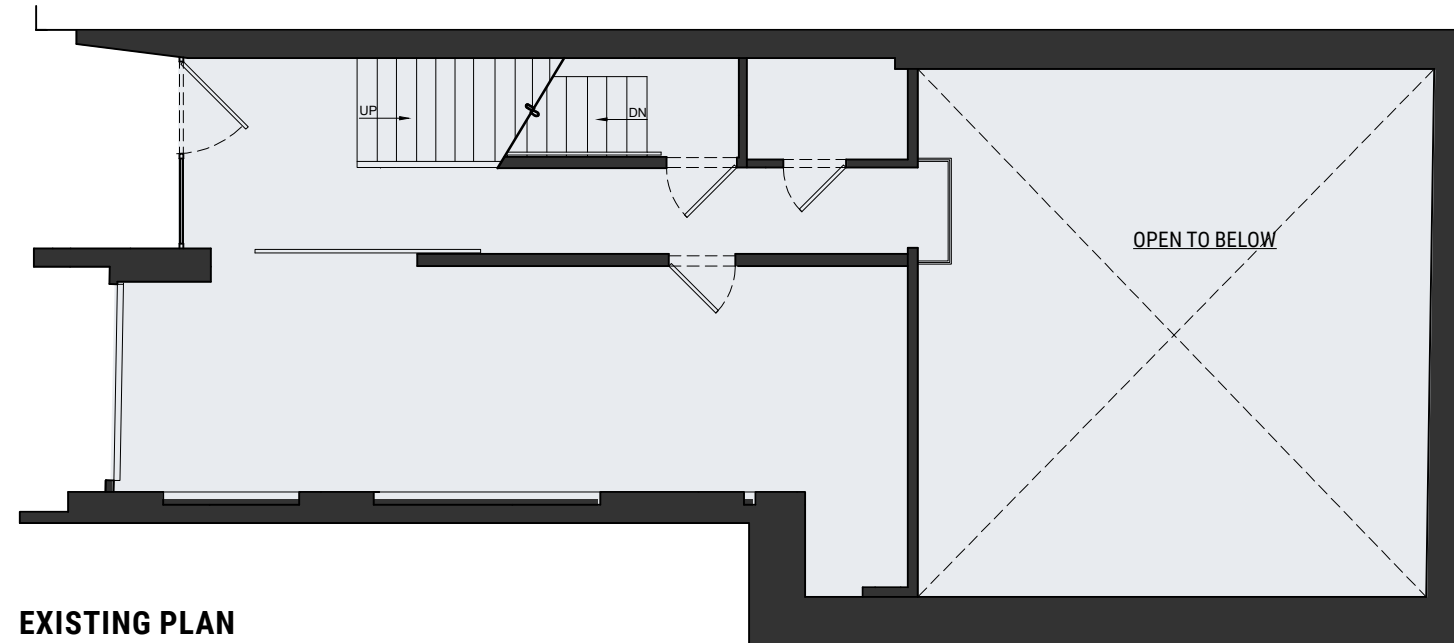
EXISTING PLAN

1
 Recessed spaces at the entry door
 and garage door on the ground level
 of the front facade are deep enough
 to be used as shelters for transient
 individuals, creating a safety hazard

Move boundary of entry and garage door out towards street to reduce exterior overhang
