# Investigation and Assessment of the Tony Dapolito Recreation Center Greenwich Village, New York, NY

## Final Report

Task 5.1  
26 October 2015

Prepared for : NYC Parks Capital Division  
Prepared by : Urbahn Architects PLLC

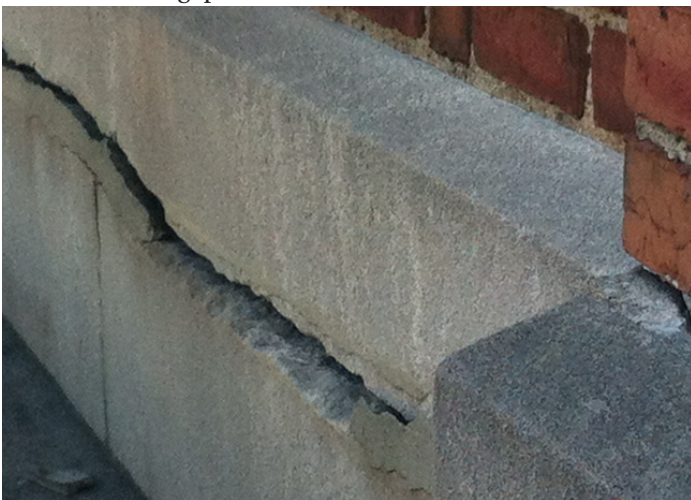
Rooftop Colonnade / Loggia - Cracks at Limestone Band

The rooftop colonnade/loggia at the southwest corner of the building (1929 addition) is the portion of the exterior envelope with the most severe deterioration. The open joints at the parapets have caused separation at the limestone banding below. As this area could present a safety hazard to anyone on the sidewalk below, we recommend repairing the parapets and resetting the limestone in the near future. (Refer to Cost Estimate - Repair and Stabilize items 3a, 4a and 4b.)

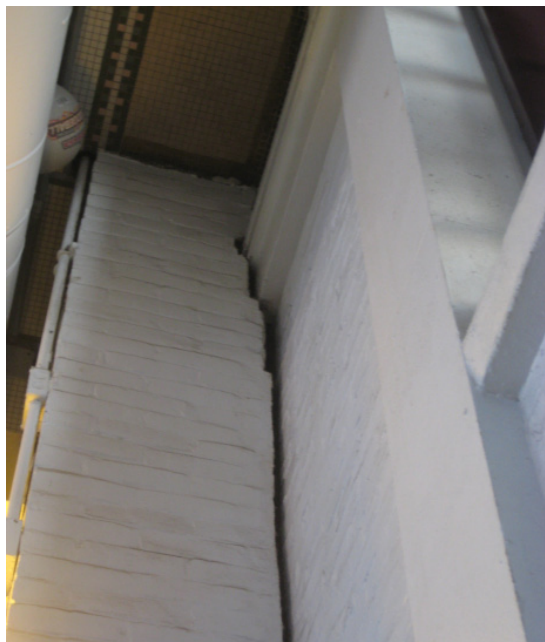
The interior of the building is worn, but in fairly good condition. There is an open joint between the original structure and the 1929 addition, where settlement has created a gap between the two structures; this is cosmetic and not a structural issue. The same can be said for a crack running transverse across the pool ceiling and the gym ceiling. These gaps are expansion related and although they are not a safety hazard at present, the tile finish may loosen and fall if the expansion joint isn't stabilized.

Expansion Separation between 1908 and 1929 Constructions

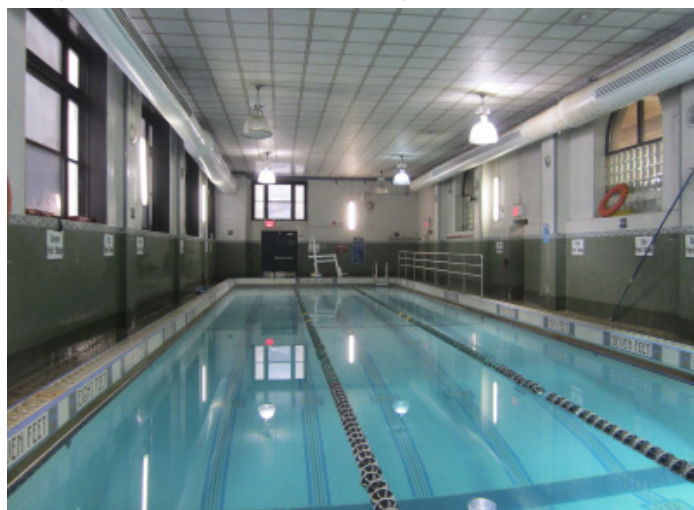
Indoor Pool - Non-Code Compliant Narrow Deck

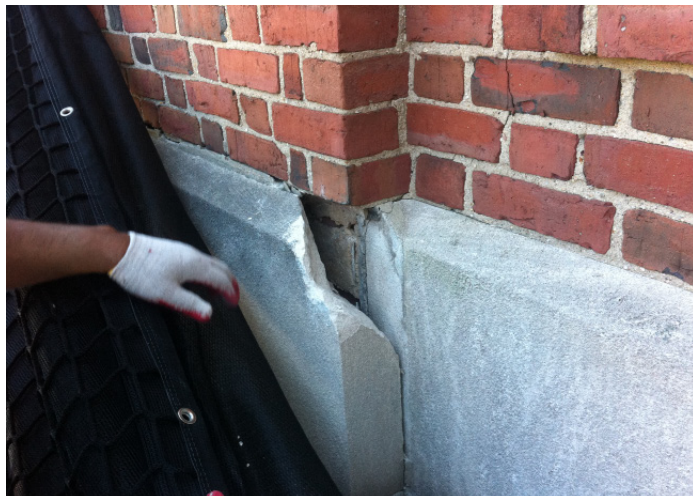
Priority 1 -Colonnade Loggia cracked and Spalled Limestone

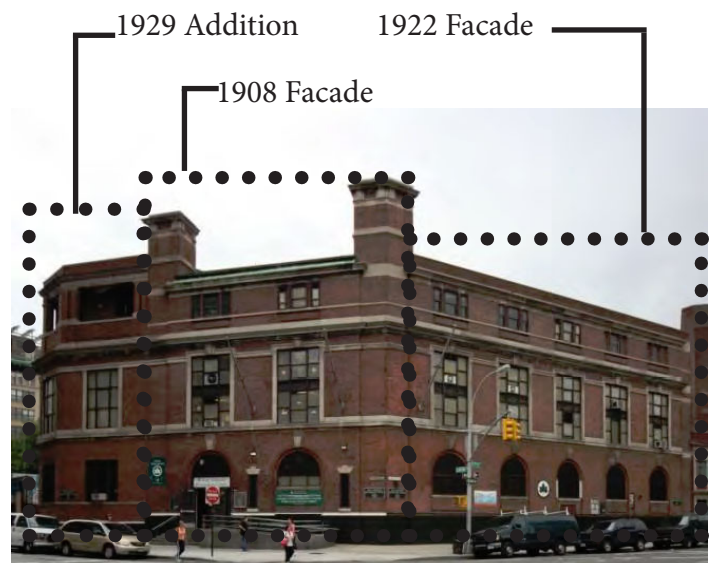
Three Eras of Facade

removed portions of the netting to assess a representative sample of each material and condition at each of the three building sections: 1908, 1922 and 1929. At the joint between the original 1908 construction and the 1929 pool addition, there is a vertical crack and spalled bricks, indicative of differential movement at the juncture of the two building systems. This also occurs, but to a lesser extent, at the Clarkson Street façade joint between the 1908 and 1922 facades.

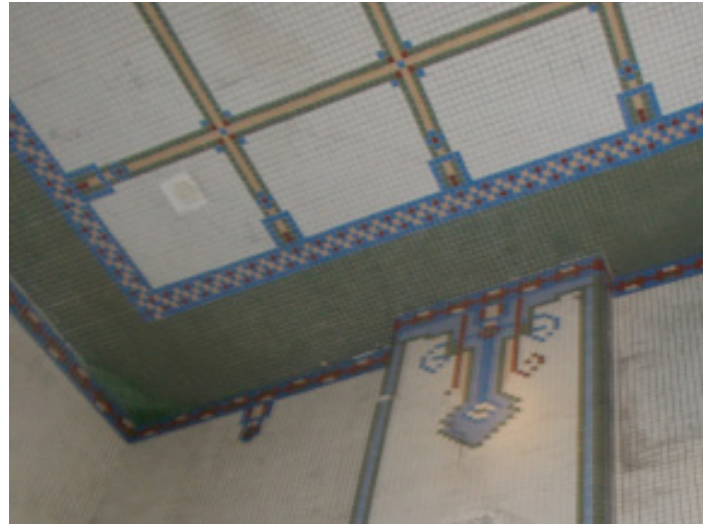
with the exception of a large crack transversing east to west above the pool. This is an expansion crack and is not structural in nature, however the historic, decorative ceiling tiles are falling and could present a safety hazard. The wall tile is in good condition except for localized areas where there is cracking and spalling. This typically occurs at the expansion joint between the addition and original construction, at the head of the adjacent arched interior window soffits, and at all the column bases along the west wall where the columns are near to the pool water. These cracks continue into the pool coping in both the horizontal and vertical planes. The First Aid Room and its vestibule have tile finishes which are in poor condition.

Indoor Pool Mosaic Tile Finish

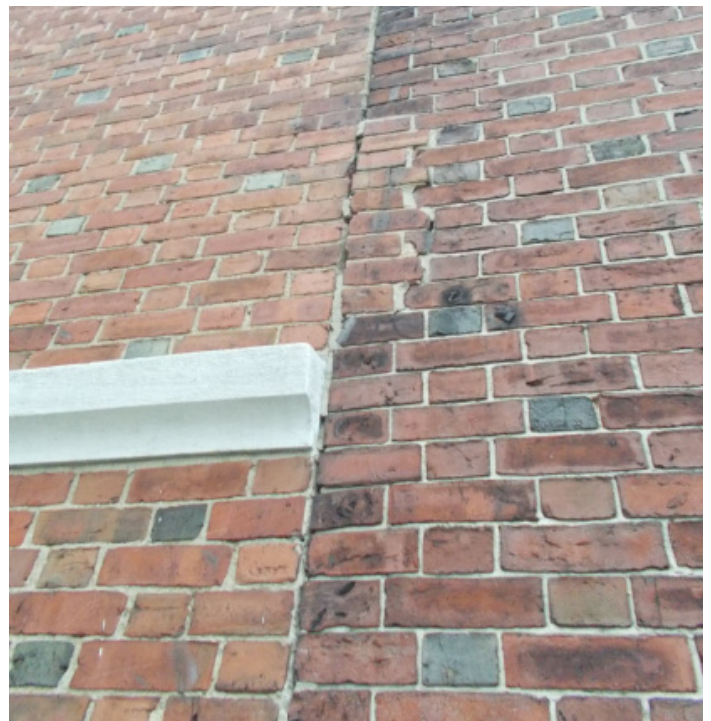
At the first, second and third floors, the steel structure of the 1929 addition appears to be sound, but has some areas which require cosmetic repair and others that require structural stabilization. As this construction is not tied to the 1908 building structure, the two sections of the building move independently, which has caused a 1/2" to 1" gap at the first and second floor between the original wall and the pilasters. This same building line translates to the floor of the 1982 3rd floor addition, with a crack in the Multi-Purpose Room VCT flooring. At the first floor, there are arched interior windows between the pool and the 1908 construction, which were originally exterior wall openings. At two of the arches there are cracks in the tile finish, but the substructure appears to be sound.

Mortared Joint between 1908 and 1929 Construction

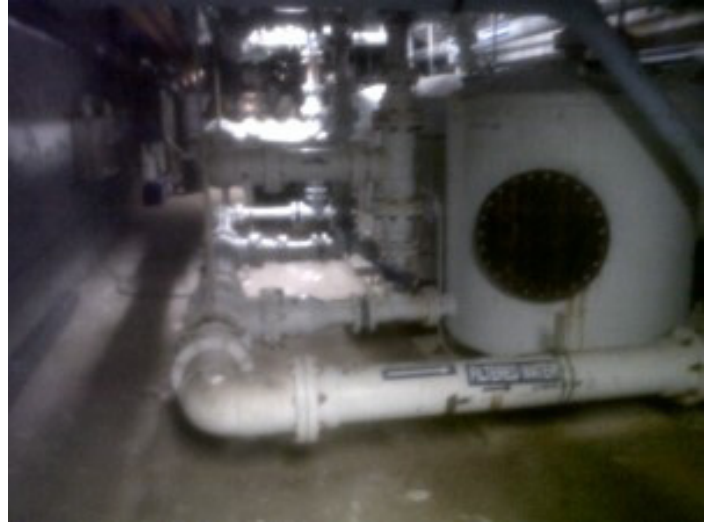
- Pool Filter Room 010 and Pool Equipment Room 020 - There are two steam unit heaters in these rooms which are not functional. One steam line was observed to be compromised and leaking condensate.

Pool Filter Room Steam Piping

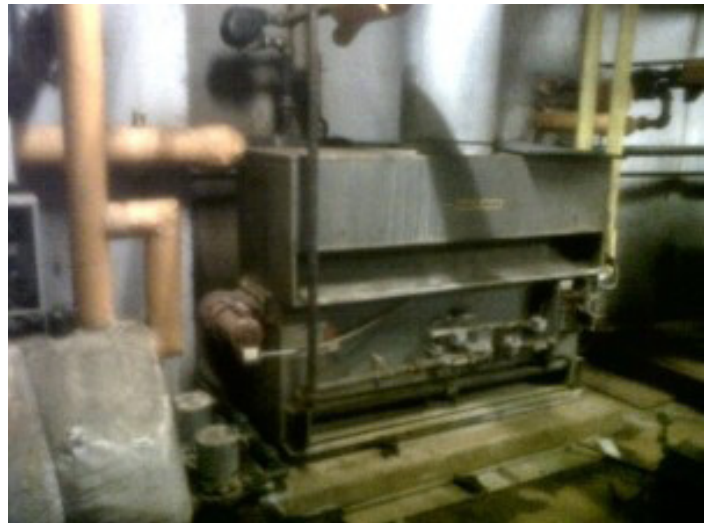
- Boiler Room 011 - This room was completely submerged during Hurricane Sandy and therefore the two gas burners for boilers 1 and 2 and the complete LAARS HW Boiler unit were replaced through an emergency project.

Boiler Room

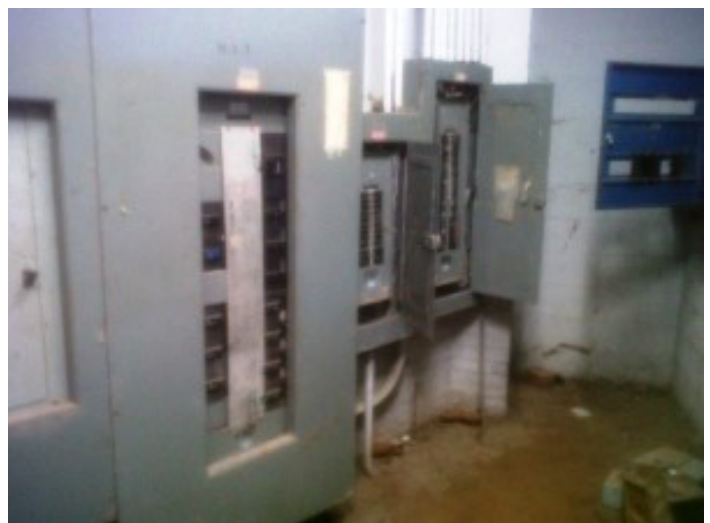
Electrical Room - Flooded During Hurricane Sandy

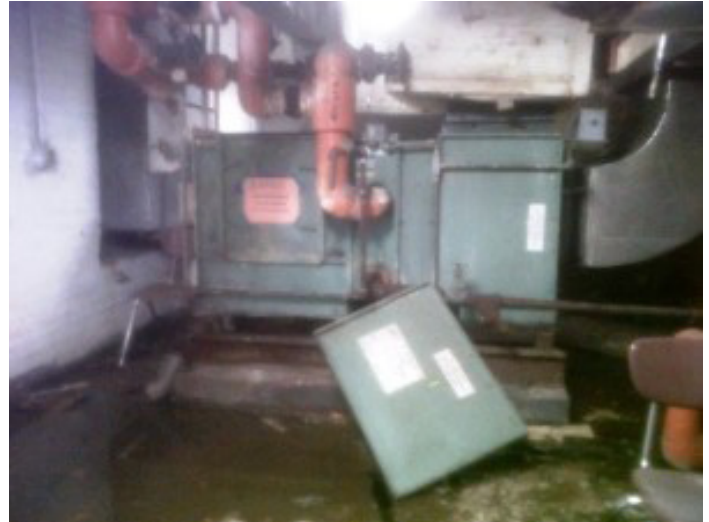
AHU 1 and AHU 2 provide ventilation to the pool and locker rooms and, as noted above, are operational but in poor condition. Ductwork at the first floor is typically exposed, round ducts and is in fair condition. The ductwork at the pool is rusting.

Air Handler Serving Locker Rooms

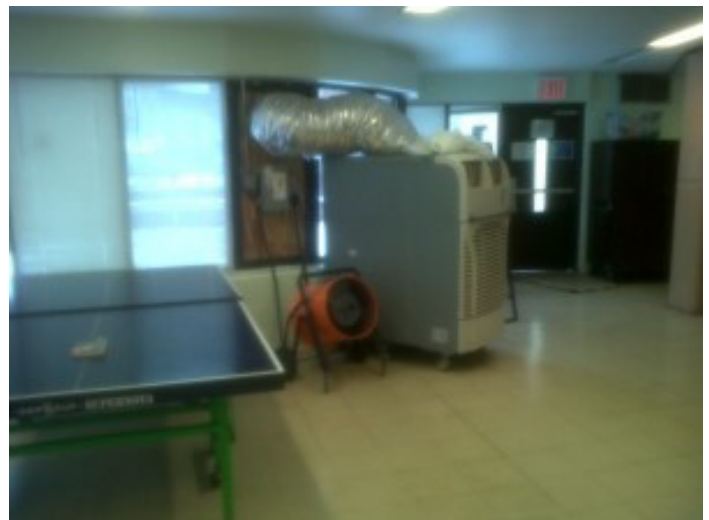
As AHU 3 is not functioning, the gyms and weight rooms are being heated only by radiators and there is no ventilation being provided. Temporary fans, window fans, and window A/C units have been installed, however they do not provide the necessary ventilation to be code compliant.

3rd Floor Temporary AC in Multi-Purpose Room

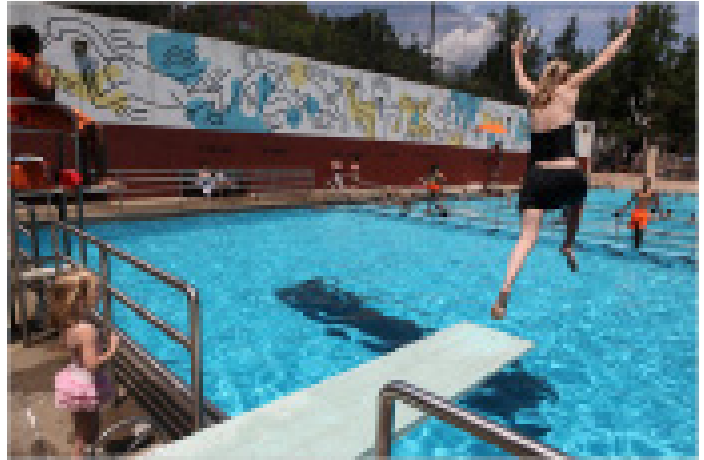
Outdoor Pool

The outdoor pool has expansion joints which are in poor condition. The concrete has spalled in areas and has been patched with cement; areas where piping has been removed have been patched. Cracks are apparent through the concrete. The gutter system is sized to capacity and can handle minimal surges, while the inlets are inadequate.

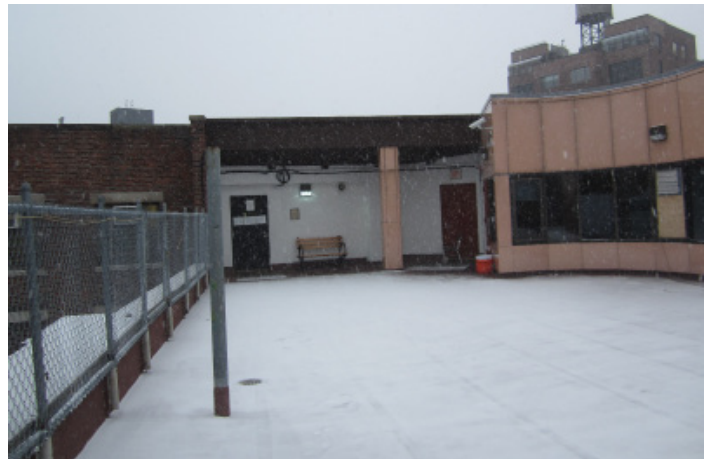
- The third floor multipurpose room has direct interior access to Stair #1 and Stair #2, but Stair #3 can only be accessed by crossing the open air roof. The third floor Computer Room can only be accessed from the roof. Although this is not a code violation, it is recommended that any modification at third floor computer room area provide at least one direct interior means of egress. This could be accomplished fairly easily by building an enclosure connecting the Computer Room to the Multi-purpose Room and Stair #2.

Computer Room Access across Roof

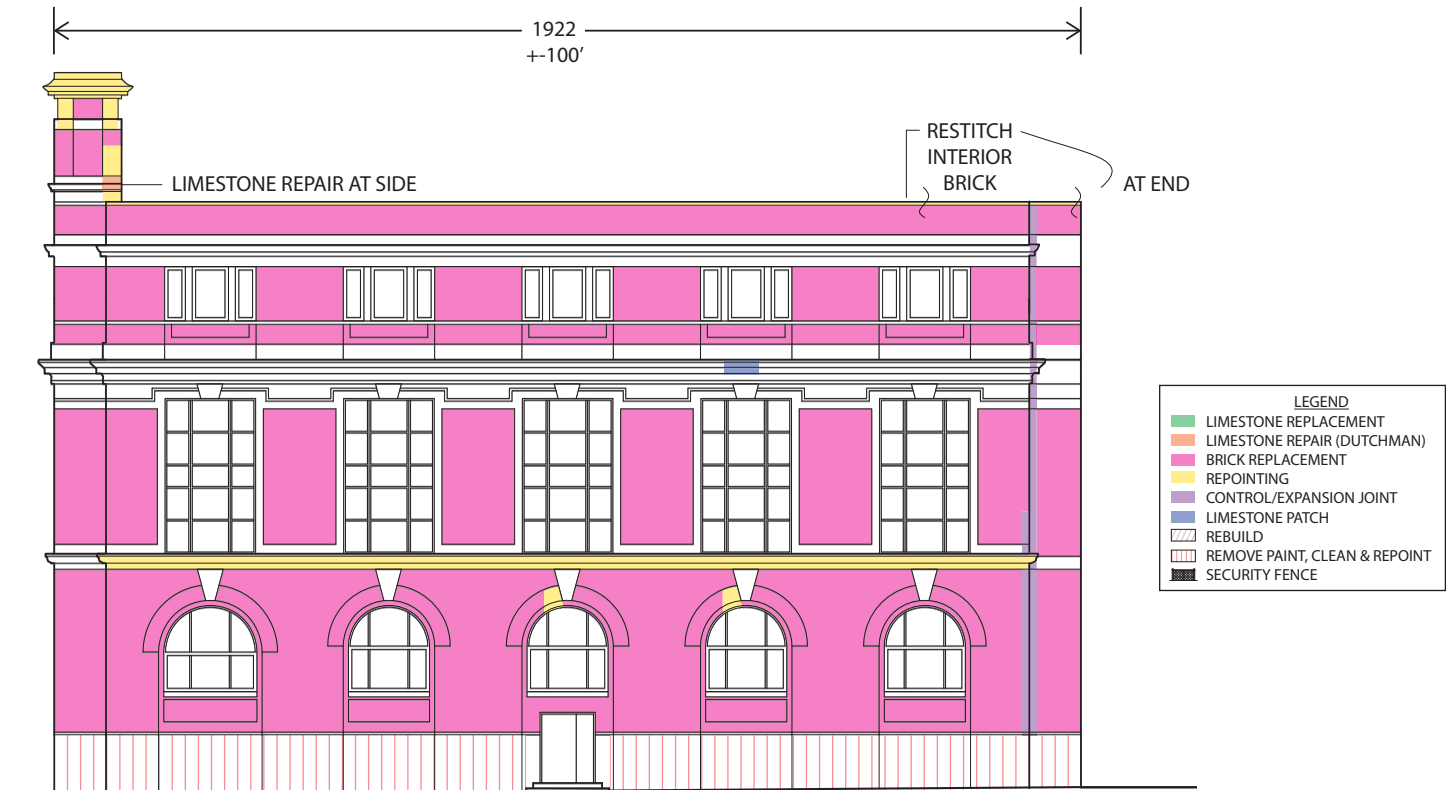
A. Facade Repair Diagram - East Elevation - Seventh Avenue

- 1922 Construction - The limestone along the Seventh Avenue façade is in good condition, but there are many areas with open limestone mortar joints and areas where the limestone has been repointed with more current mortar. There are no areas of limestone banding that are broken or missing.

*a. Limestone Replacement (total 500 SF)*

- Where an entire block of limestone is damaged or missing, it should be replaced, from joint to joint in its entirety.
- 1908 Construction -The limestone banding and cornice at this east side of the Clarkson Street façade is in good condition. There are no areas of limestone banding that are broken or missing.

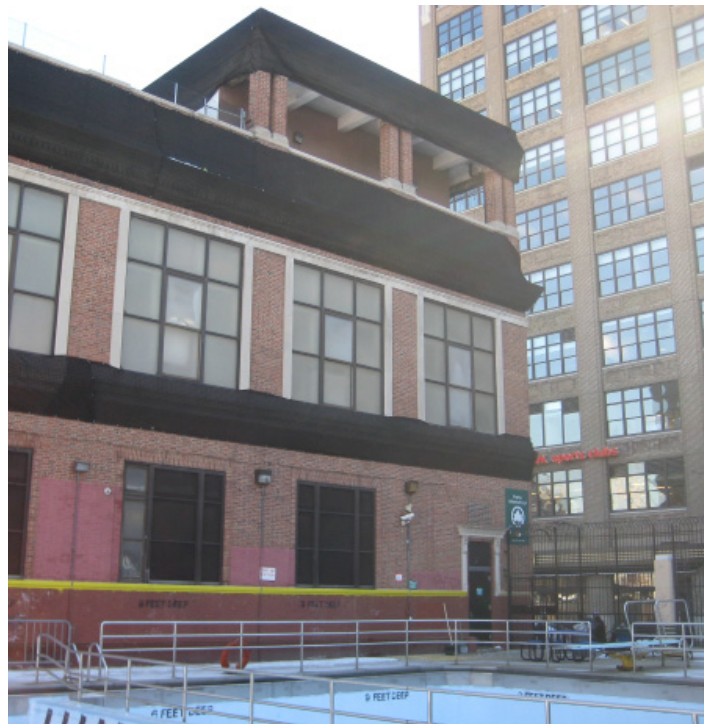
Colonnade / Mechanical Bulkhead

At the second floor mezzanine ceiling, the enclosure around the existing duct should be opened and framing installed around the duct slab opening to stabilize the mechanical room floor from cracking before the duct enclosure is re-installed.

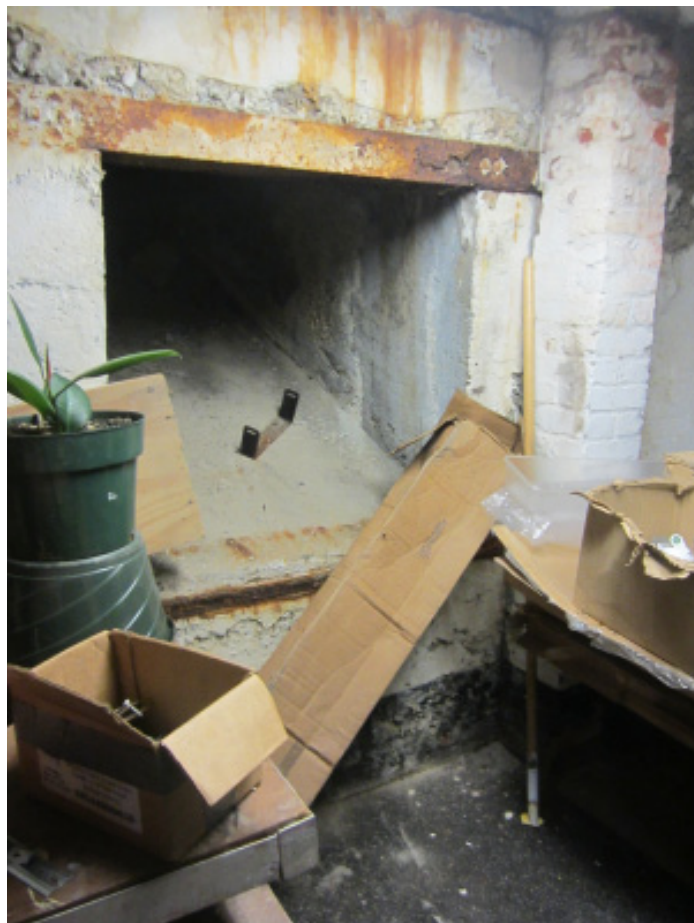
Coal Chute Opening in Basement

Remove the existing sidewalk and existing structural slab. Replace (12) W12x30 x 15' long steel tie beams and finish exposed beams with spray -on fireproofing. Provide new 9" composite concrete structural slab, provide waterproofing above the structural slab, and install new 3" sidewalk topping. Fill coal chutes with sand/gravel and block up the chute openings into the interior vault.

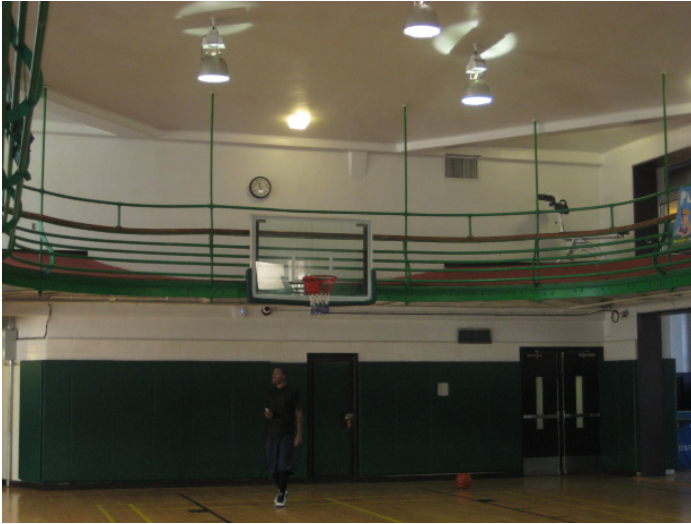
The second floor mezzanine has an existing running track circling above the perimeter of Gym #1. At the request of the facility, we reviewed removing the existing steeply banked fill to level-out the track, as well as removing the track in its entirety. We do not recommend either of these options however, since they do not add any useful space and the track is a defining element of the building that we recommend maintaining (item A-2M.4 & A-2M.5).

Gym #1 with Running Track at Mezzanine Level

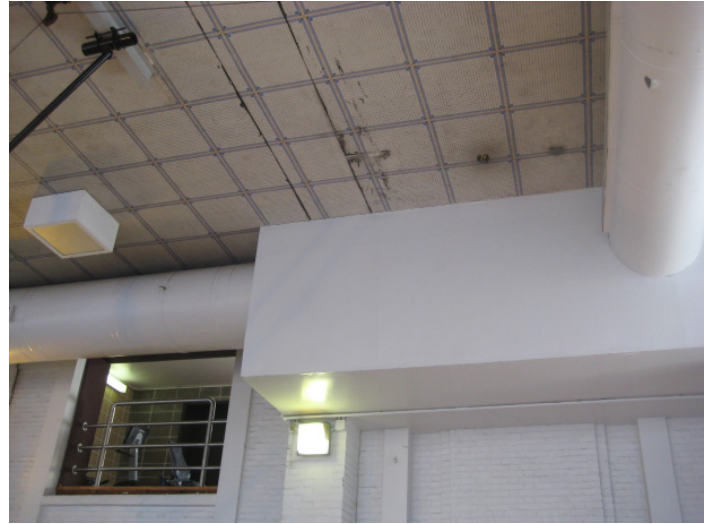
At the second floor, we are recommending construction of a mezzanine level at the south end of Gym #2. This will maintain the free floor space at the gym level. We also recommend creating an opening between the two existing weight rooms. By rerouting the mechanical duct shafts, an opening can be created from the elevator lobby & Stair #1 into Gym #2, so that patrons don't need to pass through Gym #1 to access Gym #2. This would also allow access to the new gym mezzanine from the second floor mezzanine elevator lobby & Stair #1 (item A-2.1, A-2.2 & A-2M.1).

Gym #2 - Connection to Mezzanine Level

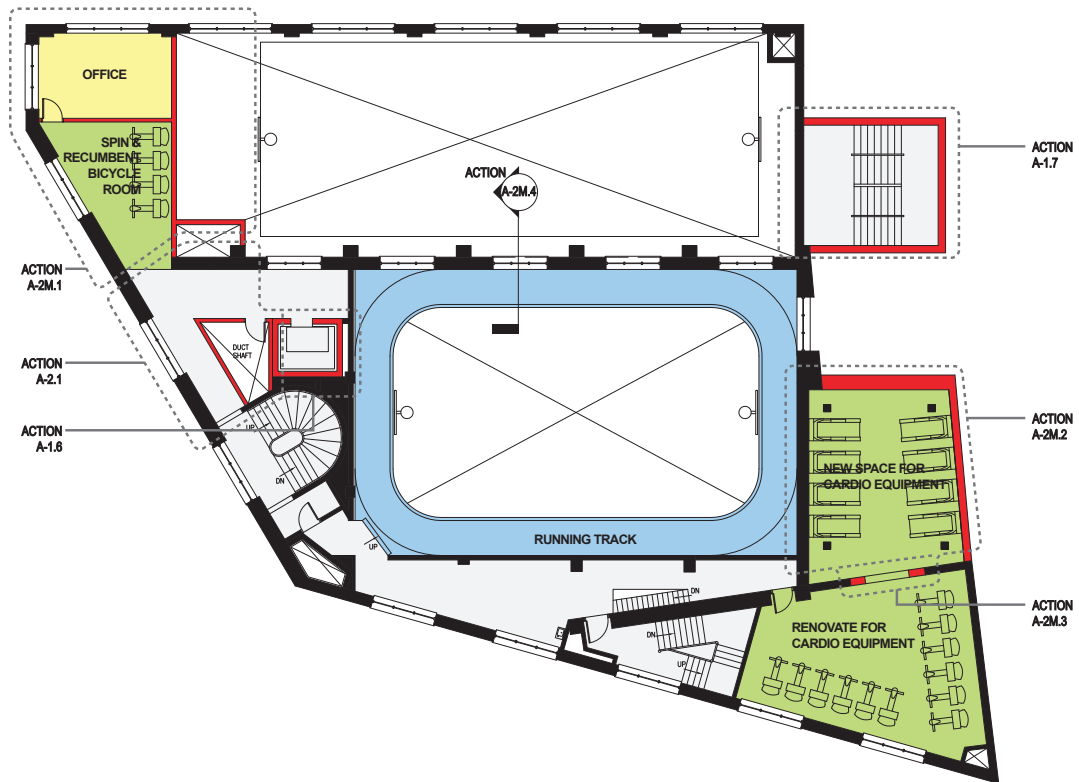
Reconfigure Interior Spaces - Second Floor Mezzanine

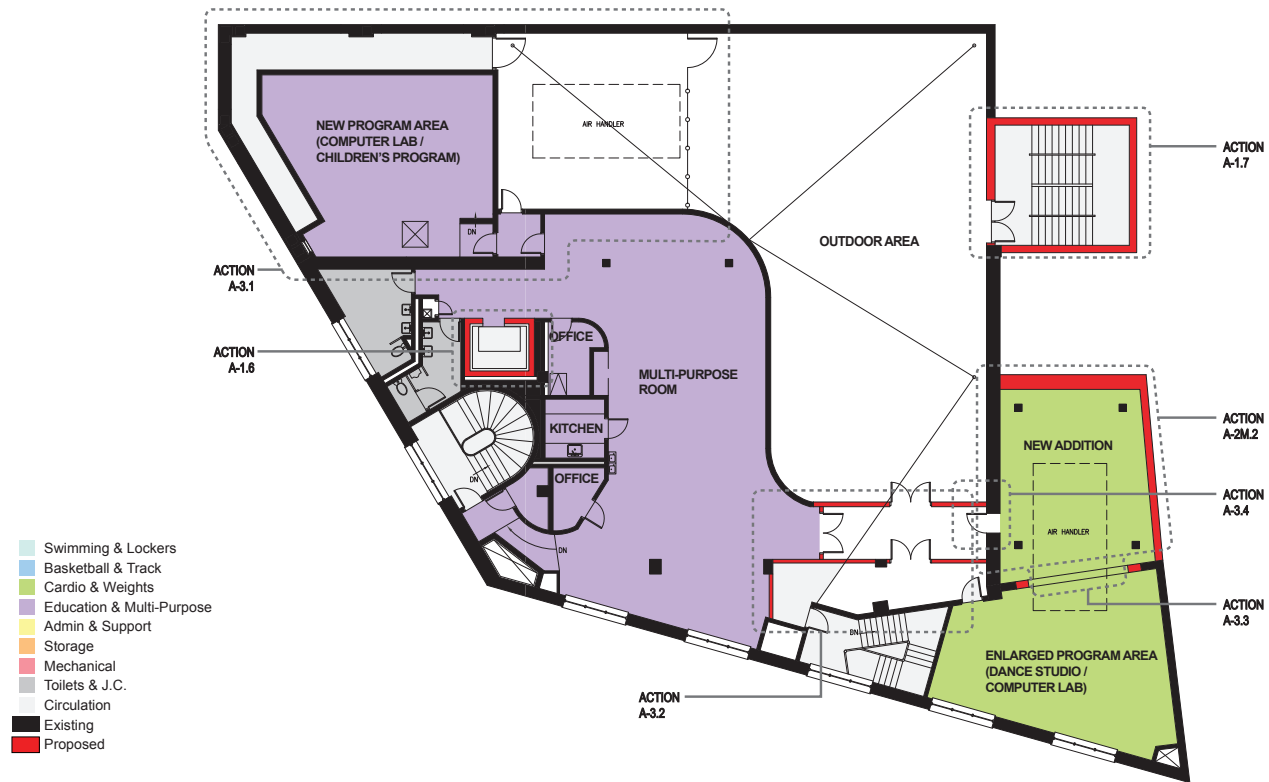
Third Floor

As noted above, we recommend a 2-story addition above Roof VI. This would provide additional program space at the second floor mezzanine and the third floor. This addition exacerbates an existing odd condition: currently a patron must to walk outside on the third floor roof to get to existing program space (Computer Room). We have therefore recommended creating a new enclosed loggia to connect the main floor area (the Multi-purpose Room and ancillary spaces), with Stair #2 and the new addition. An opening could be created to connect the addition and the existing program space (item A-2M.2, A-3.2, A-3.3 & A-3.4).
