Educational Building

70 Fifth Avenue

Landmarks Committee Hearing

I. Introduction & Existing Conditions

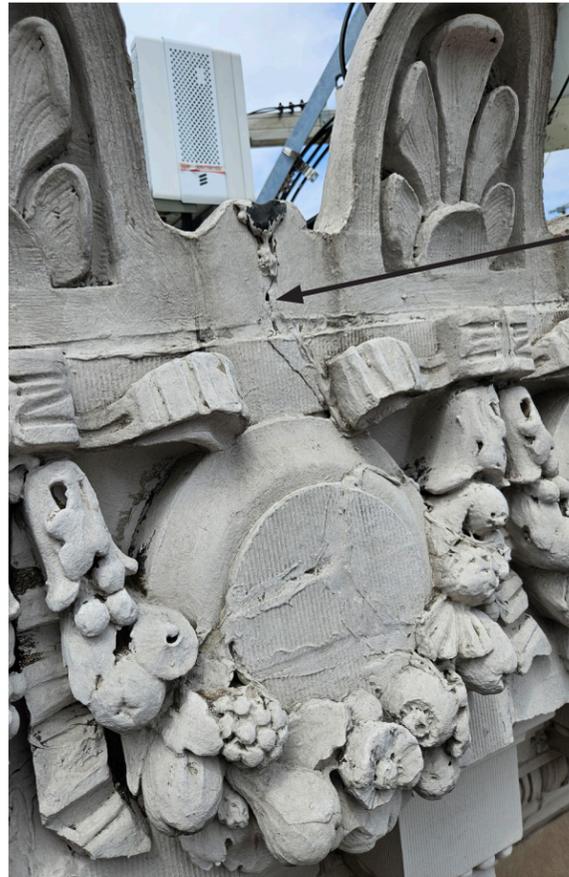
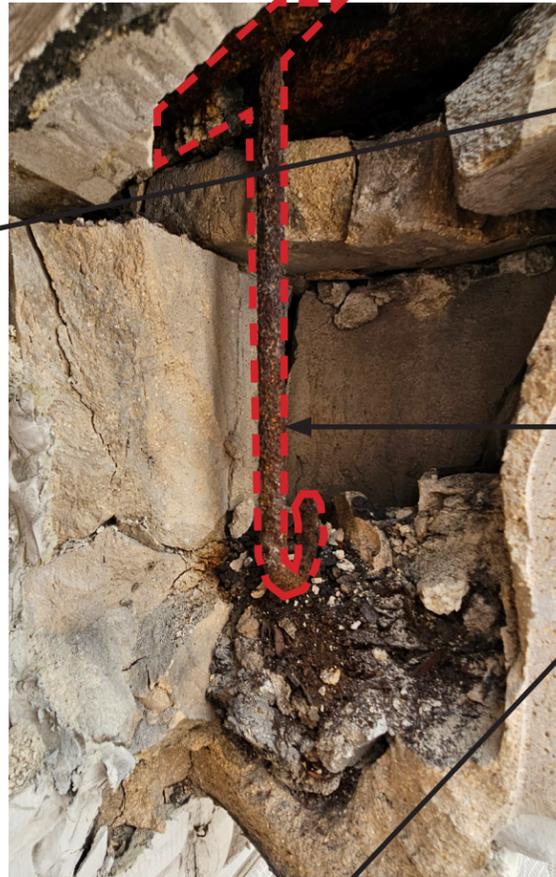
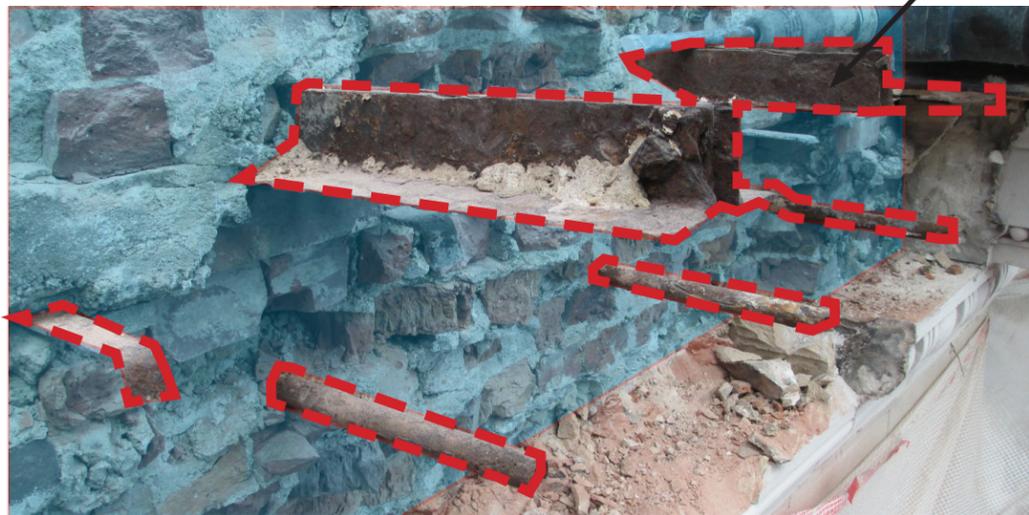
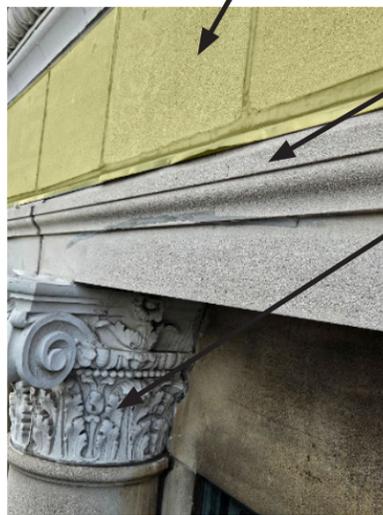
EXISTING CRACKING
TERRACOTTA CORNICE

HEAVILY CORRODED STEEL
TIE-BACK ANGLE AND RODS

EXISTING LIMESTONE AND
STEEL ANGEL

EXISTING STONE
LINTEL

EXISTING COLUMN
CAPITAL

WEIGHT TRANSLATED
TO FACADE

EXISTING 4-WYTHE BRICK
MASONRY PARAPET WALL
WITH NO HEADER COURSE
