Educational Building

70 Fifth Avenue

Landmarks Preservation Commission
Public Hearing

I. Introduction & Existing Conditions

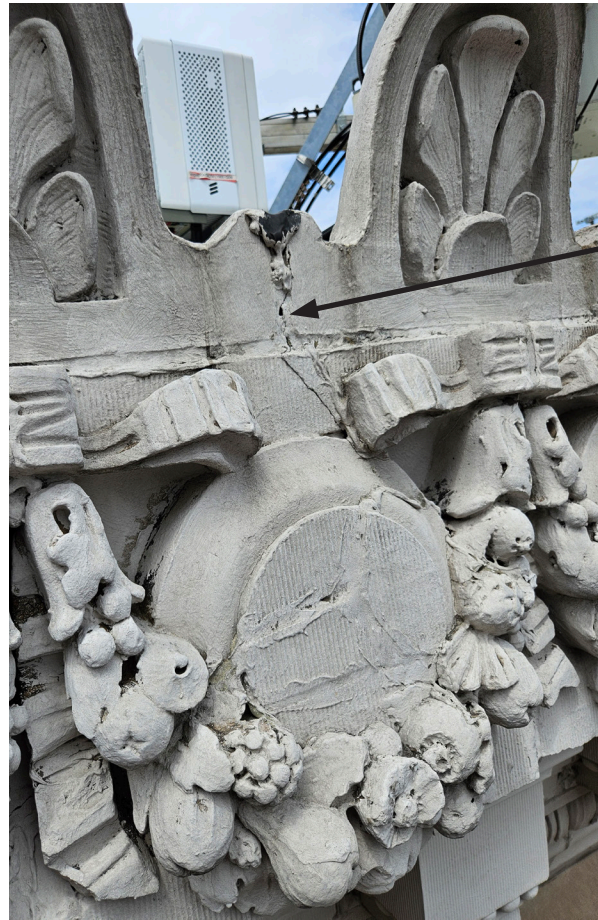
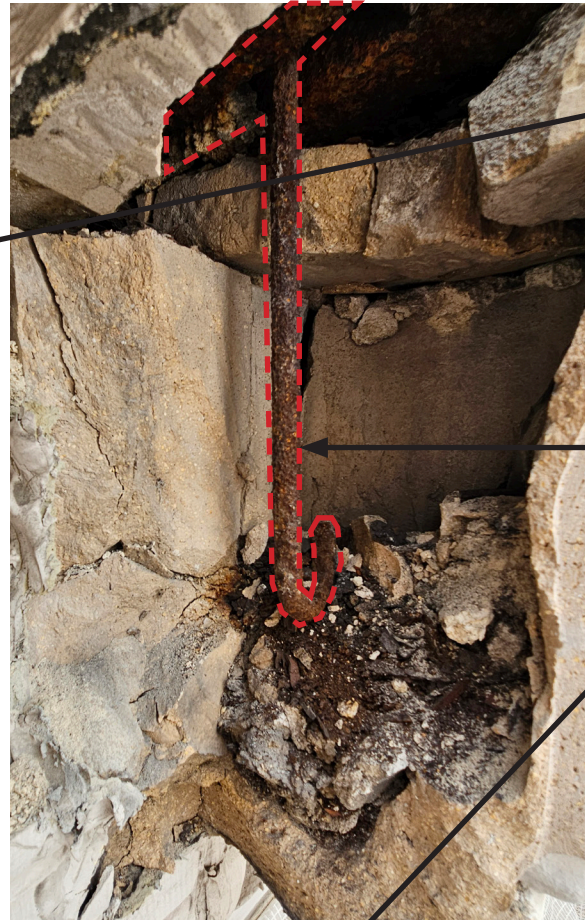
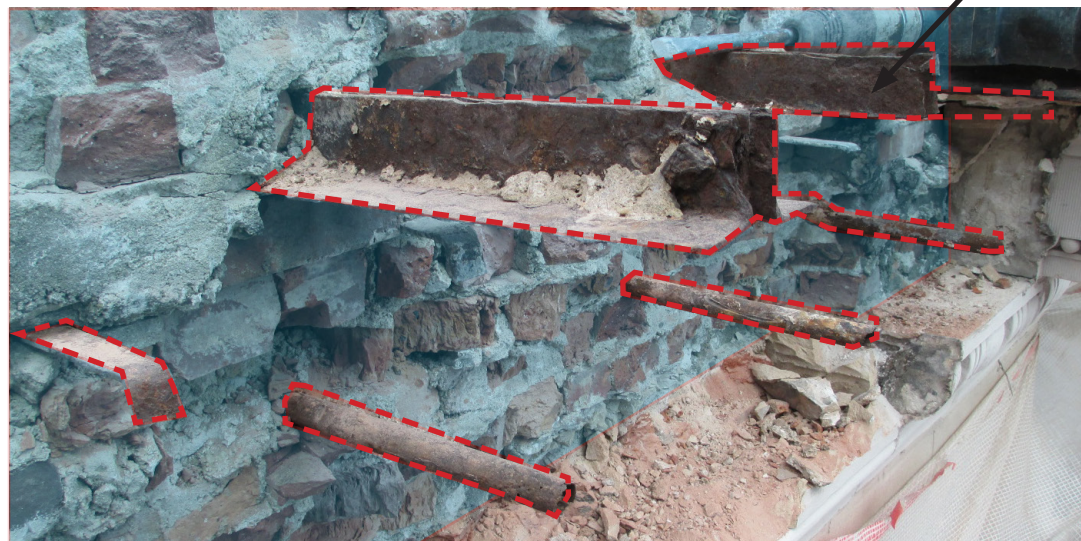
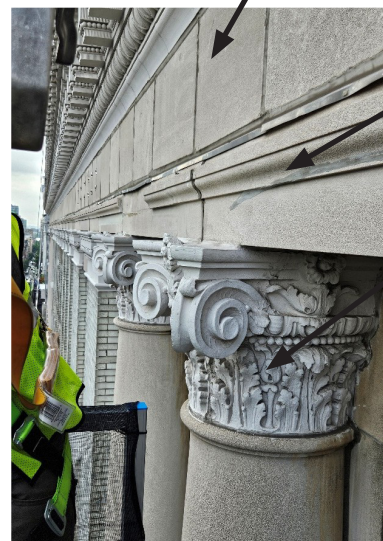
Structural Components of Cornice Parapet

EXISTING CRACKING
TERRACOTTA
CORNICE

HEAVILY CORRODED
STEEL TIE-BACK ANGLE
AND RODS

WEIGHT TRANSLATED
TO FACADE CAUSING
CRACKING

EXISTING 4-WYTHE
BRICK MASONRY
PARAPET WALL WITH NO
HEADER COURSE

1. Existing parapet does not have sufficient capacity to support the terracotta cornice, causing the load to be transferred to the building facade.
2. Reducing the cornice load allows the parapet to adequately support the remaining loads.
3. Removing compressive forces from the facade reduces stress, assisting in preventing future cracking to preserve the building.

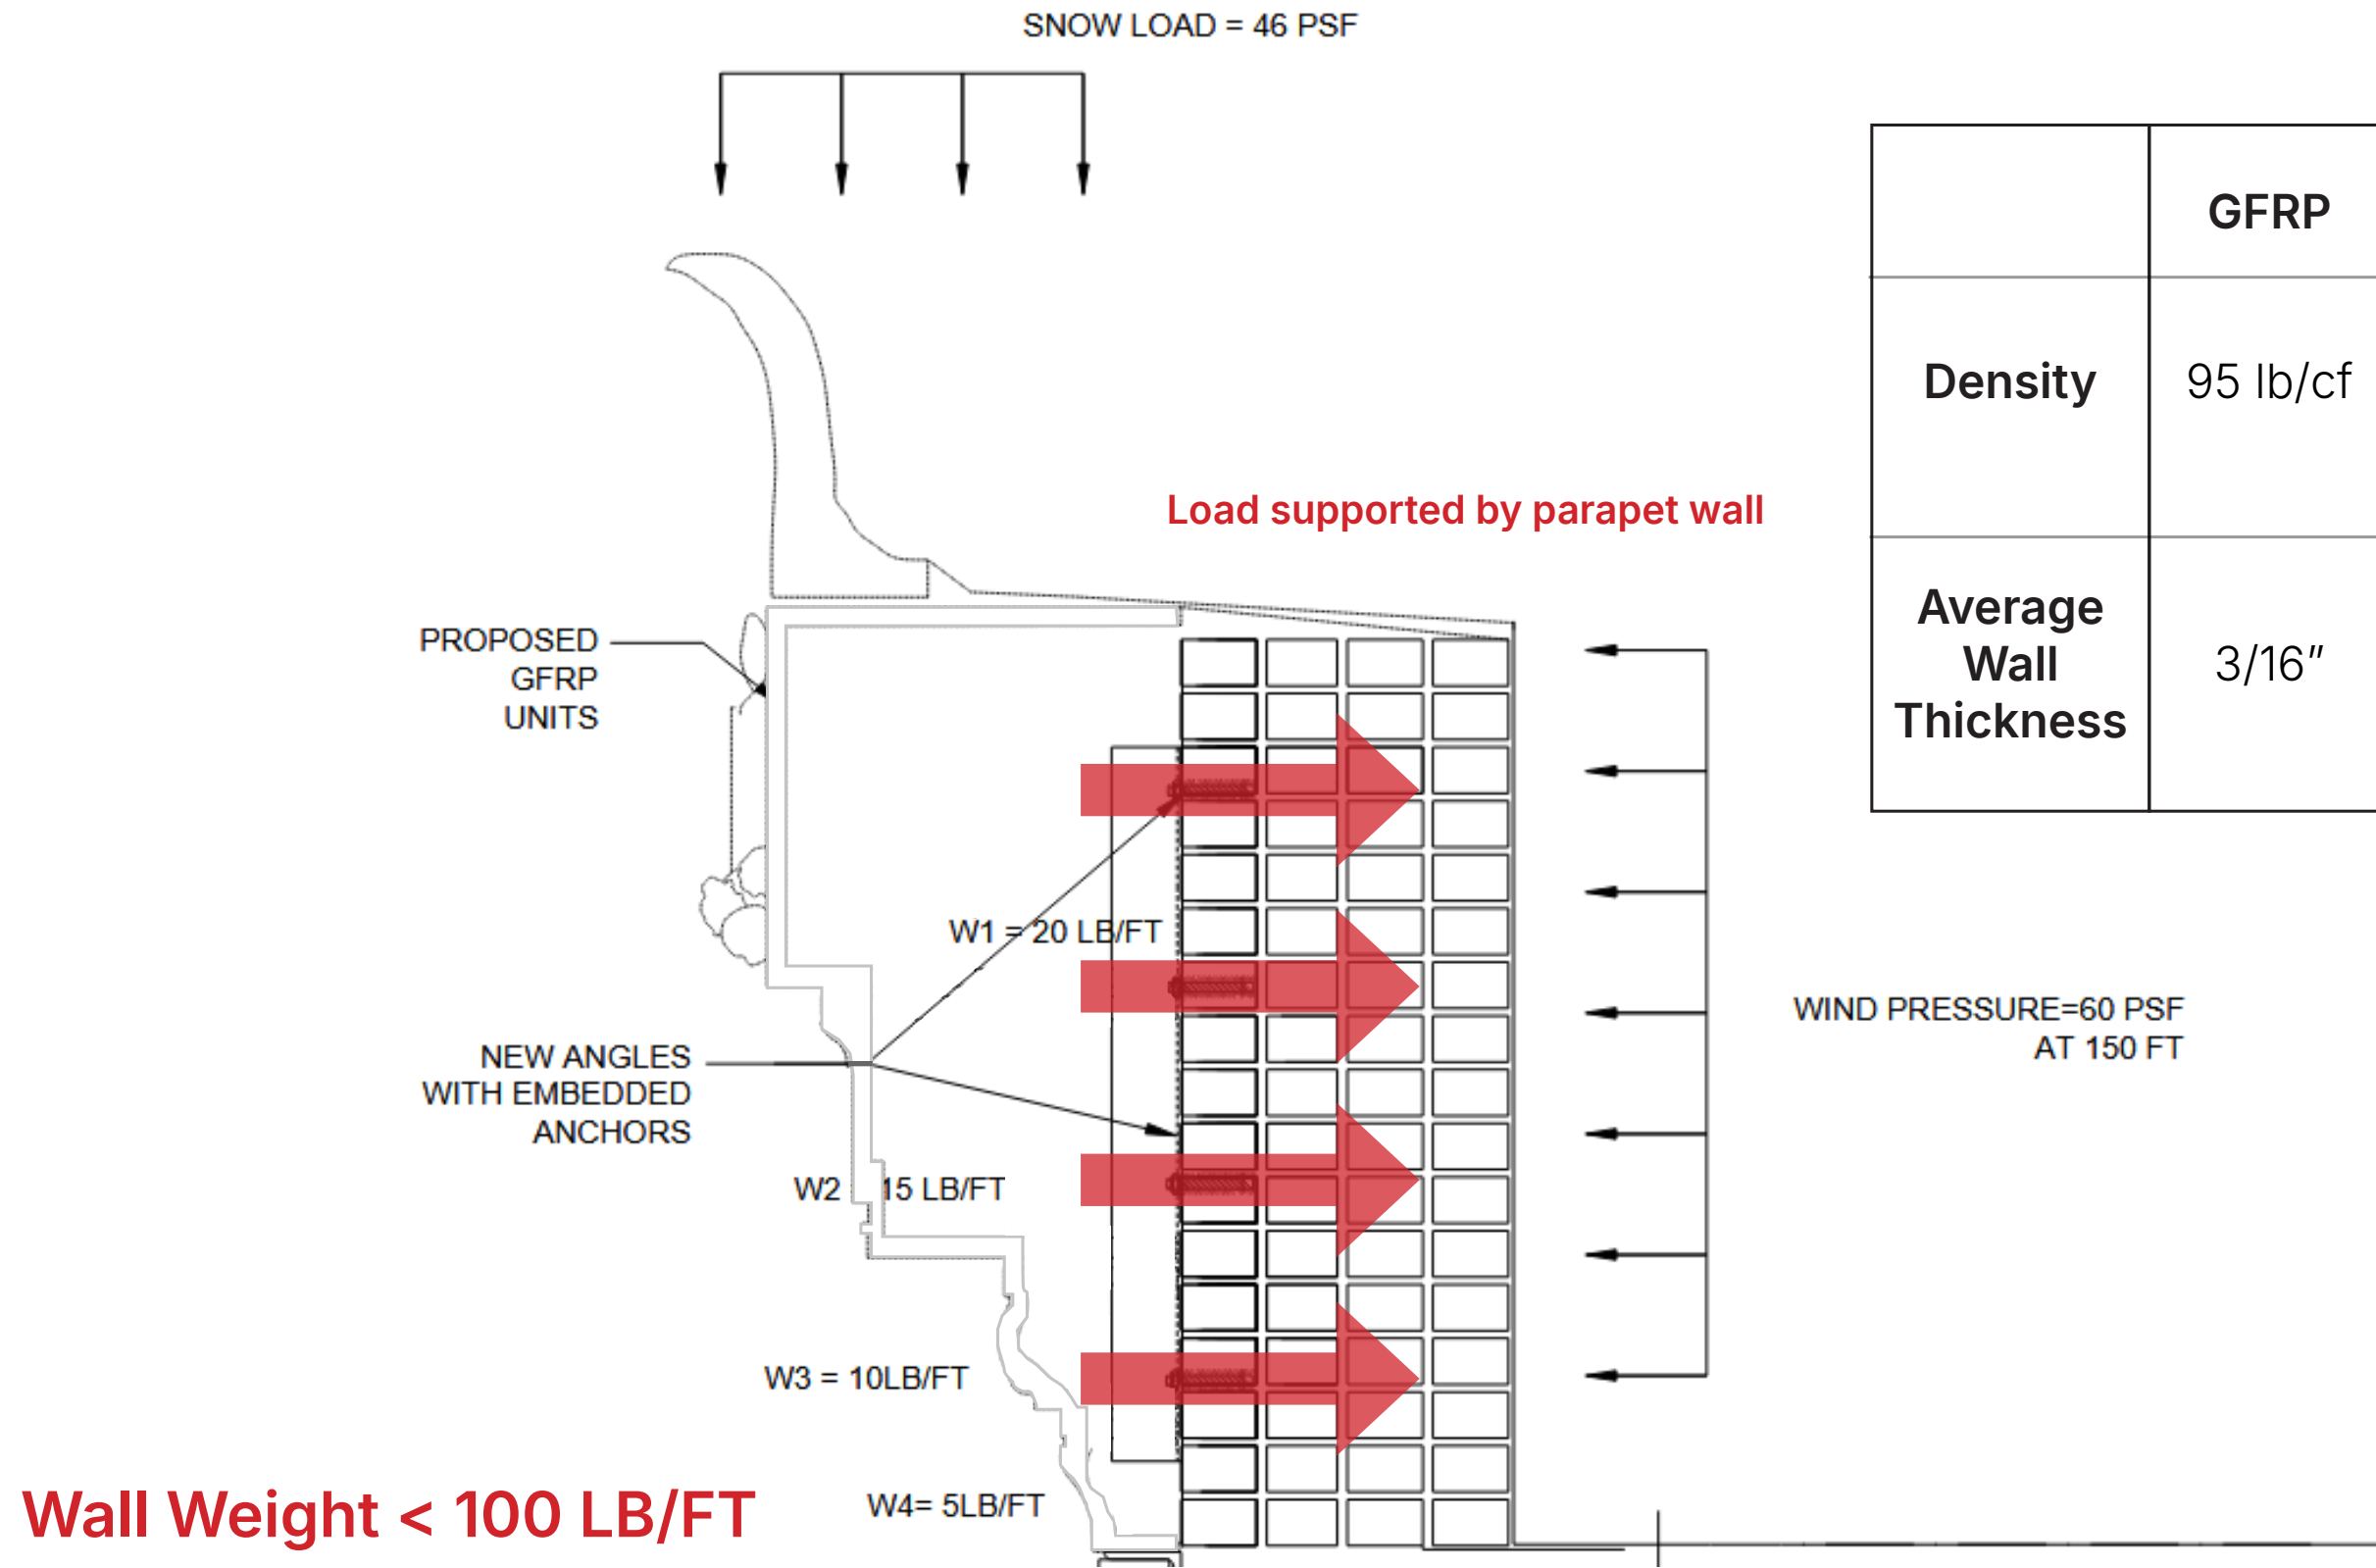
Proposed GFRP Panel Load Diagram

| | GFRP | Terracotta |
|---|---|---|
| Density | 95 lb/cf | 135 lb/cf |
| Average Wall Thickness | 3/16" | 1.25" - 1.5" |

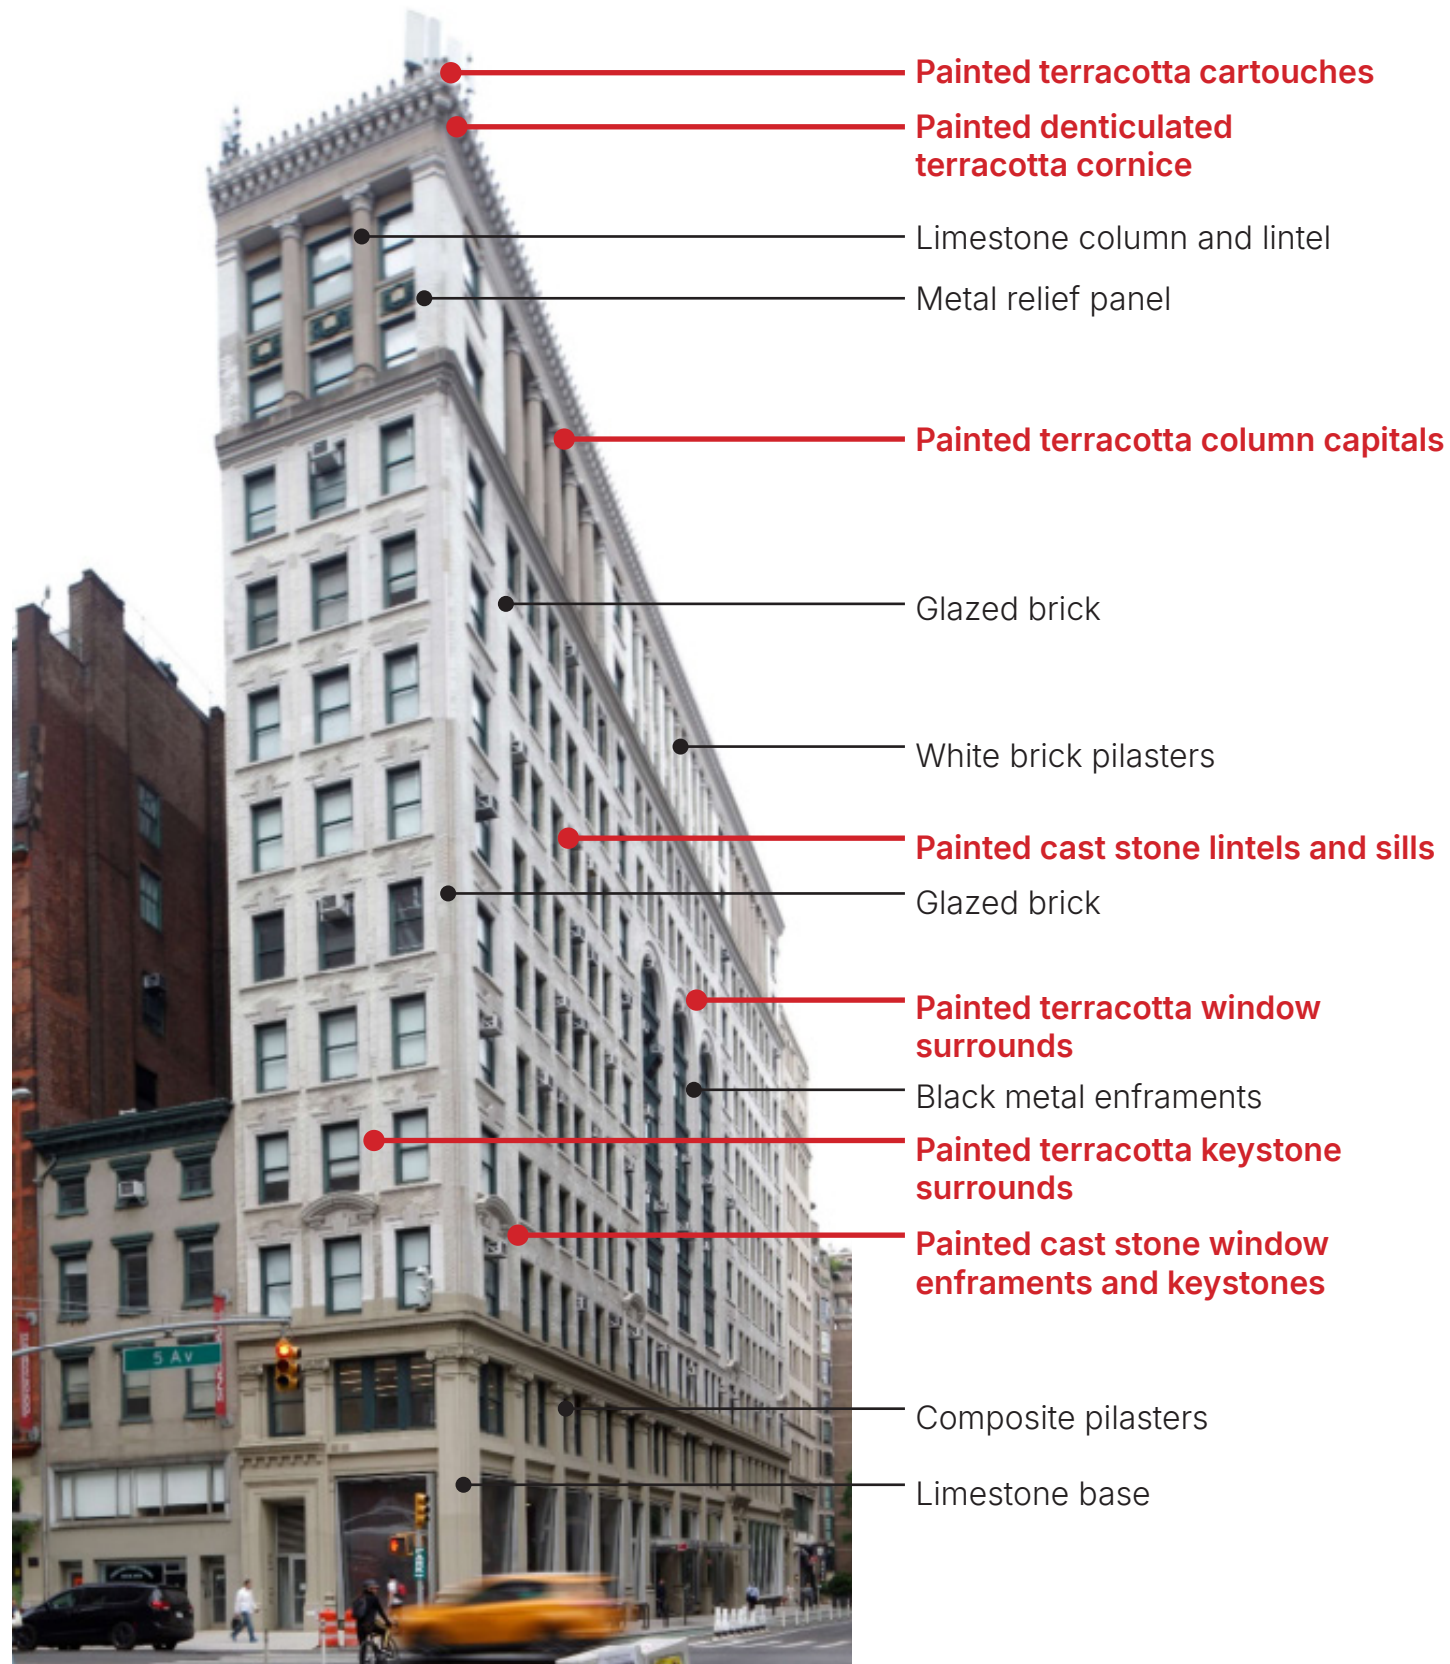
Terracotta cornice probes
