139 Thompson Street
Landmark Preservation Commission Public Hearing Presentation
March 17, 2026

Table of Contents

1. History of building up to repair work
2. Required stabilization and intervention
3. Observations & Analysis undertaken
4. CCD1 and its ramifications
5. New configuration and compliance
6. Facade conditions and assessment
7. Proposed reconstruction

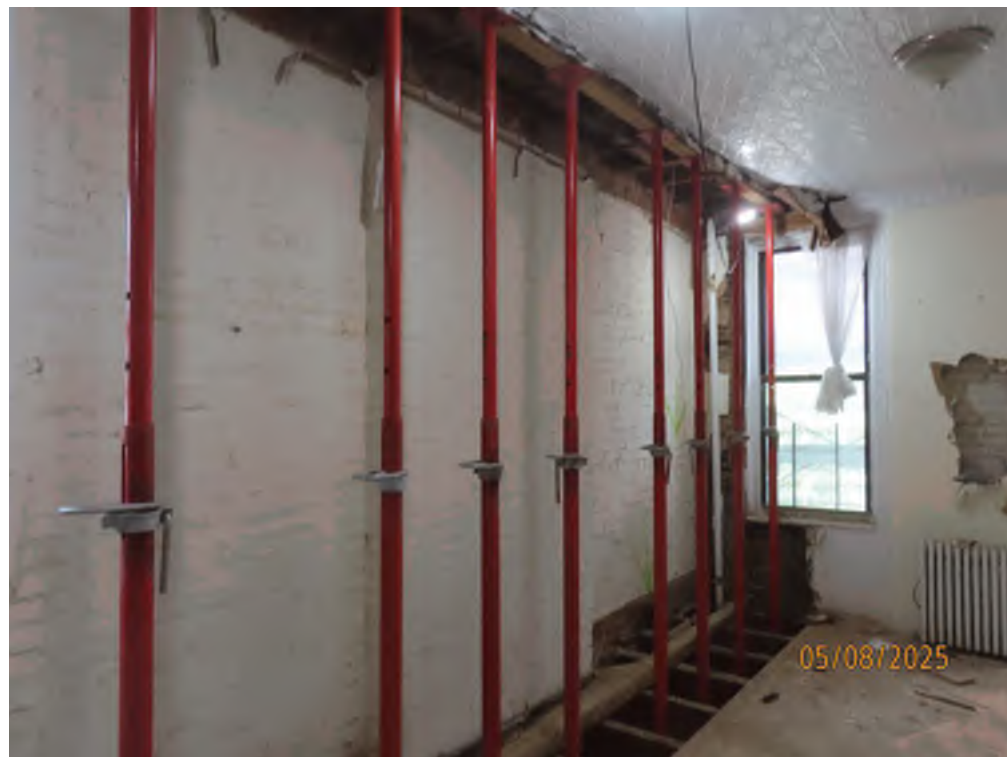
SHORING JACKS SPANNING TWO FLOORS
