FACADE REPAIRS & STAIRWELL REINFORCING

139 THOMPSON STREET
 NEW YORK, NY

Front Facade Inspection

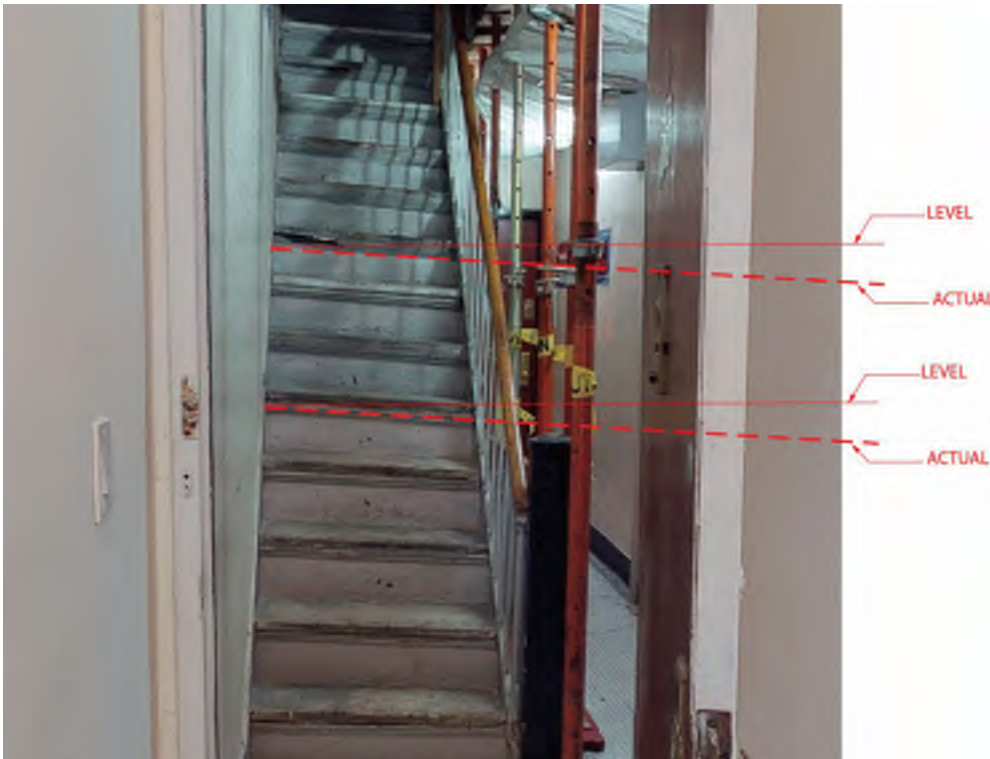
TILTED STAIRS DUE TO EXCESSIVE FLOOR JOIST DEFLECTIONS

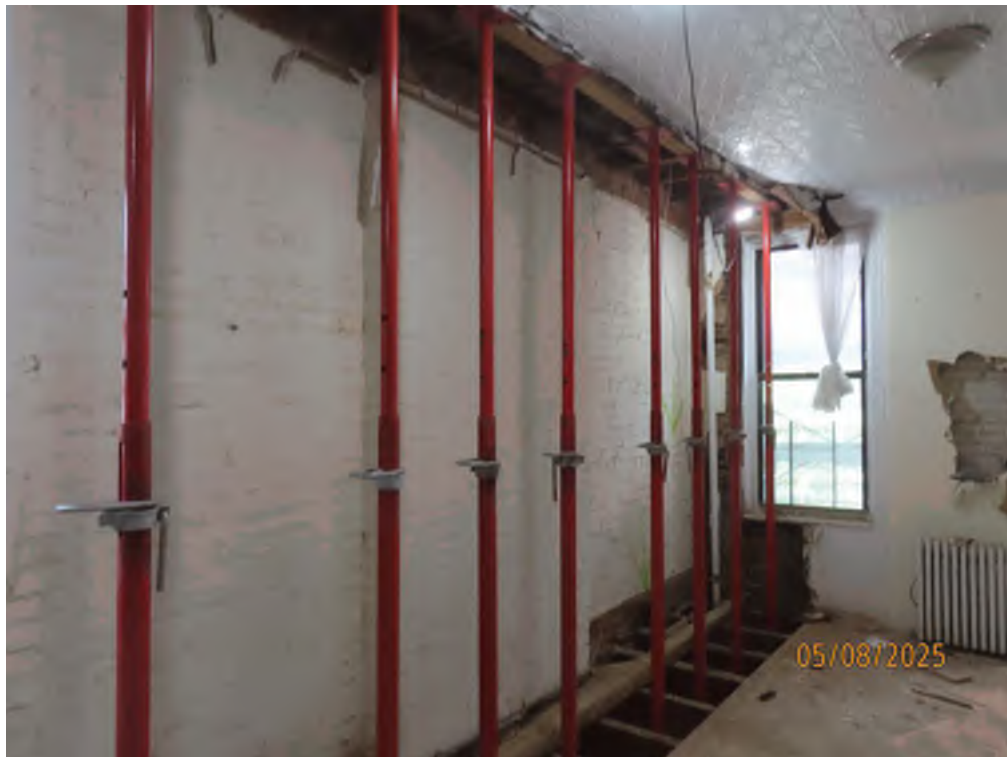
SHORING JACKS SPANNING TWO FLOORS
