# St. Mark's Church in-the-Bowery

75-42  
Continuing  
Maintenance Plan

21 JULY 2026

**BEYER  
BLINDER  
BELLE**

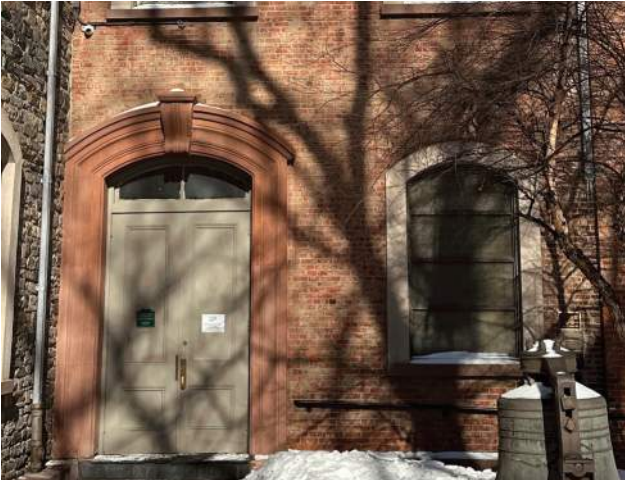
**BRICK WALLS**

The Parish Hall south facade hosts its main entry door from the yard, a stained glass window and operable windows at the Second Floor.

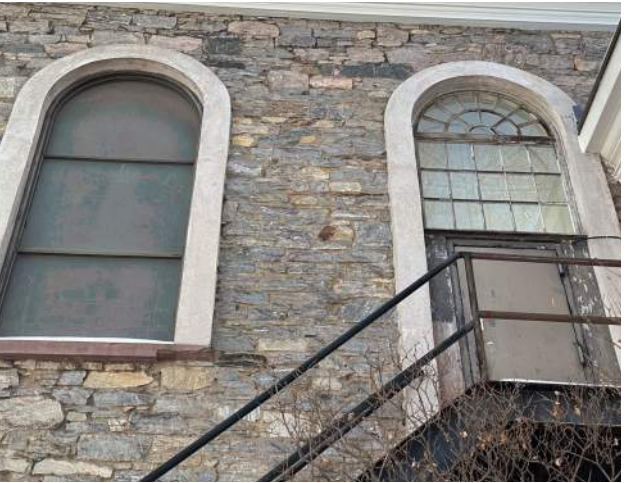
**WINDOW SURROUNDS**

An exterior stair was added for egress from the second floor ballet studio. An original window was modified to accommodate for the door.

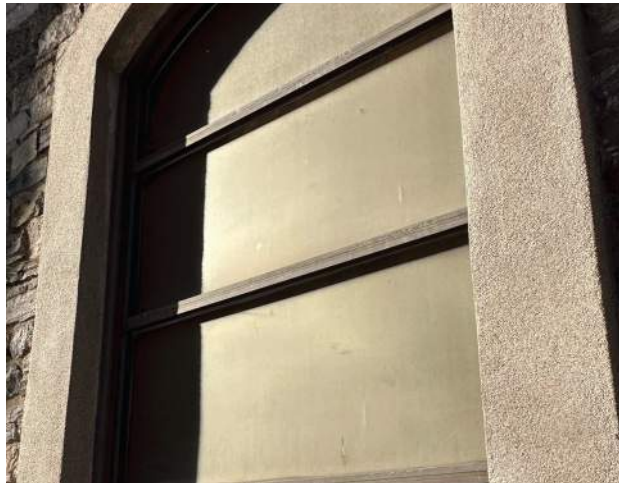
#### PROTECTIVE GLAZING

The typical protective glazing has heavy muntins that do not relate to the existing window frames, plastic glazing that has discolored and darkened, and does not allow ventilation.

**A32** - REPLACE STAINED GLASS PROTECTIVE GLAZING WITH VENTED GLAZING

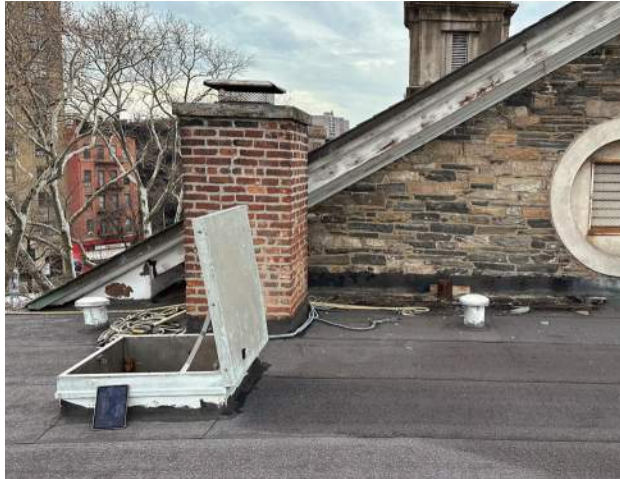
#### ROOF ACCESS

A hatch opens from the 2FL ballet studio balcony onto the low-slope roof.

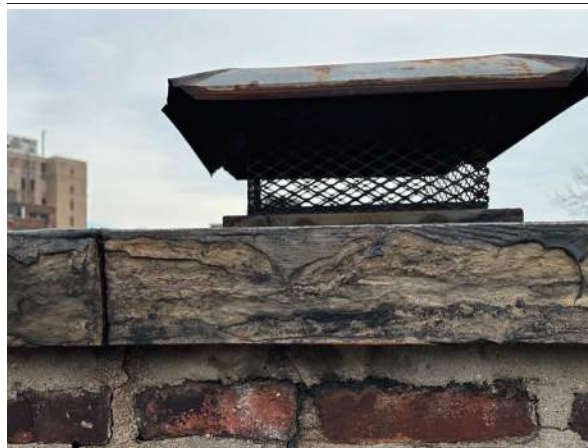
Chimney masonry shows cracked bricks and loose mortar.

**A15-3 - INSTALL WEATHER-RESISTANT CHIMNEY CAPS**

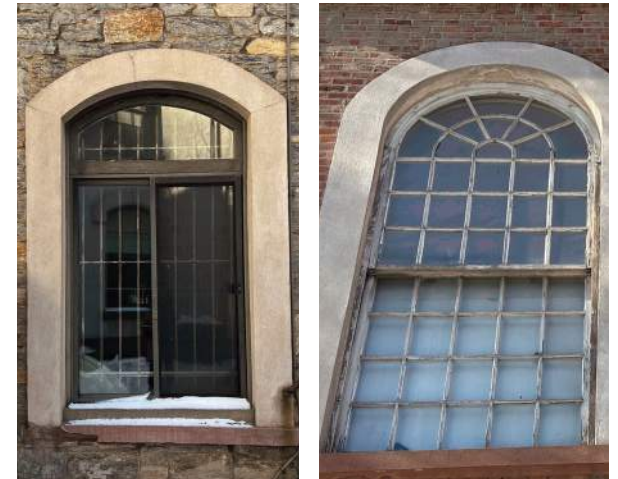
Wood windows at each facade show a similar level of paint loss and deterioration. All windows are replacements.

**A16-1 - REPAIR DETERIORATED WINDOWS**

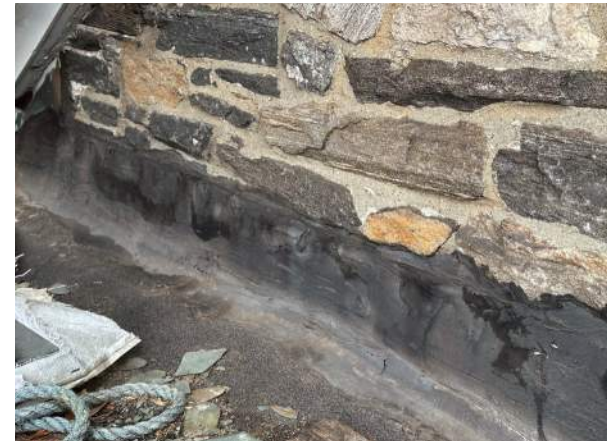
The roof membrane appears to have been in place before the parapet and base flashings were repaired, before 2017, but is in sound condition.

Open seams or other defects were not observed in the low slope membrane, however, water collected at edges and did not have scuppers to direct runoff.

**A15-1** - REPLACE PARISH HALL ROOFING MEMBRANE AT FLAT ROOF
