# 83-85 SULLIVAN STREET

PRESENTATION TO:  
**MANHATTAN COMMUNITY BOARD 2**

# LANDMARKED PAIR

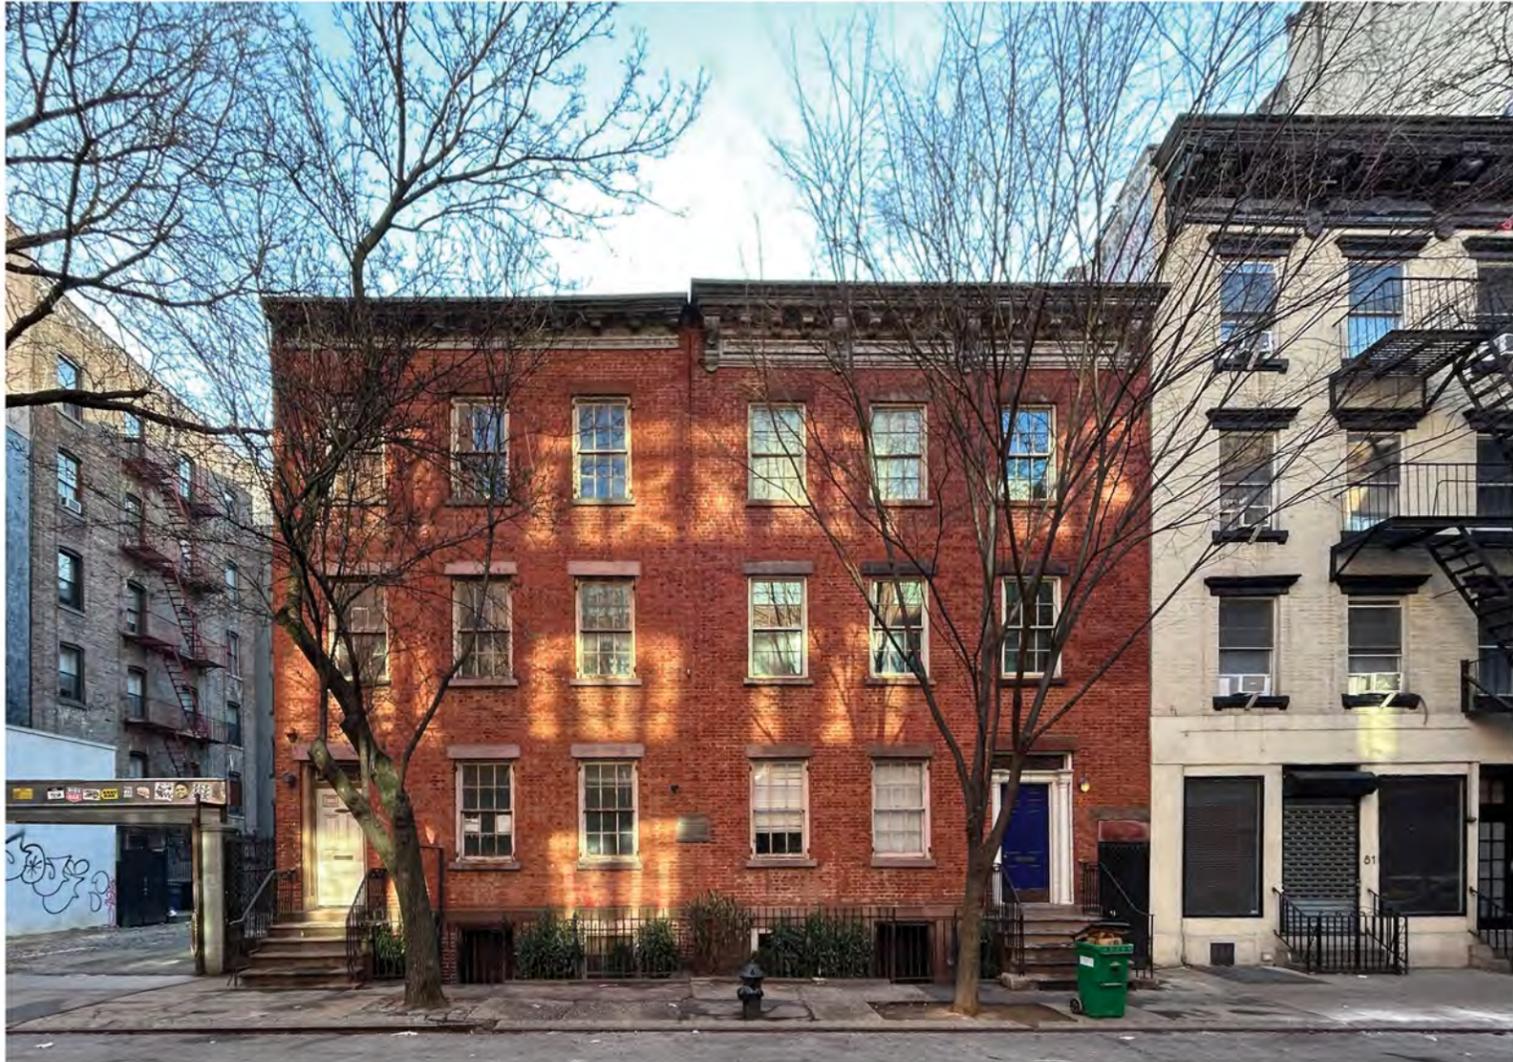
# Existing Conditions: Sullivan Street Facade

85 Sullivan

83 Sullivan

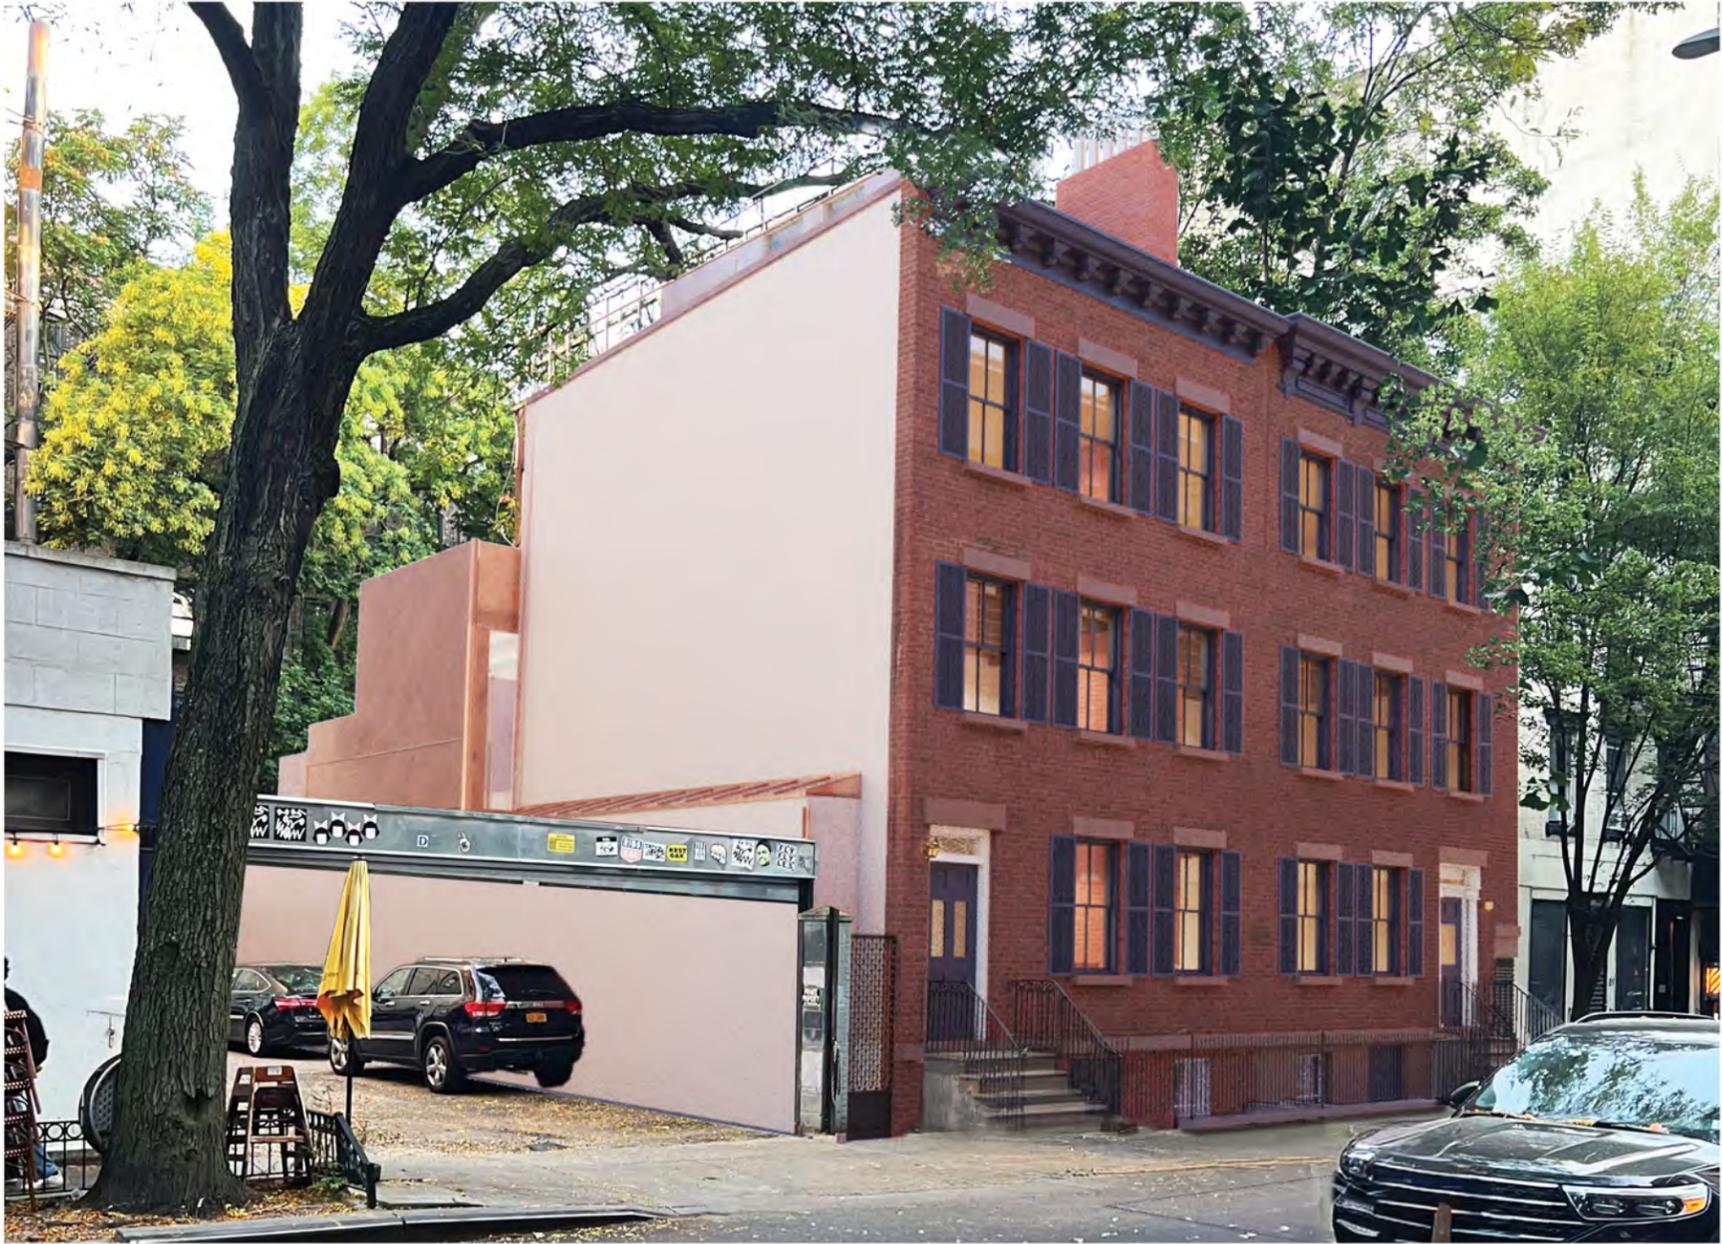
# Proposed Addition Sightlines: Side View

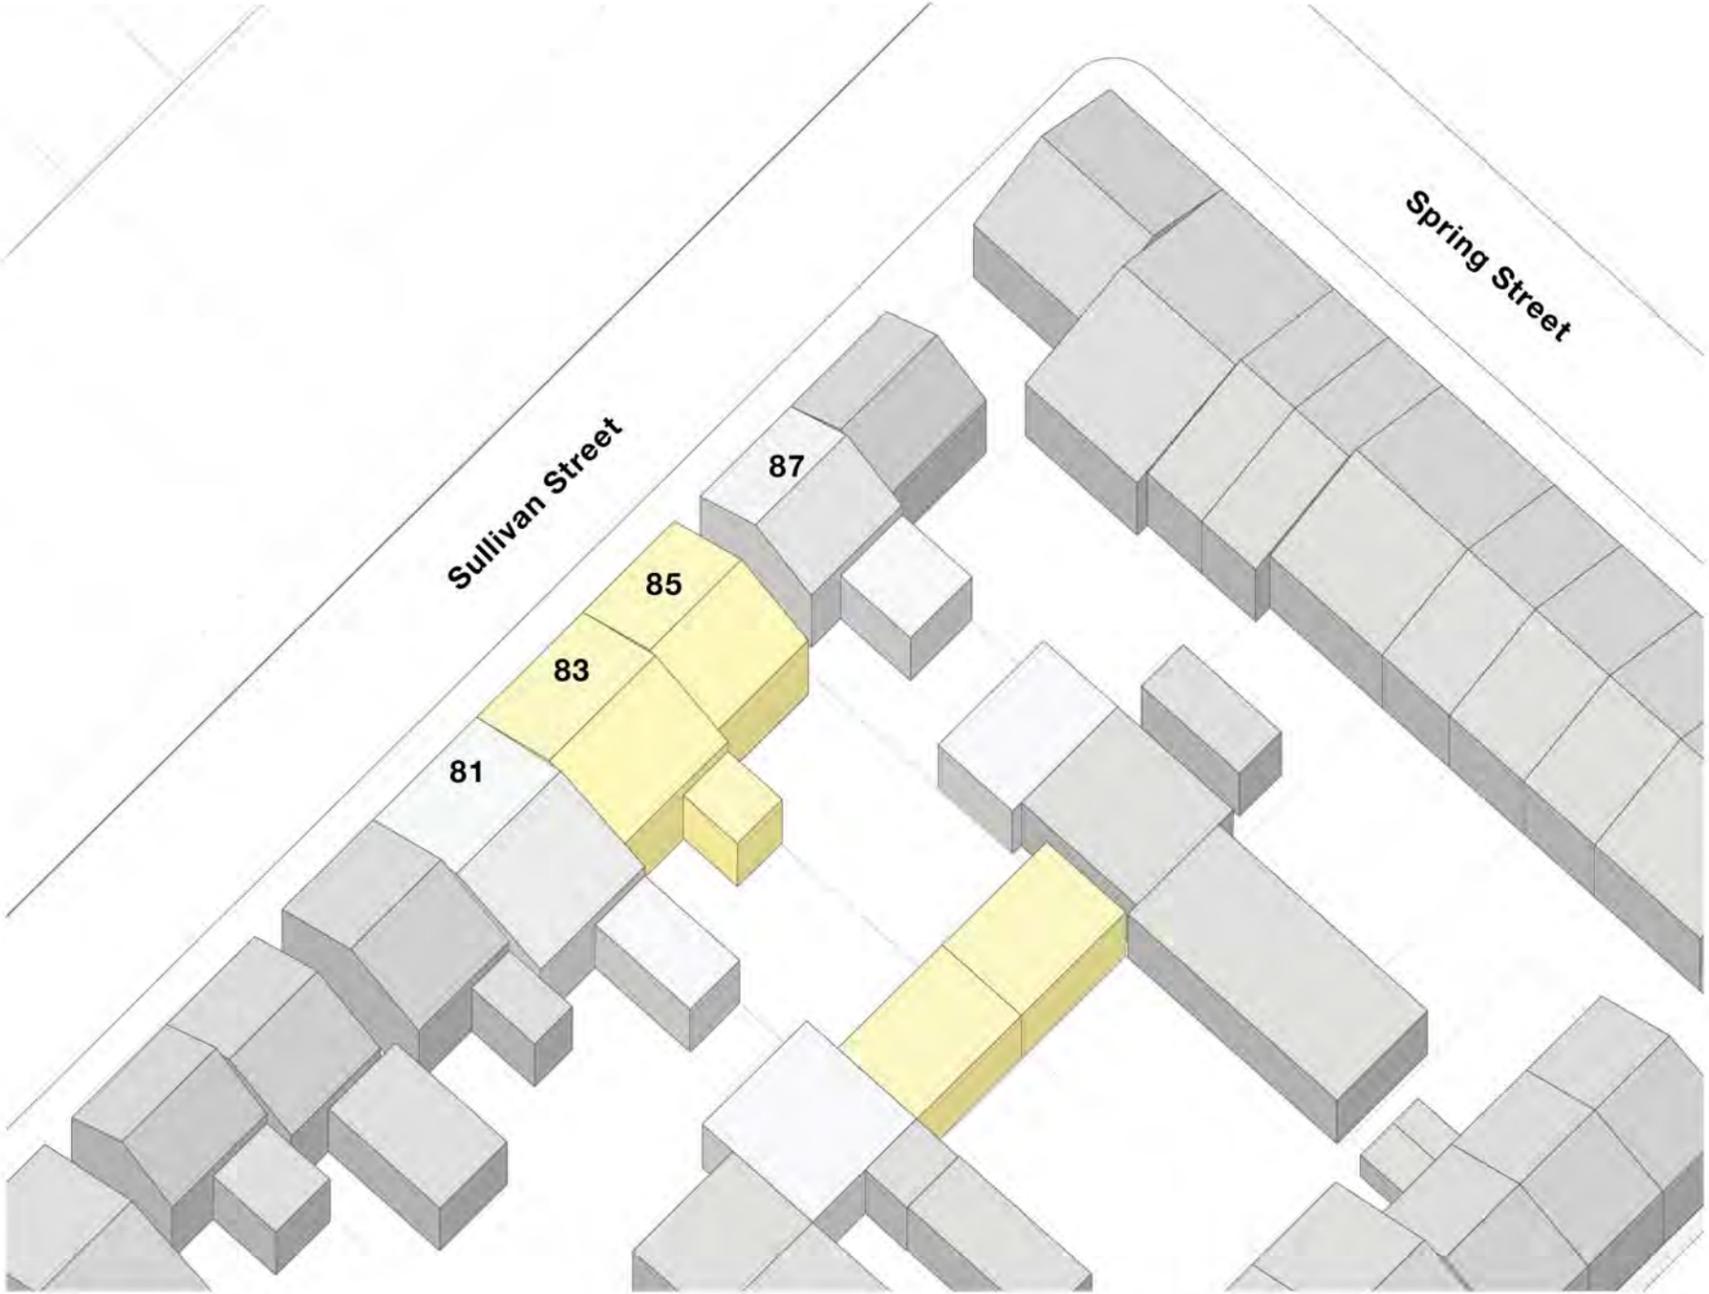
# Historic Block Massing: 1853

**1853 Block Massing**  
Source: Perris Map

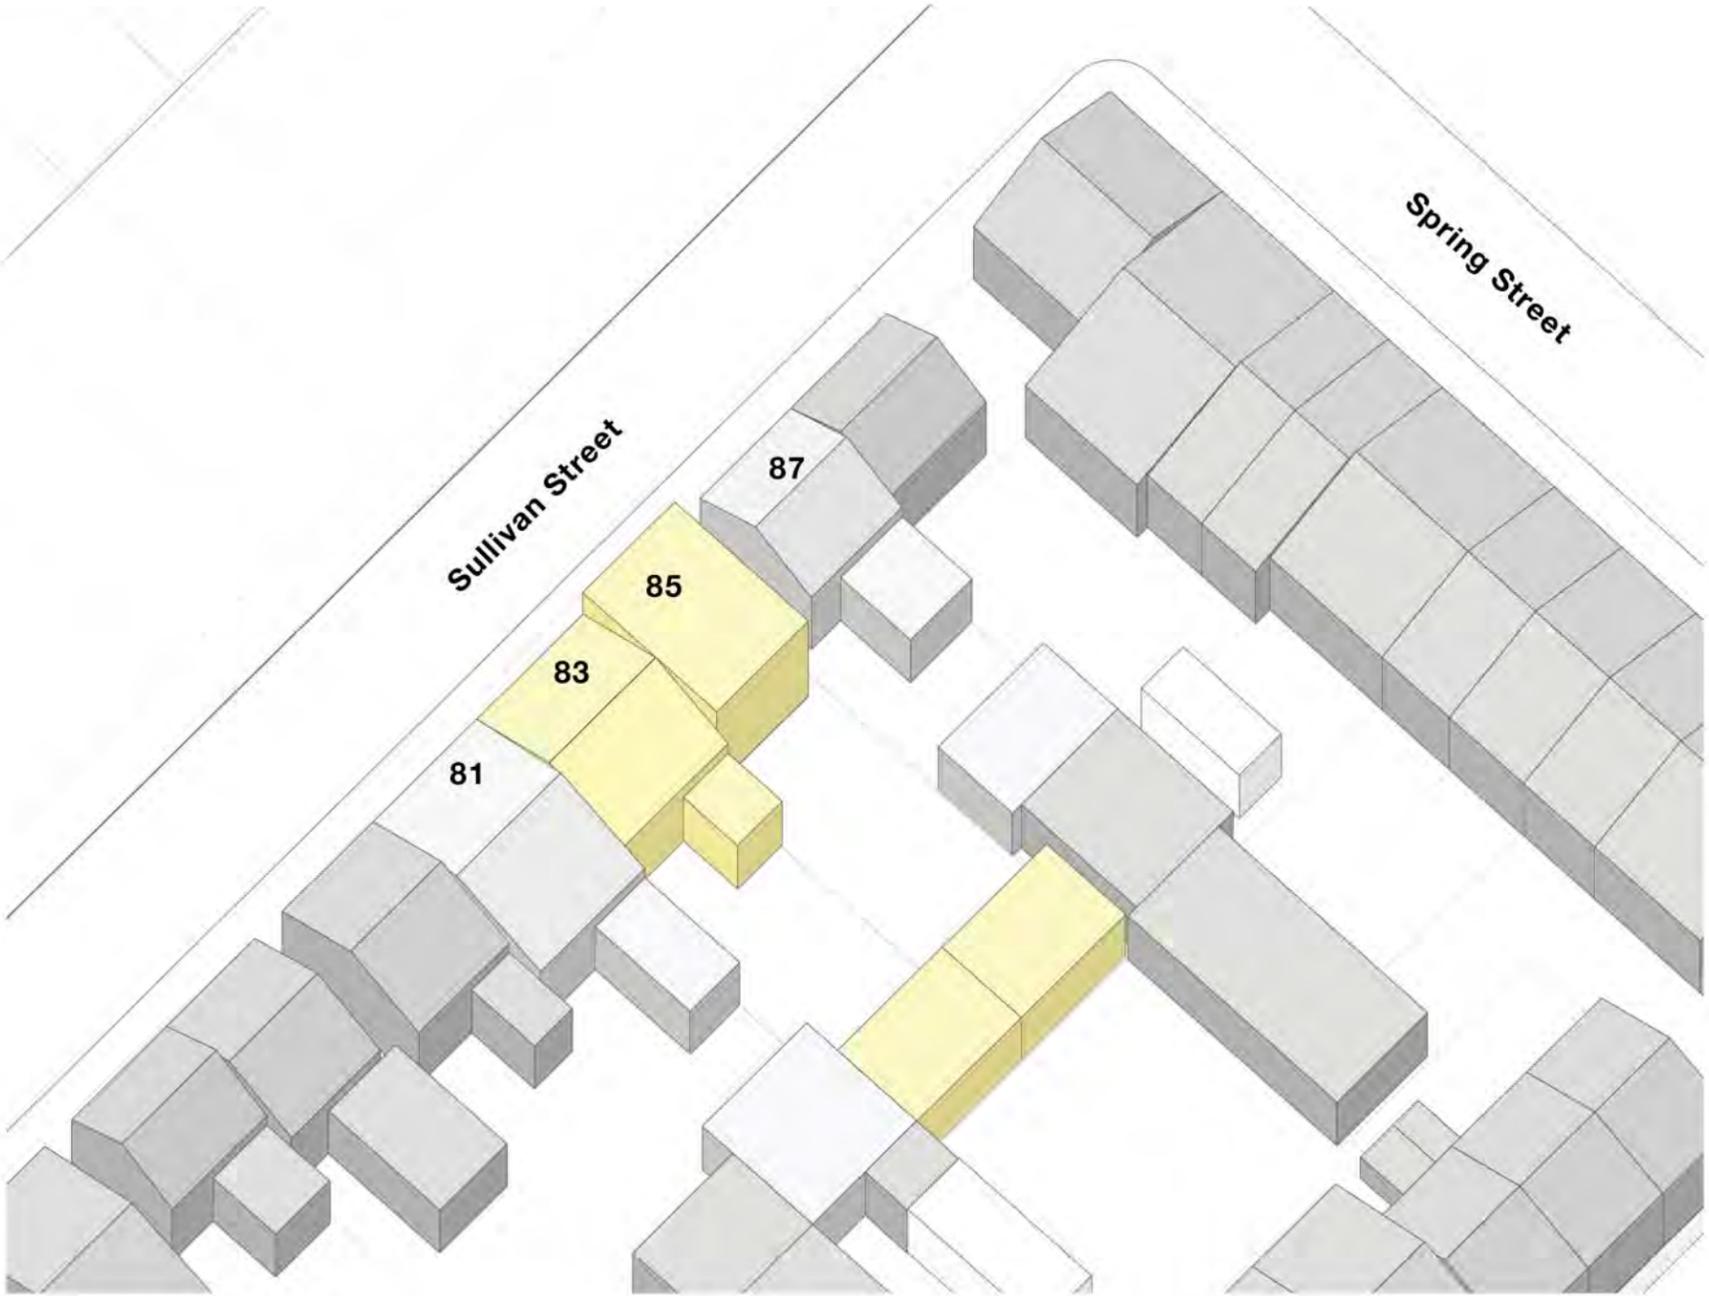
# Historic Block Massing: 1874

**1874 Block Massing**  
Source: DOB Records ALT 165-74 or ALT 1085-74

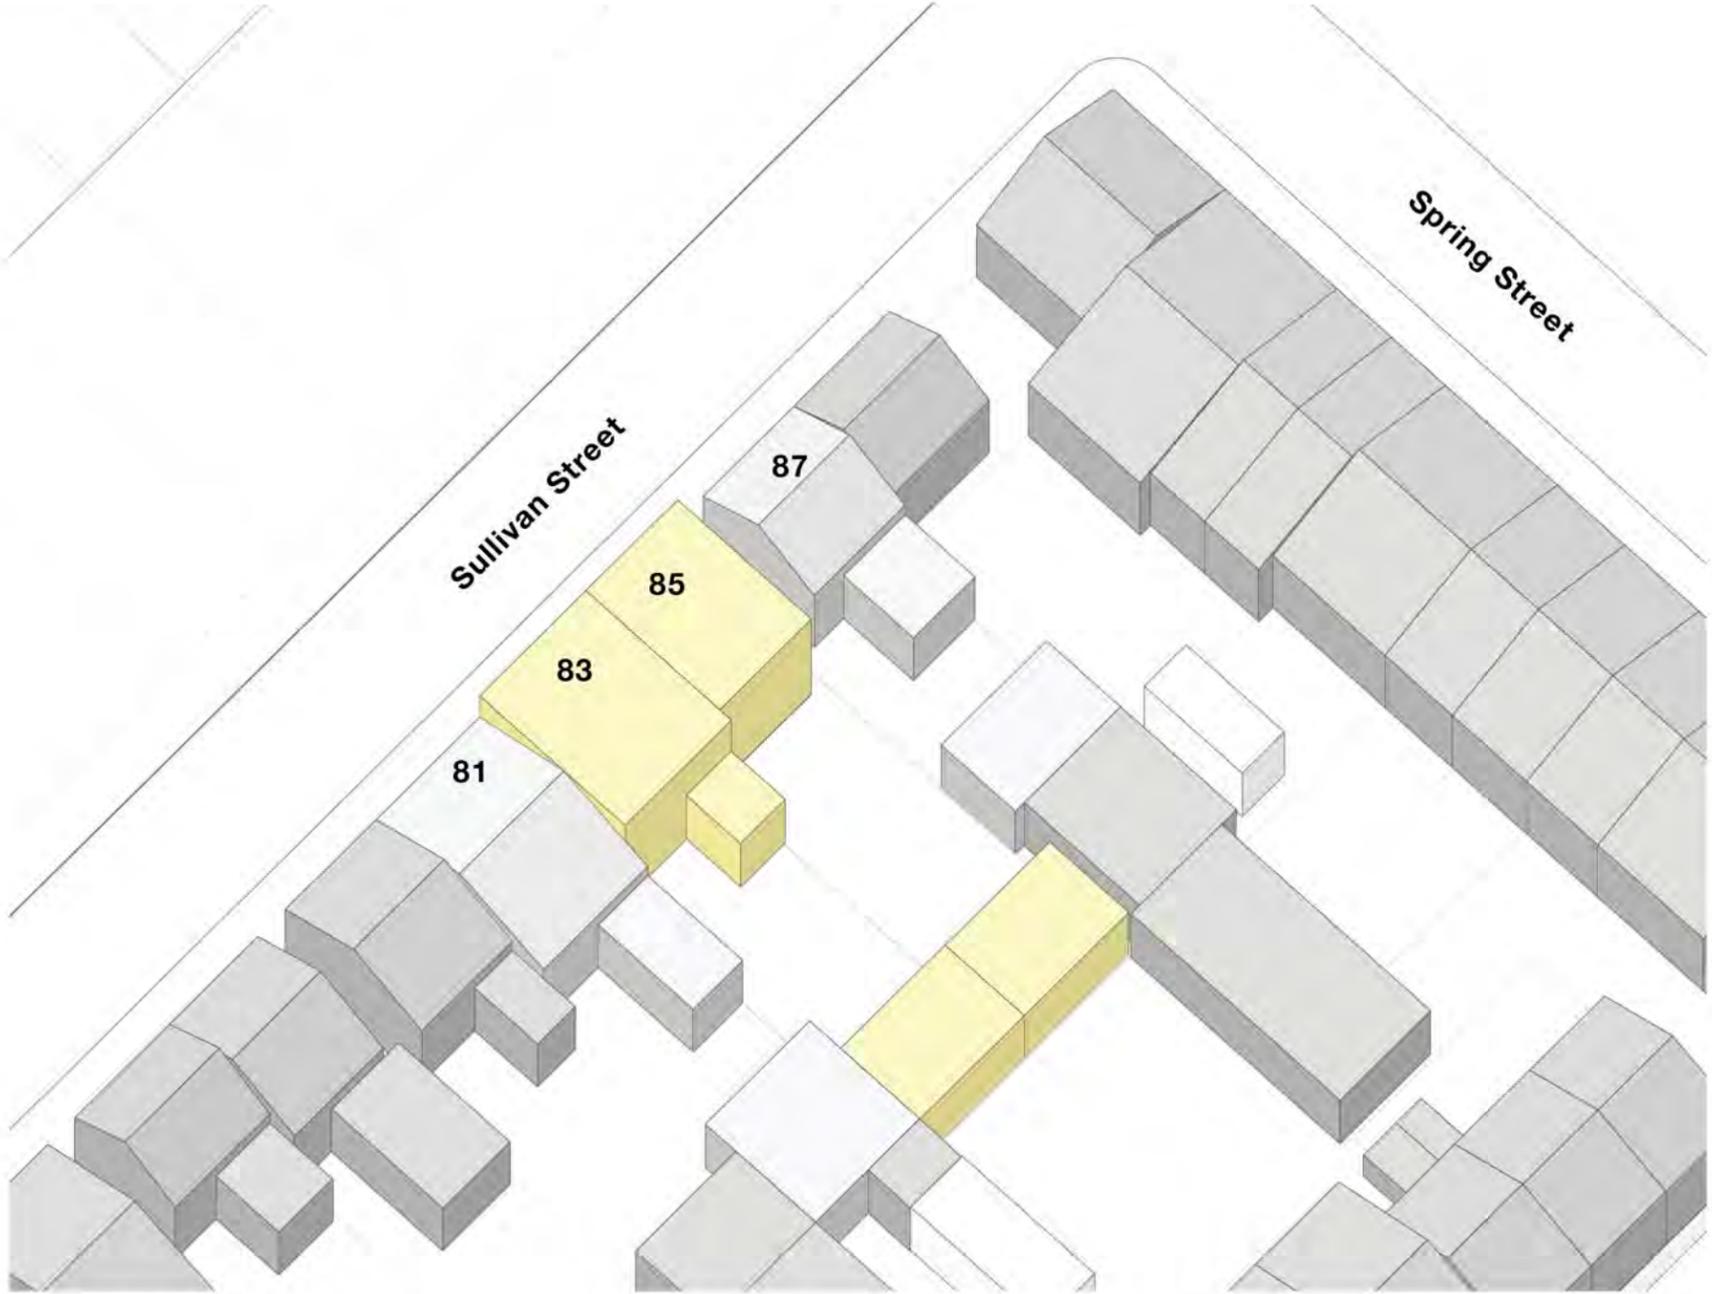
# Historic Block Massing: 1880

**1880 Block Massing**  
Source: DOB Records ALT 302-80

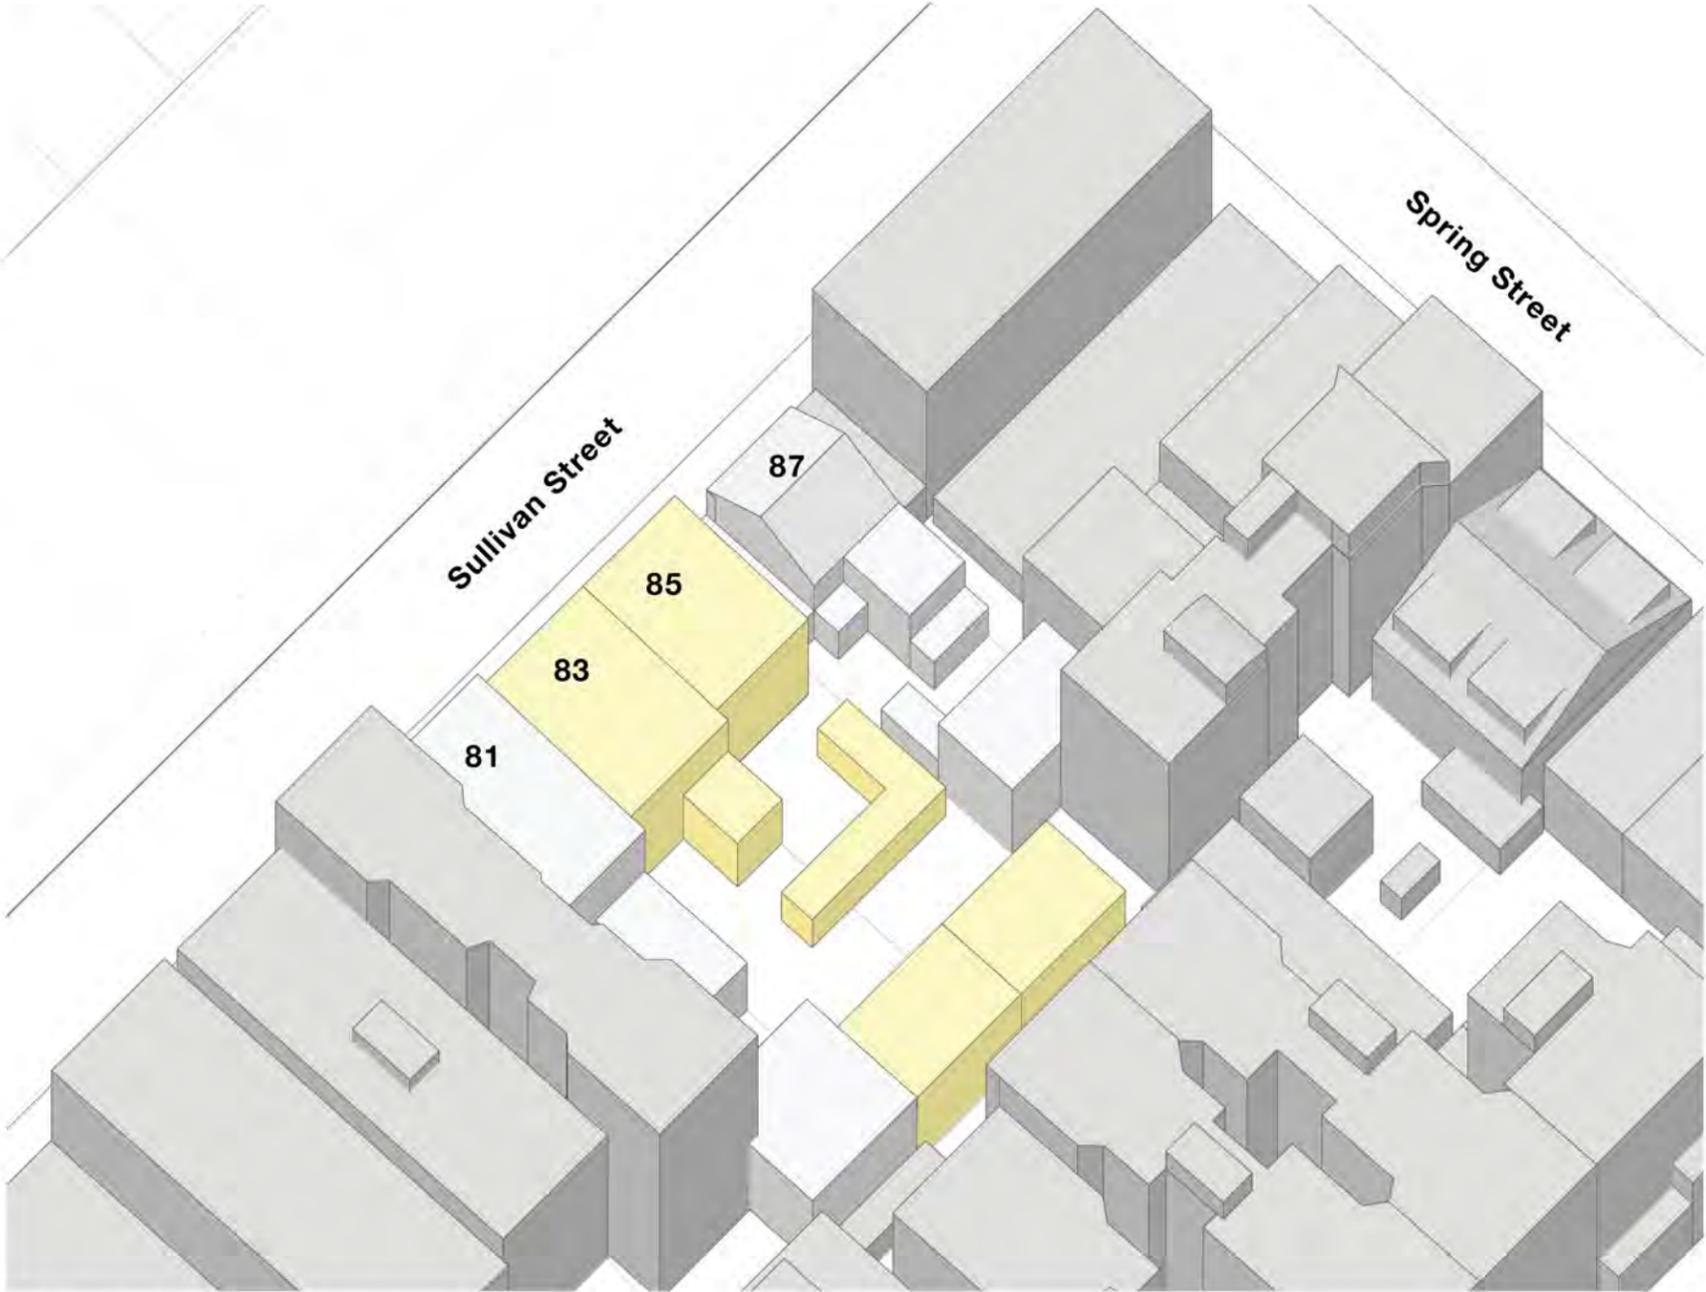
# Historic Block Massing: 1903

**1903 Block Massing**  
Source: Sanborn Fire Insurance Map

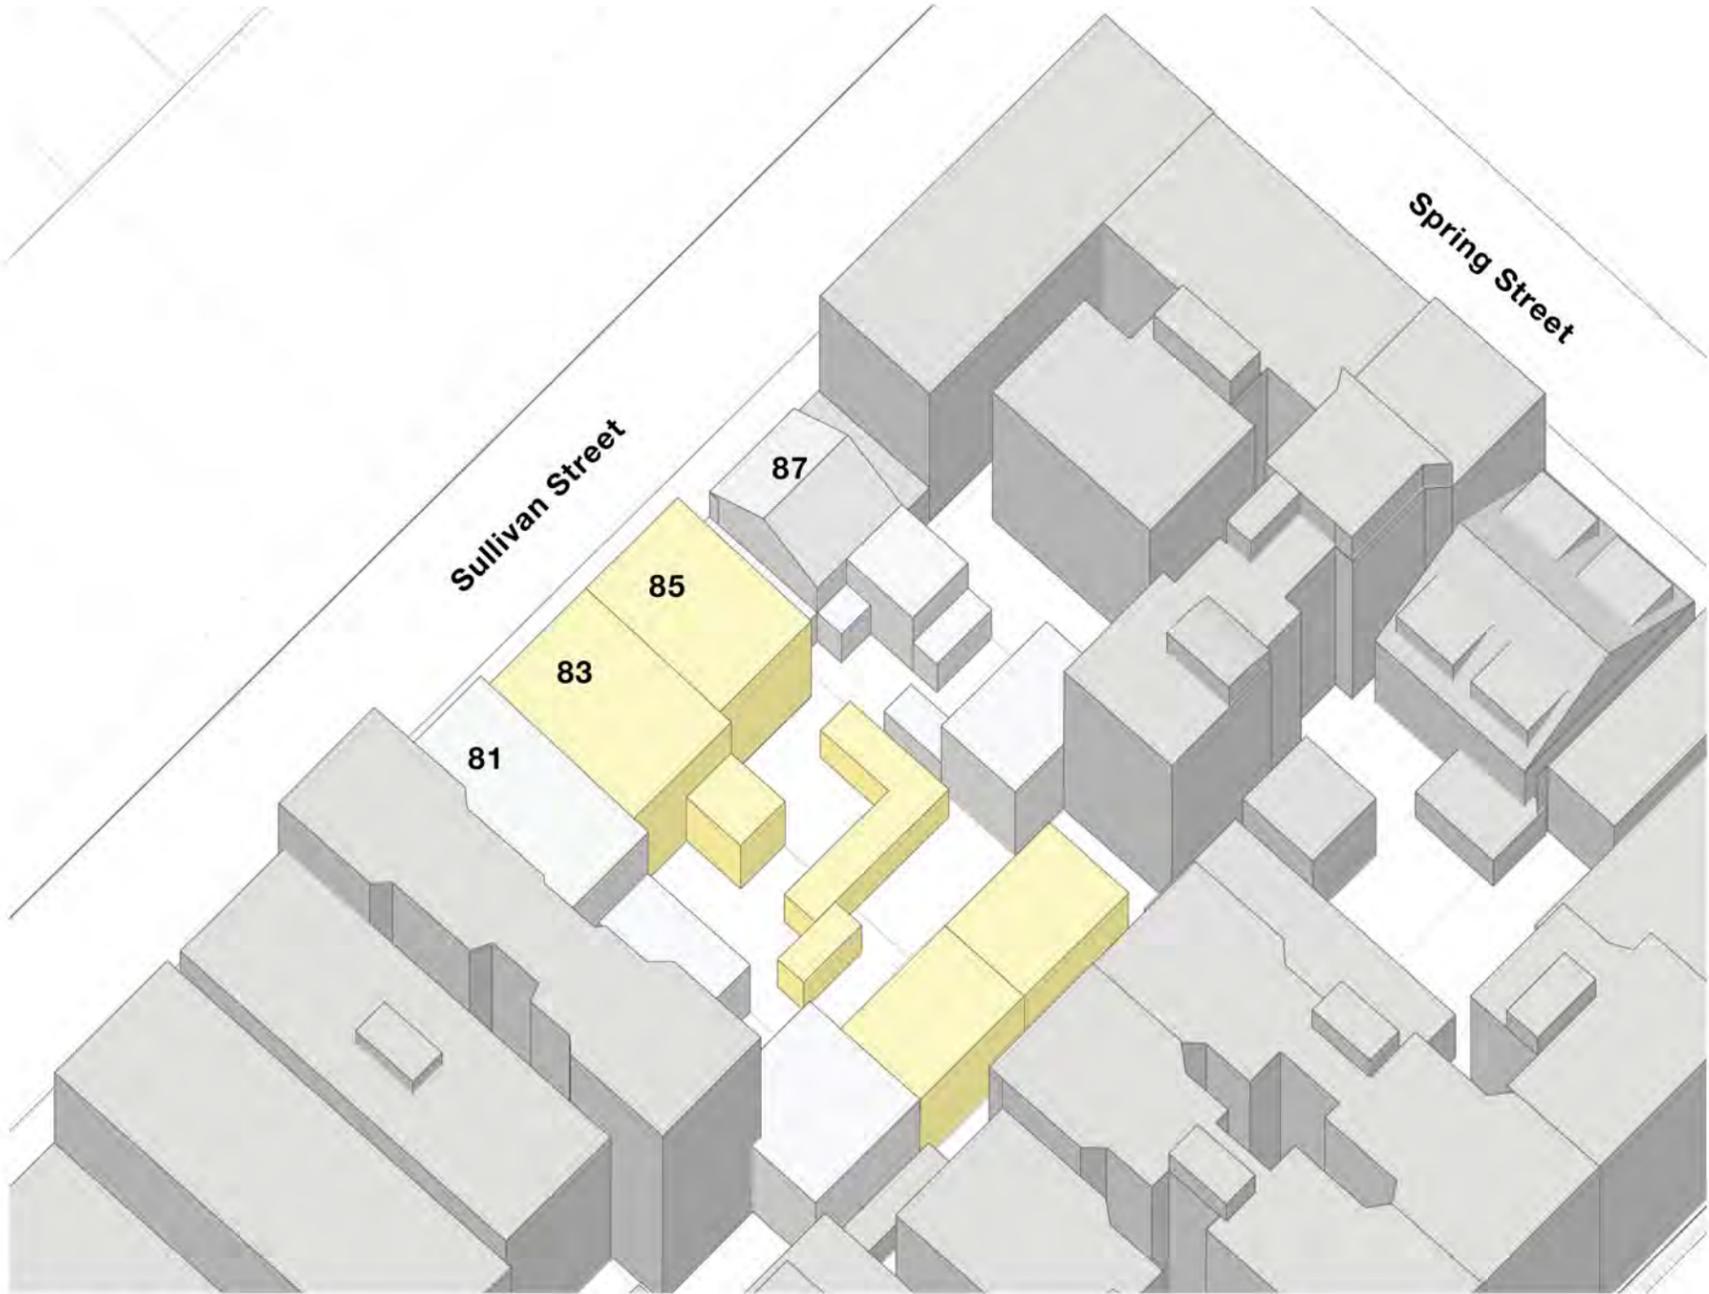
# Historic Block Massing: 1922

**1922 Block Massing**  
Source: Sanborn Fire Insurance Map

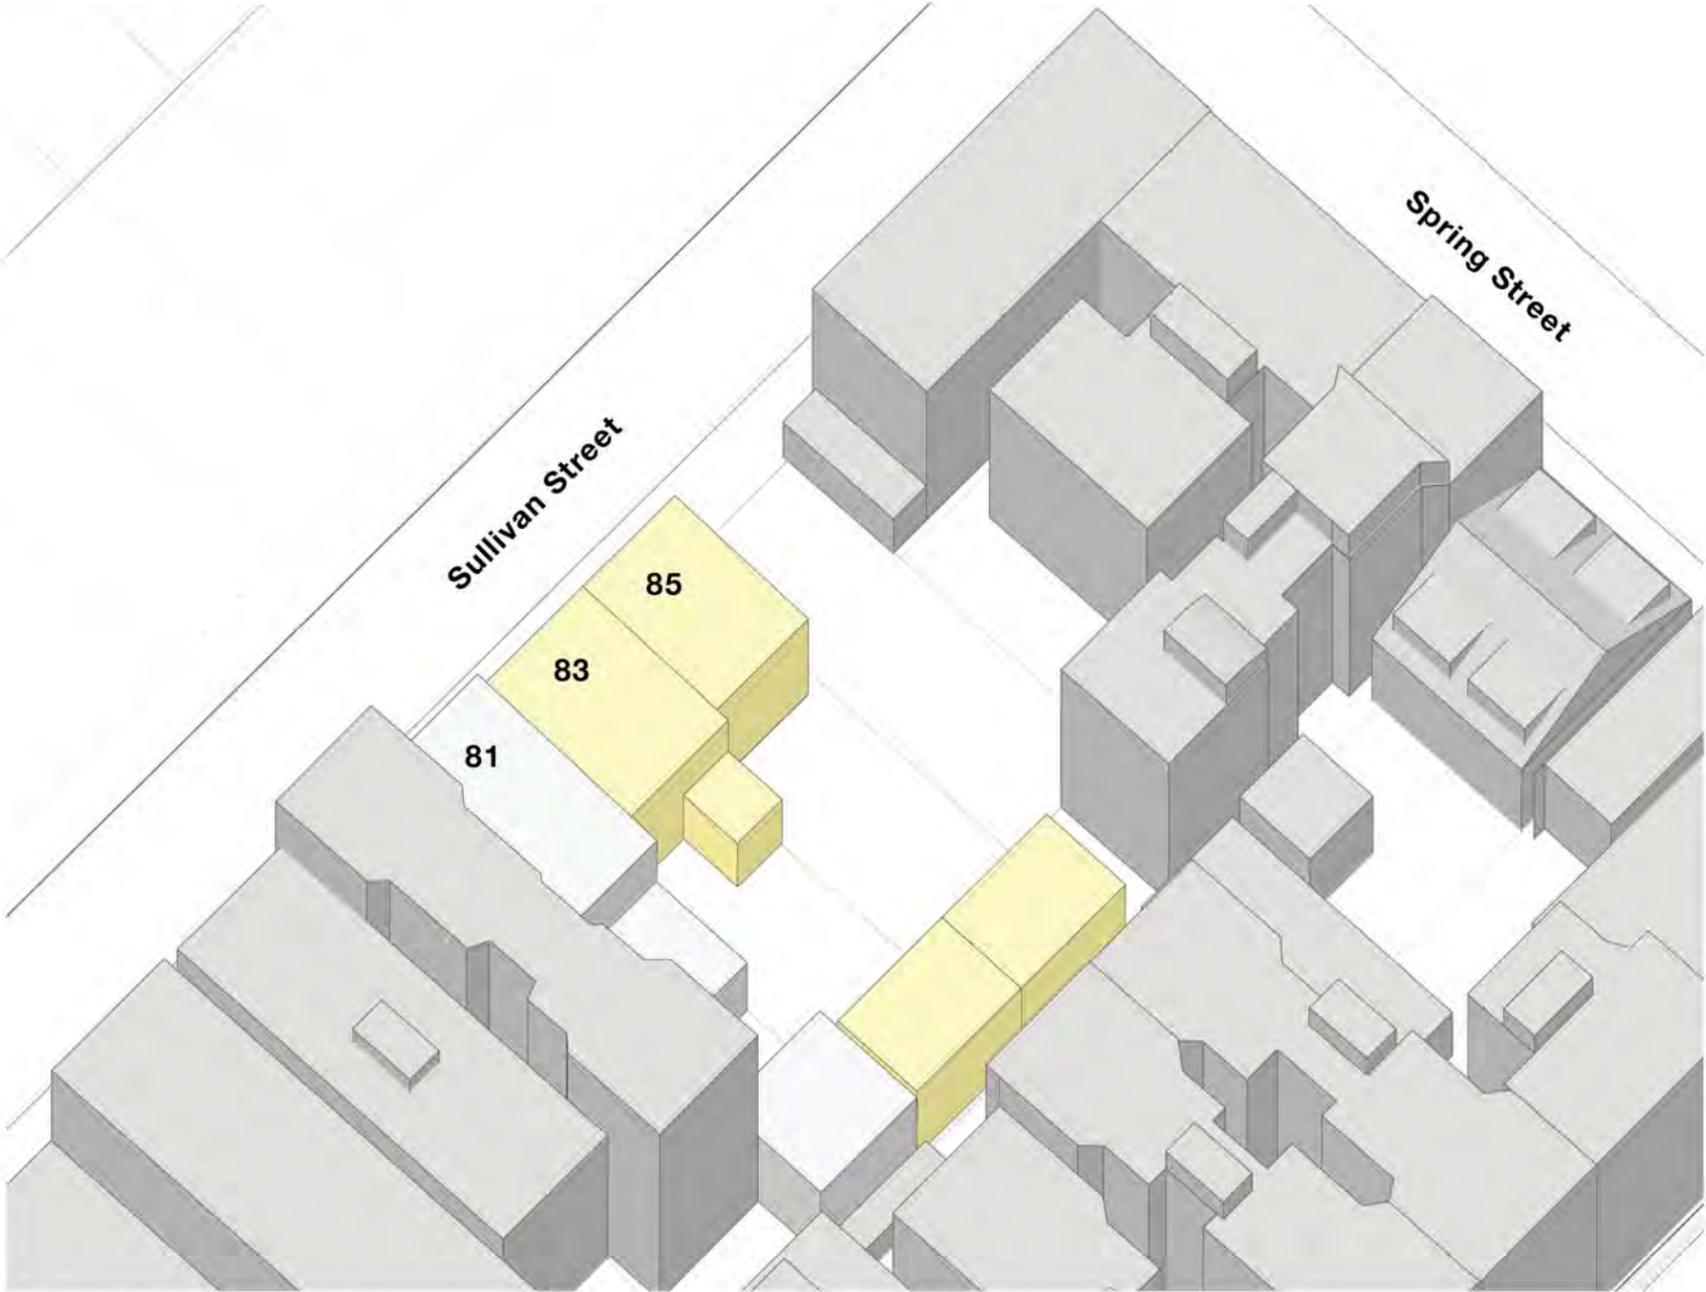
# Historic Block Massing: 1956

**1956 Block Massing**  
Source: Manhattan Land Book of the City of New York. G.W. Bromley & Co., 1955-56

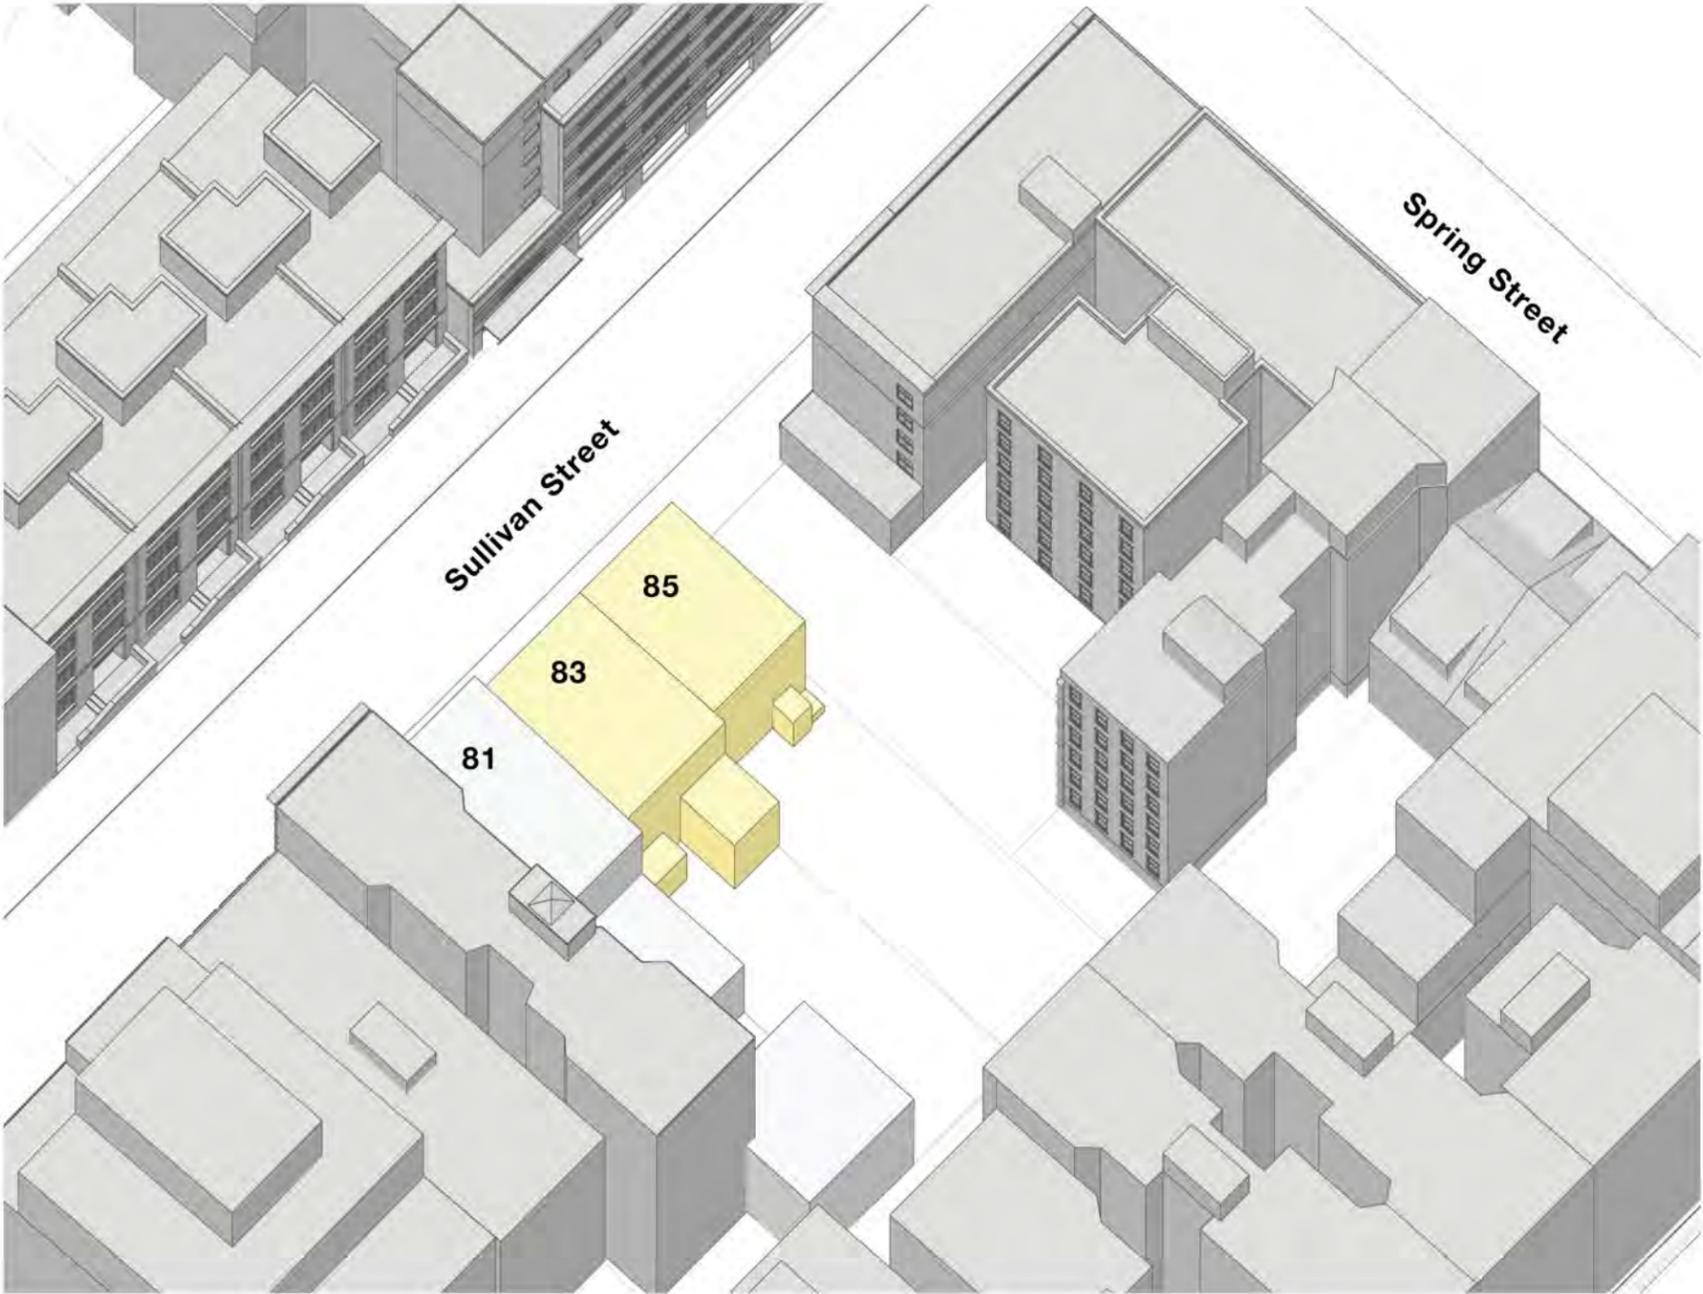
# Current Block Massing: 2025

**2025 Block Massing**  
Source: OASIS NYC, site survey

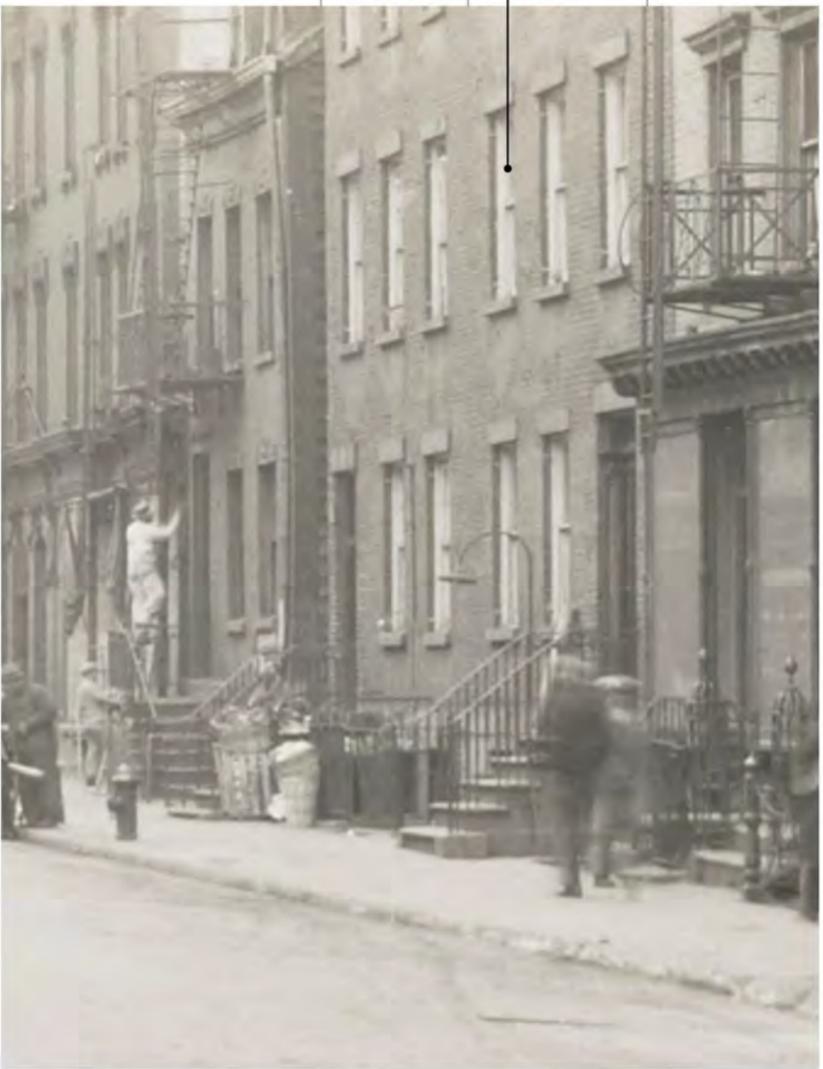
Historic reference  
for proposed  
2-over-2 windows

**83-85 Sullivan (1927)**  
Source: NYHS Photo

3-Story rear yard  
buildings

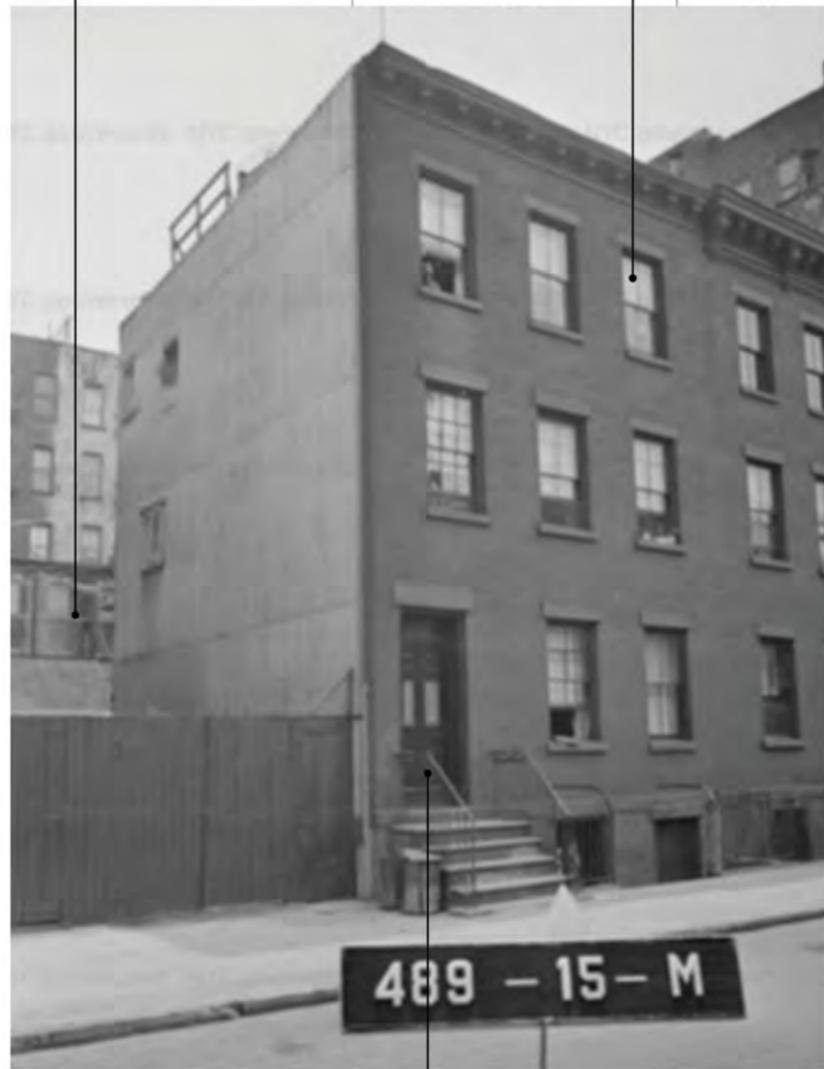
Historic reference  
for proposed  
2-over-2 windows

**85 Sullivan (c. 1940)**  
Source: NYCMA Tax Photo

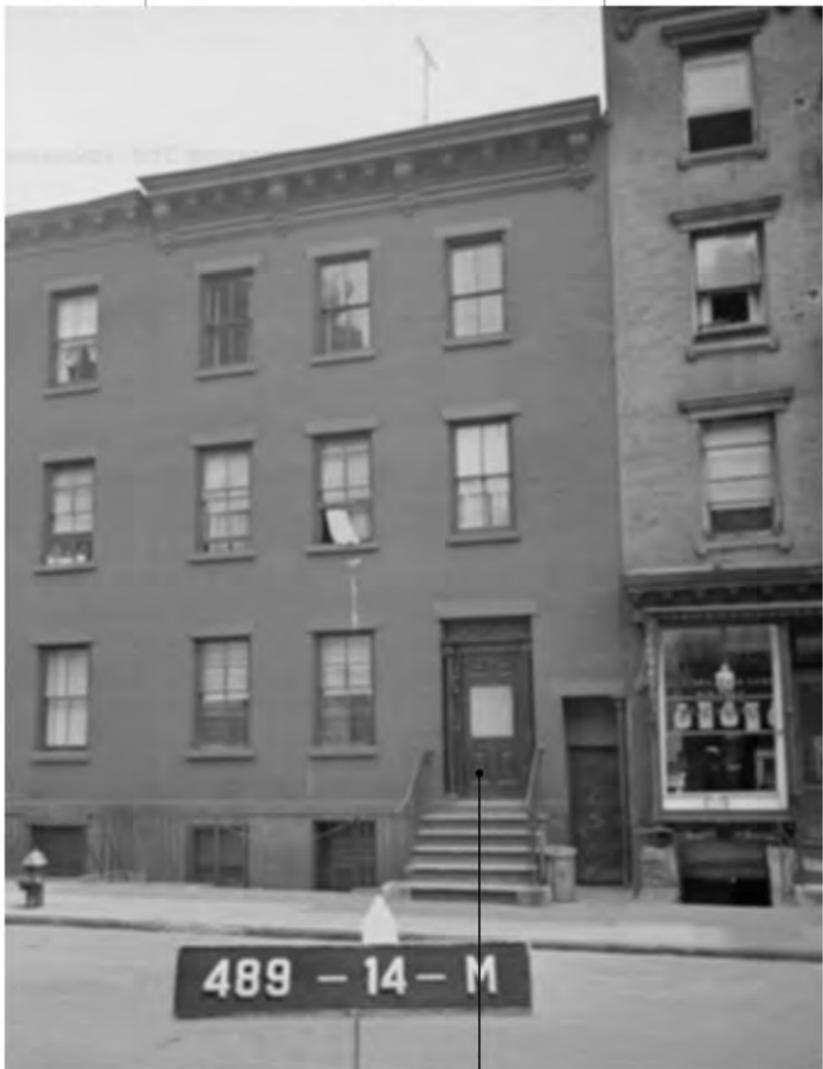
Historic reference for  
proposed door

**83 Sullivan (c. 1940)**  
Source: NYCMA Tax Photo

Non-original doors to be replaced with new doors to match historic doors w/ lites as shown in the 1940's tax photos.

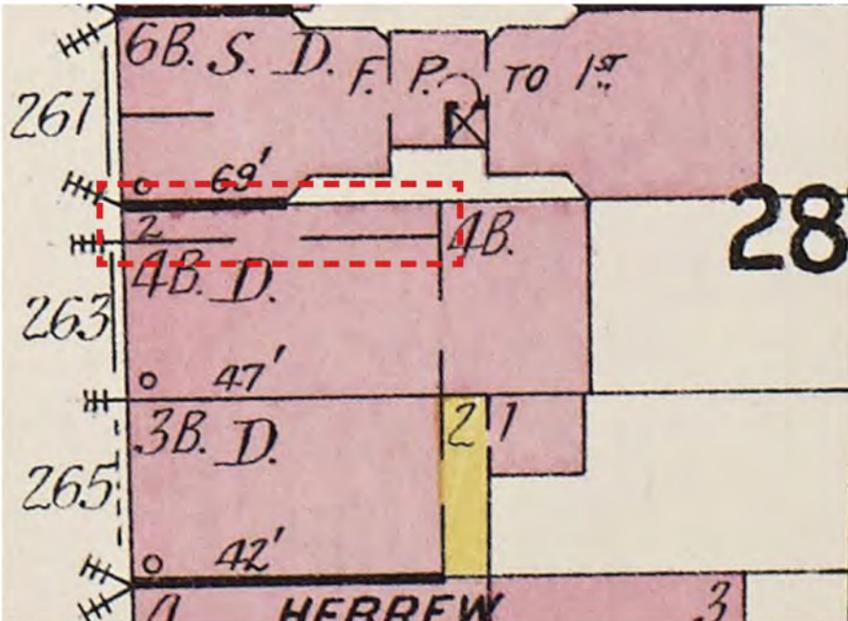
**263 Henry Street Alley Infill** (built 1827, raised 1895)  
Source: 1905 Sanborn Fire Insurance Map
