# 83-85 SULLIVAN STREET

PRESENTATION TO:  
**MANHATTAN COMMUNITY BOARD 2**

# LANDMARKED PAIR

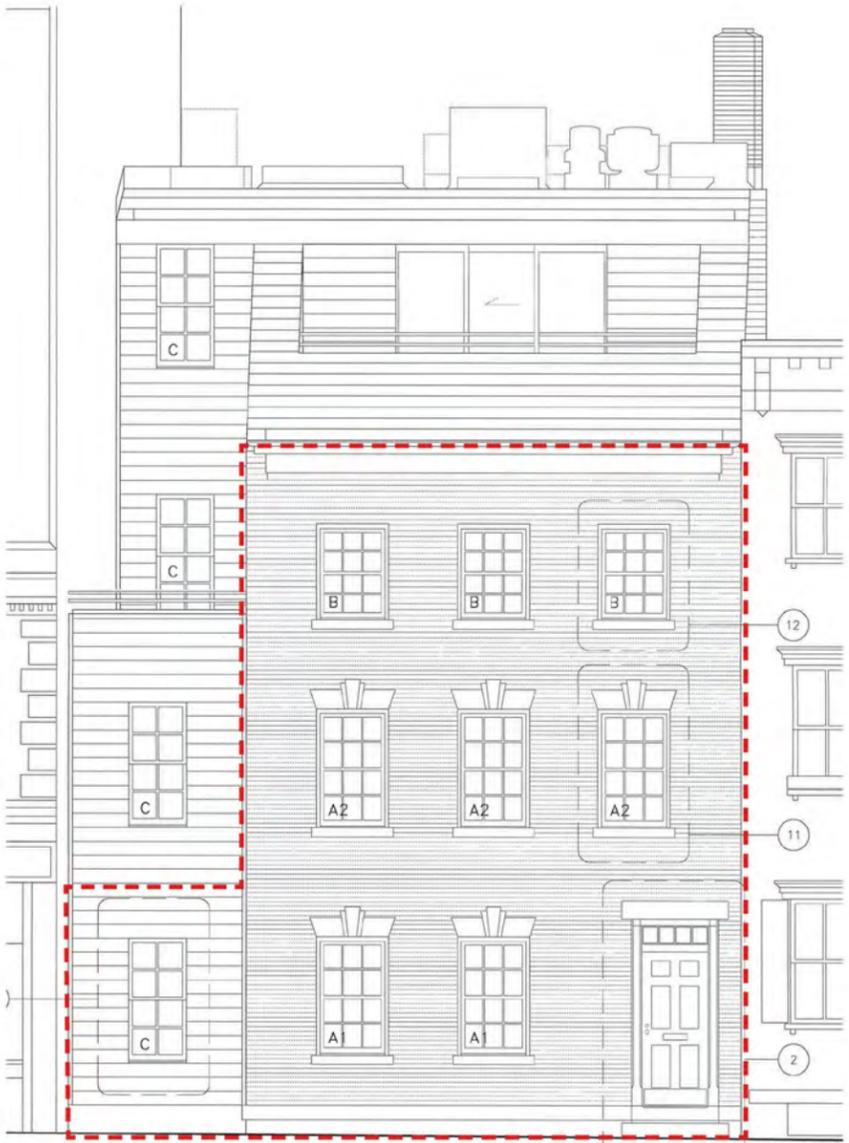
**70 Bedford St. - LPC approved 2001**  
(historic profile outlined)

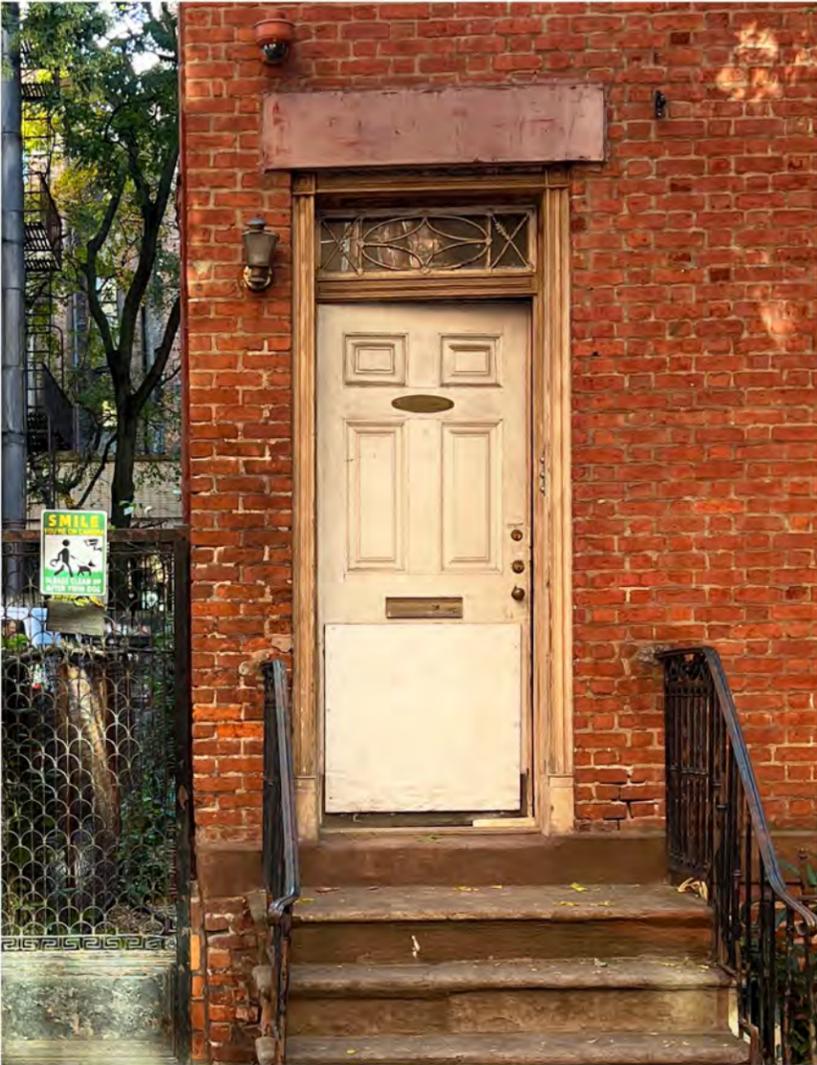
**85 Sullivan Doorway** (surround to remain)

NEW GLASS LITE INFILL IN EXSTG DOOR TO REPLACE NON-HISTORIC PANELS  
 EXSTG GATE TO REMAIN  
 RESTORE PANELING OF EXSTG DOOR  
 EXSTG WROUGHT IRON RAILING TO REMAIN, RESTORE AS REQUIRED  
 EXSTG CELLAR DOORS TO BE RESTORED

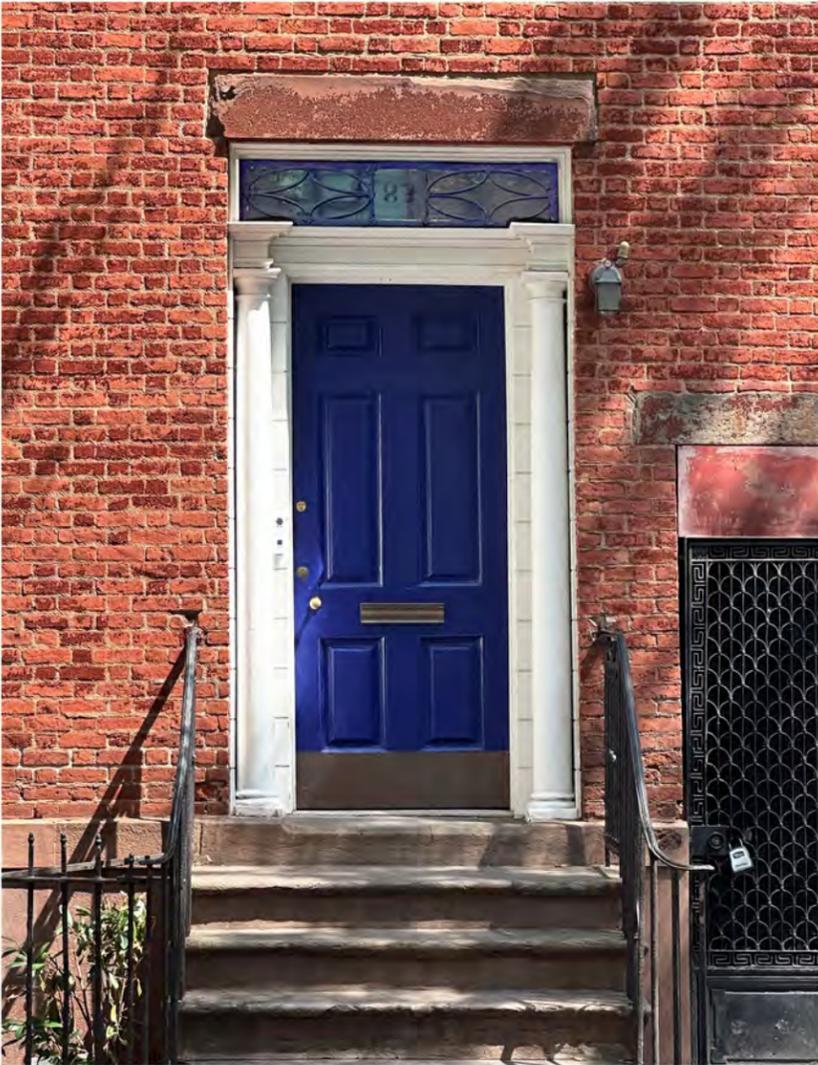
**83 Sullivan Doorway** (surround to remain)

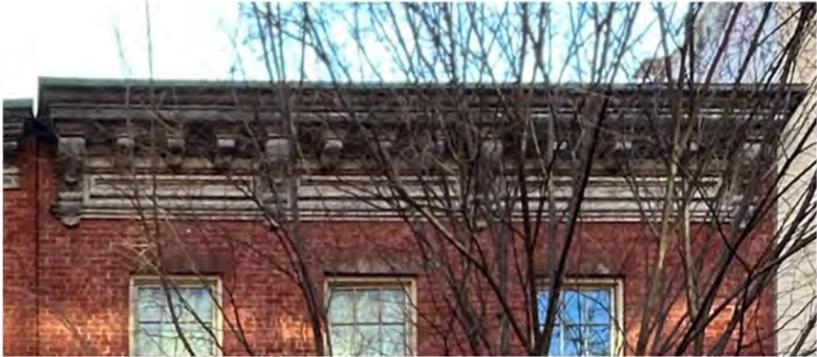
**Cornice** (to remain)

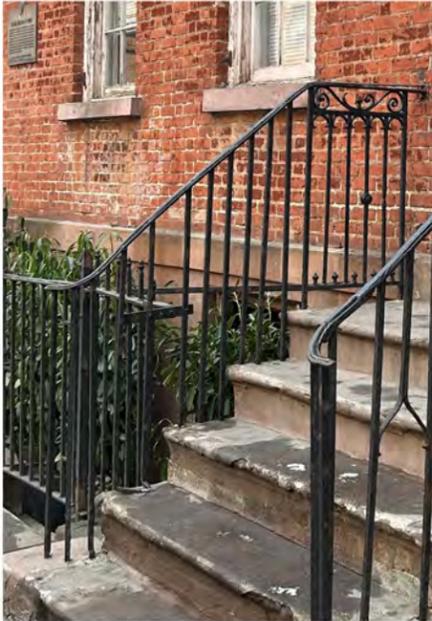
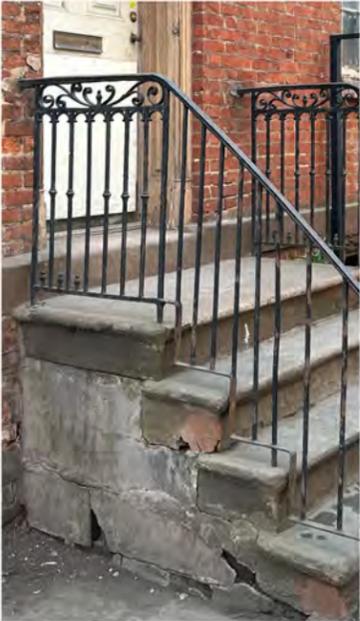
**Ironwork** (surround to remain)

Original, historic door surrounds and transoms to be preserved at both addresses.

Non-original doors to be replaced with new doors to match historic doors w/ lites as shown in the 1940's tax photos.

Original, historic cornices and wrought-iron railings to be preserved.

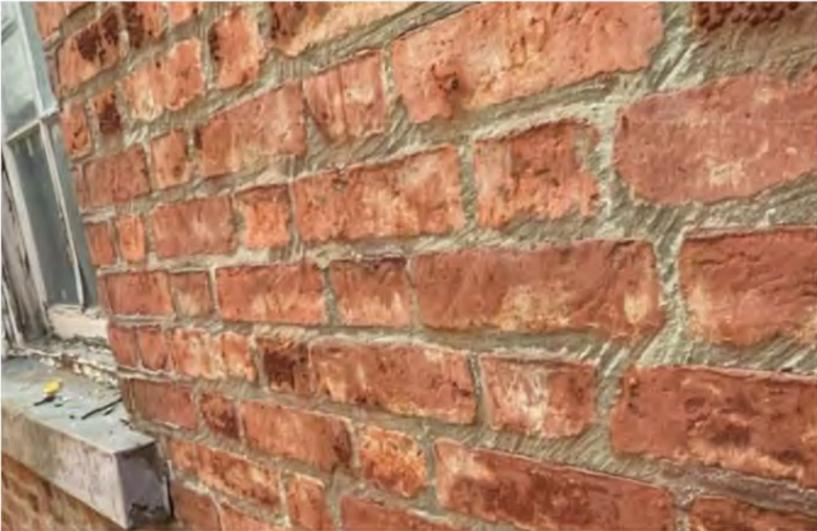
**Mechanically Scraped Bricks**

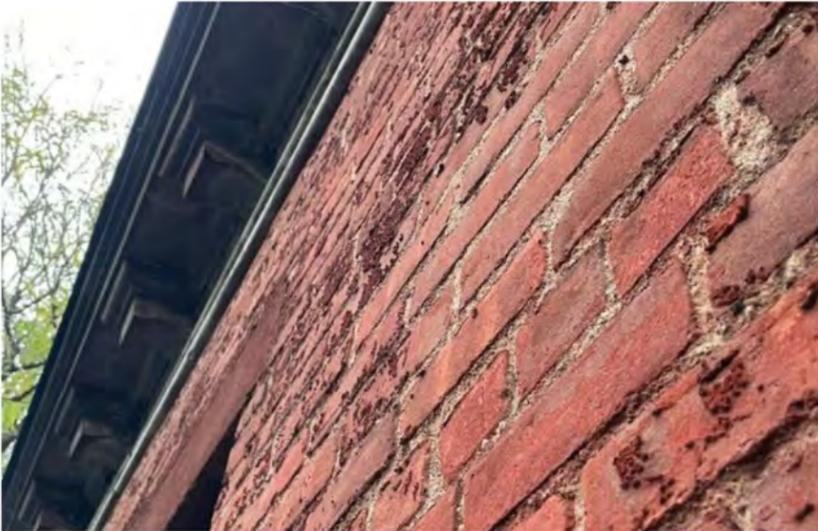
**Flaking Paint Residue**

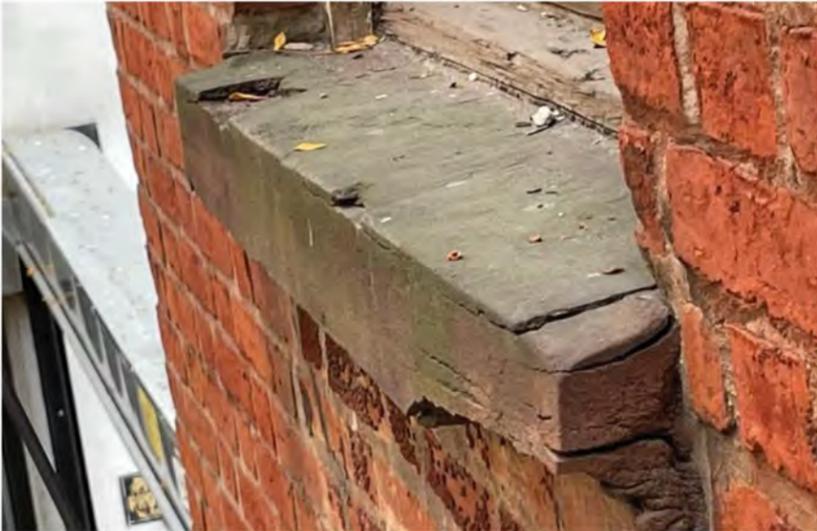
**Stone Sill Deterioration**

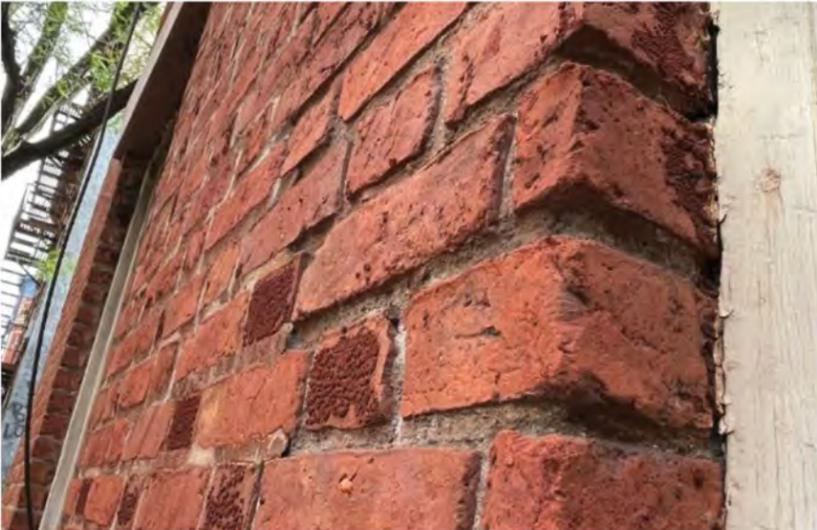
**Mortar Erosion**

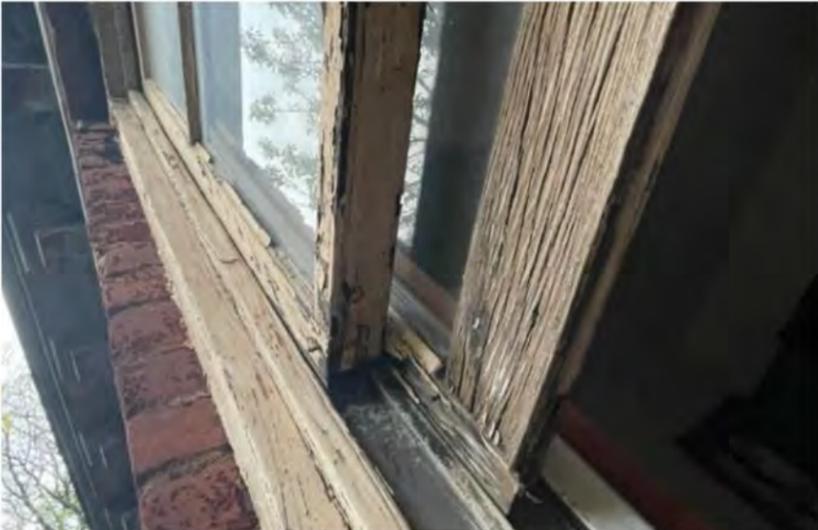
**Severe Window Frame Deterioration**

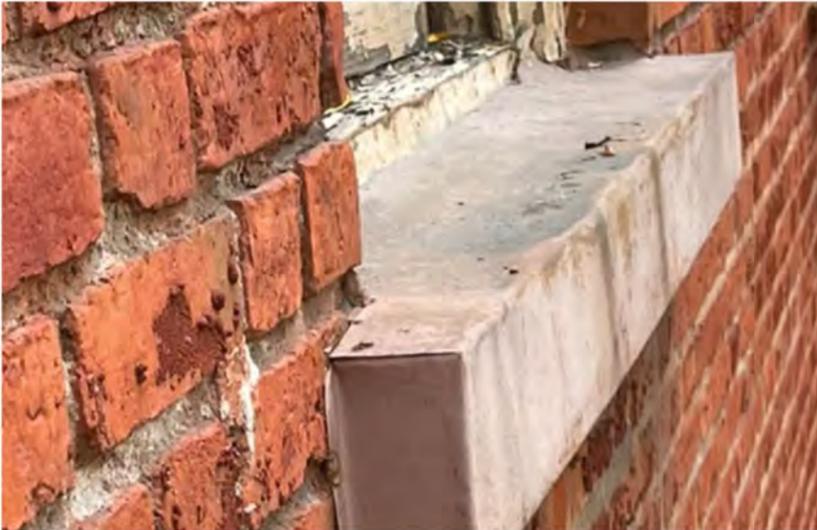
**Sill Covered in Break Metal**

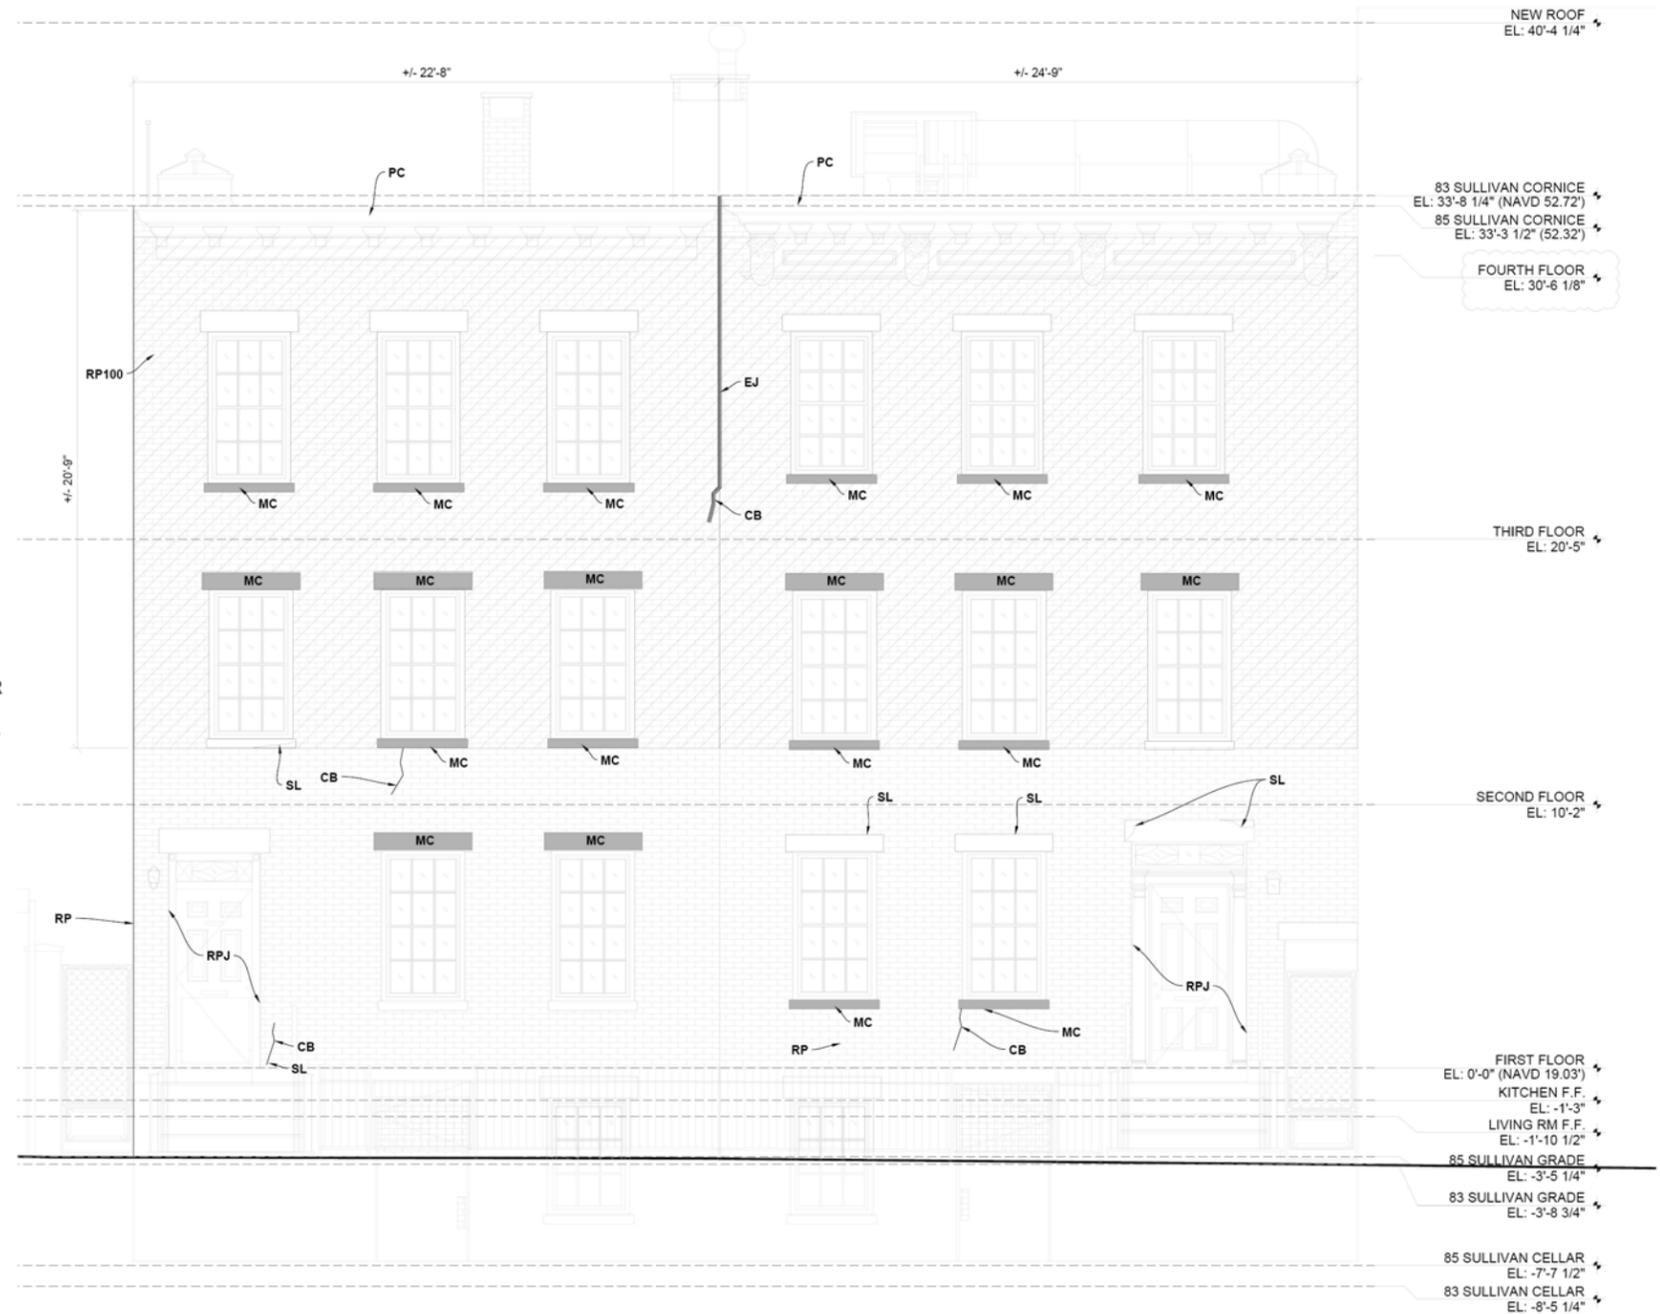
# Facade Restoration Report: Steven Winter Assoc.

RAKE OUT ALL LOOSE MORTAR AND REPOINT 100% OF JOINTS. TOOL MORTAR. MATCH EXISTING HISTORIC MORTAR TO ORIGINAL MORTAR LAB COMPOSITION RESULTS.

REMOVE EXISTING METAL COPINGS OVER BROWNSTONE SILLS AND LINTELS. PROVIDE ACCESS FOR ARCHITECT TO ASSESS UNDERLYING BROWNSTONE CONDITIONS. REPLACE WITH NEW PRECAST UNITS TO MATCH EXISTING LINTEL/SILLS IN COLOR, LAYOUT & SIZE.

REMOVE AND REPLACE CRACKED BRICK UNITS. KEY NEW UNITS INTO EXISTING. NEW BRICK TO MATCH EXISTING IN SIZE, COLOR, AND LAYOUT. PROVIDE SAMPLES FOR ARCHITECT APPROVAL.

PATCH SPALLED BROWNSTONE LINTEL/SILL USING COMPATIBLE REPAIR MORTAR. PROVIDE ACCESS FOR ARCHITECT TO ASSES BROWNSTONE CONDITIONS AFTER AREA HAS BEEN CLEARED OF SPALLED AREAS AND IS BEING PREPARED FOR APPLICATION OF PATCHING MATERIAL.

REPOINT BRICK MORTAR JOINTS AT JAMBS DOOR MASONRY OPENINGS.

REPOINT ISOLATED OPEN MORTAR JOINTS.

SCRAPE, PRIME AND PAINT EXISTING METAL CORNICE.

SEAL EXISTING JOINT BETWEEN BUILDINGS. APPLY SEALANT RECESSED IN THE JOINT TO ALLOW CONCEALING IT WITH MORTAR.

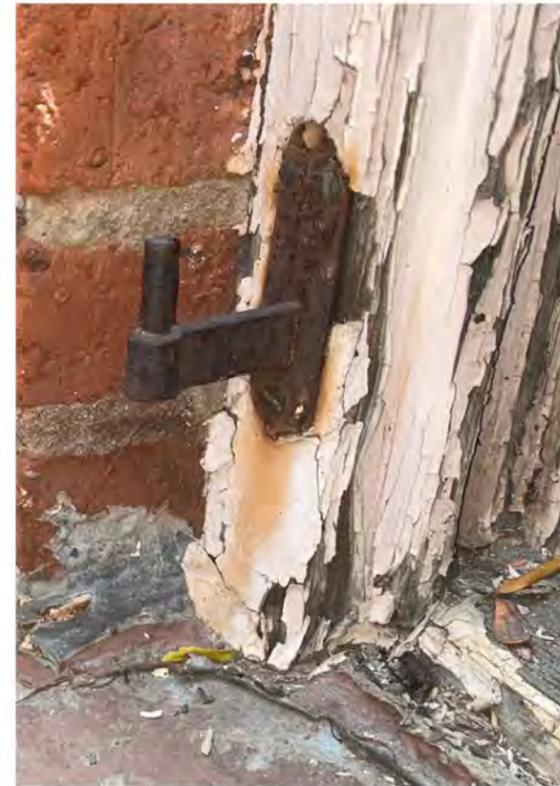
**Existing Shutter Pintle**  
Visible at 10 windows,  
83 and 85 Sullivan

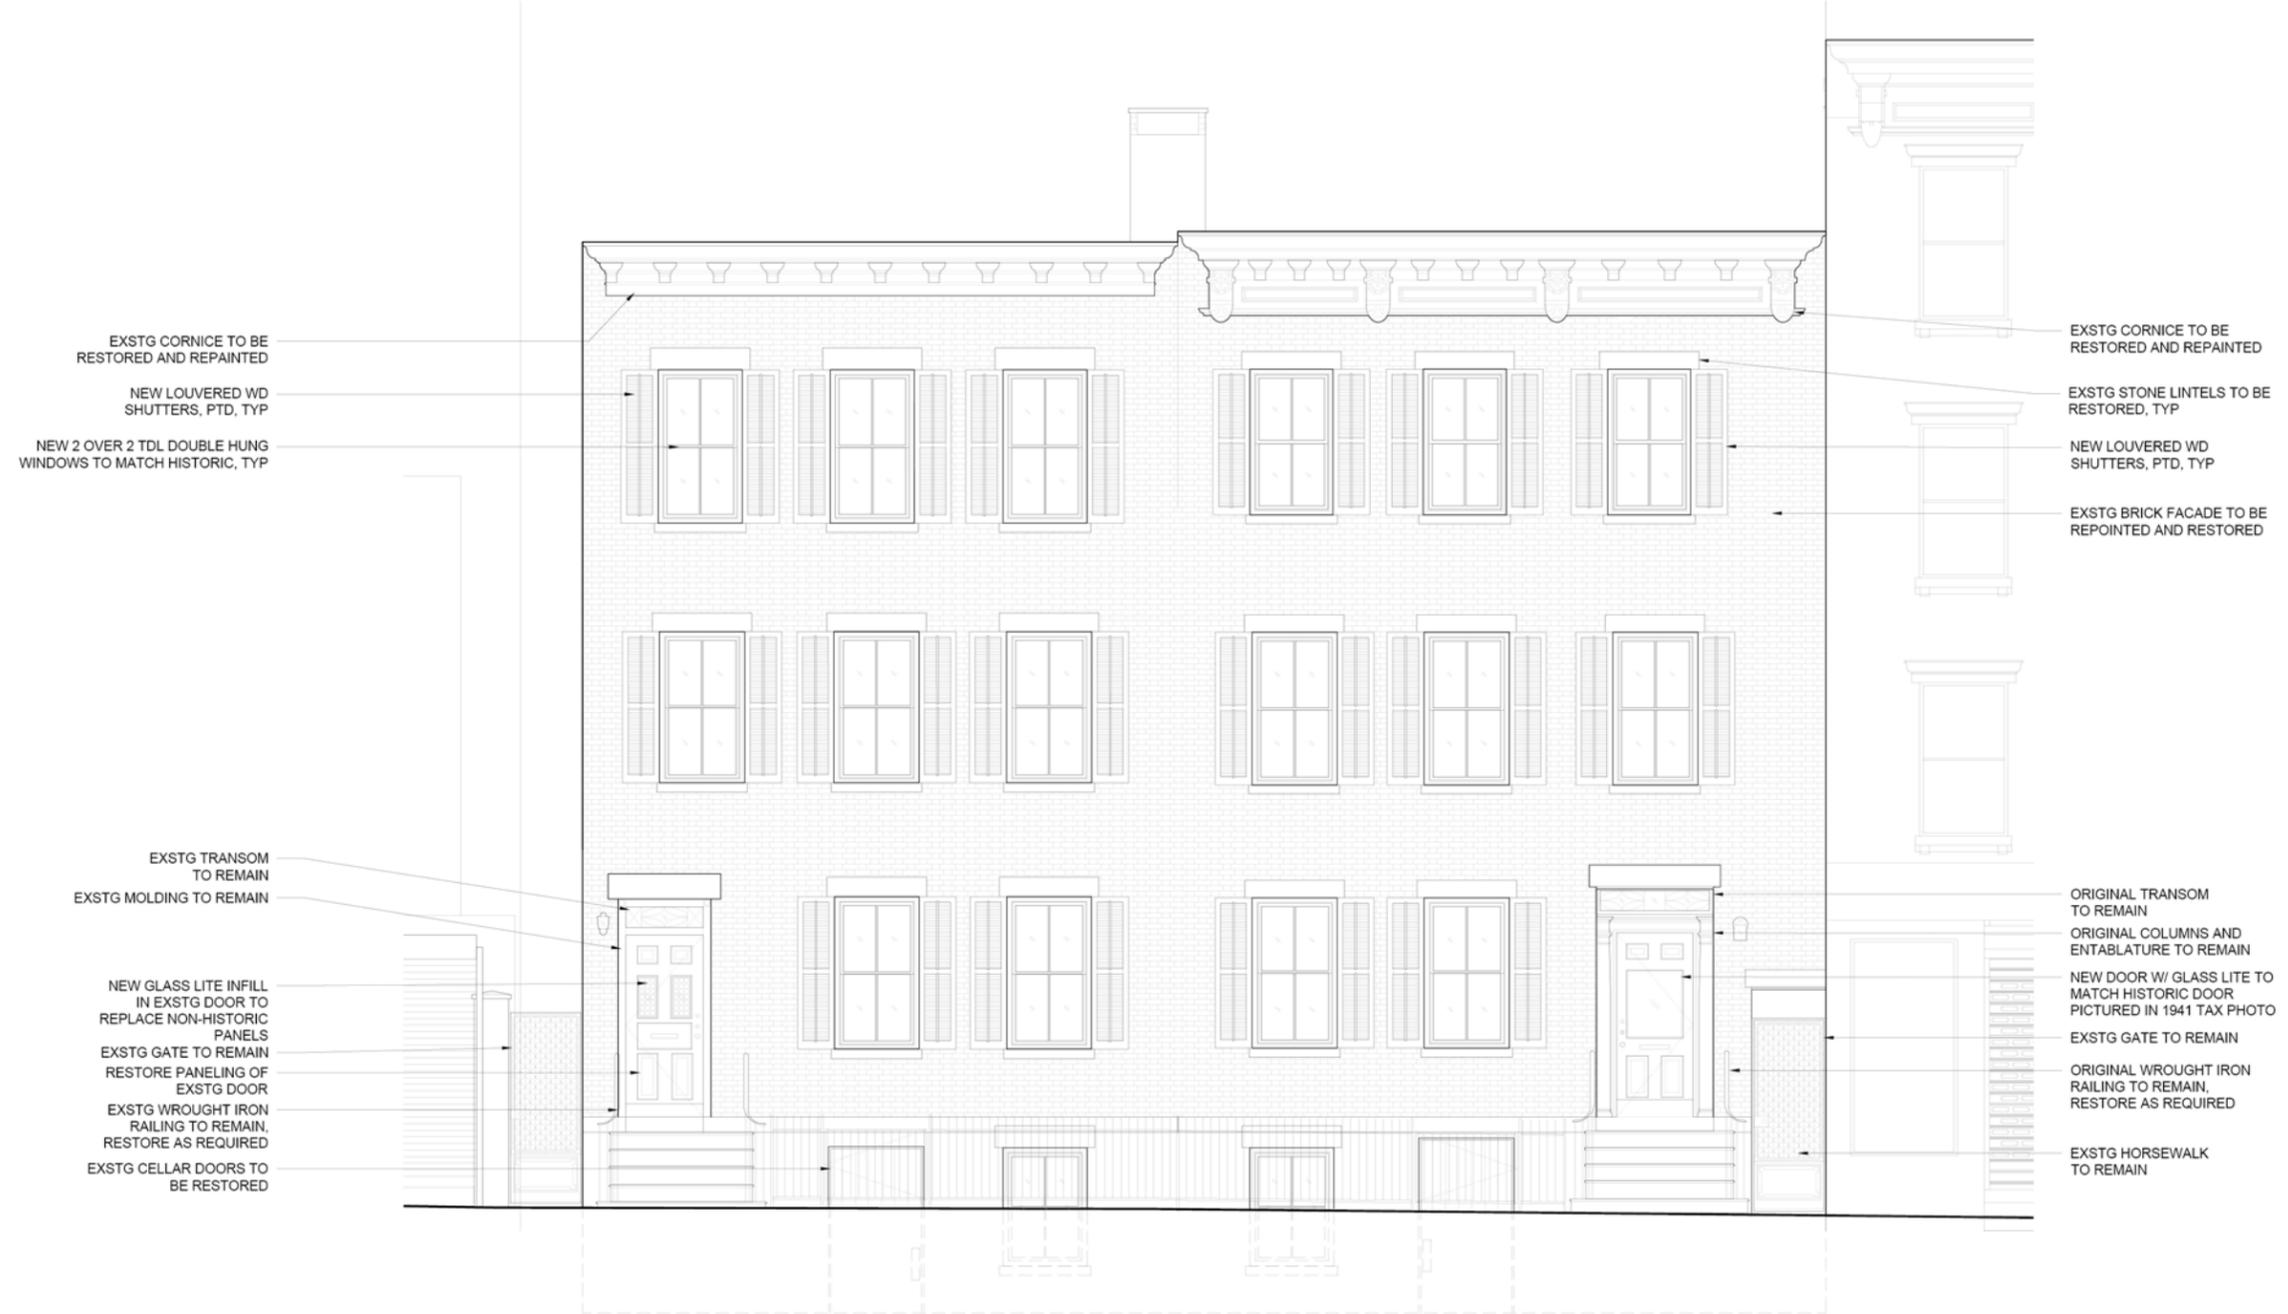
# Restored Facade

EXSTG CORNICE TO BE RESTORED AND REPAINTED  
 NEW LOUVERED WD SHUTTERS, PTD, TYP  
 NEW 2 OVER 2 TDL DOUBLE HUNG WINDOWS TO MATCH HISTORIC, TYP

EXSTG TRANSOM TO REMAIN  
 EXSTG MOLDING TO REMAIN

EXSTG CORNICE TO BE RESTORED AND REPAINTED

EXSTG STONE LINTELS TO BE RESTORED, TYP

NEW LOUVERED WD SHUTTERS, PTD, TYP

EXSTG BRICK FACADE TO BE REPOINTED AND RESTORED

ORIGINAL TRANSOM TO REMAIN  
 ORIGINAL COLUMNS AND ENTABLATURE TO REMAIN

NEW DOOR W/ GLASS LITE TO MATCH HISTORIC DOOR PICTURED IN 1941 TAX PHOTO  
 EXSTG GATE TO REMAIN

ORIGINAL WROUGHT IRON RAILING TO REMAIN, RESTORE AS REQUIRED

EXSTG HORSEWALK TO REMAIN

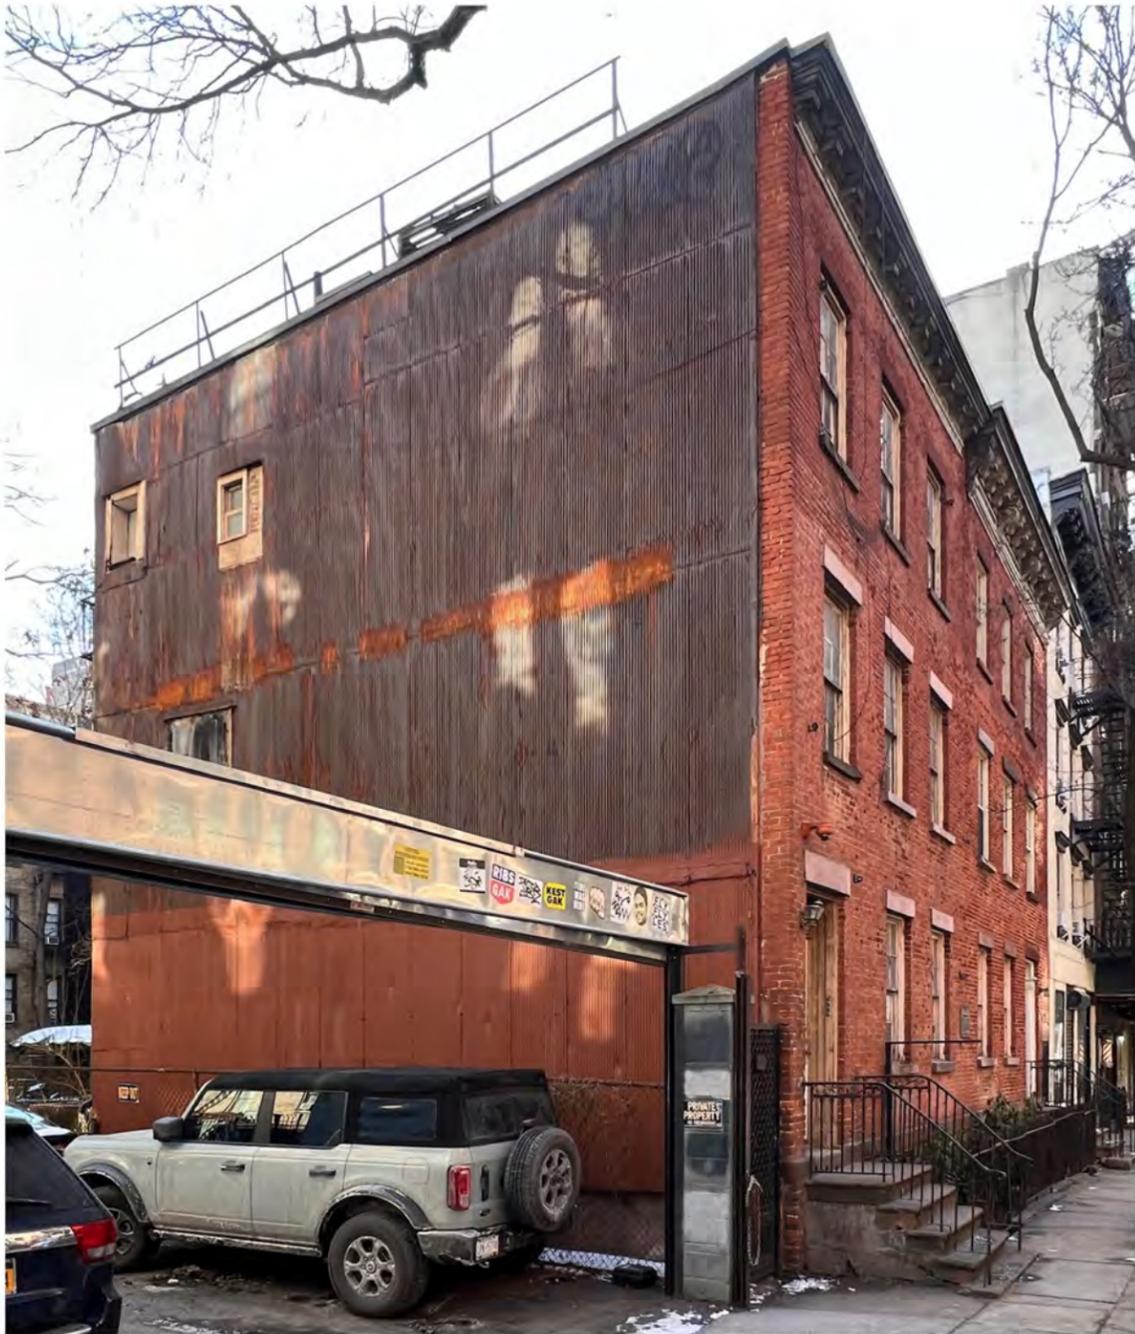
**85 Sullivan Street North Facade**  
Current photograph, deteriorated metal cladding, installed in 1930s

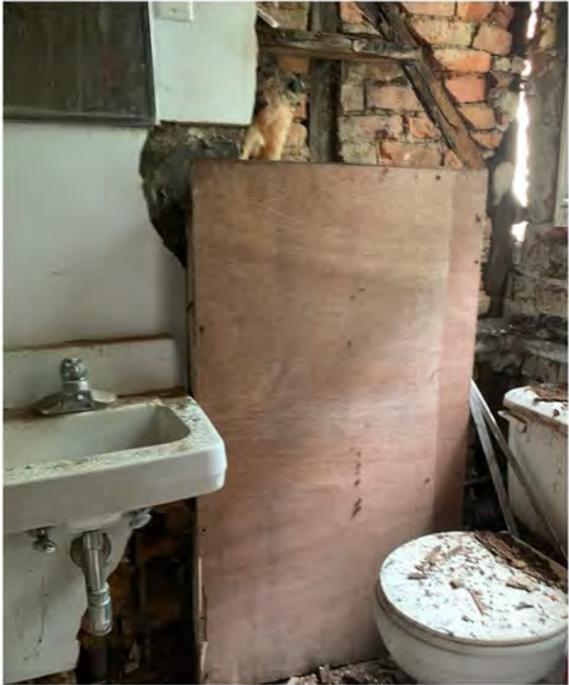
**Interior deterioration** due to weather infiltration at open exterior corner

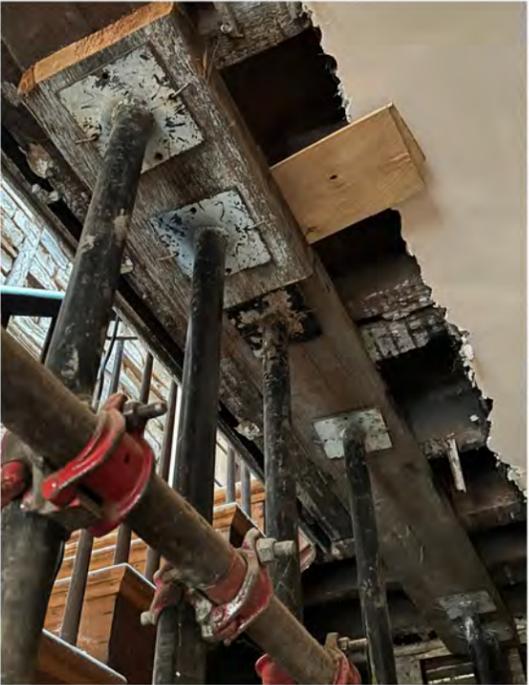
**Structural shoring**, installed in 2009 to prevent building collapse

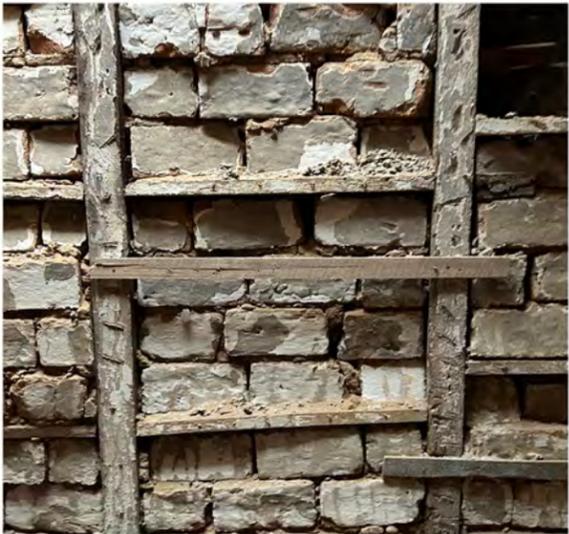
**Decay of brick nogging wall**, including loose brick and rot at original structural timbers

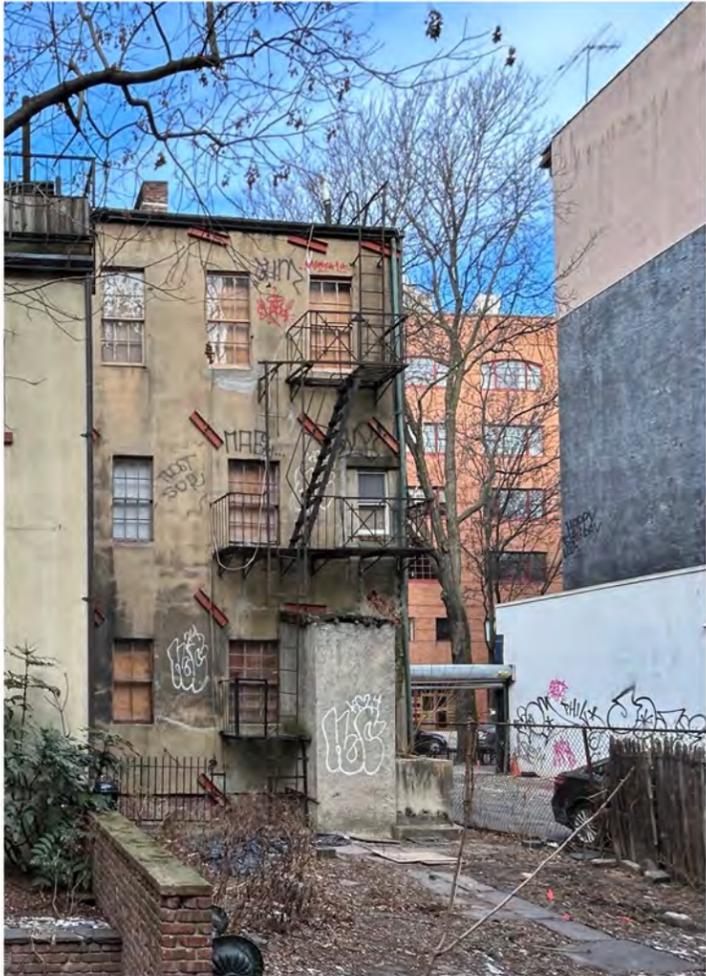
**Rear Facade**  
Structural tie-backs to secure unstable wall, weather infiltration at missing windows

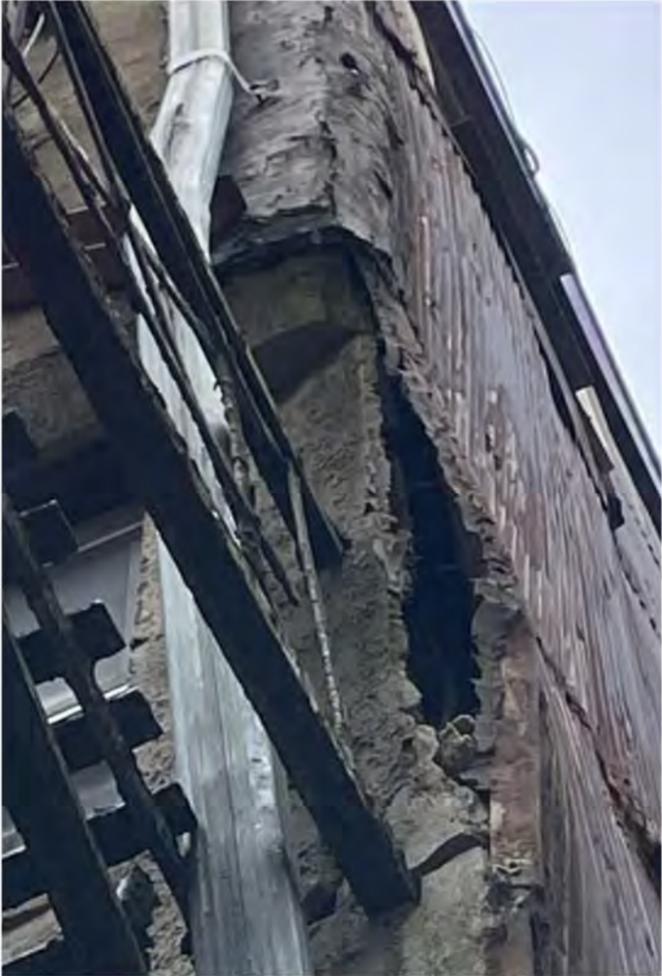
**Buckling Wall**  
Separation of the north and east wall, source of considerable water infiltration

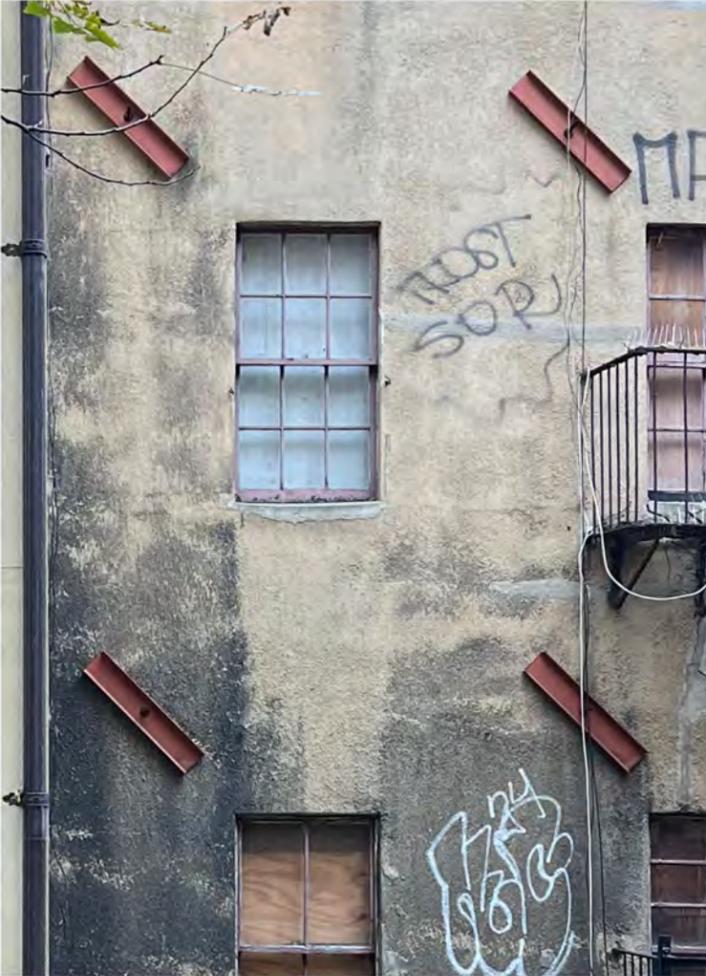
**Exposed Structural Tie-Backs**  
Installed in 2009 to help stabilize the building and prevent further separation of the facade

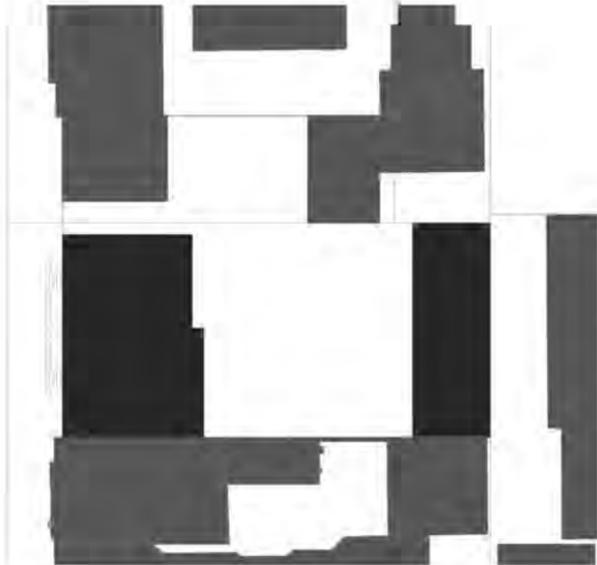
**1825**  
 83/85 Sqft (w/o cellar): 3,015 sqft  
 Additions (w/o cellar): 1,800 sqft  
**Total: 4,815 sqft**

Source: LPC Designation Report

# Historic Site Massing Plans

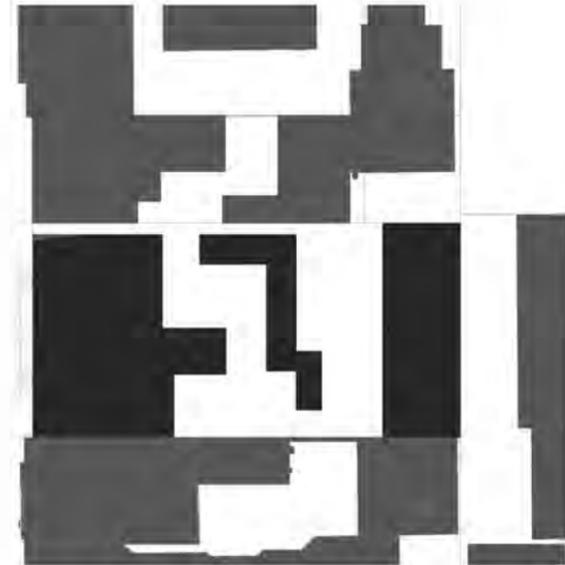
**1922**  
 83/85 Sqft (w/o cellar): 4,785 sqft  
 Additions (w/o cellar): 3,115 sqft  
**Total: 7,900 sqft**

Source: 1922 Sanborn Fire Insurance Map

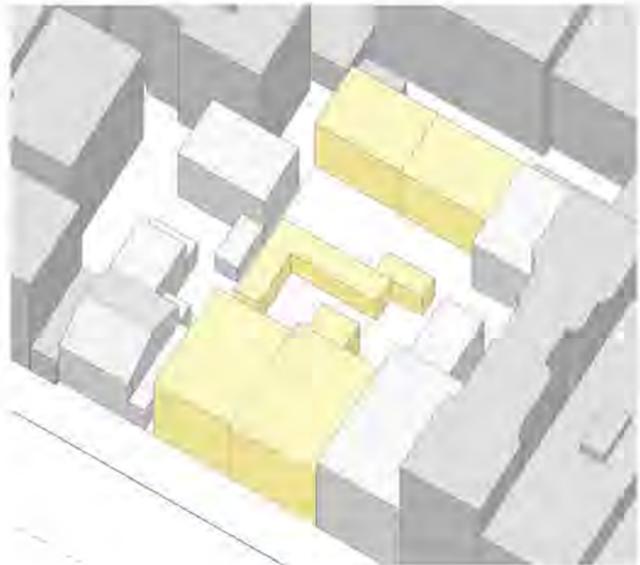
**1922 Massing**  
 Alley Infill at 87 Sullivan

Source: 1922 Sanborn Fire Insurance Map

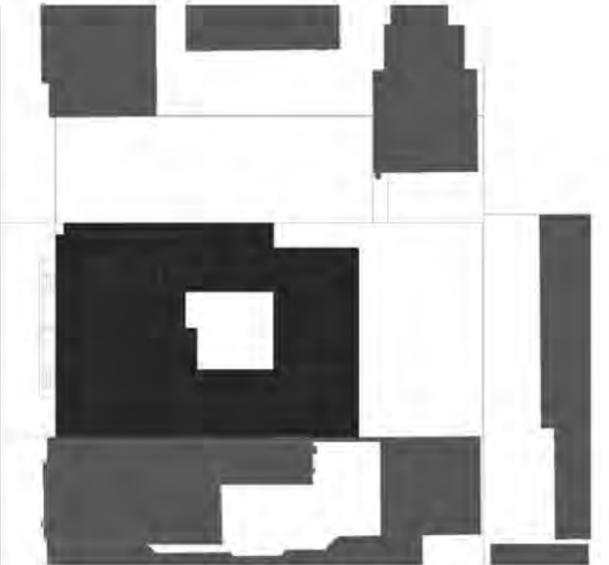
**PROPOSED**  
 83/85 Sqft (w/o cellar): 4,375 sqft  
 Additions (w/o cellar): 3,380 sqft  
**Total: 7,755 sqft**
