Portico Restoration and Ramp

St. Mark's Church in the Bowery

*install ADA accessibility ramp and
repair cast iron portico*

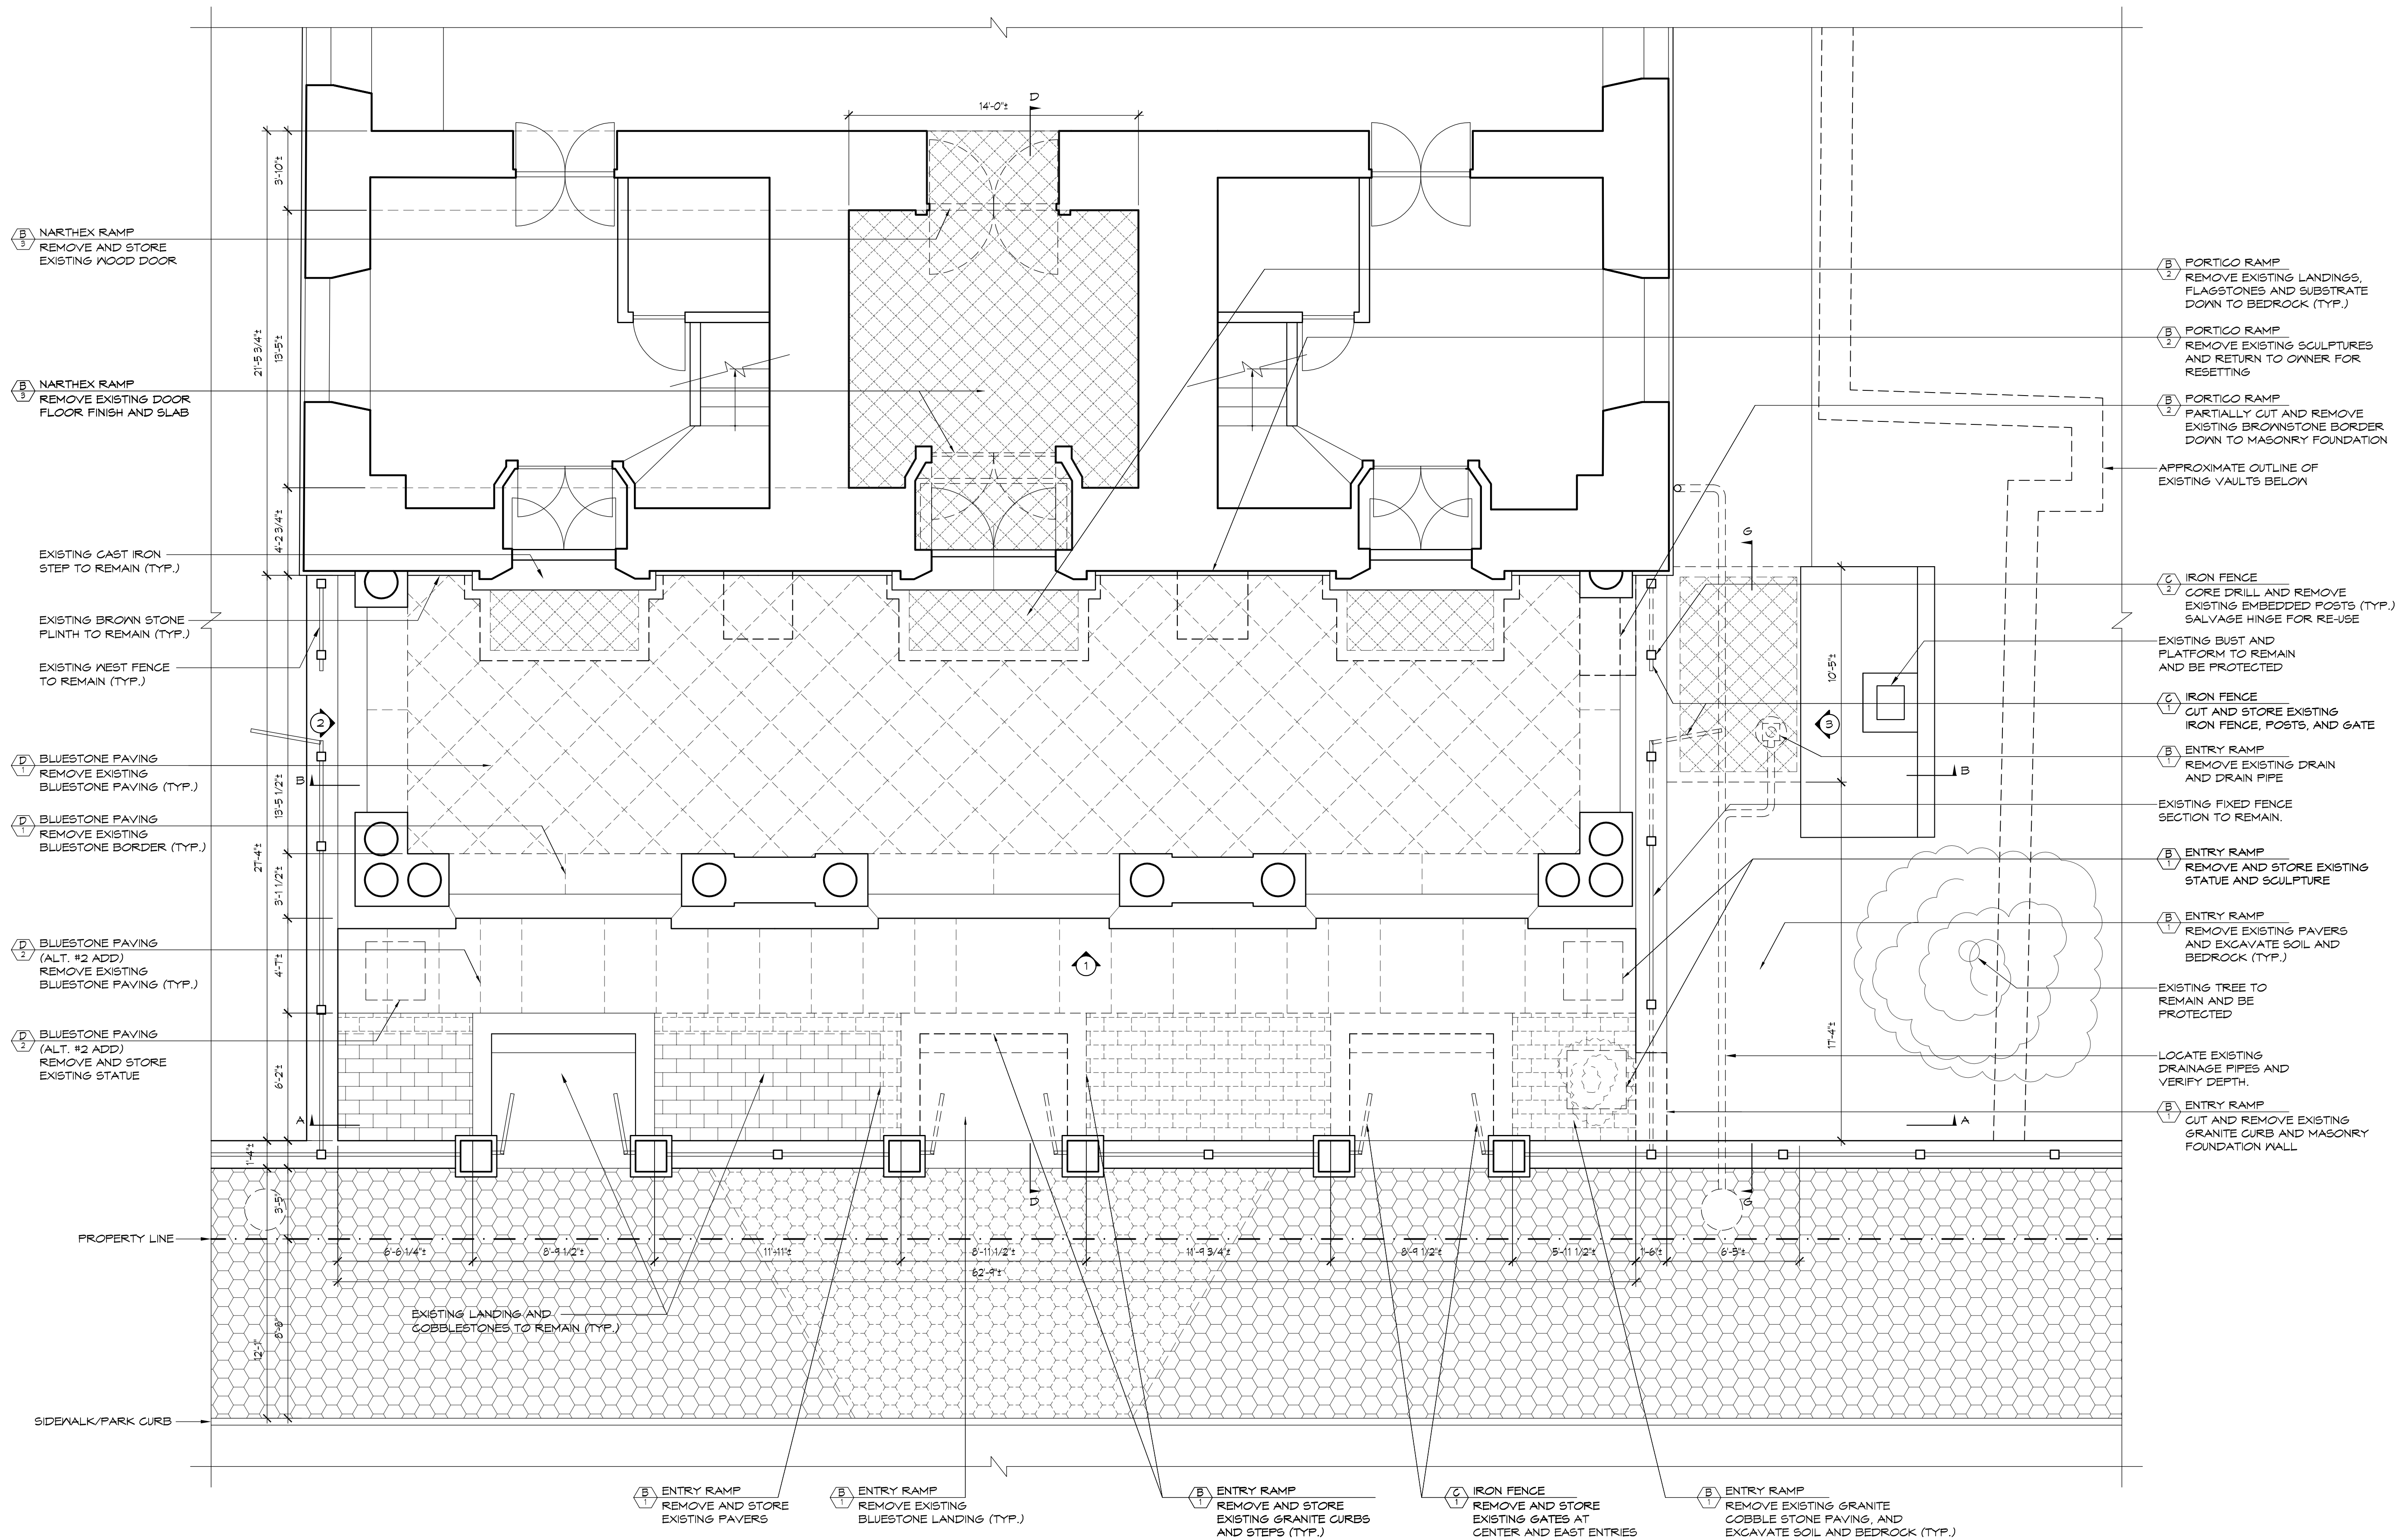
1 EXISTING PORTICO PLAN - PROPOSED DEMOLITION
SCALE: 1/4" = 1'-0"

- NOTES:
- VERIFY ALL DIMENSIONS IN FIELD.
 - NOTIFY ARCHITECT FOR INSPECTION OF SALVAGED UNITS TO BE RESET.

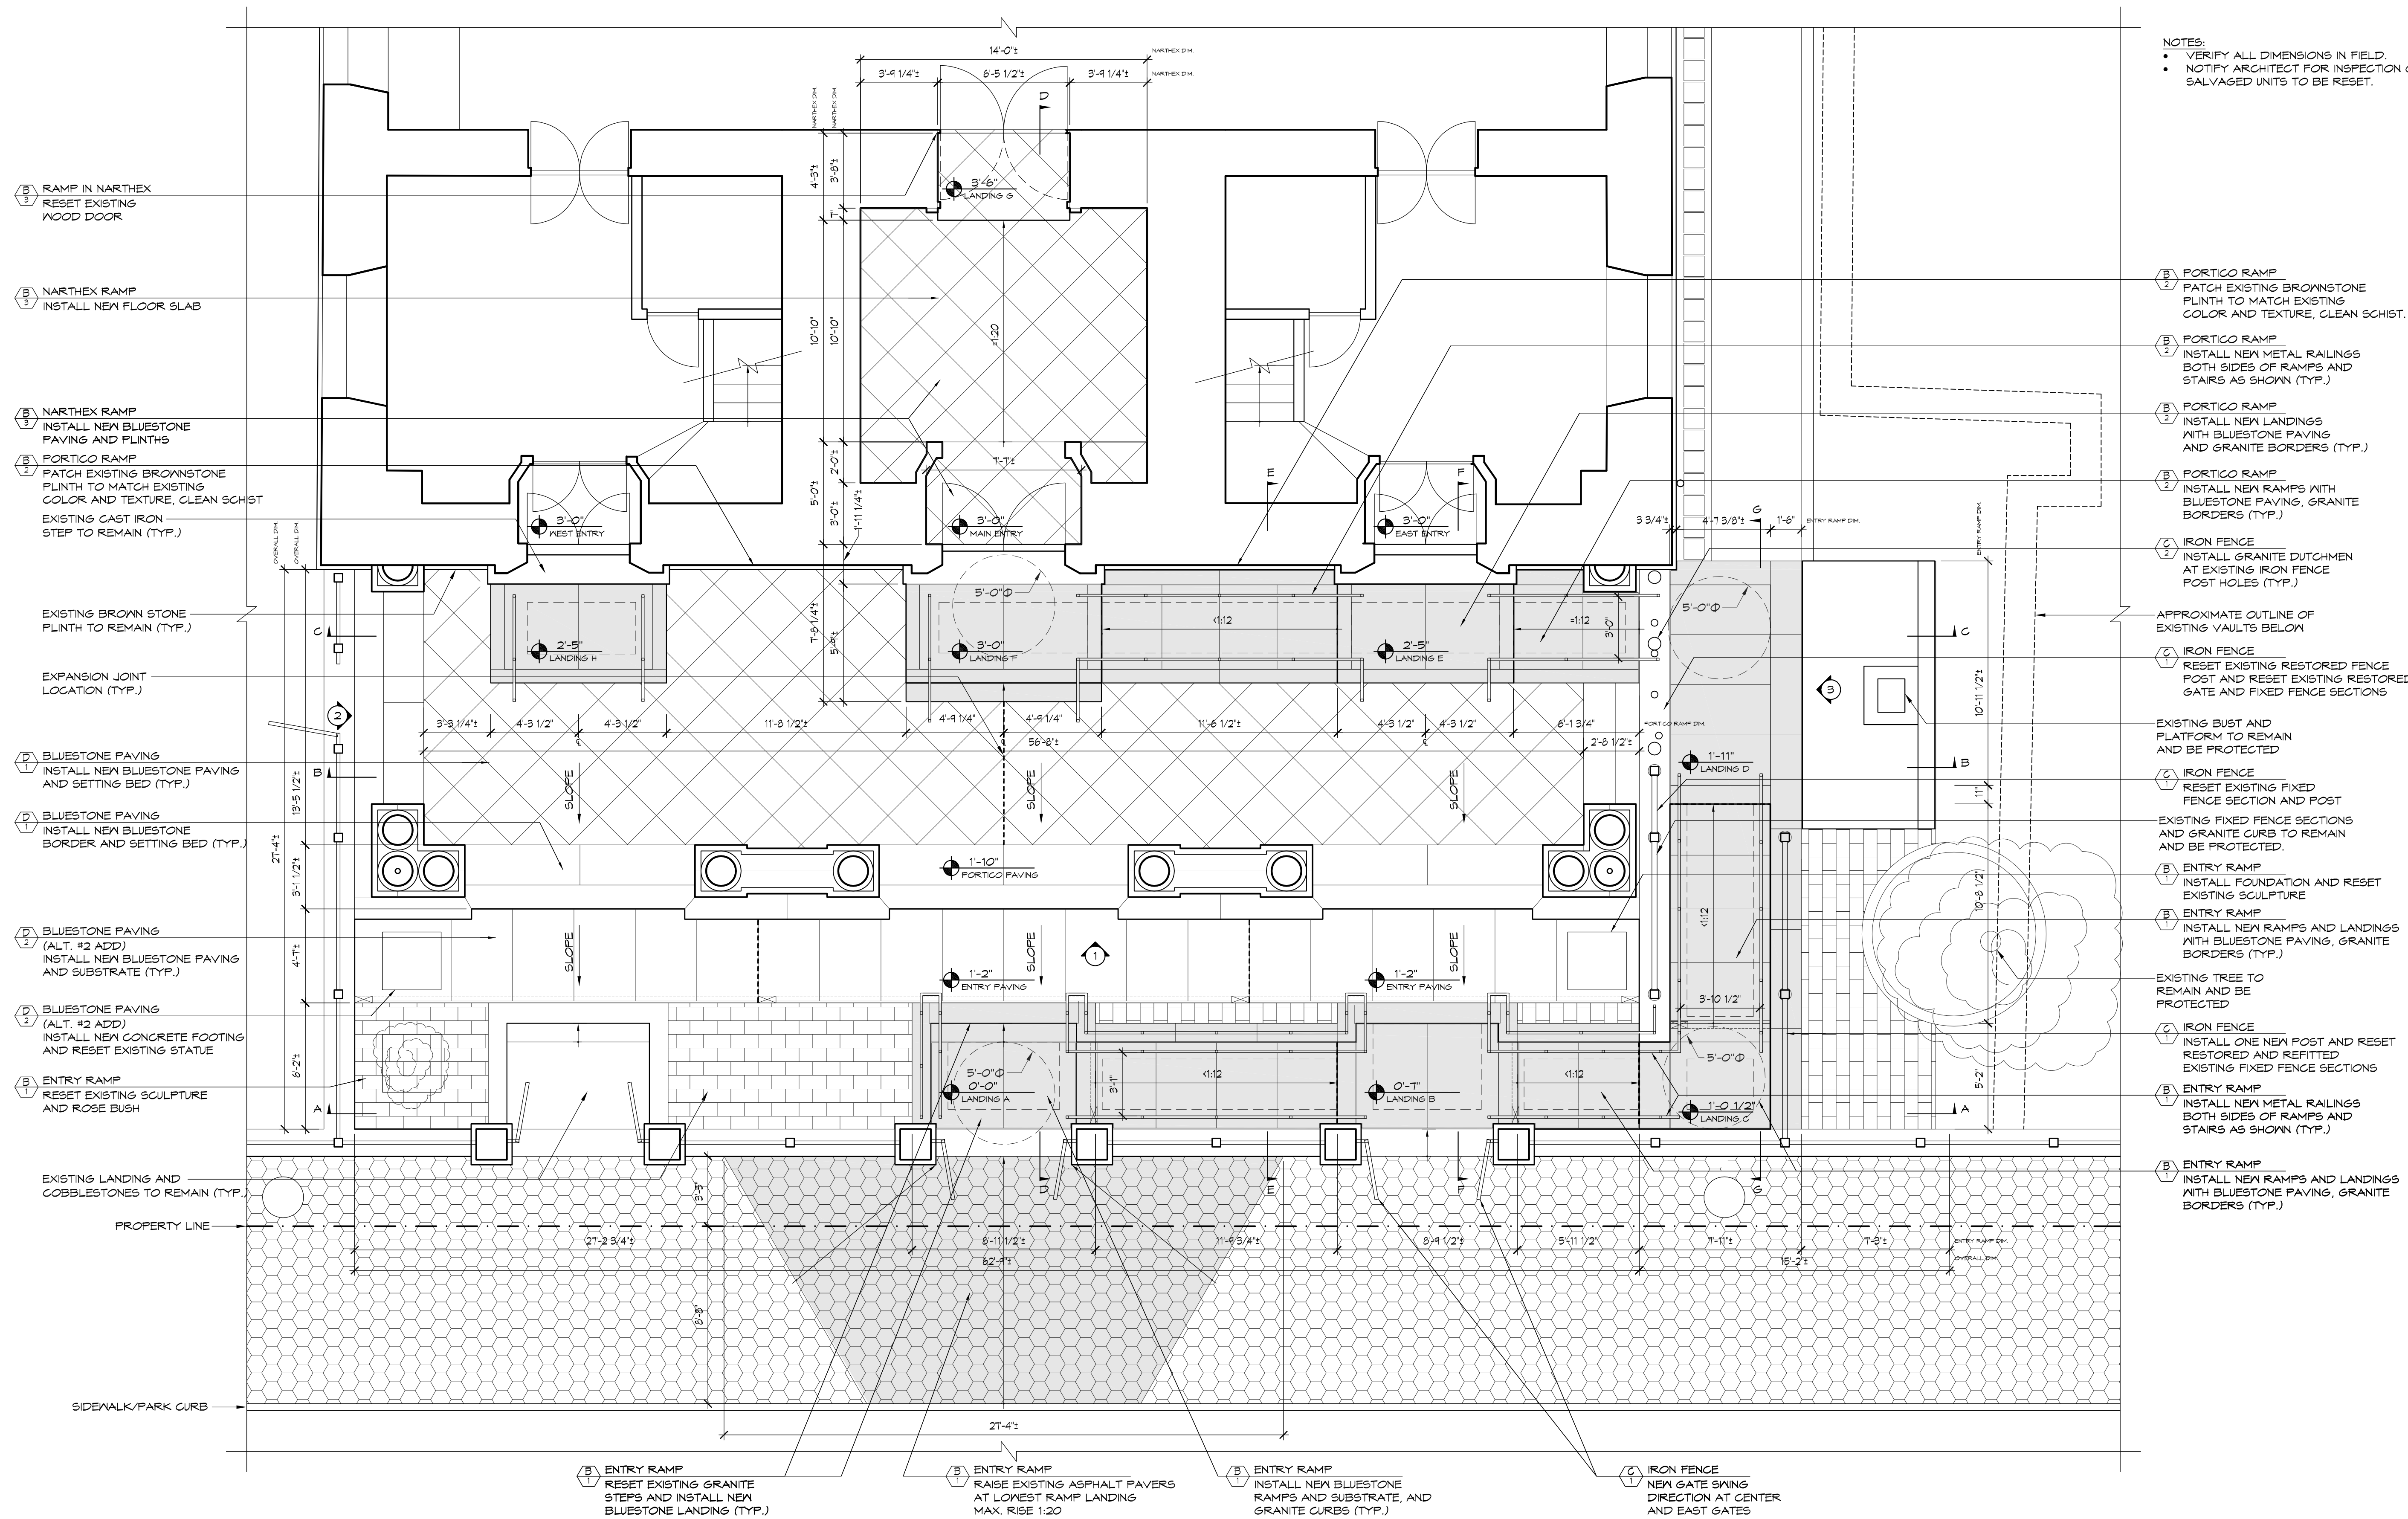
1 PROPOSED PORTICO PLAN - ADA RAMP INSTALLATION
SCALE: 1/4" = 1'-0"

- (B) PORTICO RAMP
PATCH EXISTING BROWNSTONE PLINTH TO MATCH EXISTING COLOR AND TEXTURE, CLEAN SCHIST.
- (B) PORTICO RAMP
INSTALL NEW METAL RAILINGS BOTH SIDES OF RAMPS AND STAIRS AS SHOWN (TYP.)

- (B) PORTICO RAMP
INSTALL NEW LANDINGS WITH BLUESTONE PAVING AND GRANITE BORDERS (TYP.)
- (B) PORTICO RAMP
INSTALL NEW RAMPS WITH BLUESTONE PAVING, GRANITE BORDERS (TYP.)

- (C) IRON FENCE
INSTALL GRANITE DUTCHMEN AT EXISTING IRON FENCE POST HOLES (TYP.)
- APPROXIMATE OUTLINE OF EXISTING VAULTS BELOW
- (C) IRON FENCE
RESET EXISTING RESTORED FENCE POST AND RESET EXISTING RESTORED GATE AND FIXED FENCE SECTIONS

- EXISTING BUST AND PLATFORM TO REMAIN AND BE PROTECTED
- (C) IRON FENCE
RESET EXISTING FIXED FENCE SECTION AND POST
- EXISTING FIXED FENCE SECTIONS AND GRANITE CURB TO REMAIN AND BE PROTECTED.

- (B) ENTRY RAMP
INSTALL FOUNDATION AND RESET EXISTING SCULPTURE
- (B) ENTRY RAMP
INSTALL NEW RAMPS AND LANDINGS WITH BLUESTONE PAVING, GRANITE BORDERS (TYP.)

- EXISTING TREE TO REMAIN AND BE PROTECTED
- (C) IRON FENCE
INSTALL ONE NEW POST AND RESET RESTORED AND REFITTED EXISTING FIXED FENCE SECTIONS
- (B) ENTRY RAMP
INSTALL NEW METAL RAILINGS BOTH SIDES OF RAMPS AND STAIRS AS SHOWN (TYP.)

- (B) ENTRY RAMP
INSTALL NEW RAMPS AND LANDINGS WITH BLUESTONE PAVING, GRANITE BORDERS (TYP.)

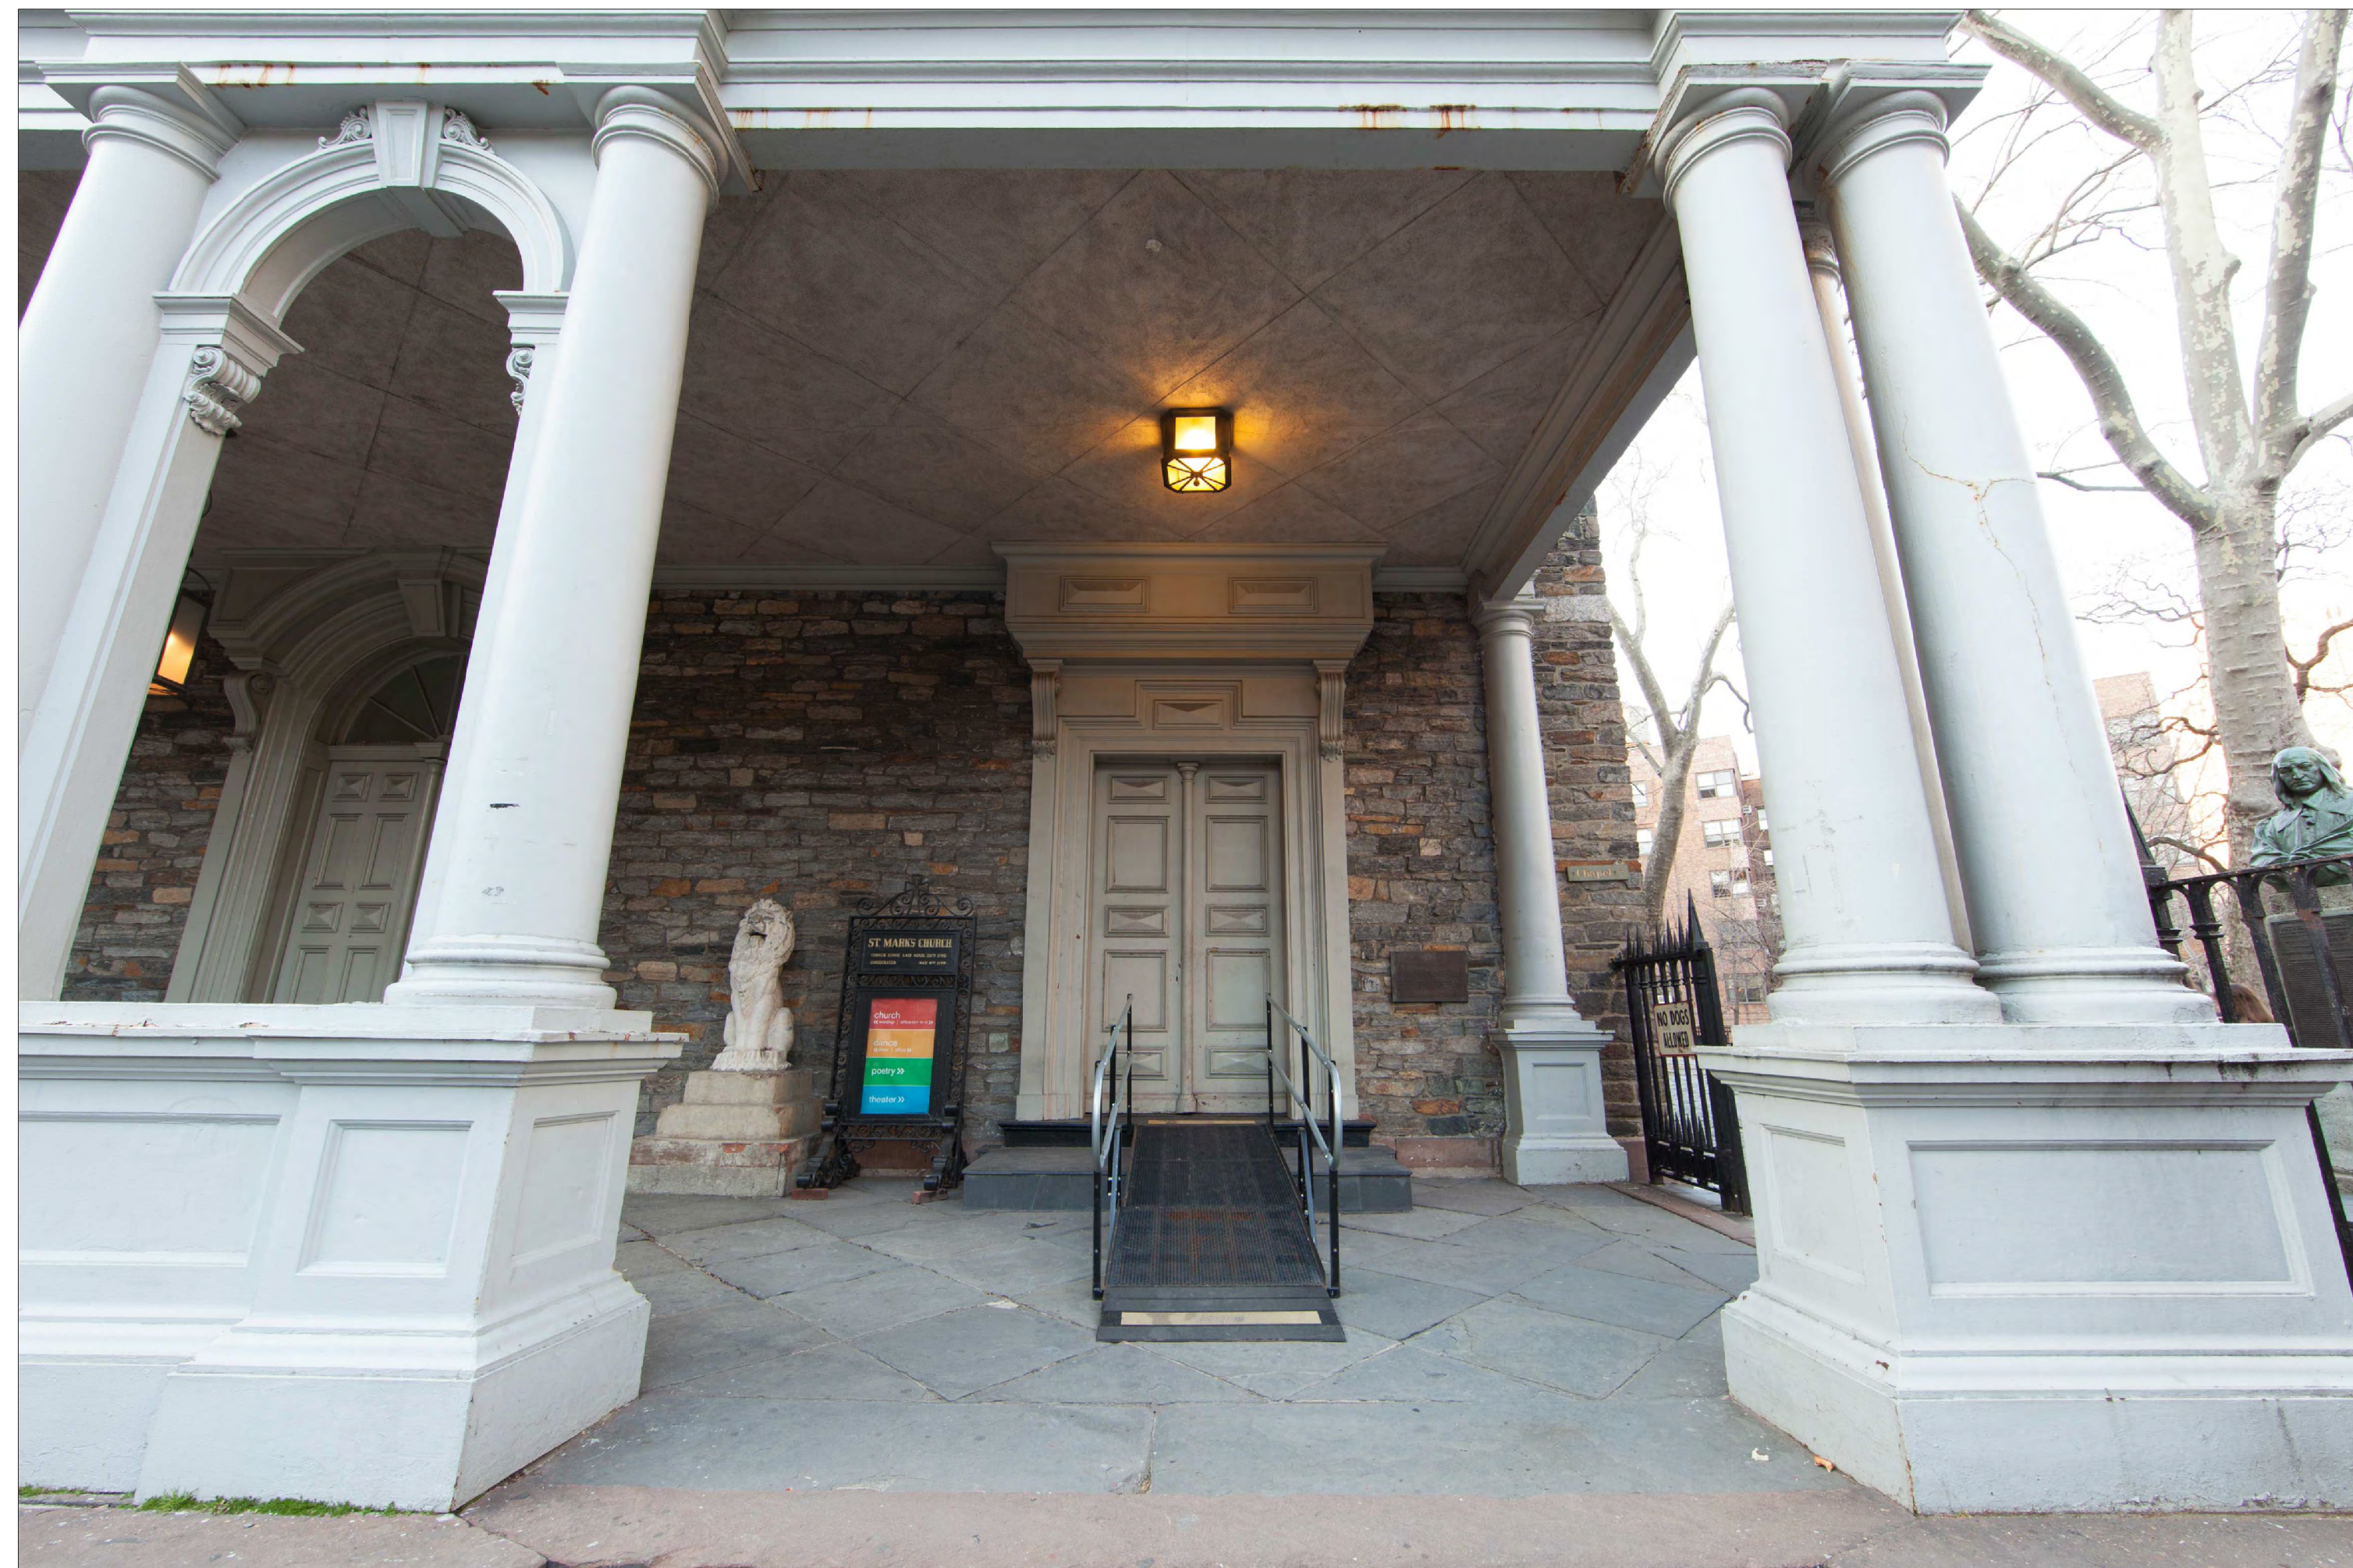
1A EAST VESTIBULE - EXISTING CONDITION
2/2013 PROPOSED WORK AREA

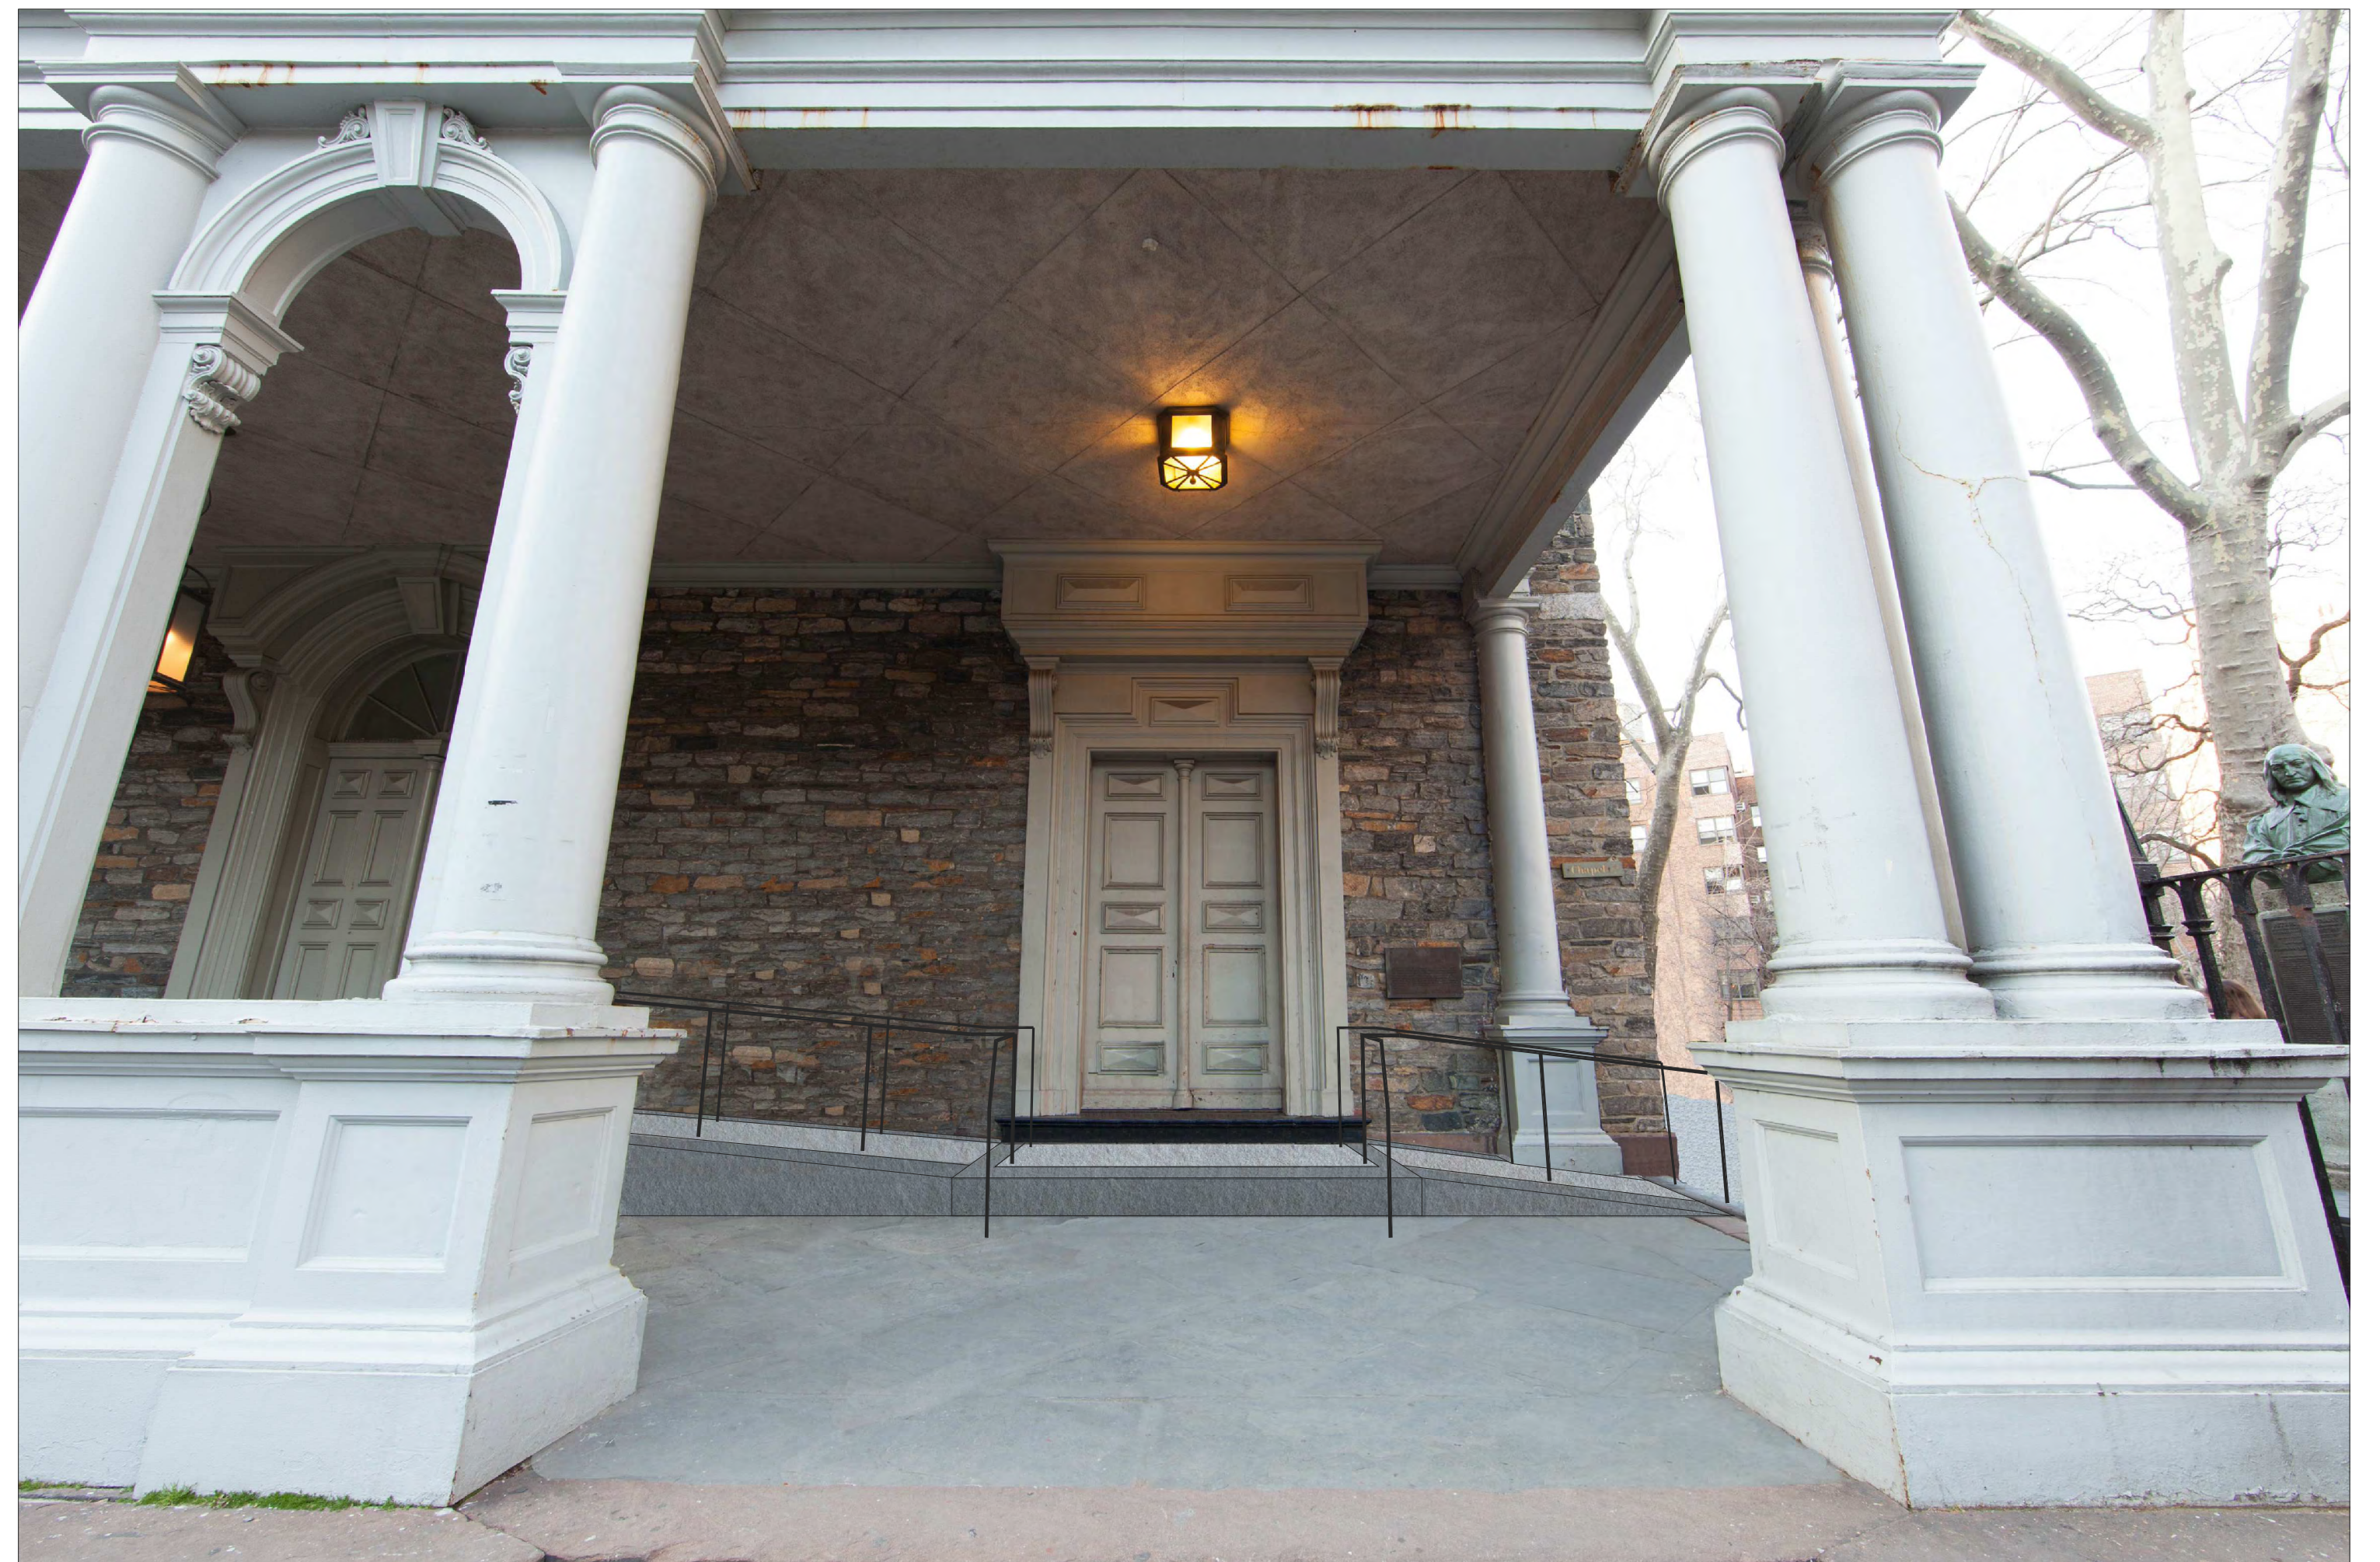
1B EAST VESTIBULE - PROPOSED RAMP
2/2013 PROPOSED WORK AREA

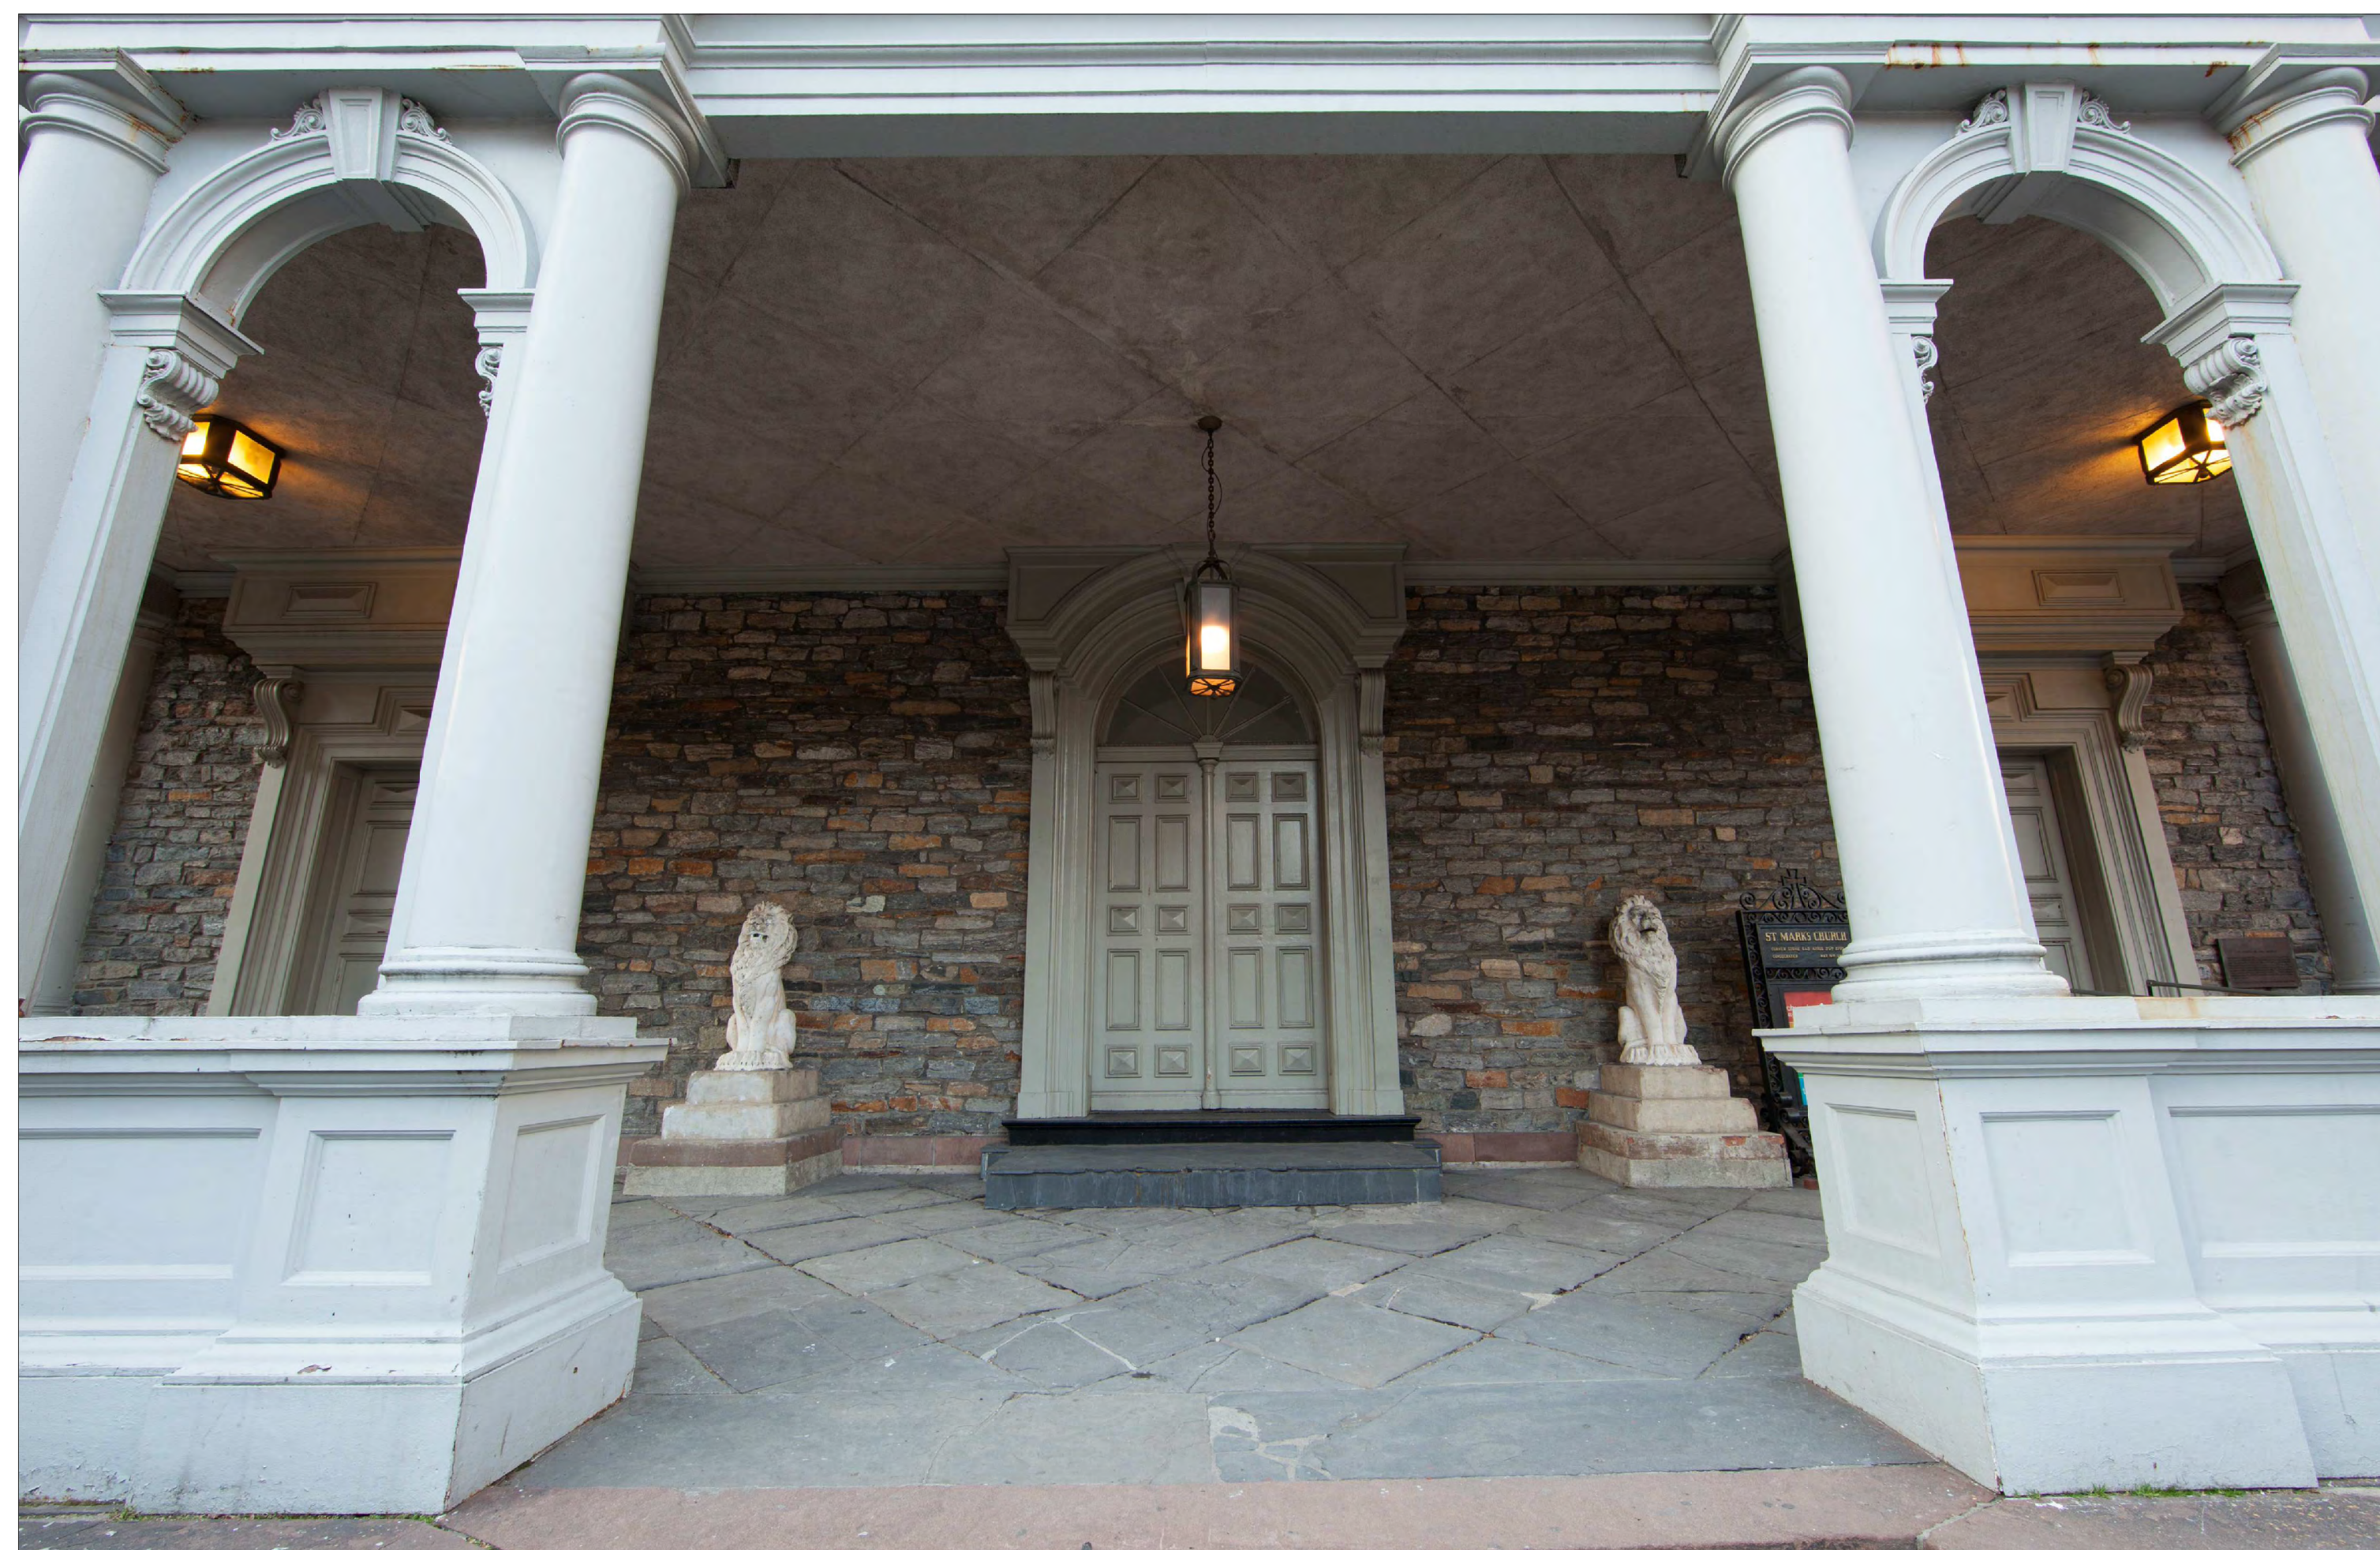
2A SANCTUARY ENTRY - EXISTING CONDITION
2/2013 PROPOSED WORK AREA

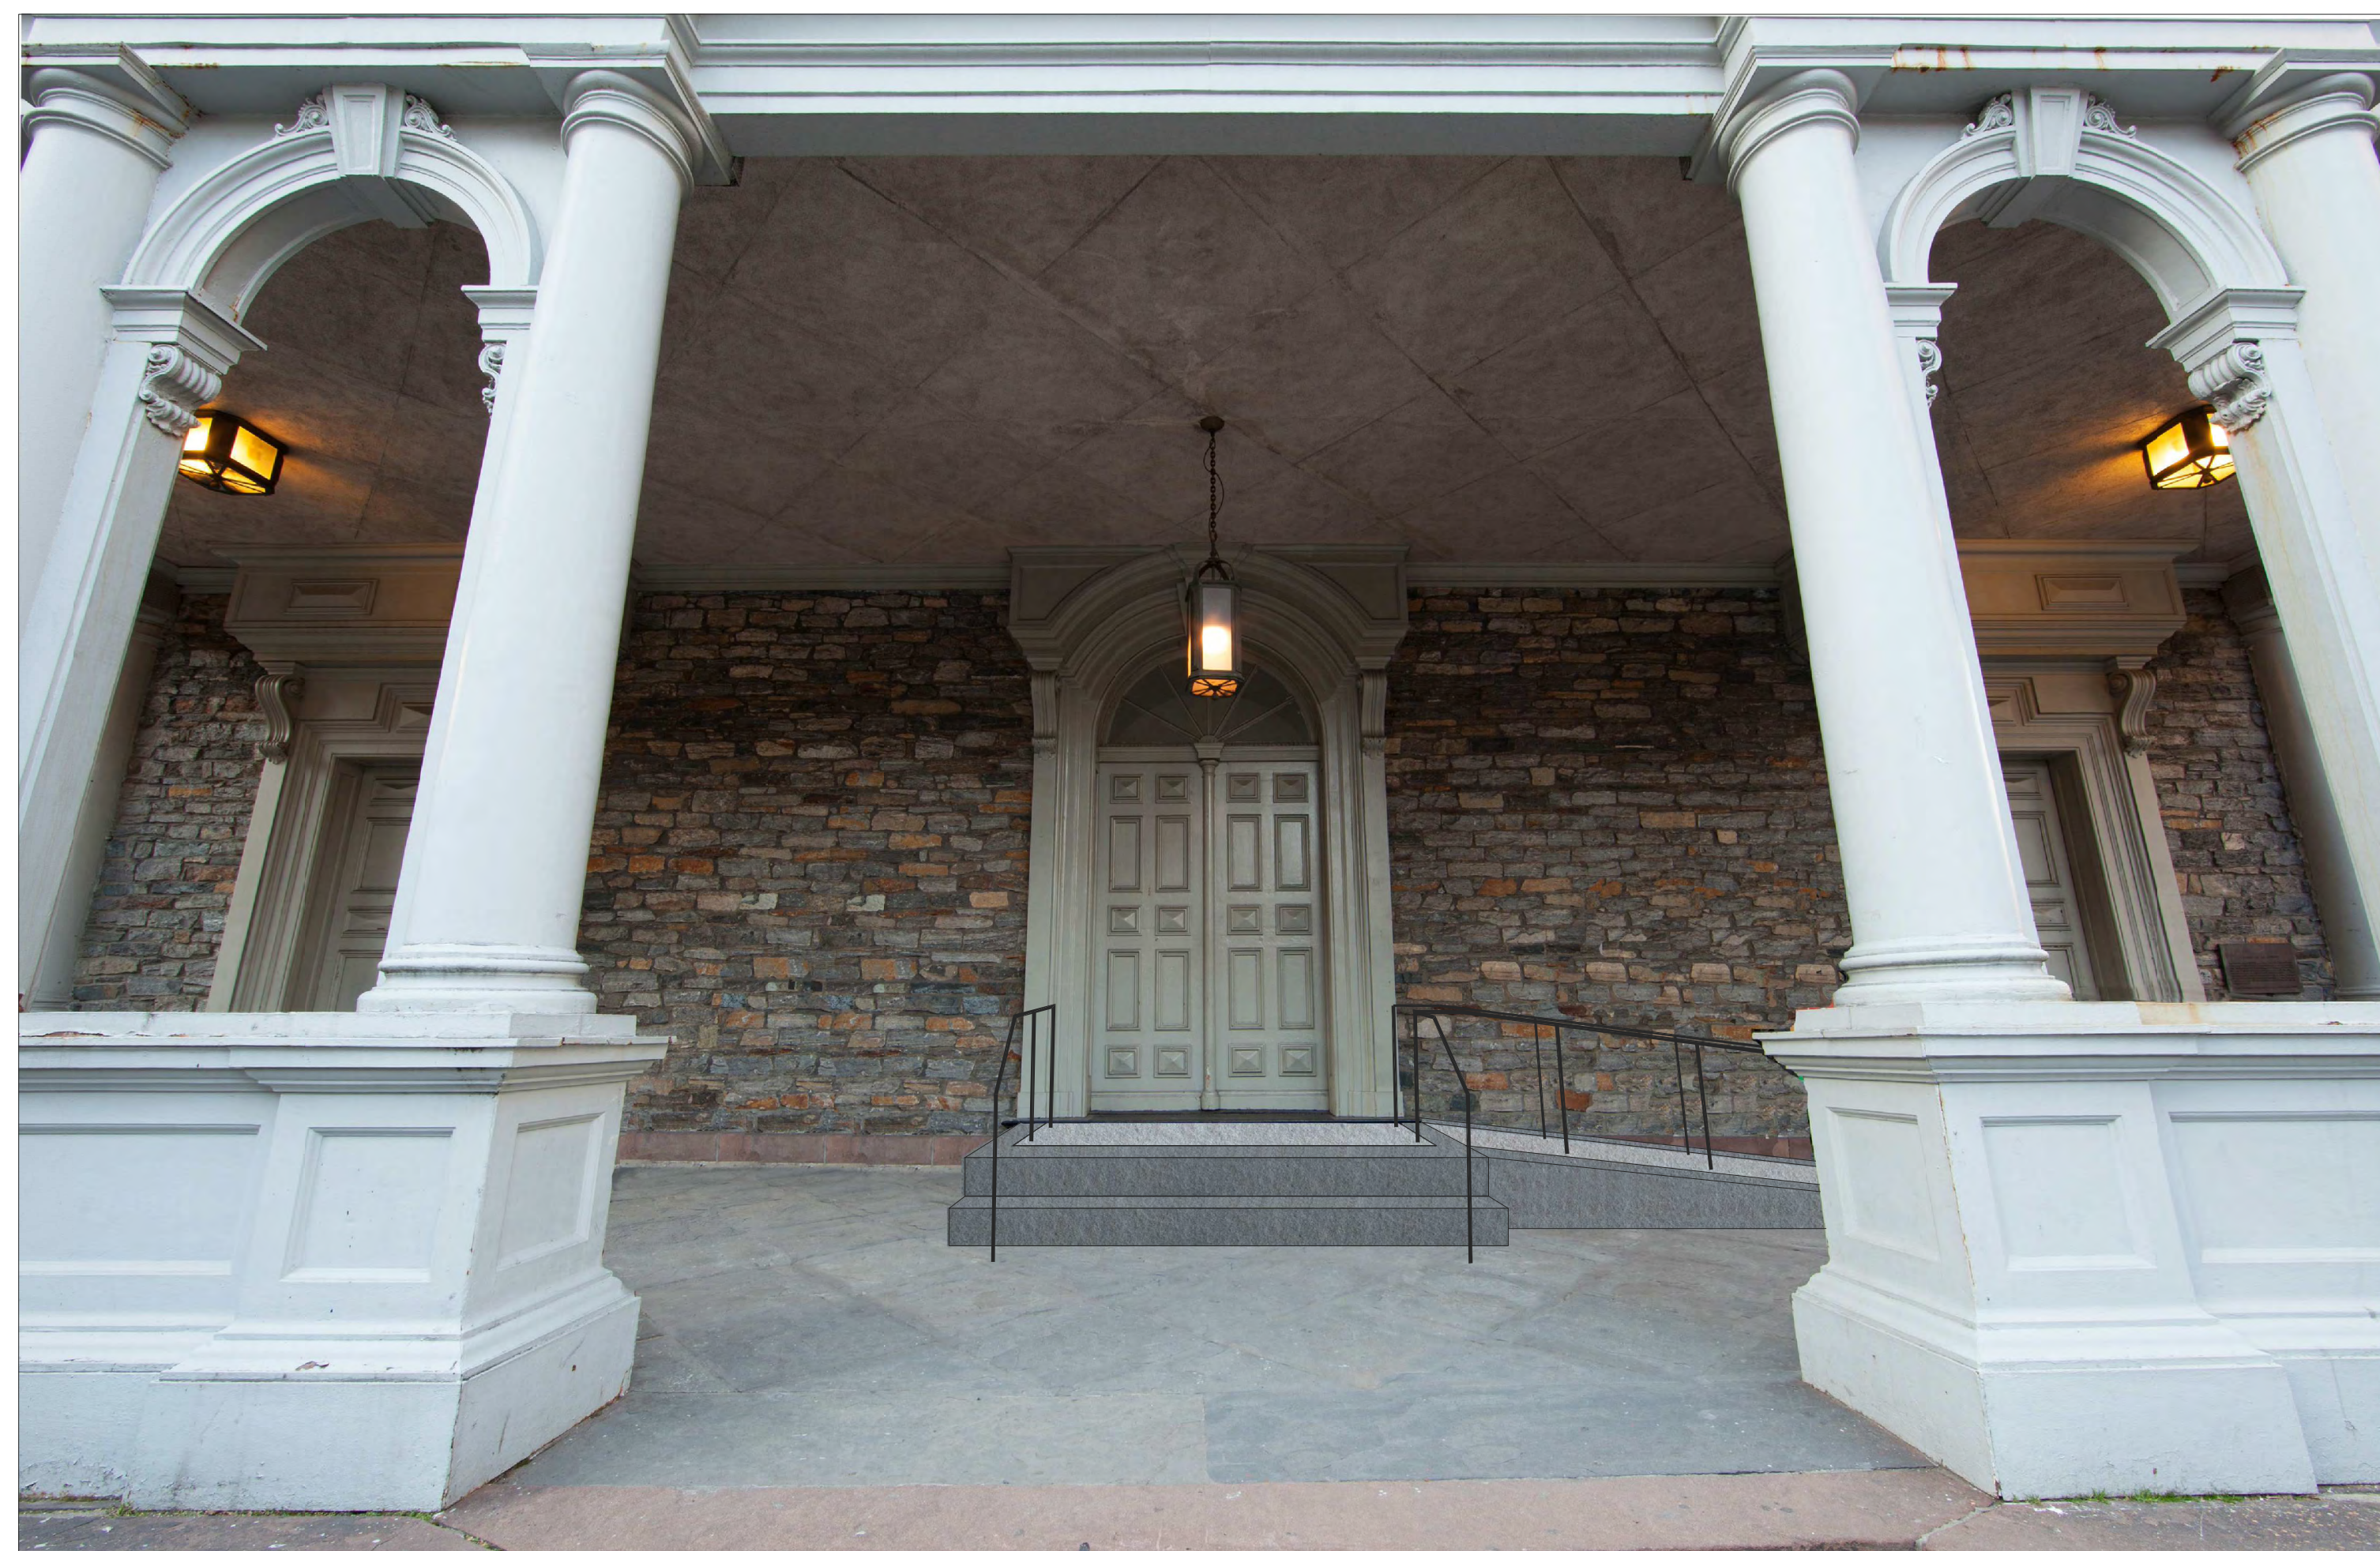
2B SANCTUARY ENTRY - PROPOSED RAMP
2/2013 PROPOSED WORK AREA
