Portico Restoration and Ramp

St. Mark's Church in the Bowery

*install ADA accessibility ramp and
repair cast iron portico*

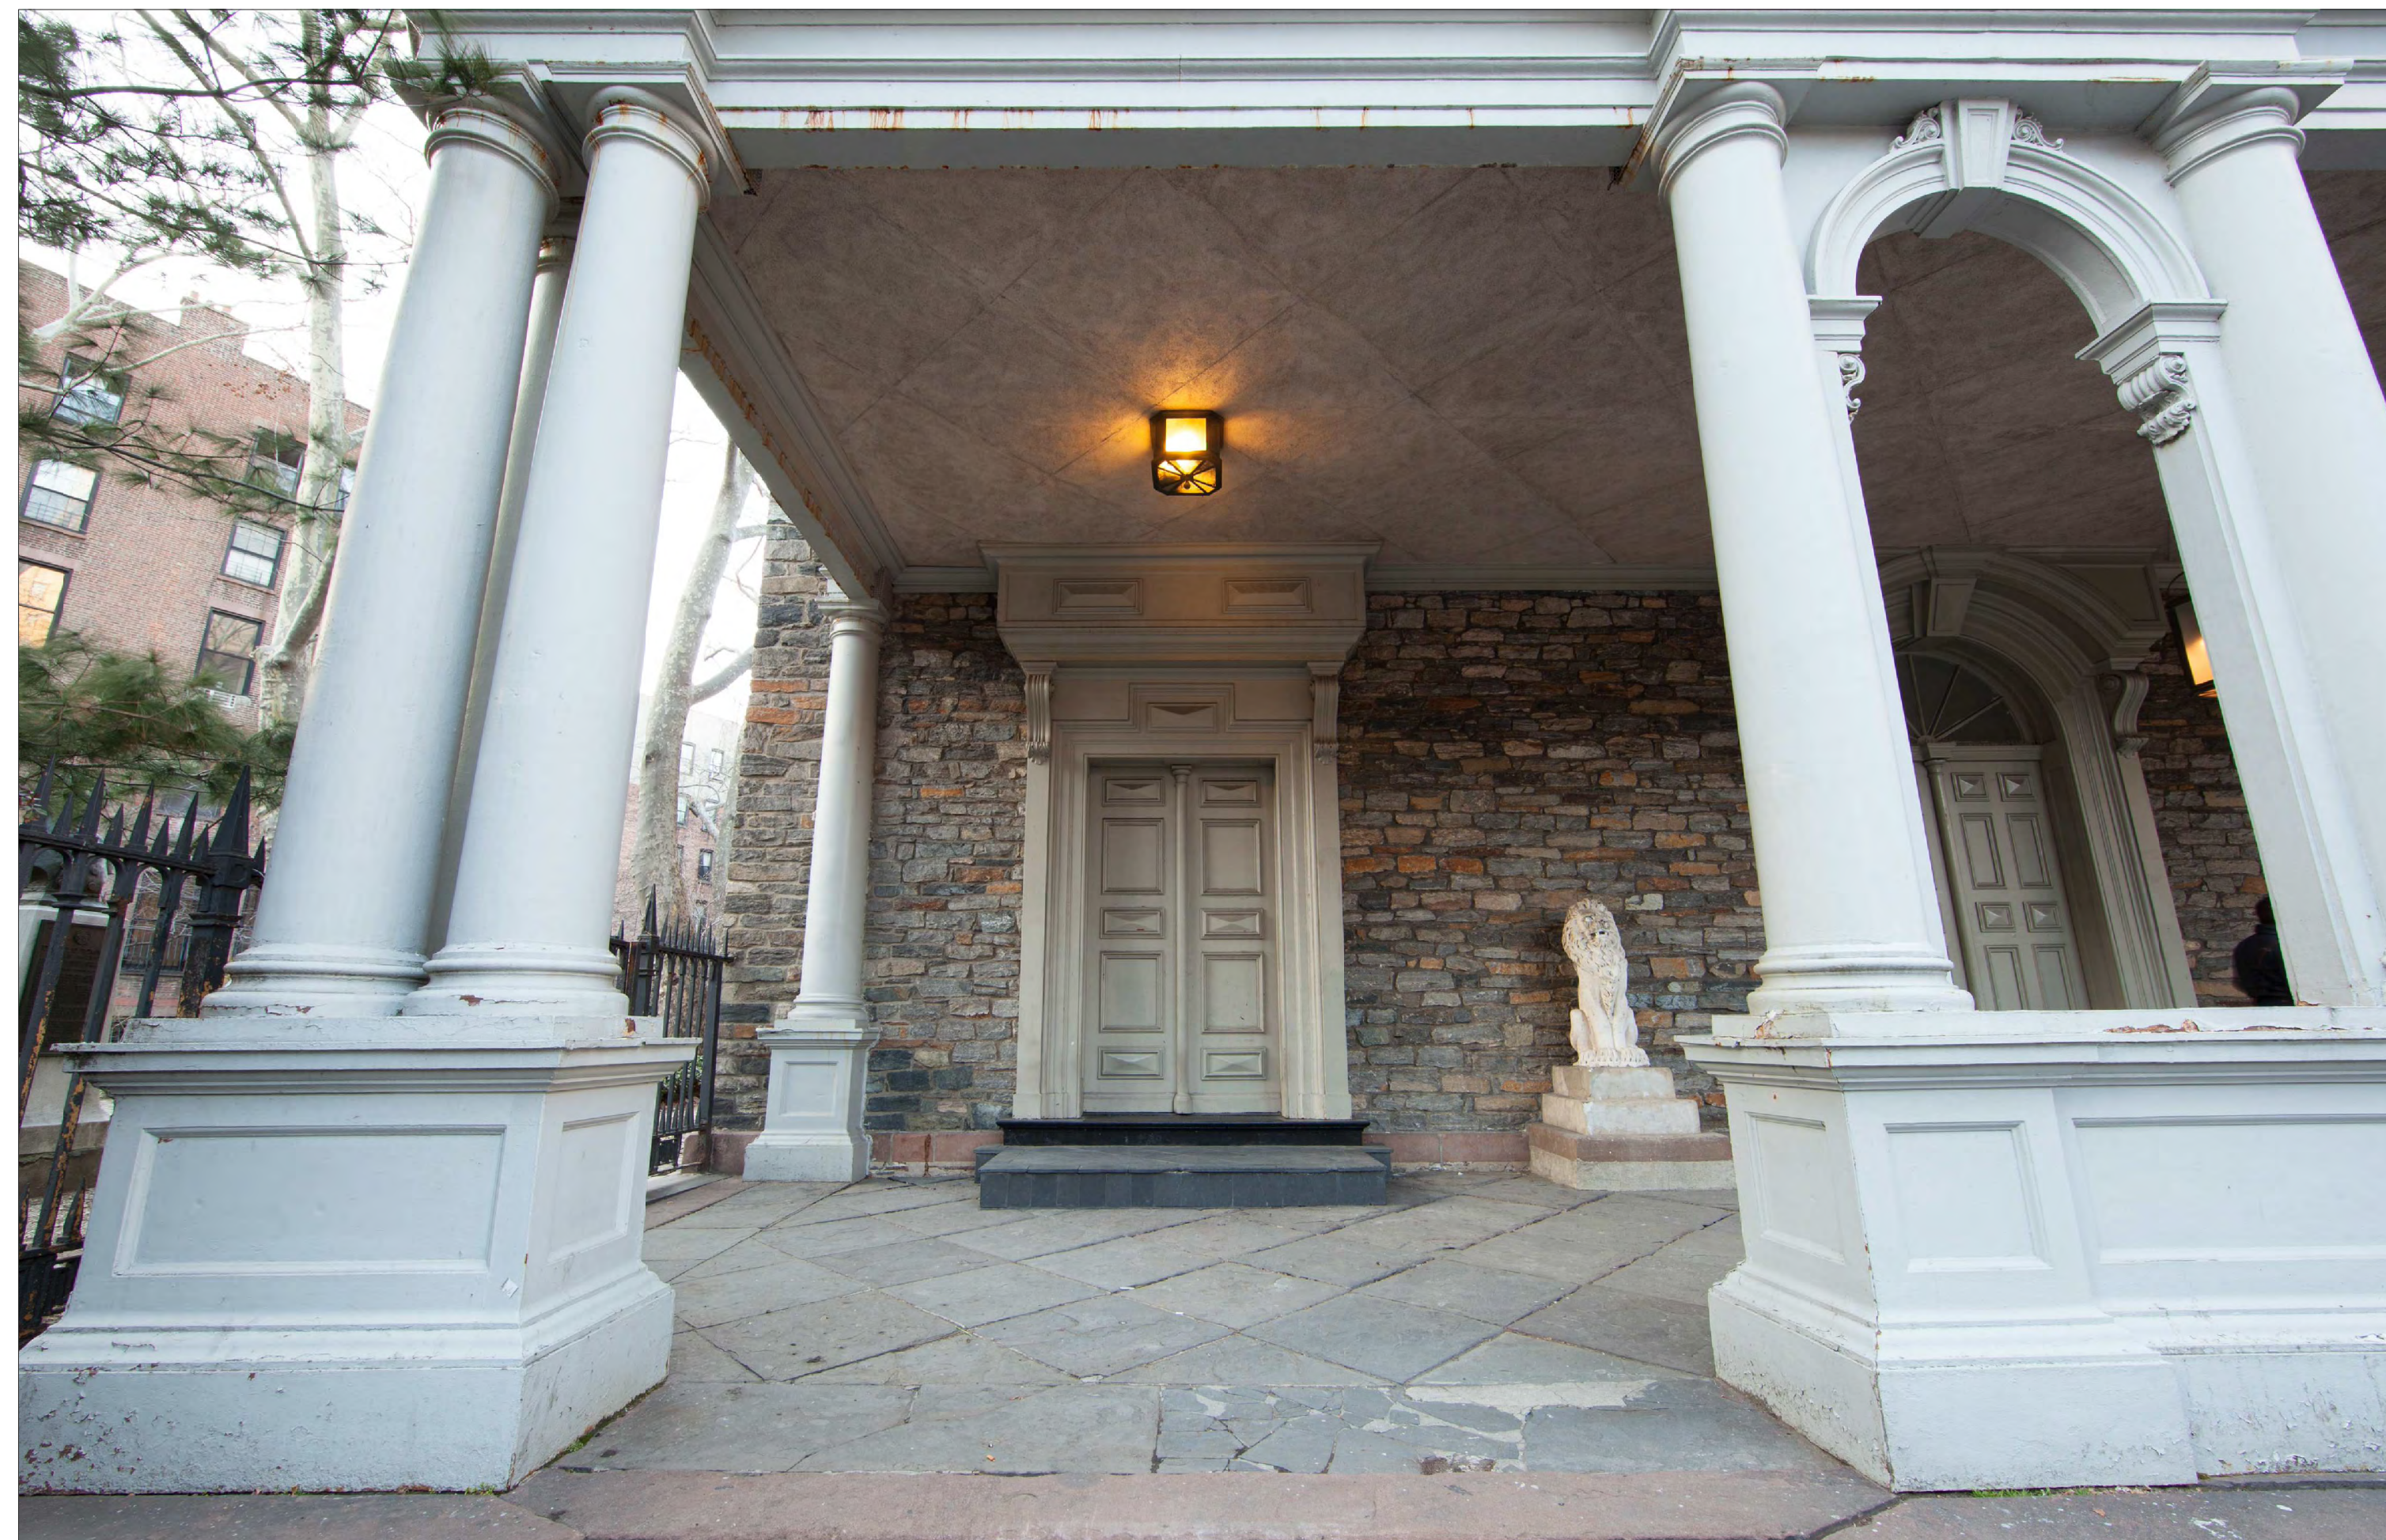
3A WEST VESTIBULE - EXISTING CONDITION
2/2013 PROPOSED WORK AREA

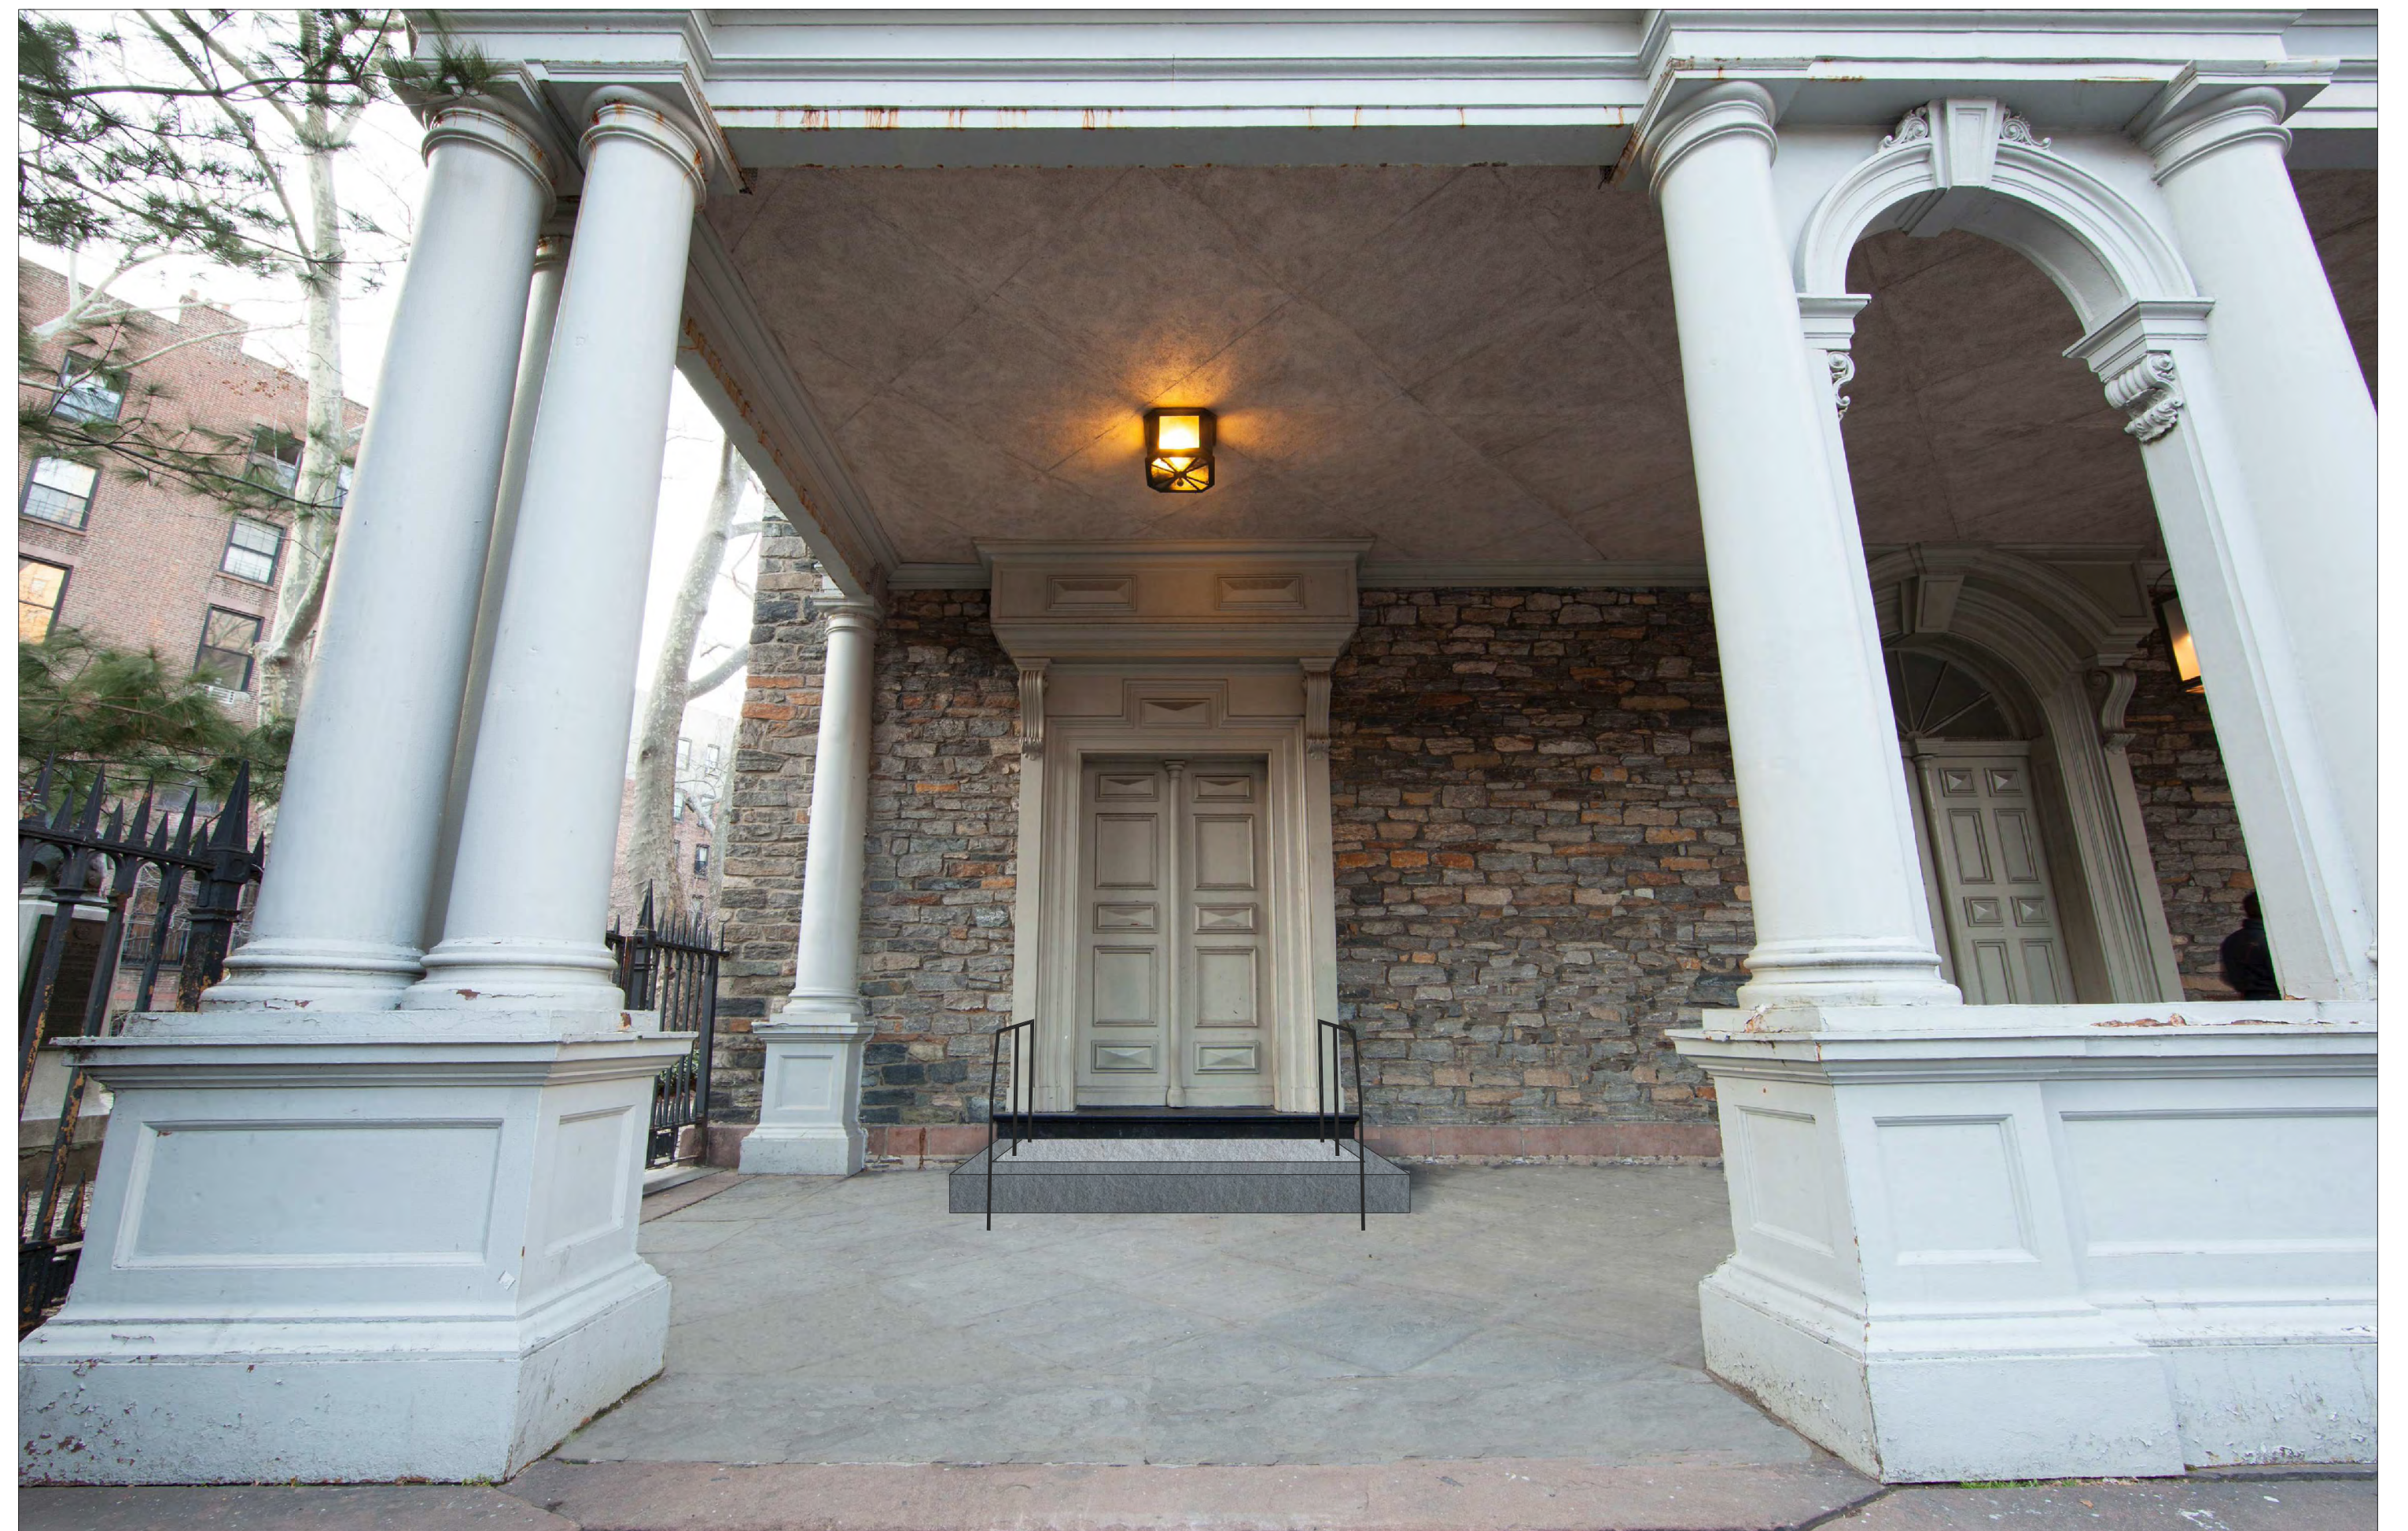
3B WEST VESTIBULE - PROPOSED RAMP
2/2013 PROPOSED WORK AREA

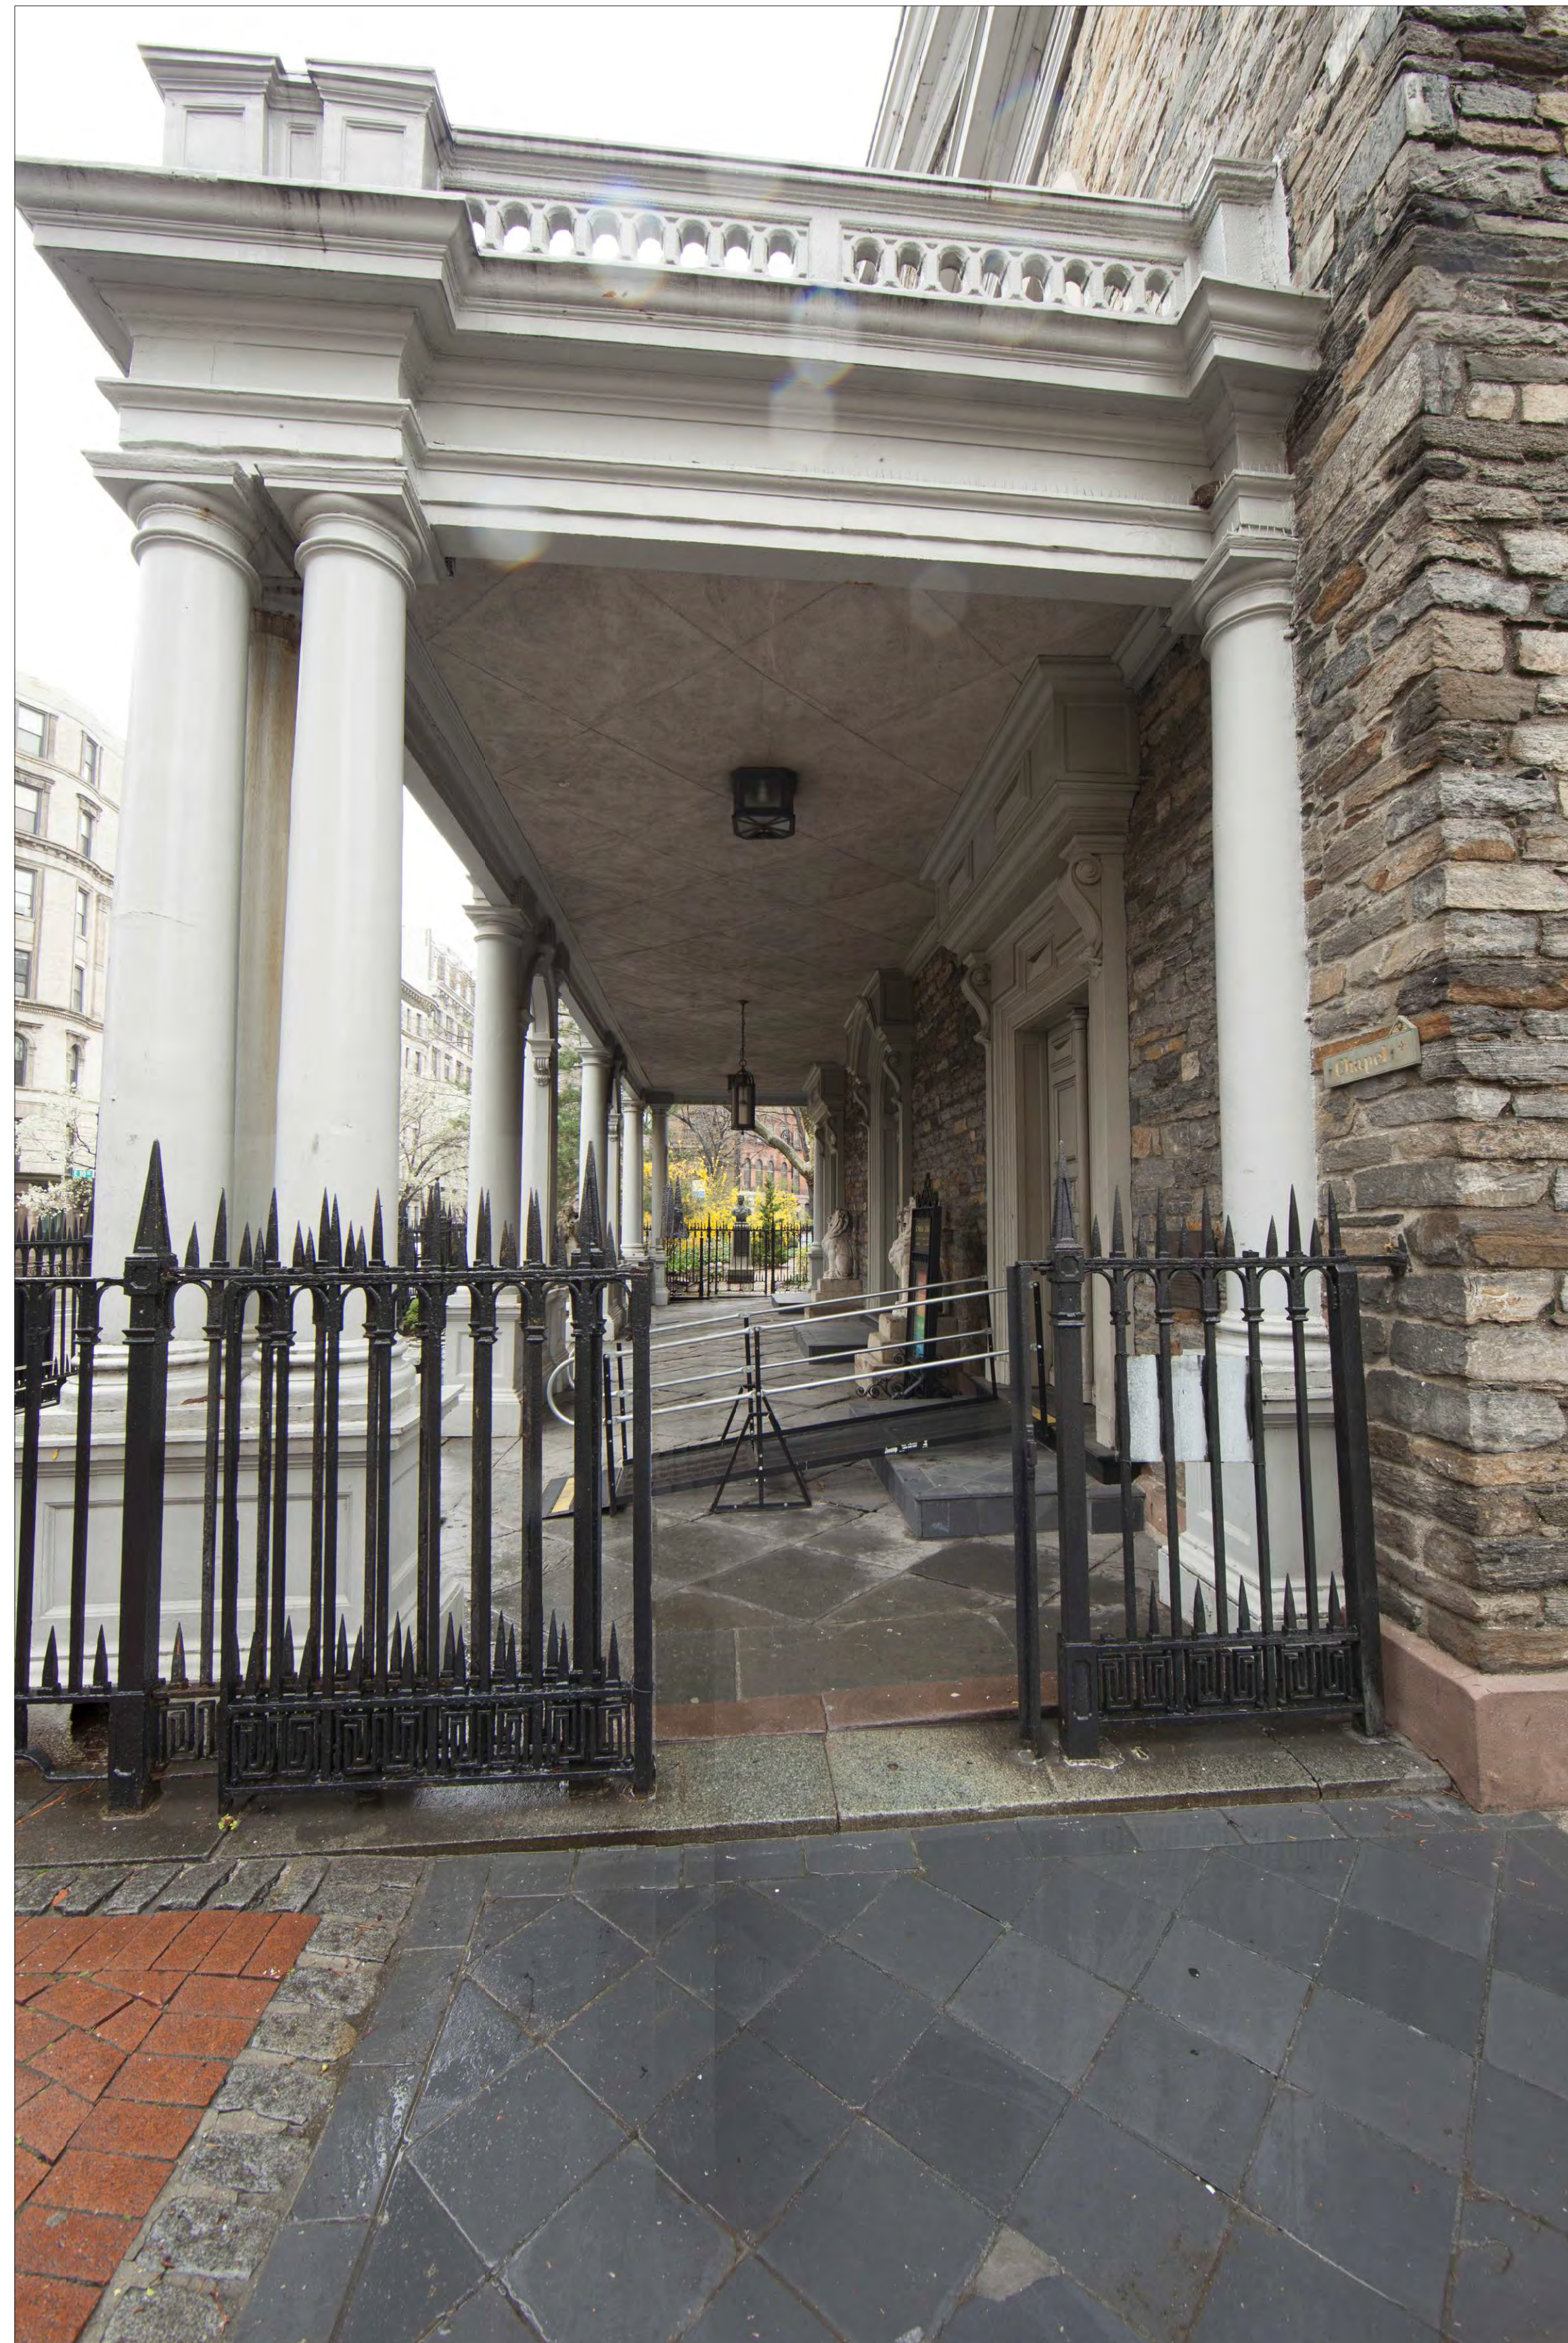
4A EAST ELEVATION - EXISTING CONDITION
2/2013 PROPOSED WORK AREA

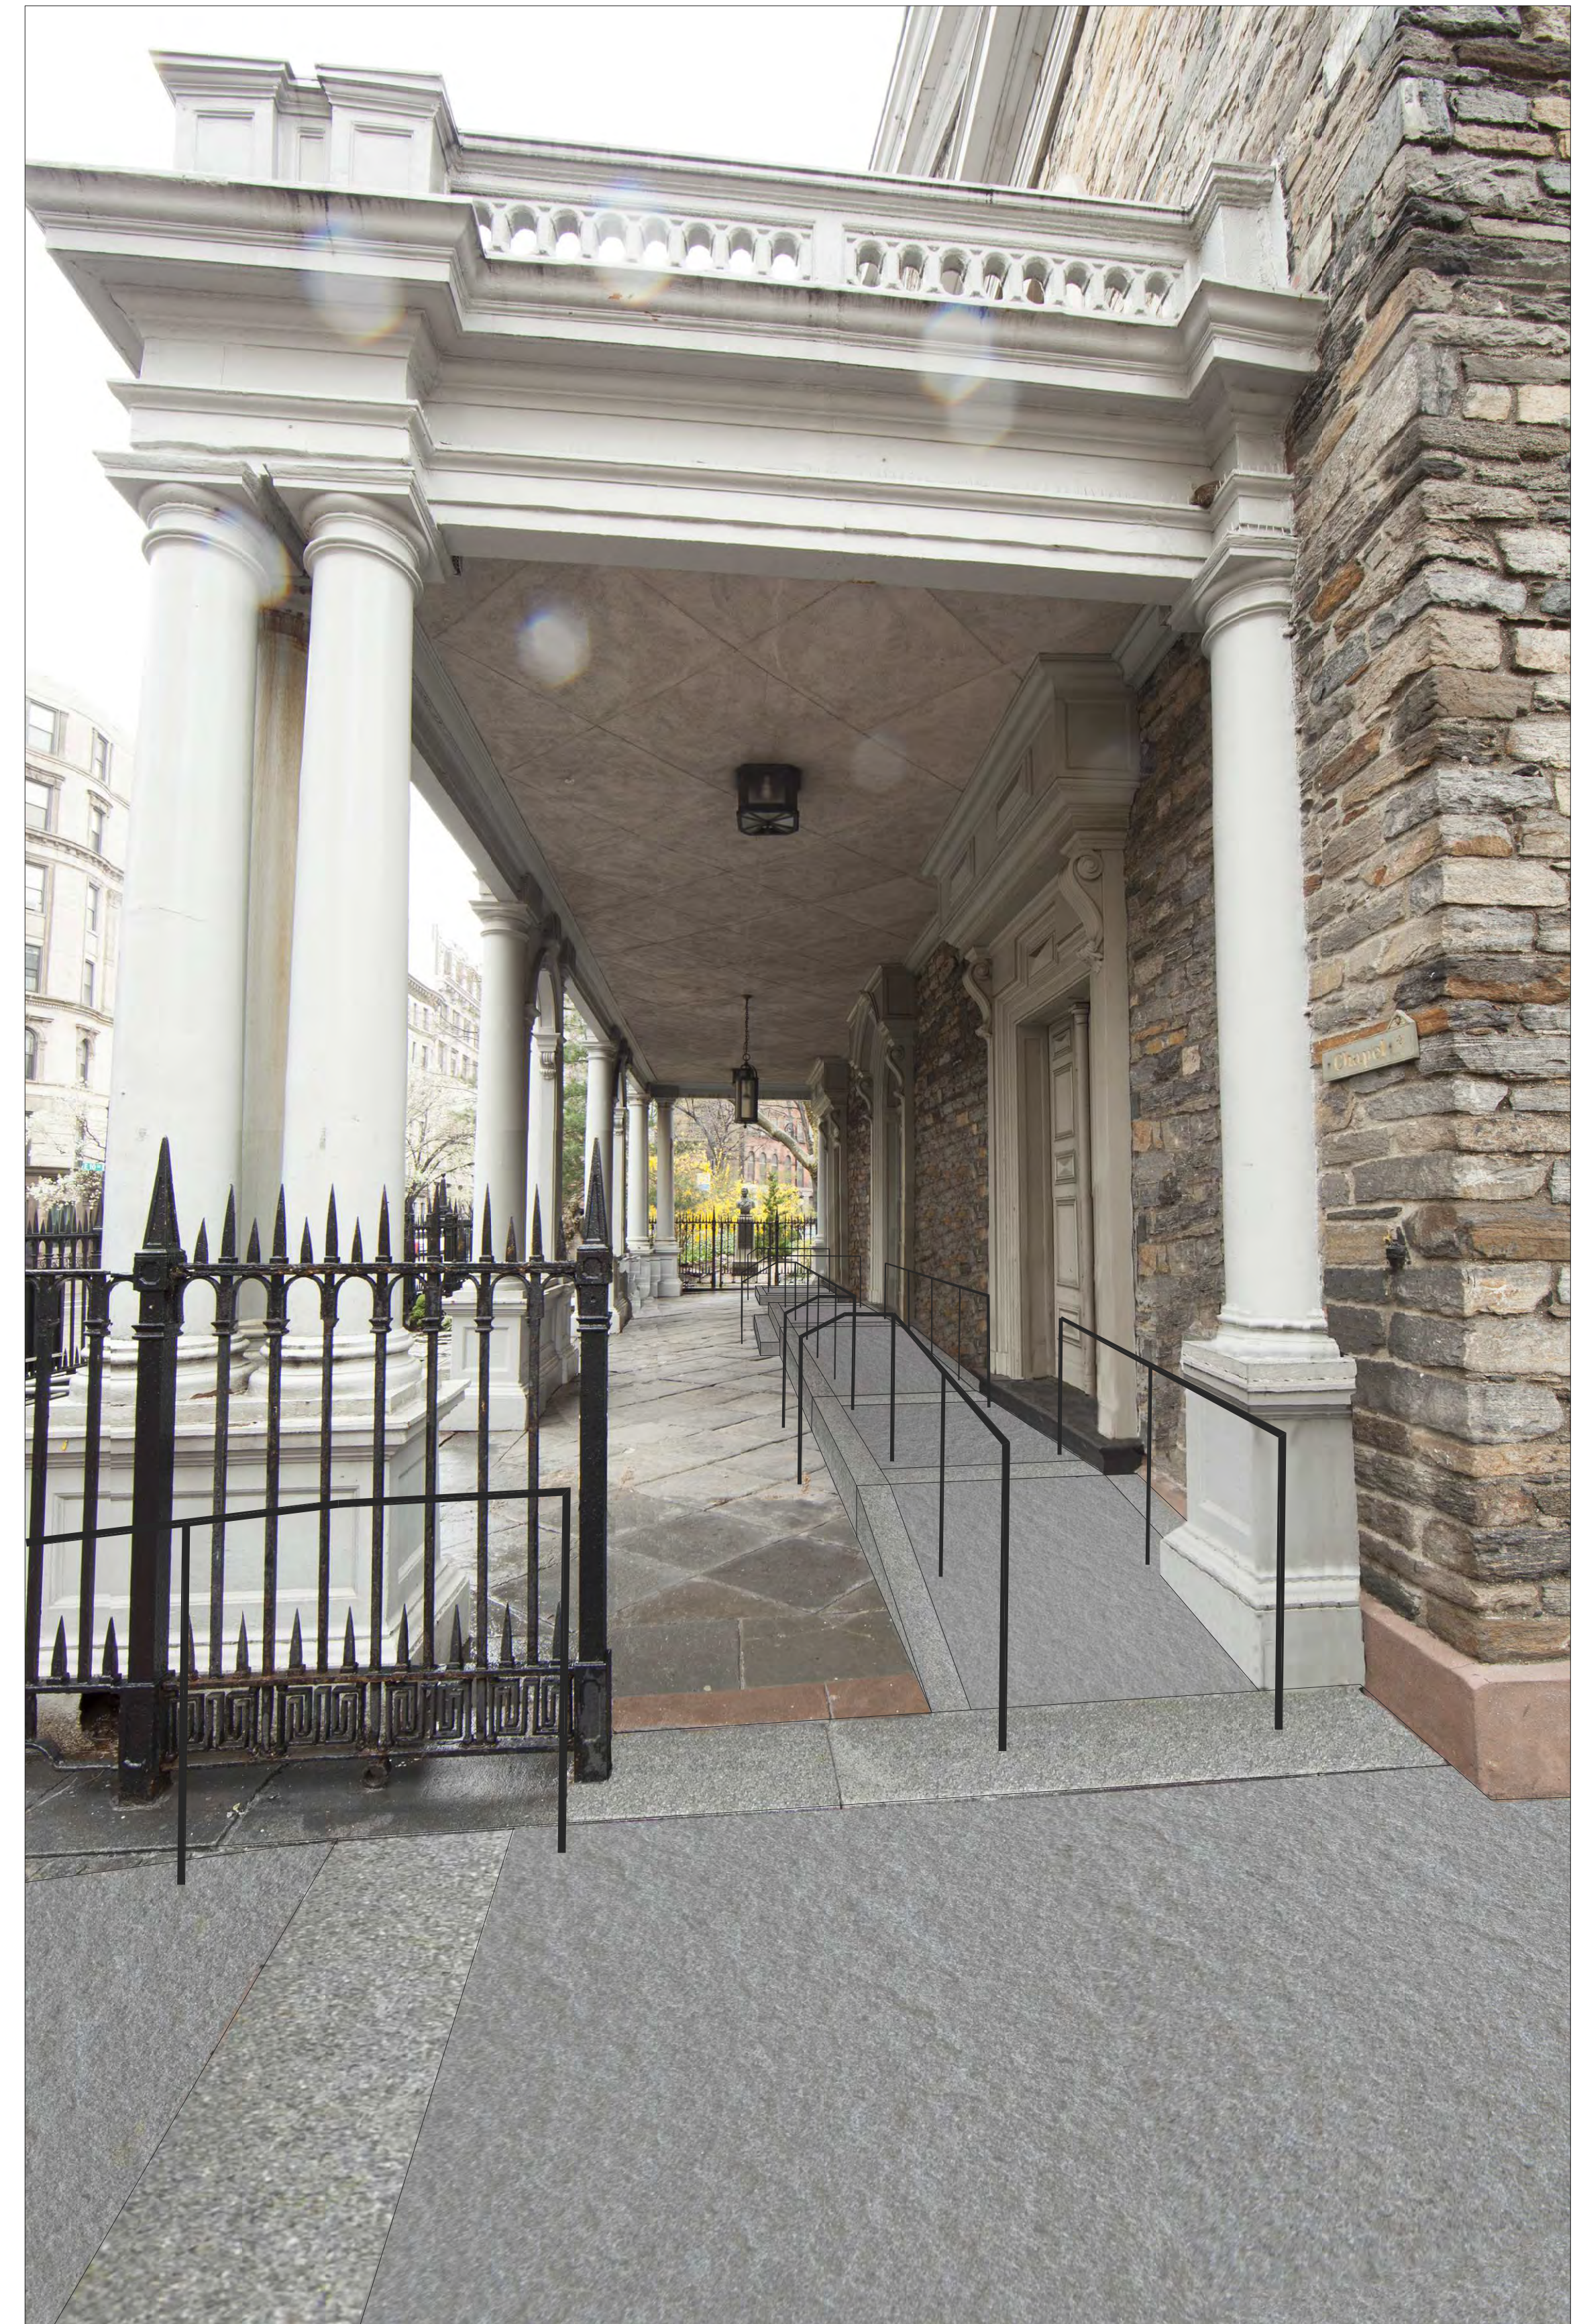
4B EAST ELEVATION - PROPOSED RAMP
2/2013 PROPOSED WORK AREA

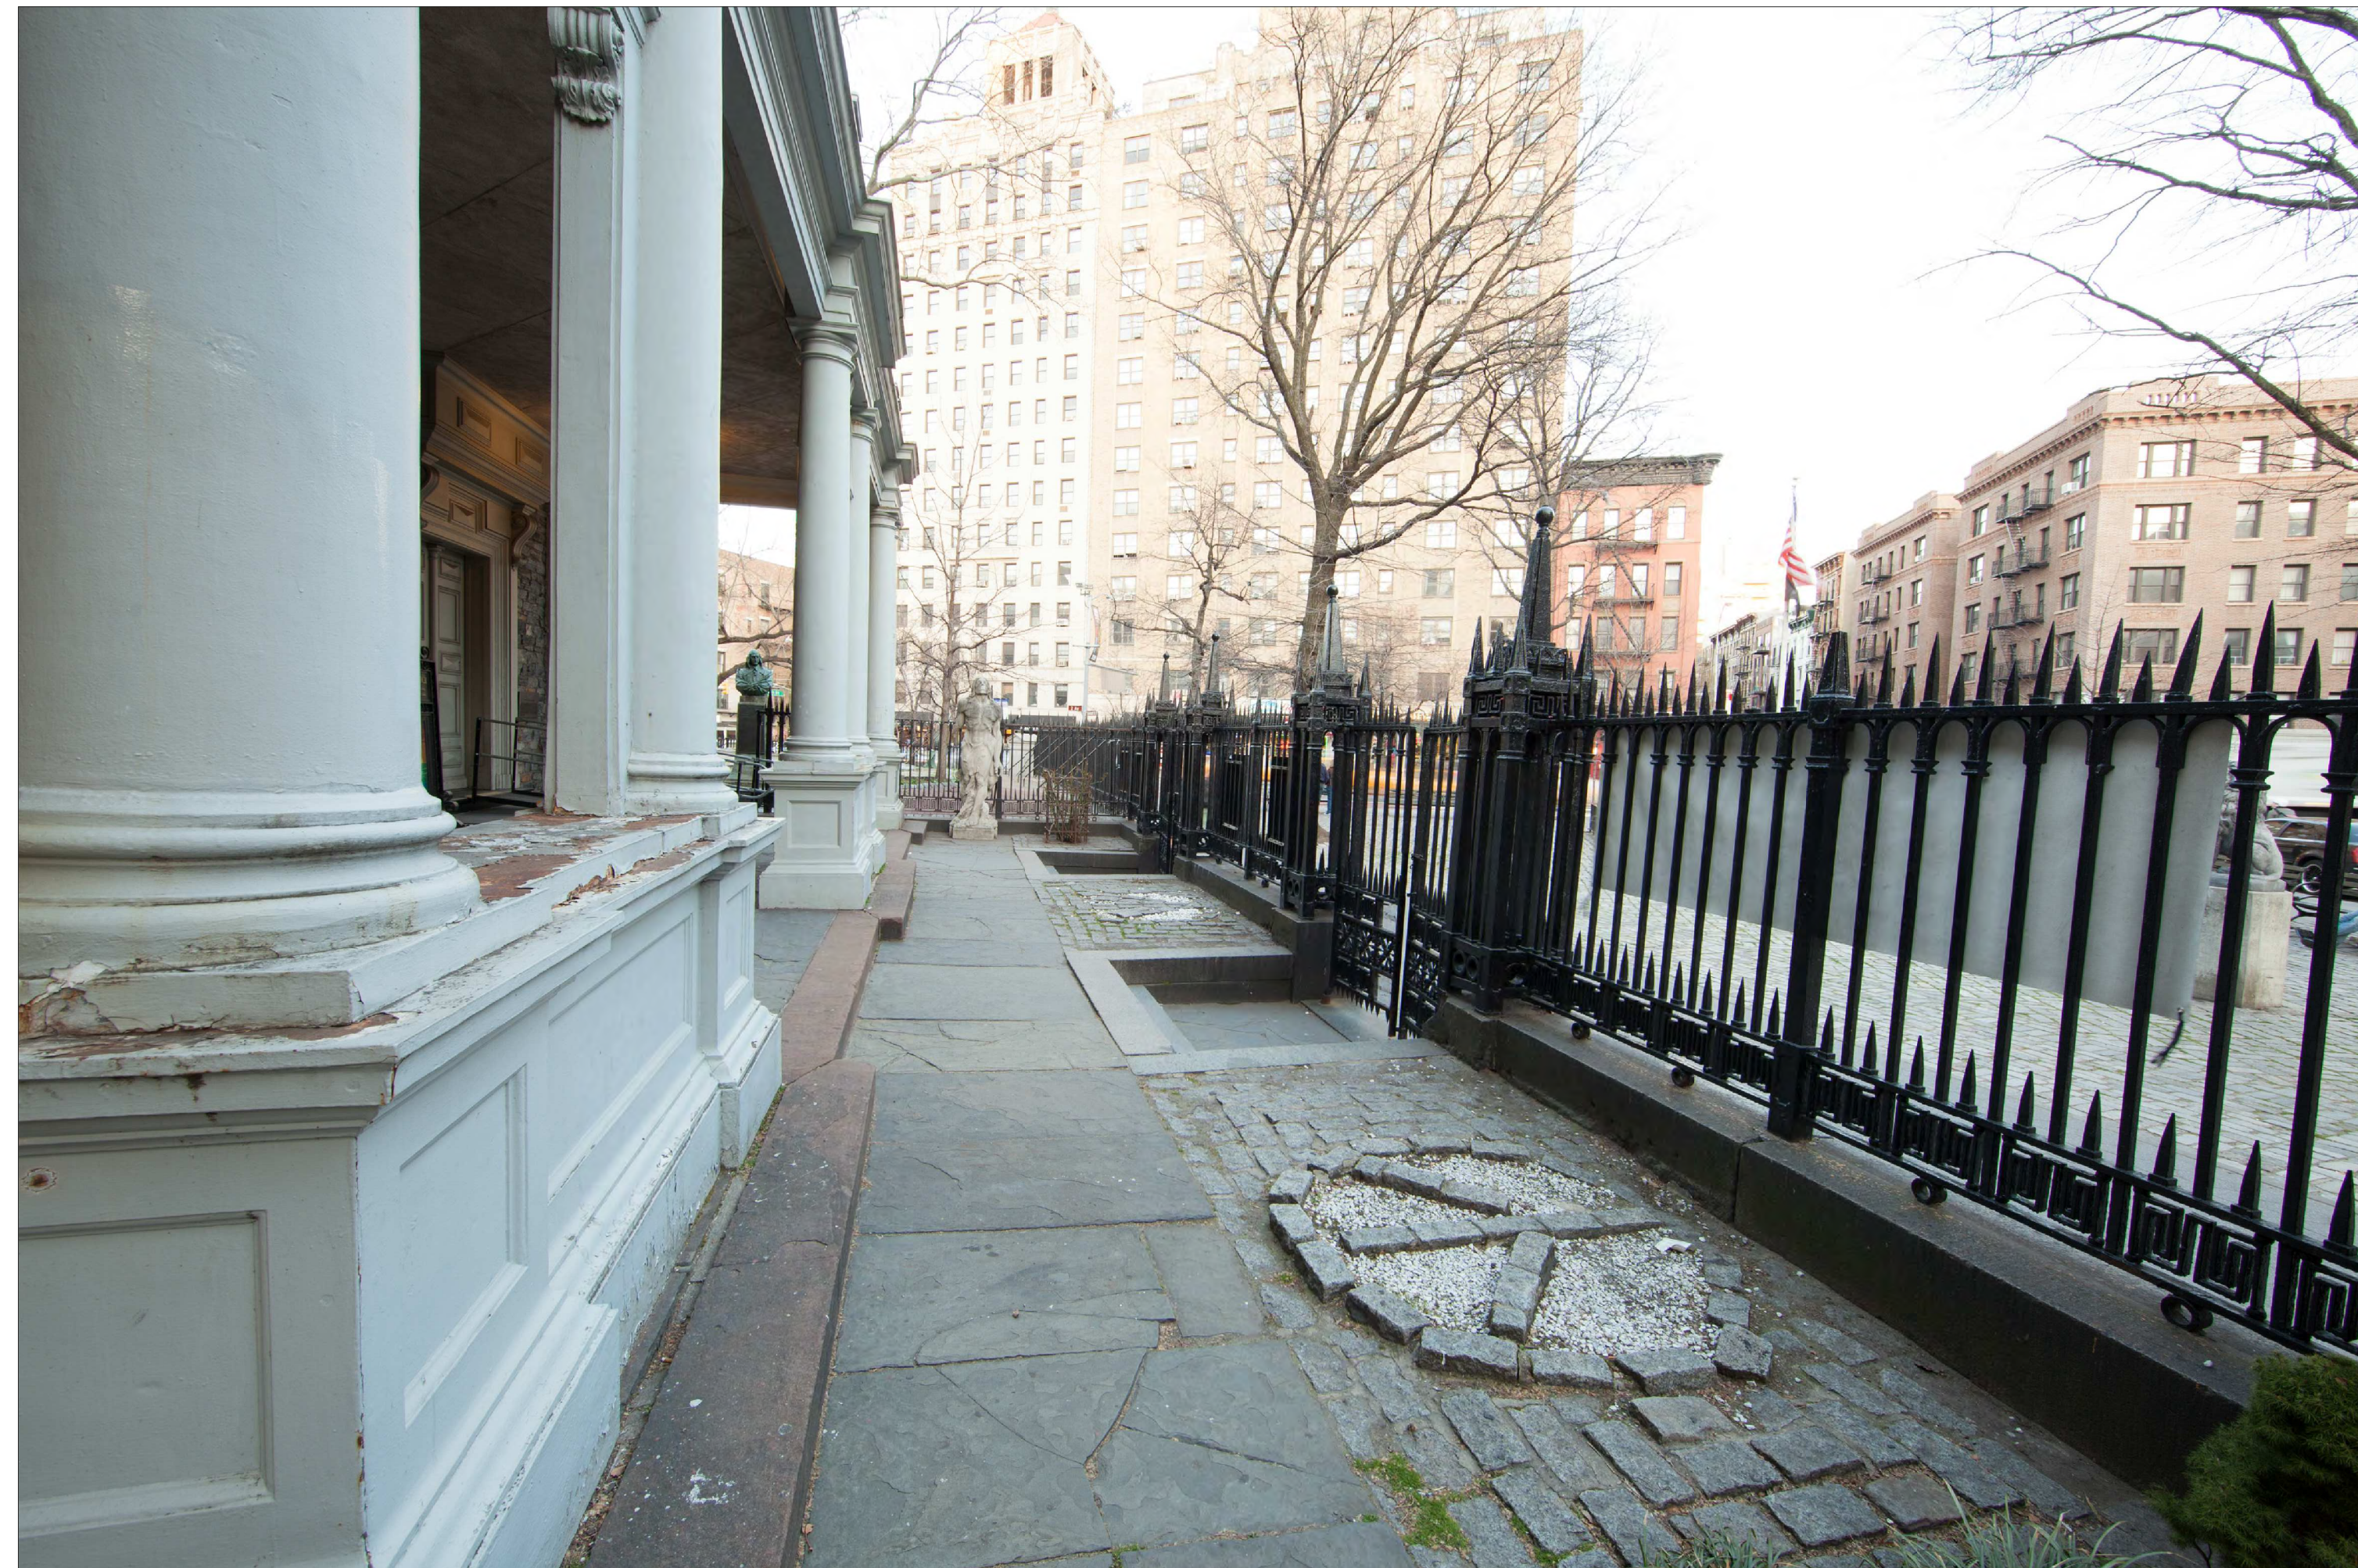
5A ENTRY RAMP - EXISTING CONDITION
2/2013 PROPOSED WORK AREA

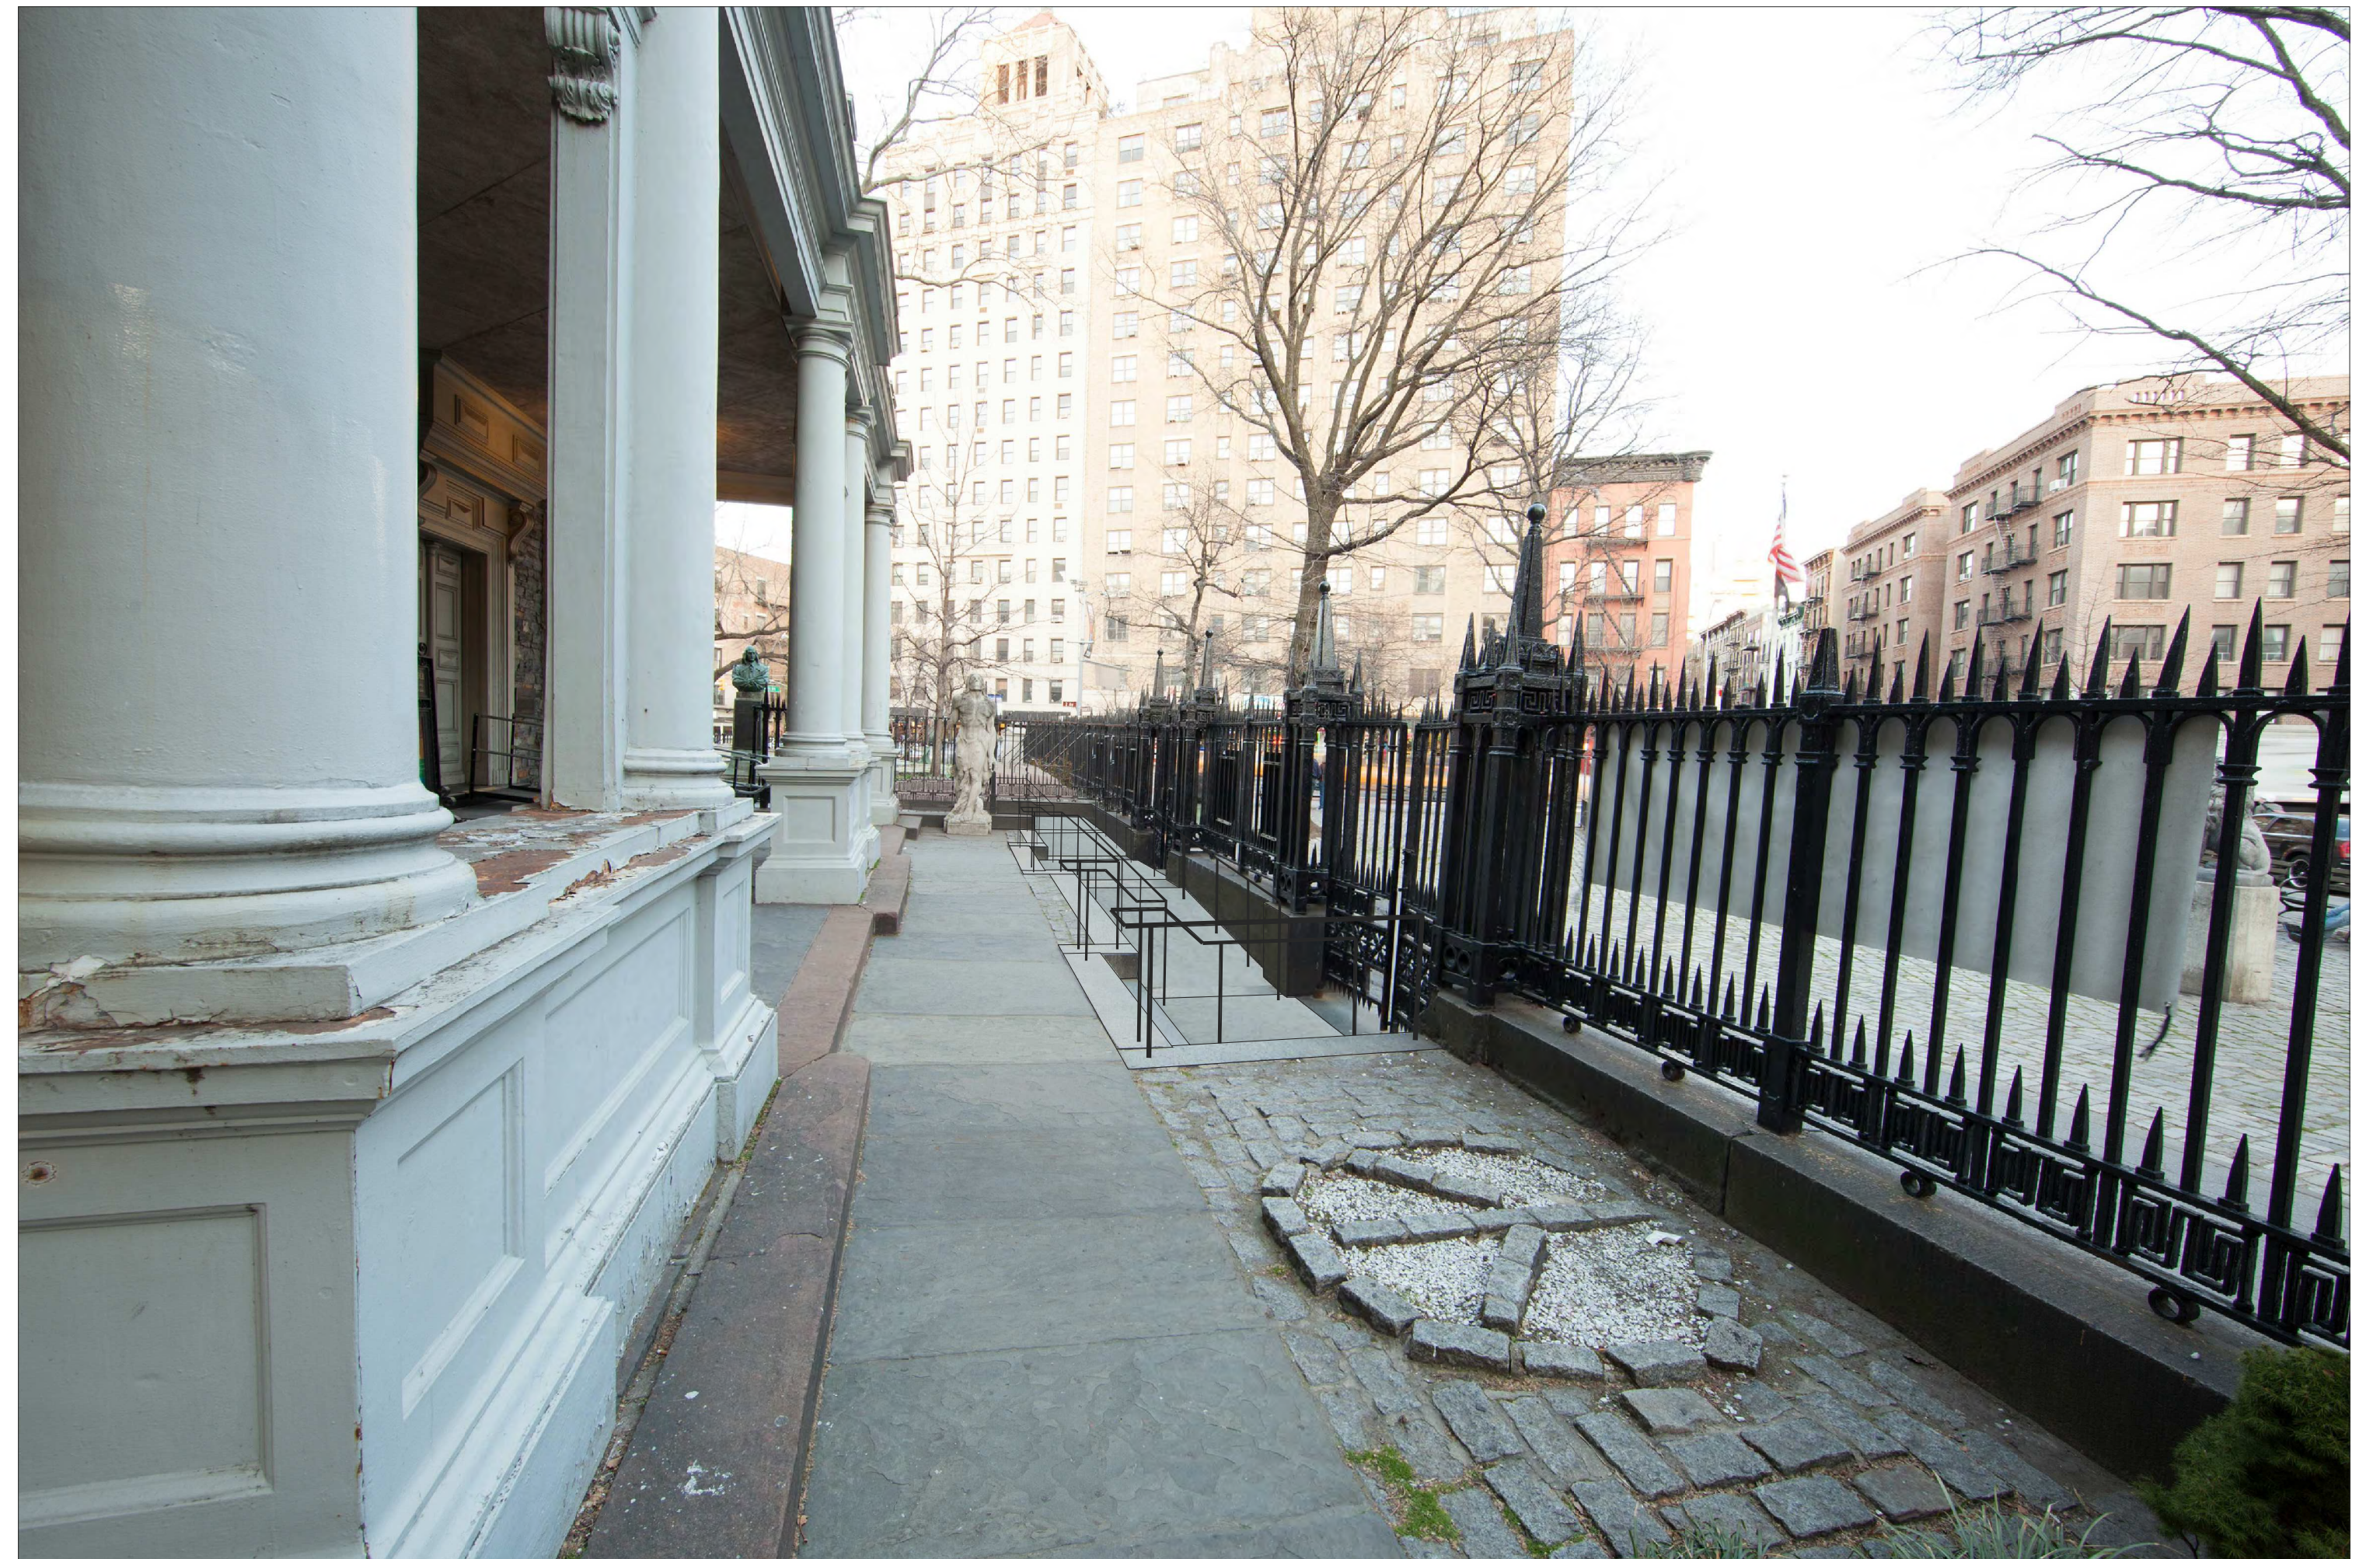
5B ENTRY RAMP - PROPOSED RAMP
2/2013 PROPOSED WORK AREA
