Portico Restoration and Ramp

St. Mark's Church in the Bowery

*install ADA accessibility ramp and
repair cast iron portico*

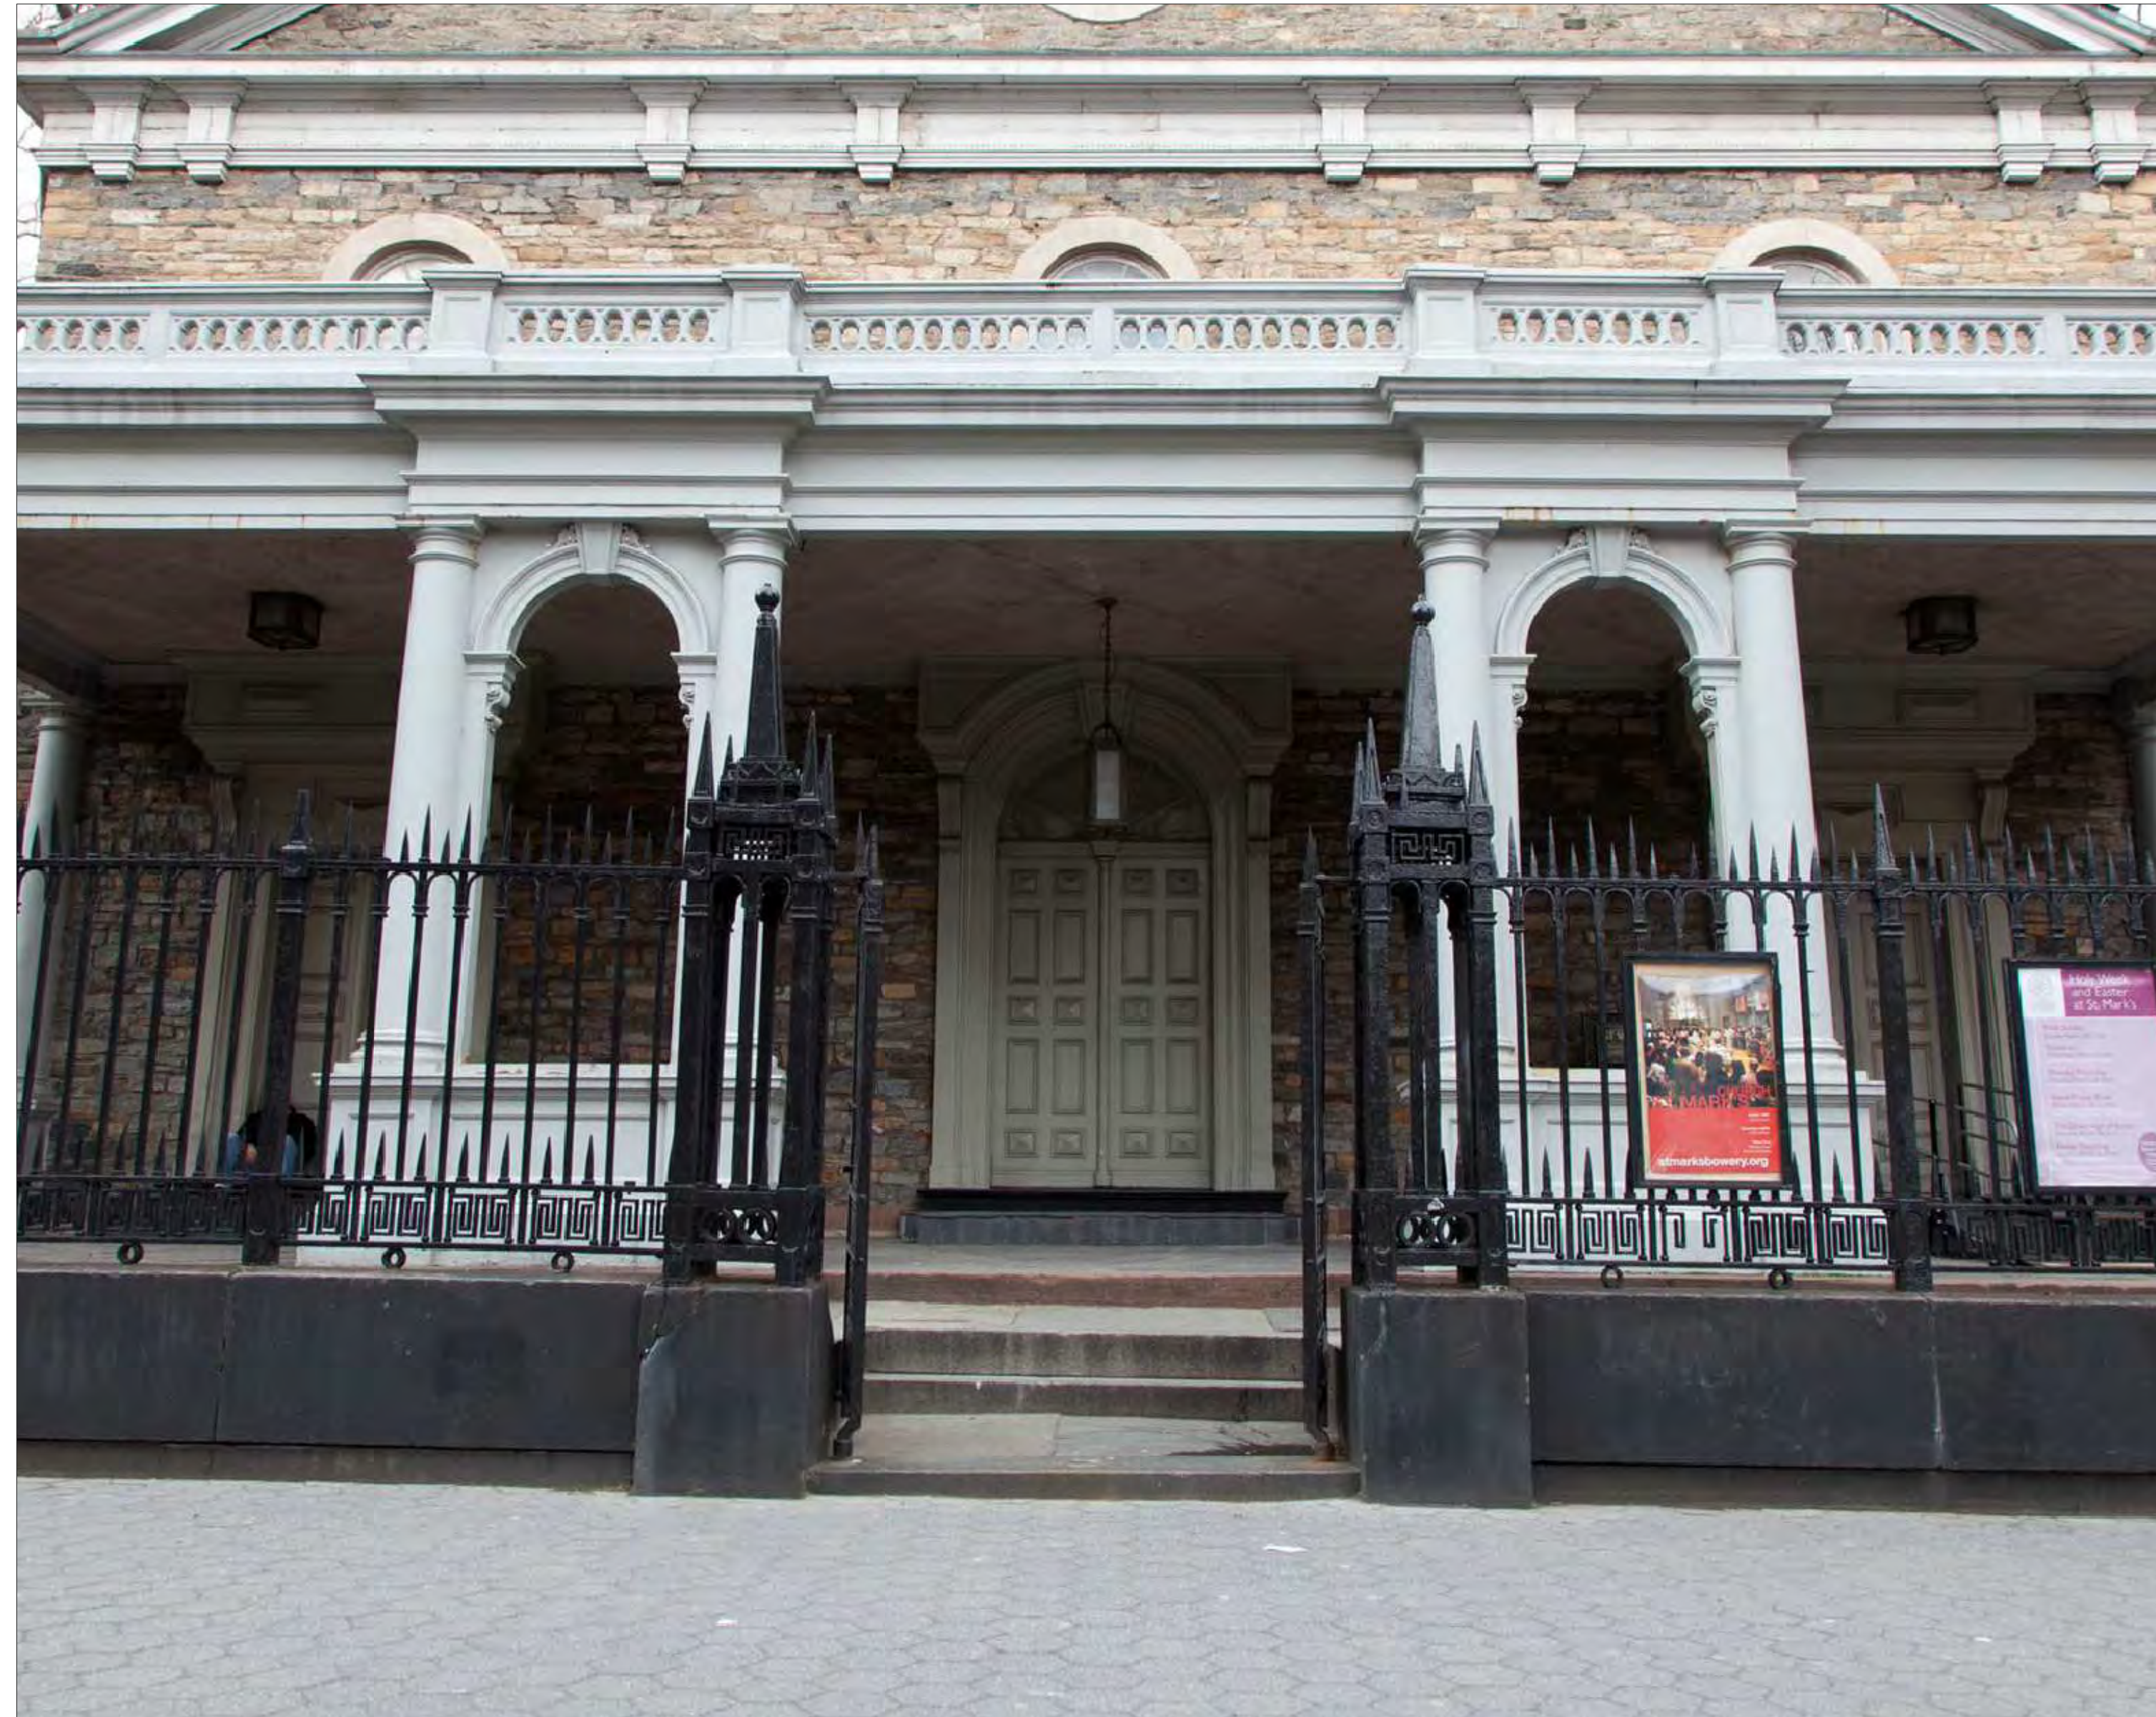
6A CENTER GATE - EXISTING CONDITION
2/2013 PROPOSED WORK AREA

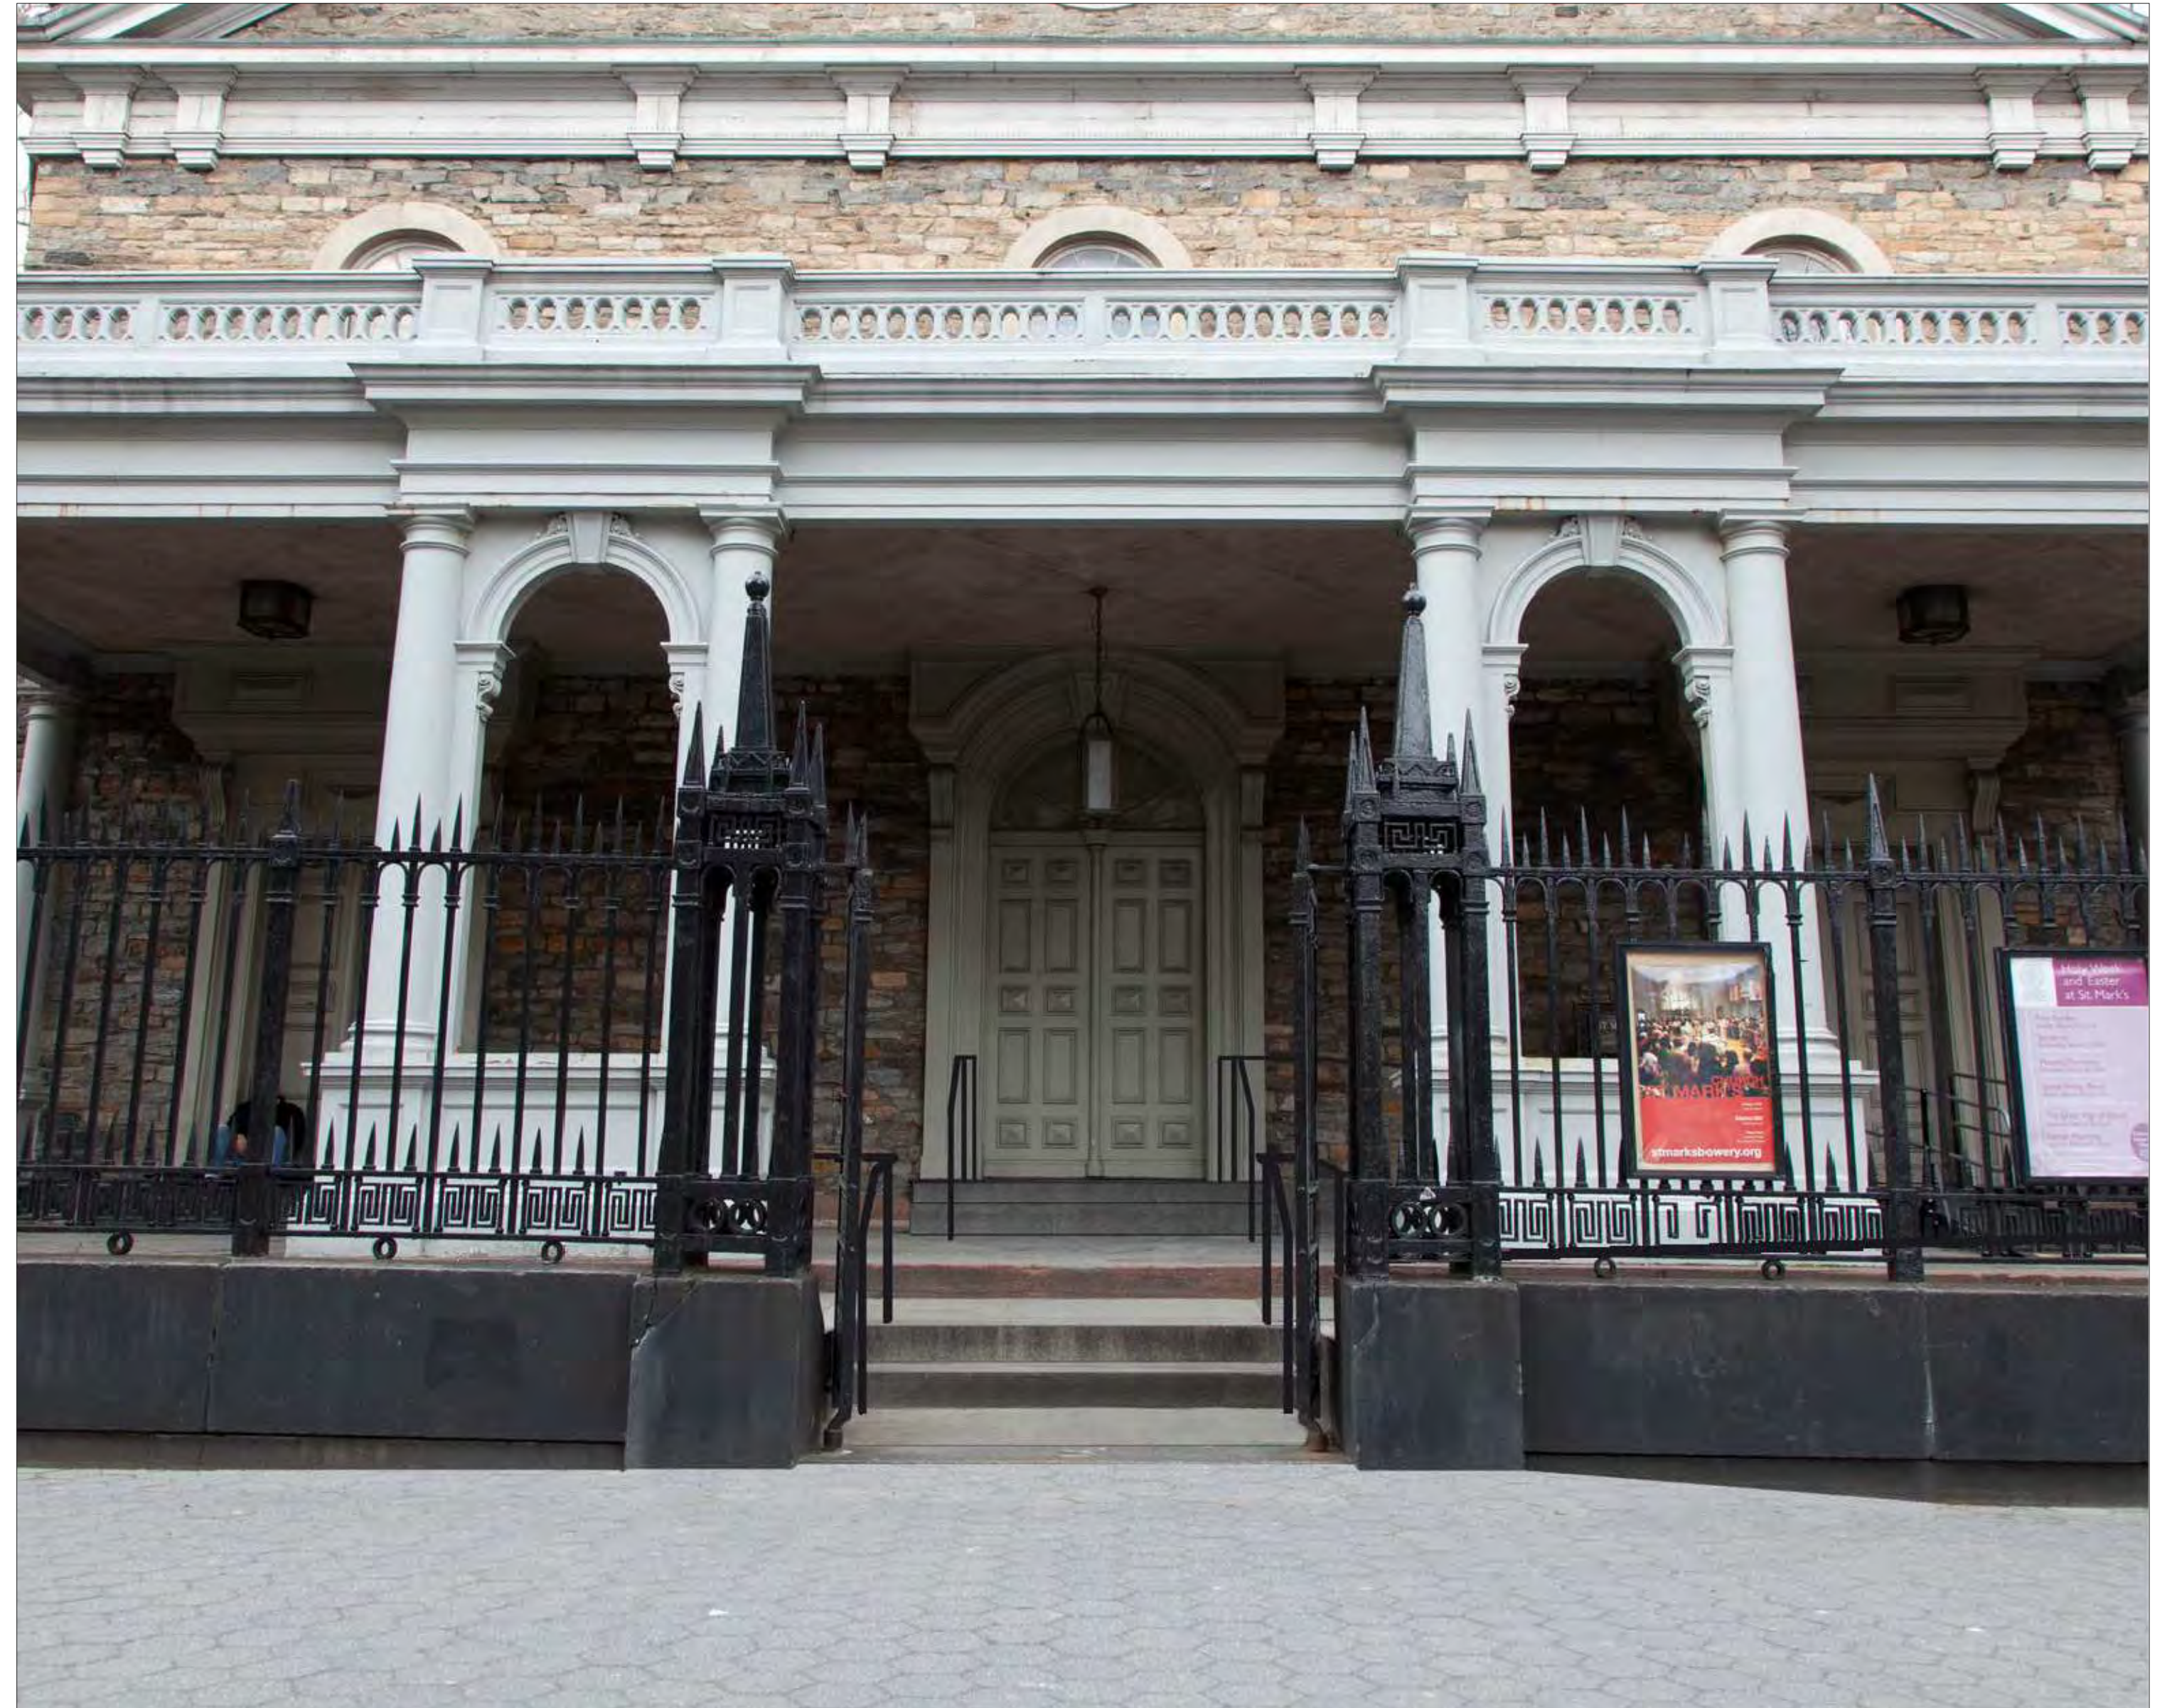
6B CENTER GATE - PROPOSED RAMP
2/2013 PROPOSED WORK AREA

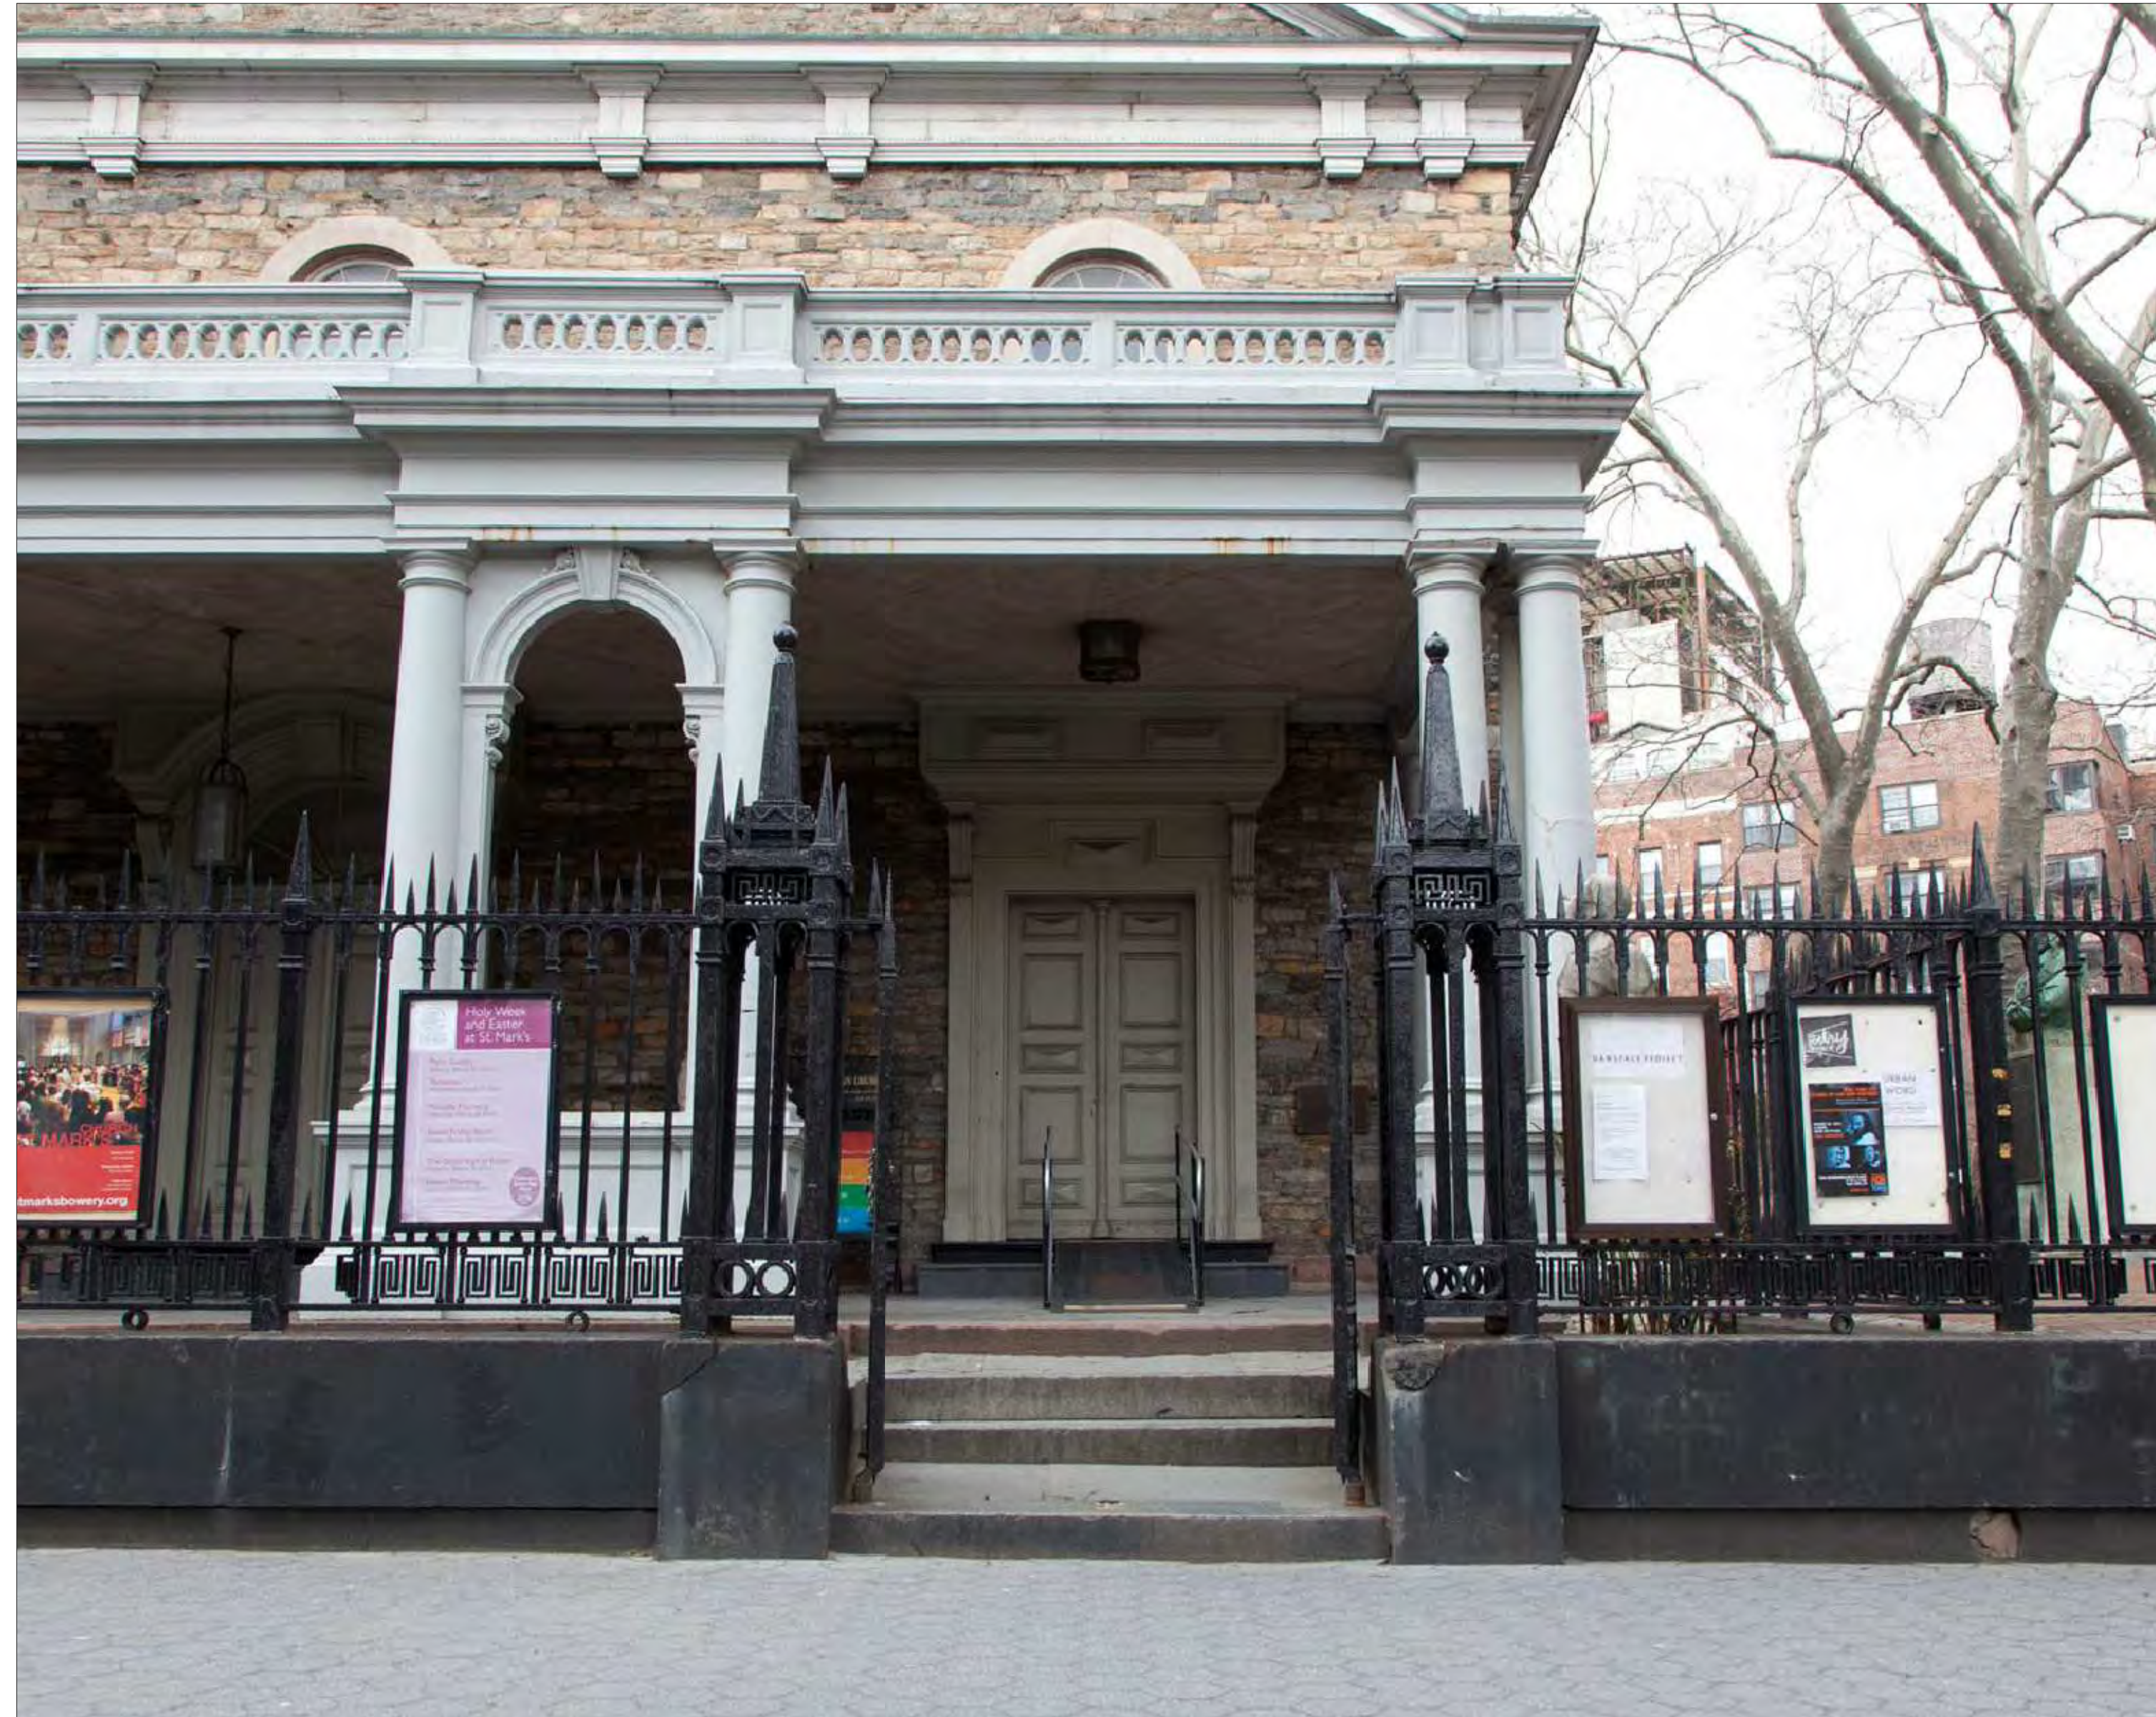
7A EAST GATE - EXISTING CONDITION
2/2013 PROPOSED WORK AREA

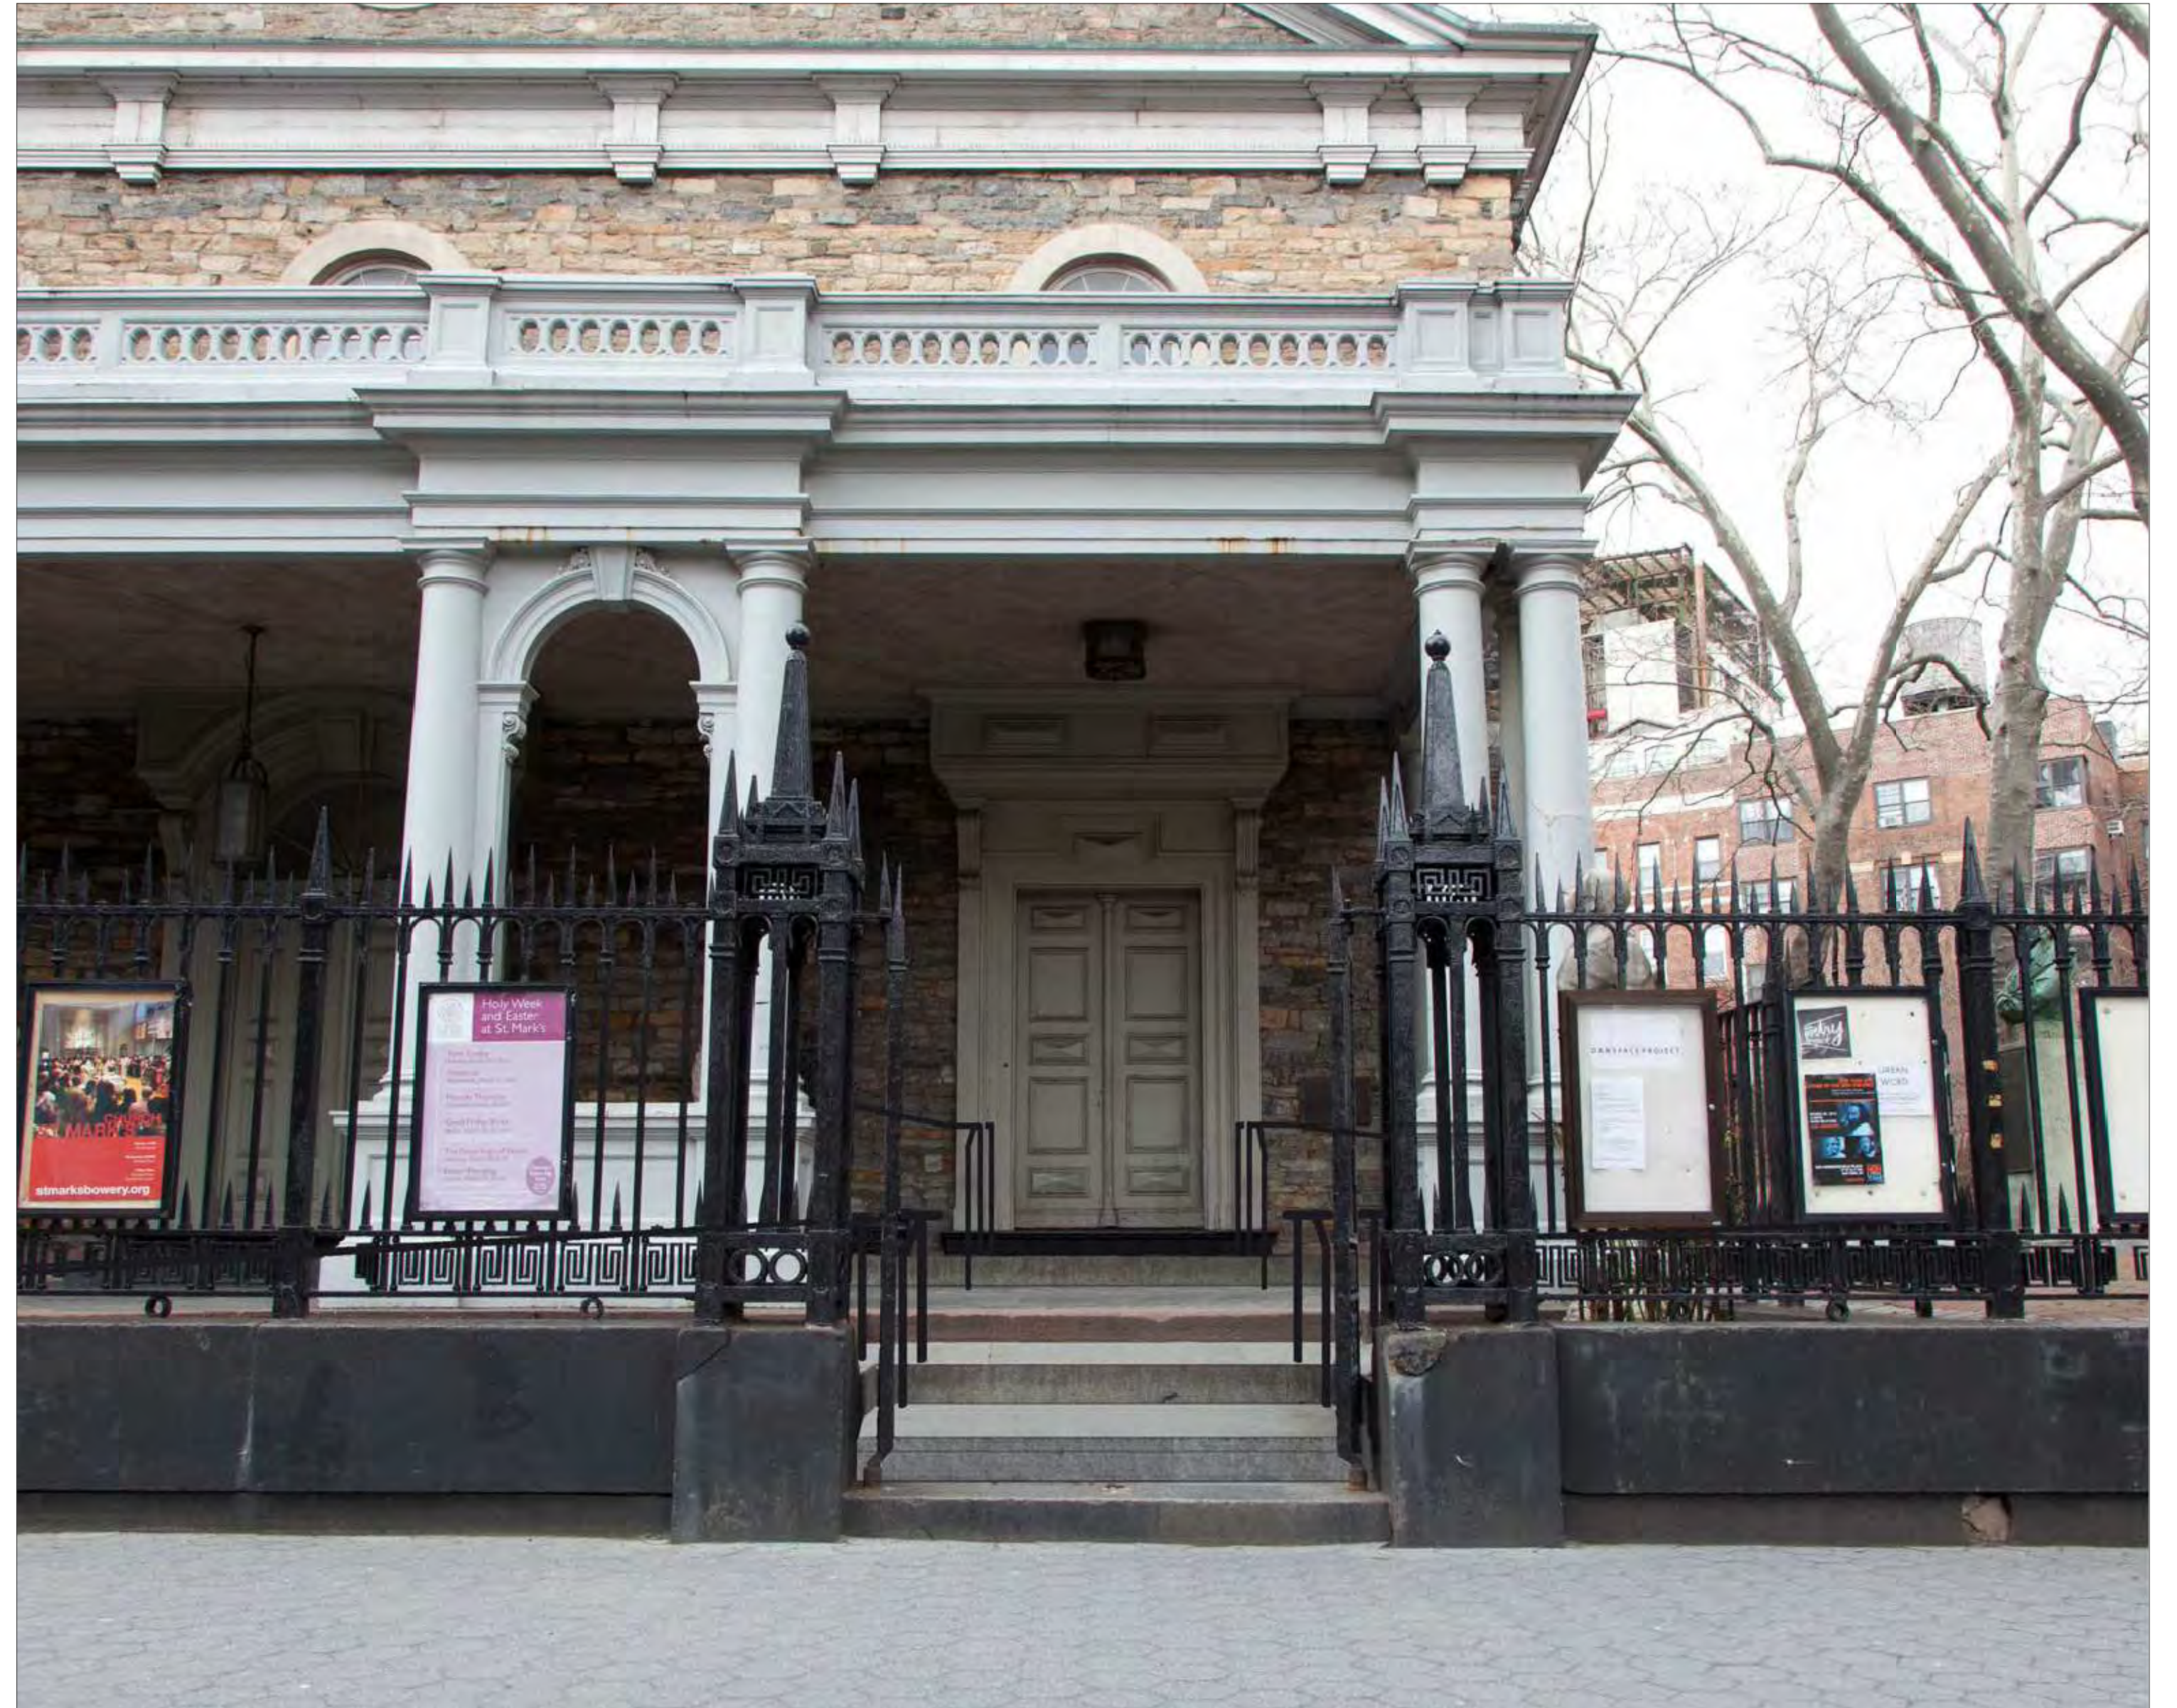
7B EAST GATE - PROPOSED RAMP
2/2013 PROPOSED WORK AREA
