128 West 13th Street
12/20/2011

Mary B Dierickx Historic Preservation Consulting

128 West 13th Street Conditions
12/20/2011

128 West 13th Street
Coated Stone on West 13th Block
Mary B Dierickx Historic Preservation Consulting

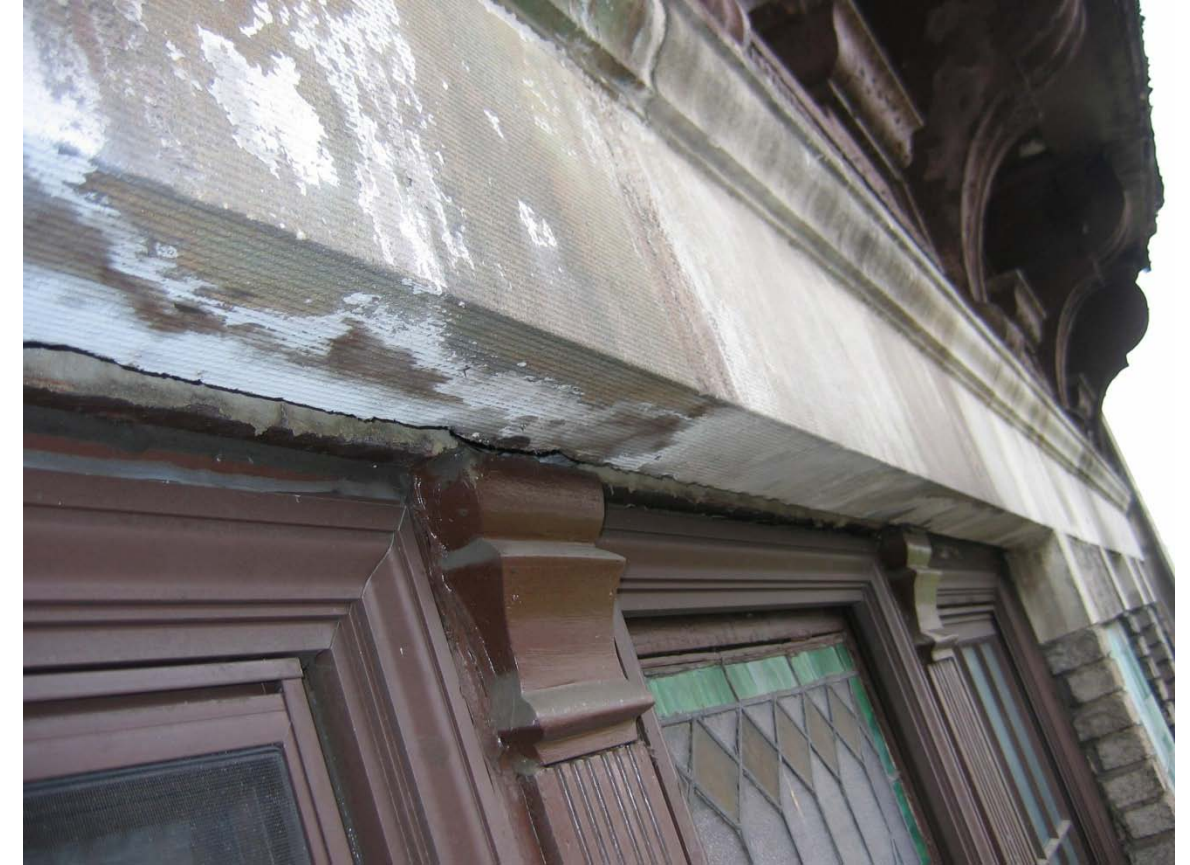
Existing Conditions Before Repair Showing Stained, Water Damaged & Weathered Stone

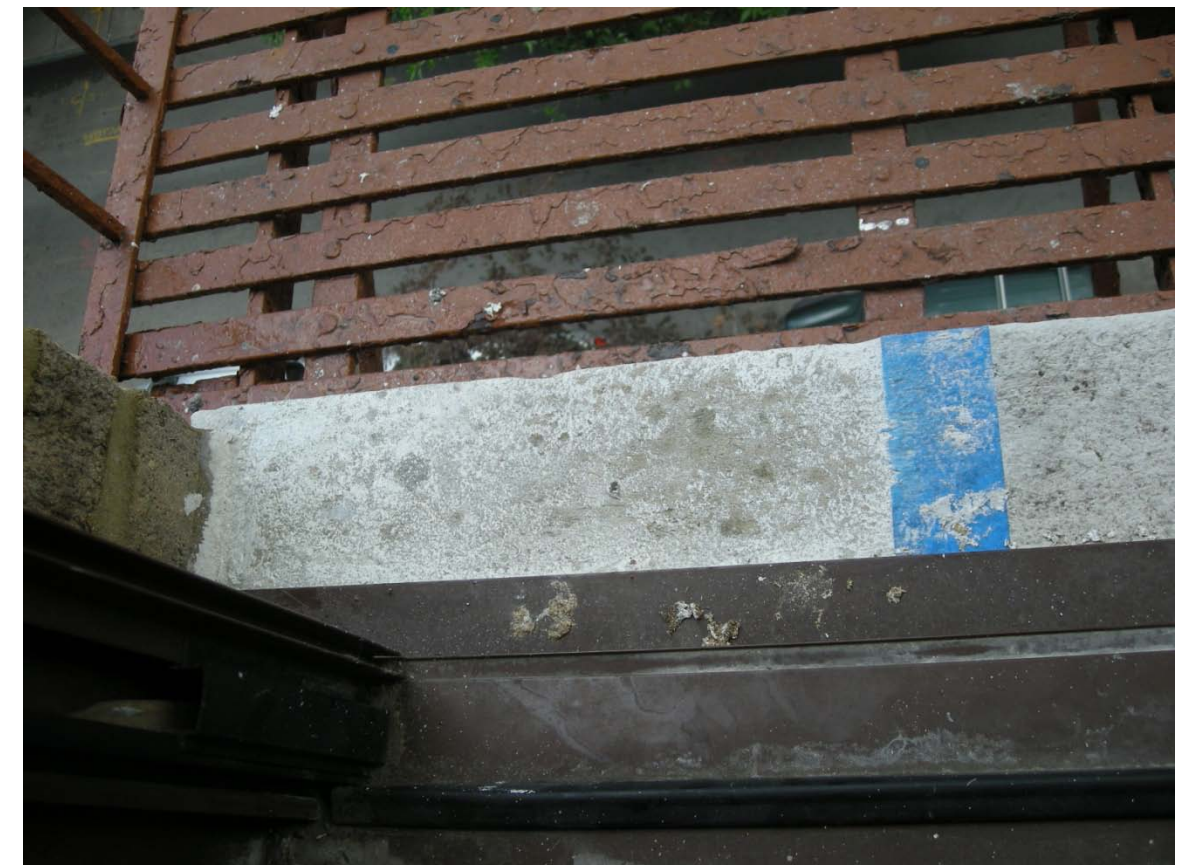
Masonry coating removal test after
2 applications of paint remover
rinsed with water spray, no pressure
