188 SPRING STREET

SCOPE OF WORK:

STREET LEVEL FAÇADE ALTERATION AND REAR HORIZONTAL ENLARGEMENT OF EXISTING 4-STORY RESIDENCE. REPLACEMENT OF ALL WINDOWS AND DOORS.

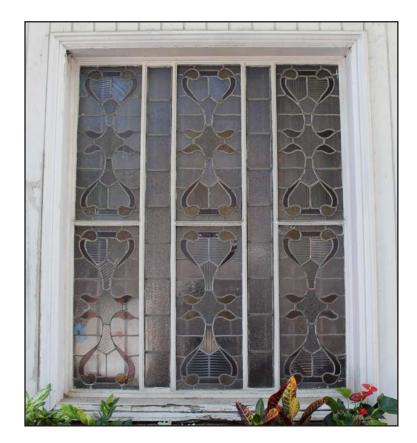
1960s FIRST FLOOR FIXED STAINED GLASS WINDOW

MAIN FAÇADE (NORTH): FIRST-FLOOR CONVERTED TO COMMERCIAL PRIOR TO C. 1940; MOLDED WINDOW LINTELS REMOVED PRIOR TO C. 1940; FIRST-FLOOR COMMERCIAL SPACE CONVERTED TO RESIDENTIAL LIKELY C. 1962; WOOD CLAPBOARD INSTALLED ON FIRST FLOOR; ATTIC DORMER ADDED PRIOR TO 1964; WOOD MOLDED LINTELS REINSTALLED; STAINED GLASS WINDOW INSTALLED ON FIRST FLOOR

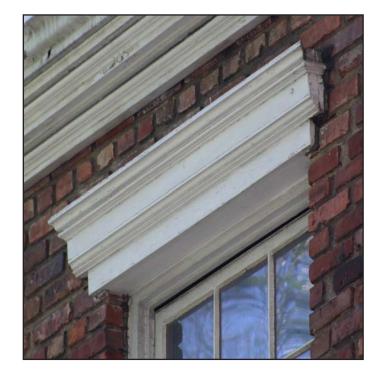
NON-HISTORIC 2ND & 3RD FLOOR WOOD LINTEL

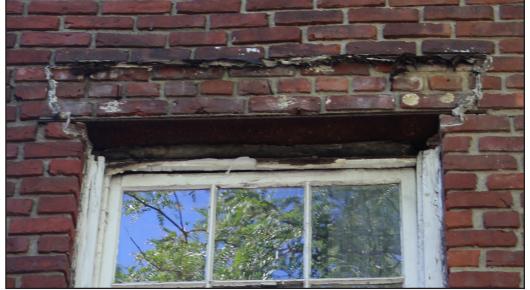
REMOVED NON-HISTORIC 2ND & 3RD FLOOR WOOD LINTEL

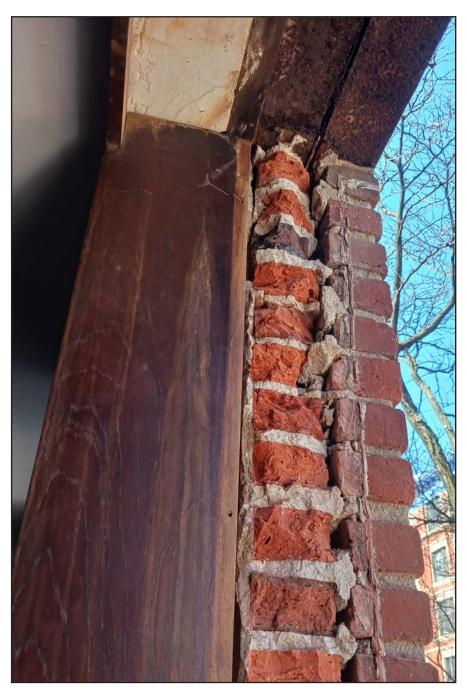
PROBE AT 2ND FLOOR WINDOW SHOWING REPLACED BRICK FACADE

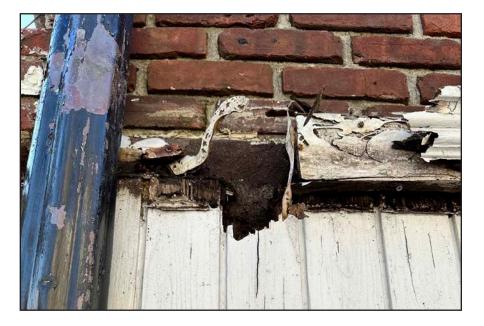
WOOD CLADDING PROBE REVEALING ORIGINAL BROWNSTONE LINTEL

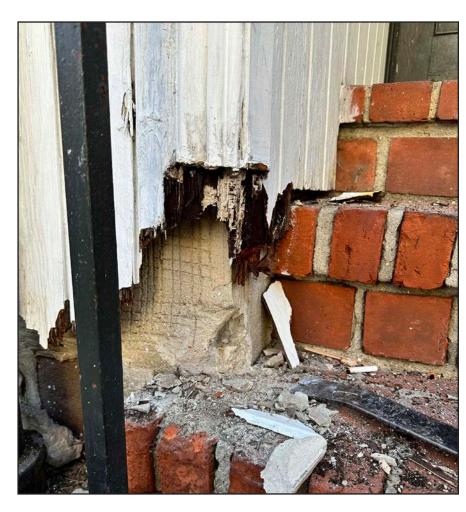
WOOD CLADDING PROBE REVEALING CEMENT INFILL 9
