109 WAVERLY PL,
MANHATTAN, NY 10011
BLOCK 553 LOT 34 – DOCKET# LPC-26-05562

Description of the Work

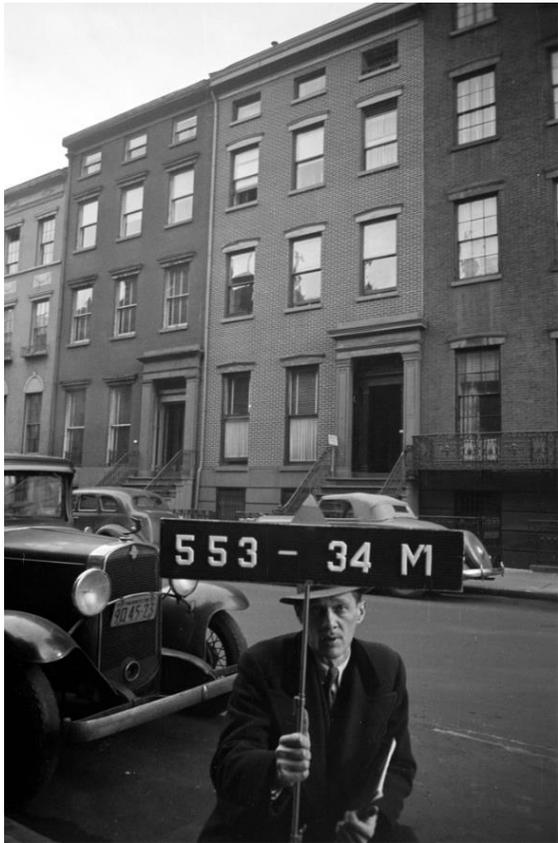
Historic Tax Photo: 1940s

Historic and Existing Property Condition 109 Waverly Pl.

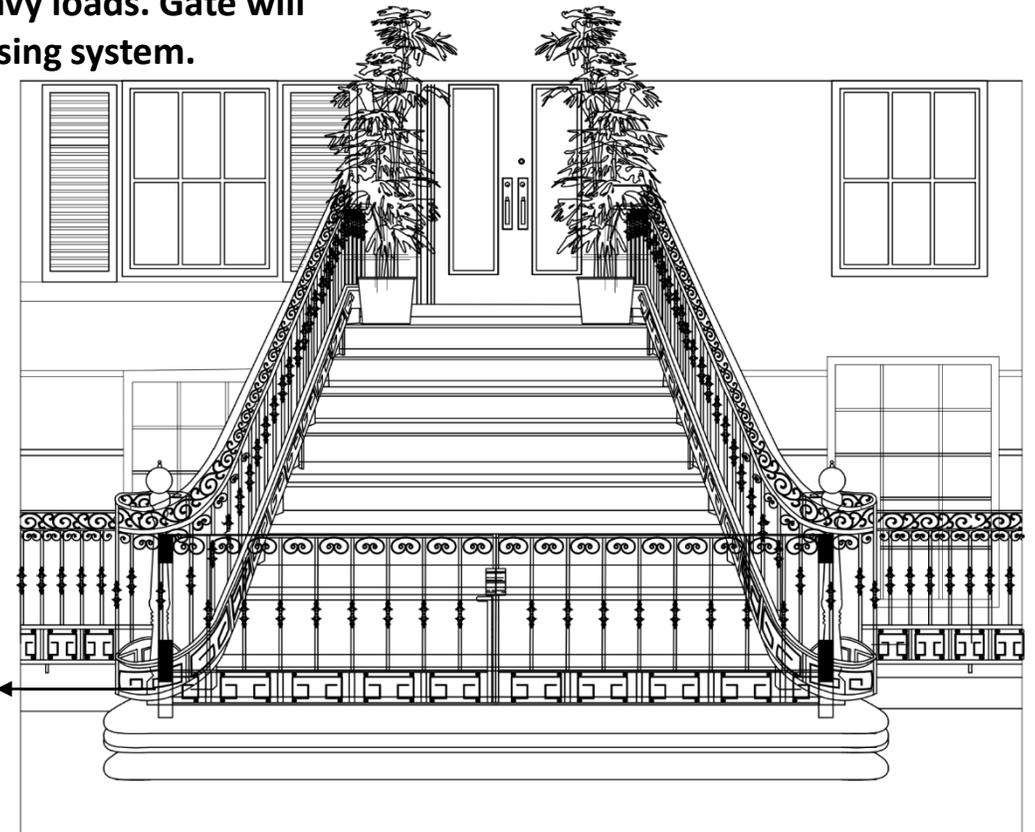
FRONT ELEVATION

Front Elevation Proposed

NOTE: Left gate panel will be the access side to the staircase. Right gate panel will be permanently closed and only opened for heavy loads. Gate will also include self-closing system.

Gate will be positioned towards the back of the front step. Gap between ground of front step and gate bottom is 1"

- We want to install an ornamental iron stoop gate for security at the bottom step of the existing front stair of the property, as it is shown on the elevation drawing (attached on document)
- Stoop gate design follows the existing ironwork alignments and aesthetic design, located at front of the property, which promotes historic site preservation. With the stoop gate, we can manage security, safety, and cleanliness concerns related to homeless or unknown individuals who are causing these concerns for the family.

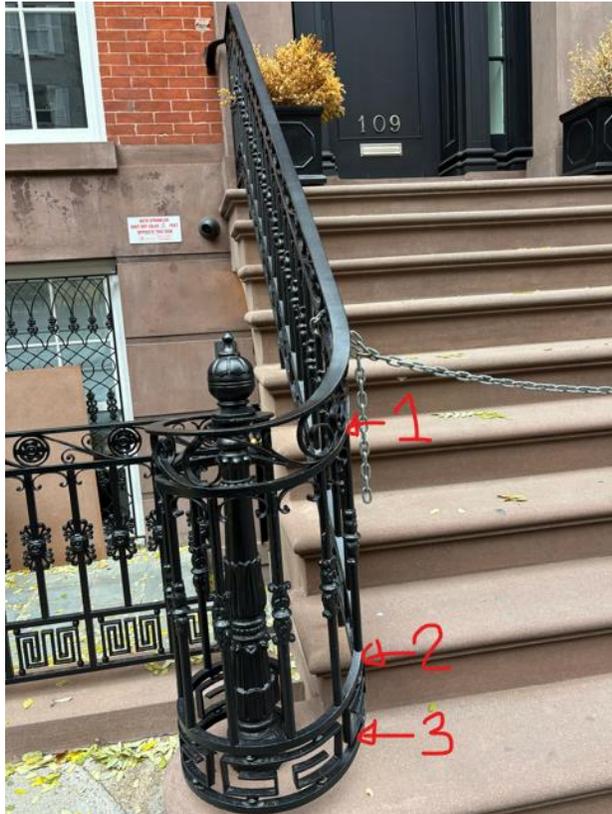
DETAIL A1.1
POST ADAPTATION - SIDE VIEW

Note: In order to protect and conserve the existing iron and avoid stone step openings, the Gate will be attached to existing railing post through a new iron flat post adaption (ref. 1 1/4", 42" height) as shown on detail A1.1.

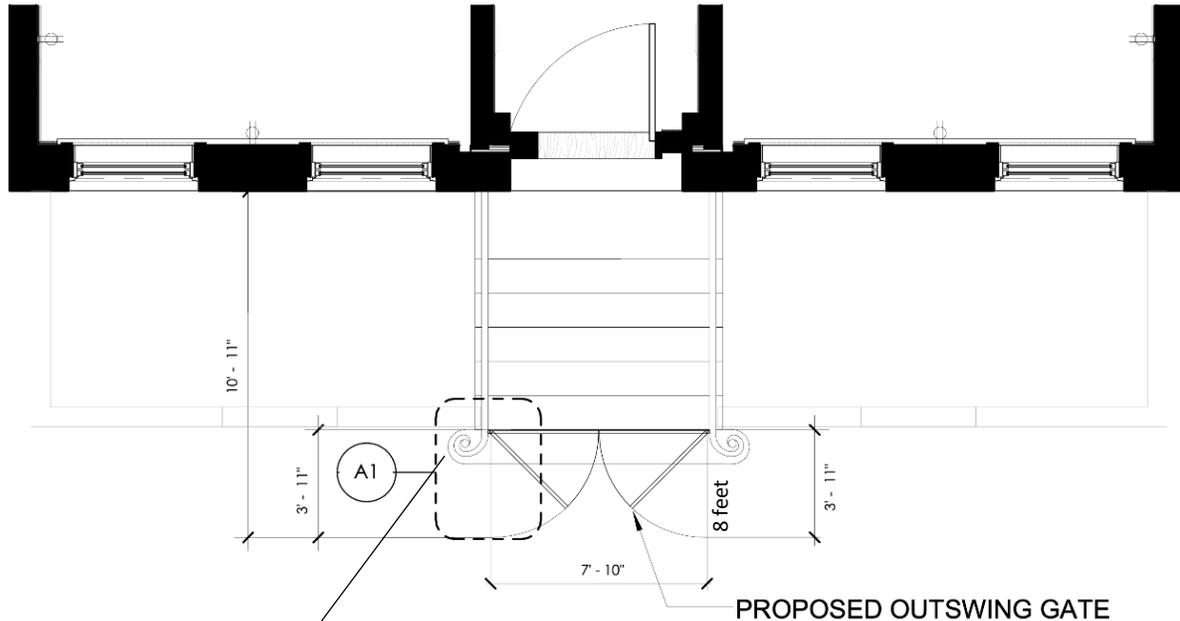
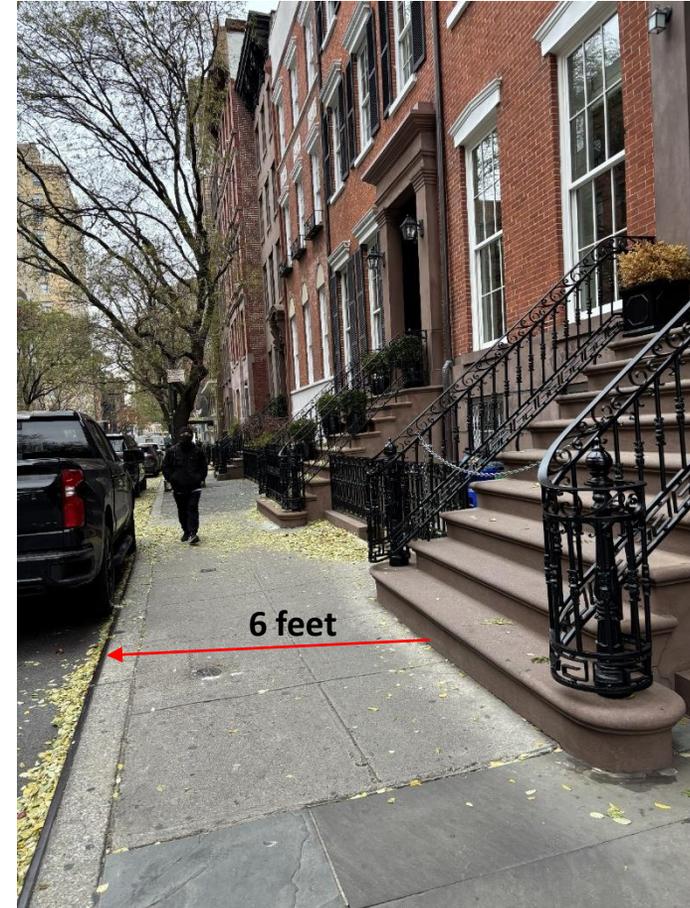
Gate will be positioned towards the back of the front step.

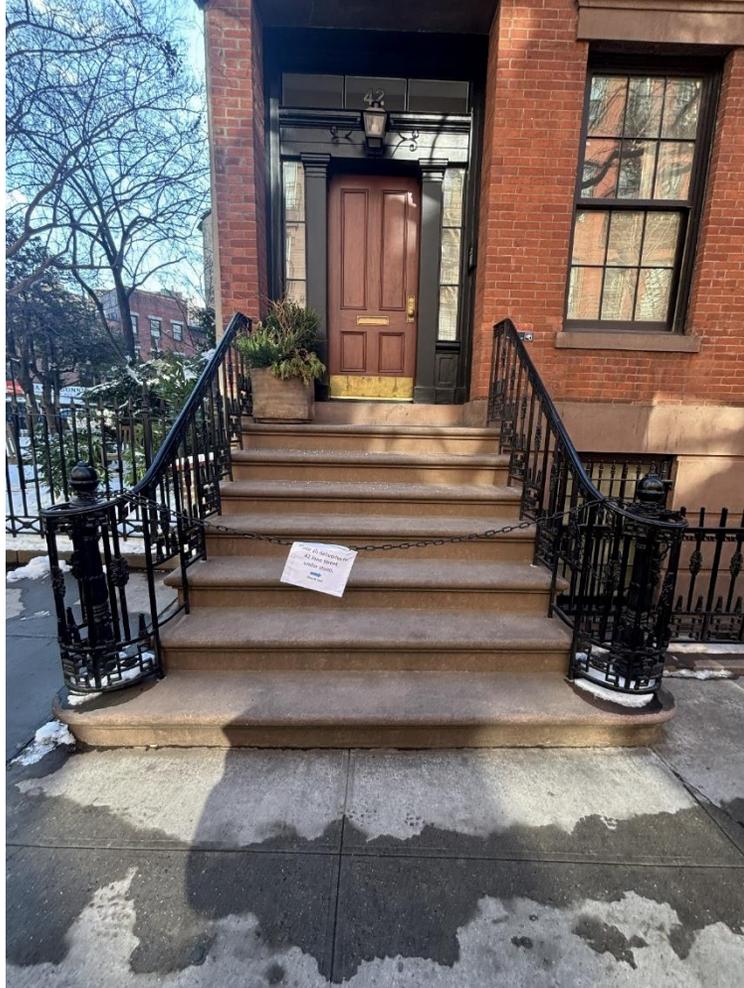
Before

Previous Approved Stoop Gate at 42 Jane St.

*Property had same issues:
