ARCHITECTURAL DRAWINGS & DOCUMENTS
FOR PROPOSED RESTORATION & ALTERATION OF:

432 HUDSON STREET
WEST VILLAGE HISTORIC DISTRICT
NEW YORK, NY 10014

PETER PENNOYER ARCHITECTS

CB2 LANDMARKS COMMITTEE 12.11.25

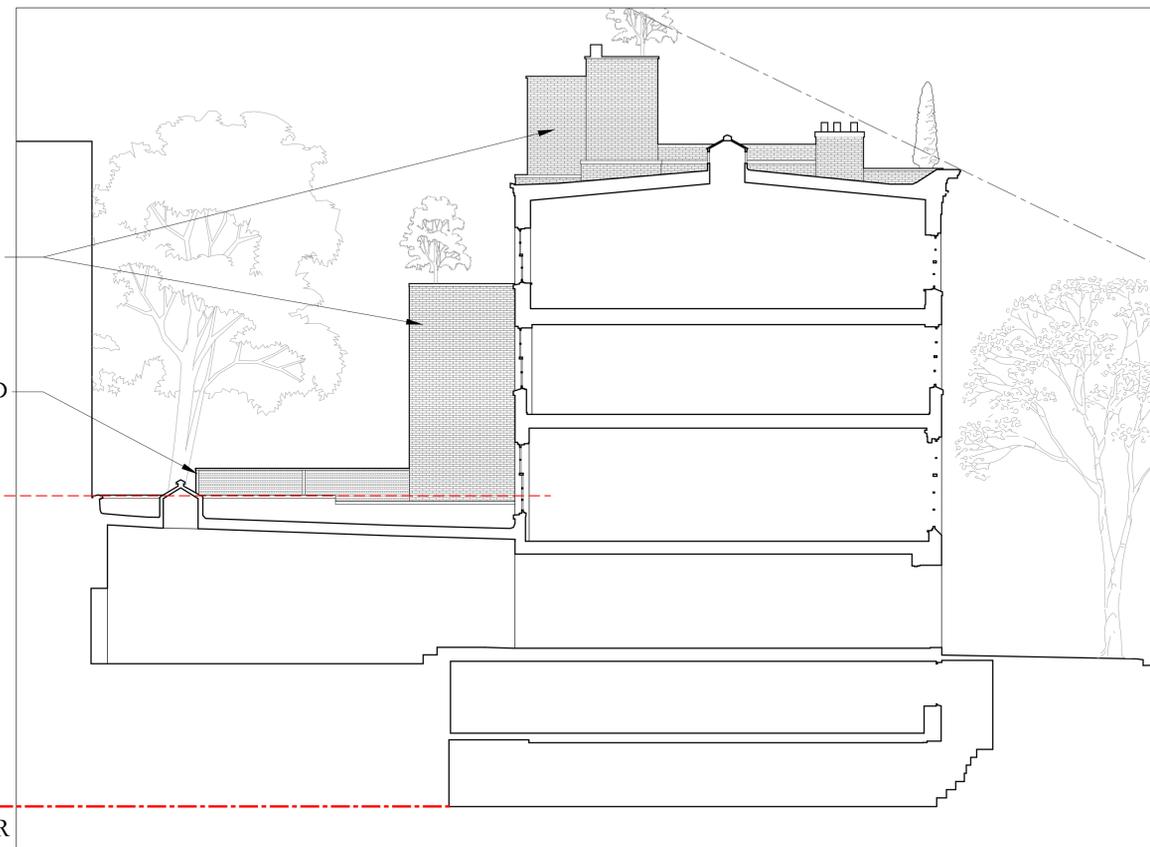
02
LPC-05 EXISTING BUILDING SECTION FACING SOUTH 1/8" = 1'-0"

EXISTING PARAPET HEIGHT @ REAR EXTENSION

EXISTING CELLAR FLOOR LEVEL

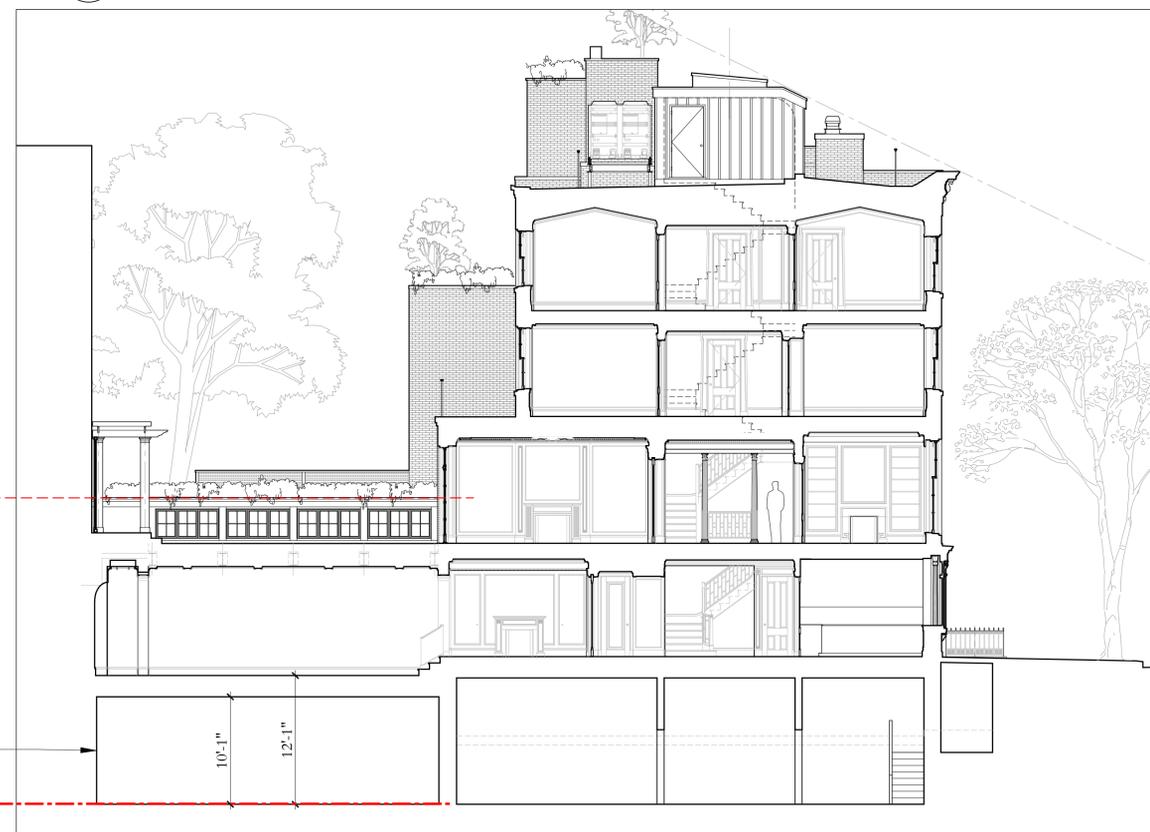
01
LPC-05 PROPOSED BUILDING SECTION FACING SOUTH 1/8" = 1'-0"

PROPOSED NEW EXCAVATED SPACE

EXISTING CELLAR FLOOR LEVEL

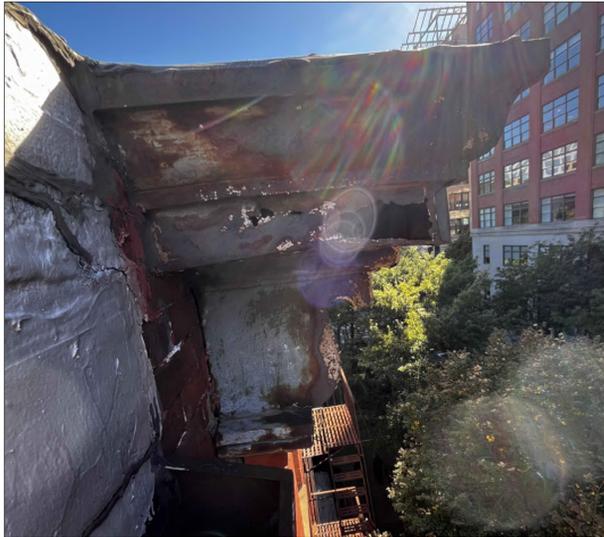
WIDESPREAD CORROSION & SECTION LOSS AT
PAINTED GALVANIZED METAL CORNICE

NEW SHEET METAL CORNICE TO
REPLICATE ORIGINAL PAINTED
GREEN

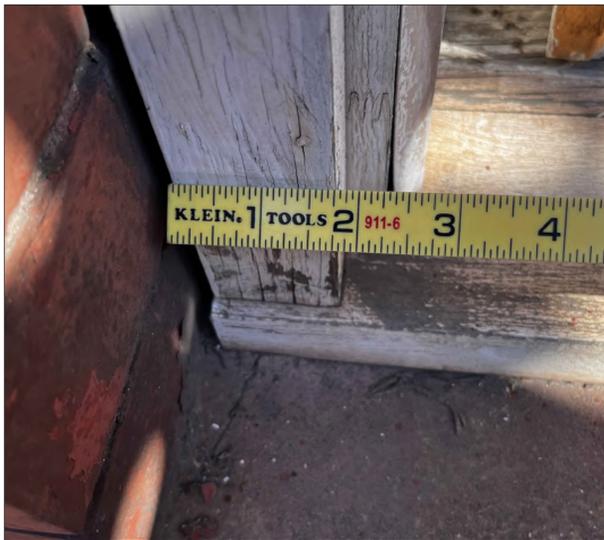
NON-ORIGINAL WINDOWS WITH NO BRICK MOULD
OR CAULKING

NEW DOUBLE-HUNG WOOD
WINDOWS PAINTED GREEN TO
MATCH SAMPLE

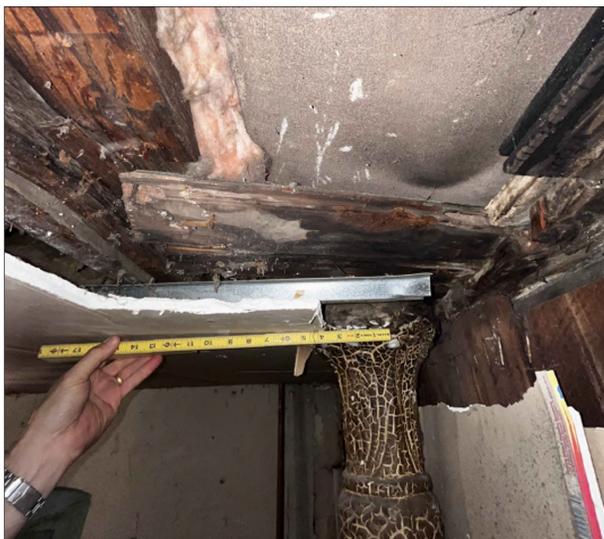
EXISTING CAST IRON COLUMNS SUPPORTING
BROWNSTONE LINTEL BEHIND STUCCO FACADE

EXISTING CAST IRON COLUMNS TO
BE REFINISHED & REMAIN IN PLACE

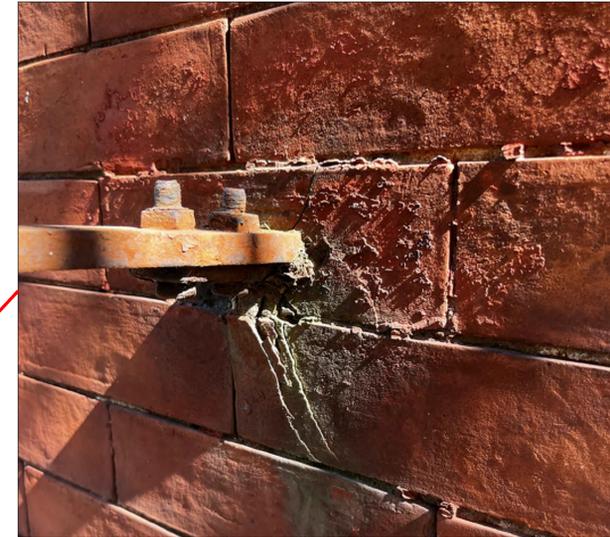
DAMAGED BRICK & RUSTING AT FIRE ESCAPE
ATTACHMENT POINTS

- NEW SHOPFRONT
- NEW ENTRY DOOR & TRANSOM
- NEW ENTRY RAILING & GATE
- NEW WOOD DOUBLE-HUNG WINDOWS
- NEW CAST 'BROWNSTONE' LINTELS & SILLS
- BRICK RESTORATION WORK
- NEW SHEET METAL CORNICE TO REPLACE DAMAGED EXISTING
- REMOVE FIRE ESCAPE

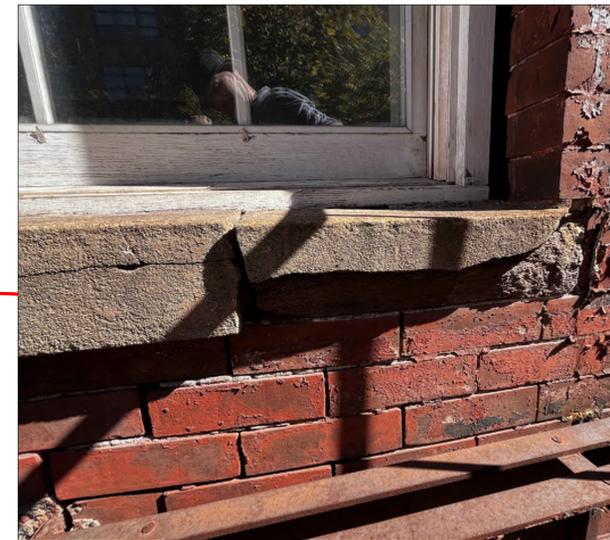
CRACKED, DISLOCATED & SPALLED CEMENTITIOUS
PARGING OVER BROWNSTONE WINDOW SILLS

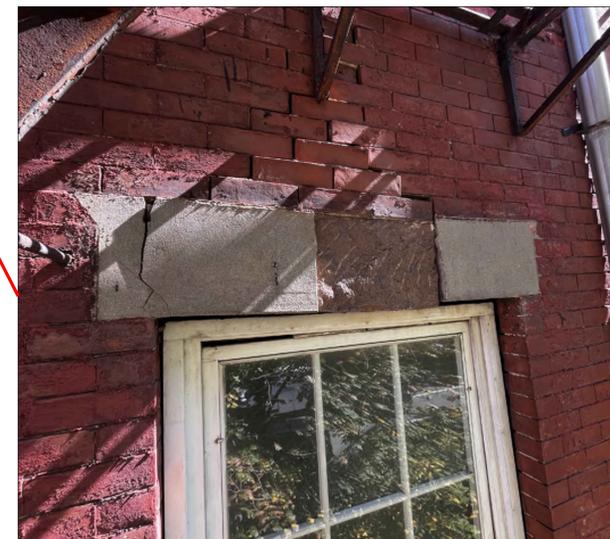
CRACKED BROWNSTONE LINTEL, DISPLACED
BRICK, AND DELAMINATED PARGING

NEW BROWNSTONE LINTELS
WITH CAP PROFILE TO MATCH
NEIGHBOR

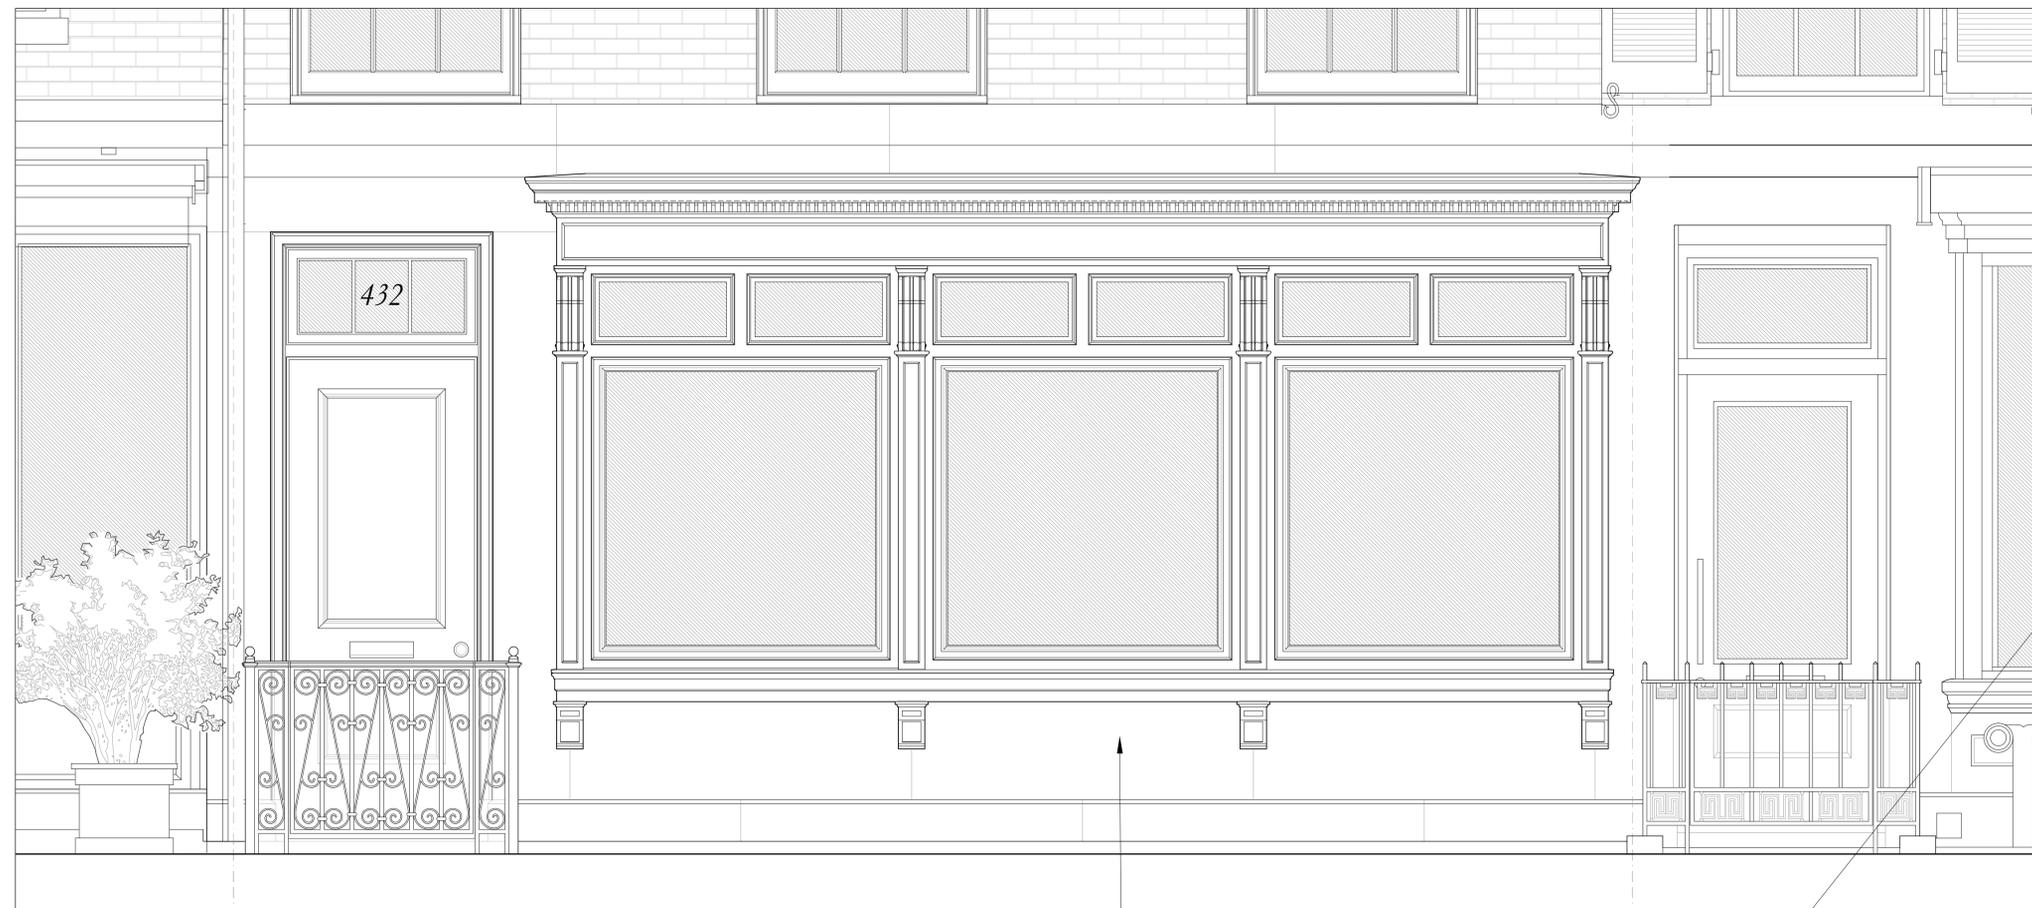
02 PROPOSED VICTORIAN SHOPFRONT ELEVATION
LPC-09

STUCCO WALL FINISH TO MATCH
NEIGHBORING FACADES

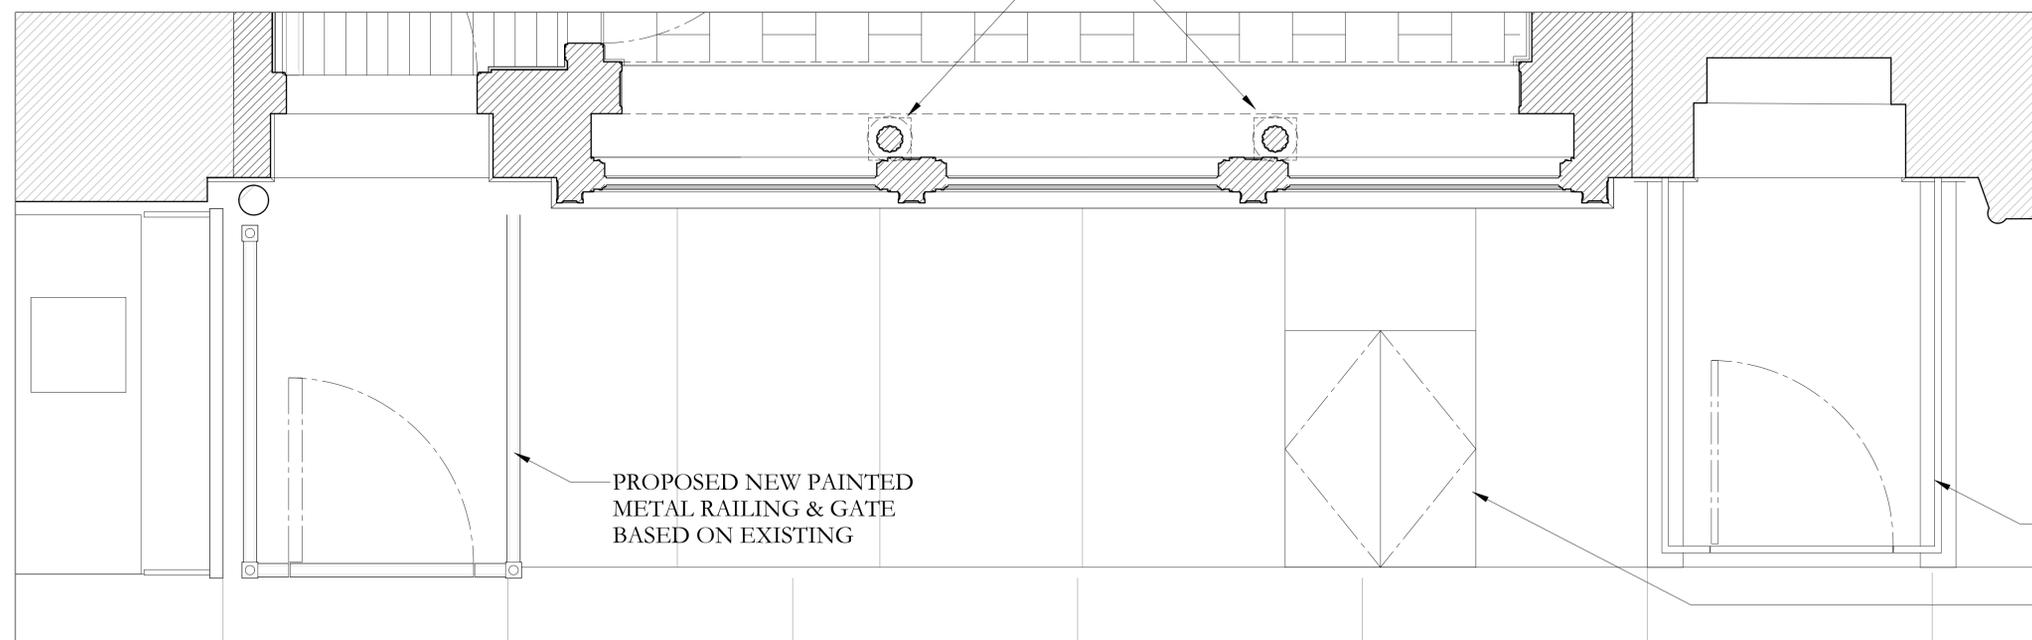
01 PROPOSED PLAN @ SHOPFRONT & SIDEWALK
LPC-09

PROPOSED NEW PAINTED
METAL RAILING & GATE
BASED ON EXISTING

NEW SIDEWALK HATCH

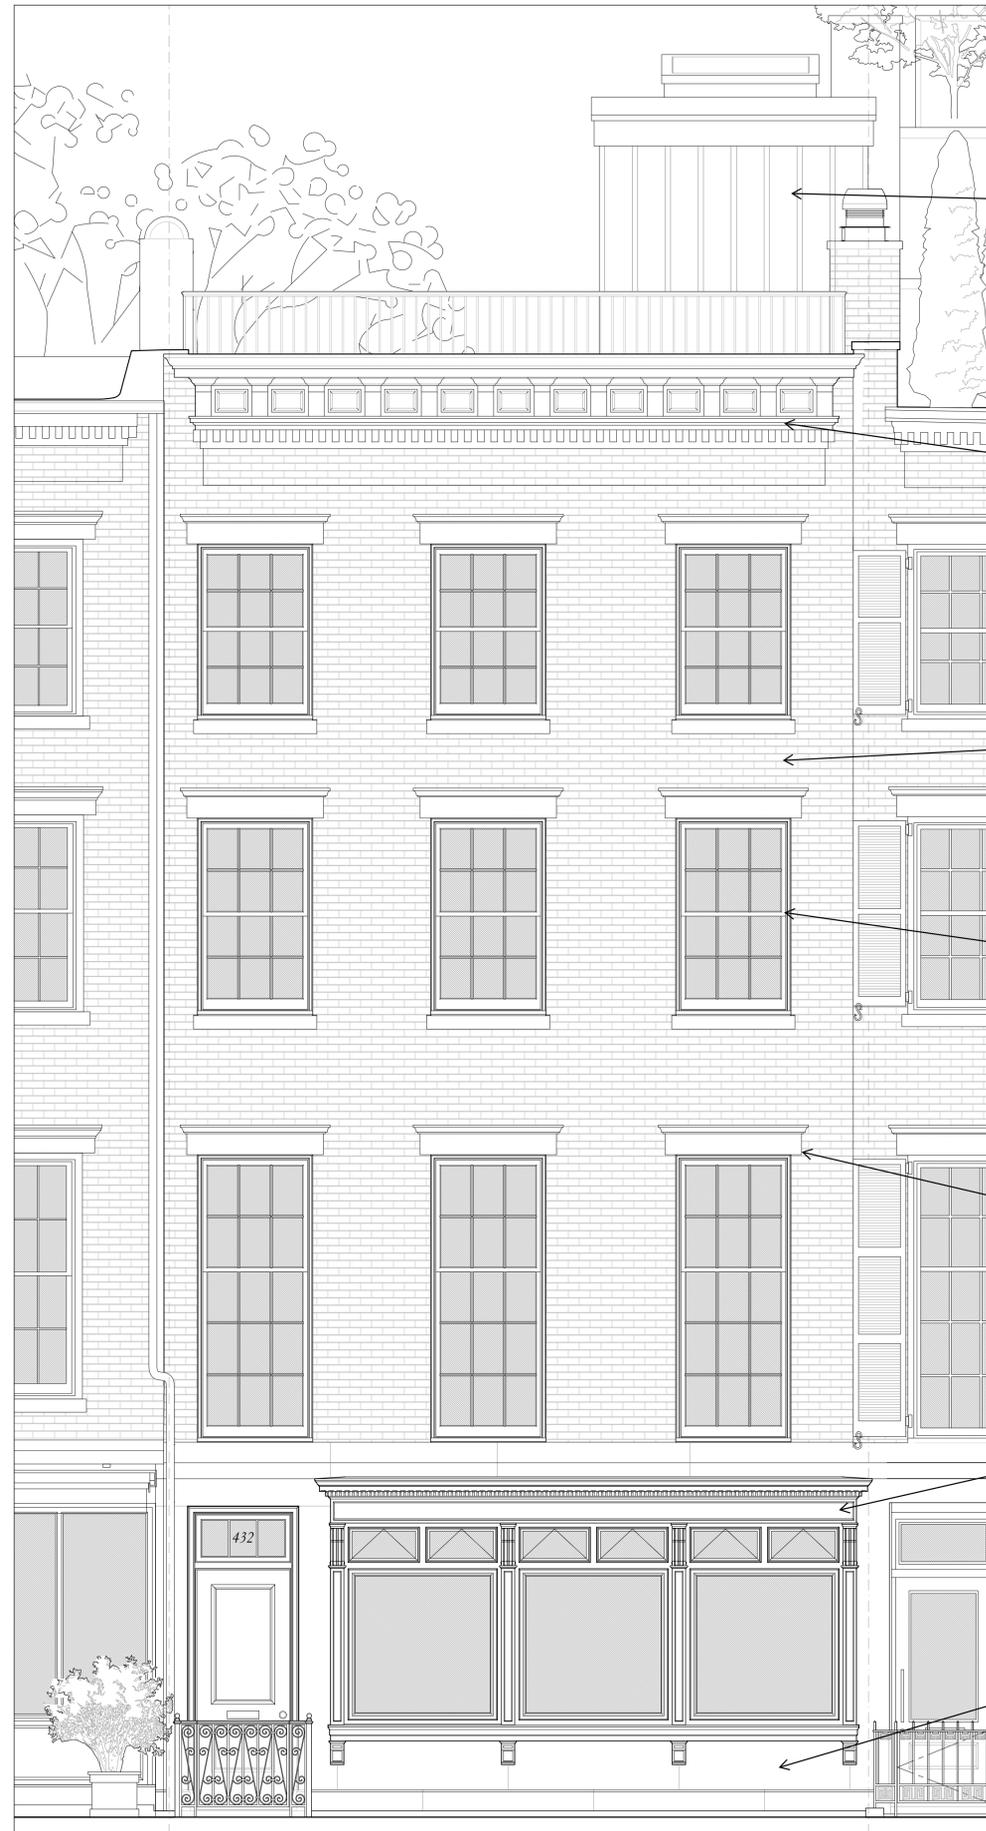
01 PROPOSED HUDSON STREET FACADE

BULKHEAD TO BE CLAD IN ZINC
COATED COPPER IN A BOARD &
BATTEN

EXISTING BRICK TO REMAIN IN
PLACE AND BE RESTORED

WOODEN SHOPFRONT PAINTED
GREEN TO MATCH SAMPLE
TAKEN FROM ORIGINAL WINDOW
AT REAR

BROWNSTONE STUCCO - TO
MATCH NEIGHBORING DOOR
SURROUNDS

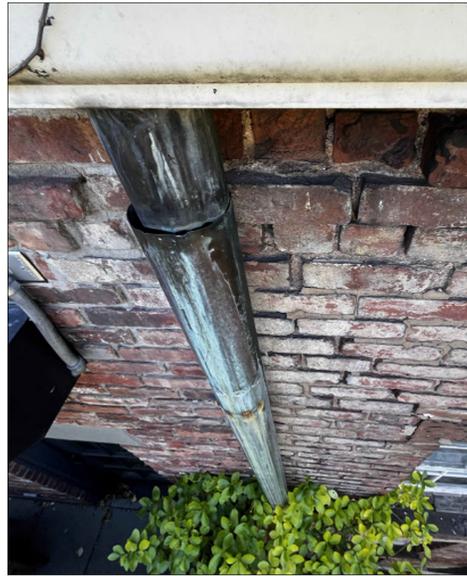
STEP CRACKS & OPEN JOINTS
BELOW DOWNSPOUT LEADER

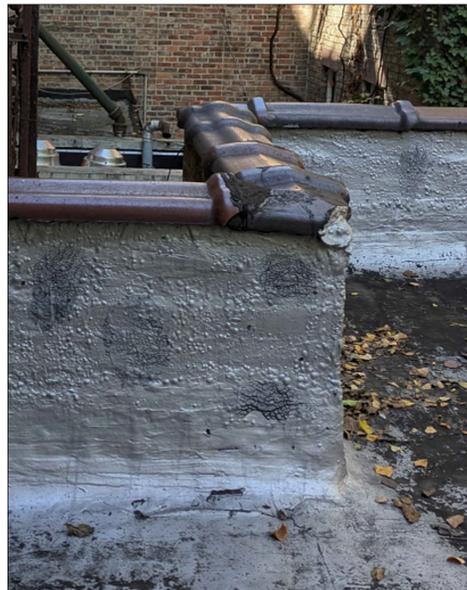
ROOFING & PARAPET IN POOR
CONDITION

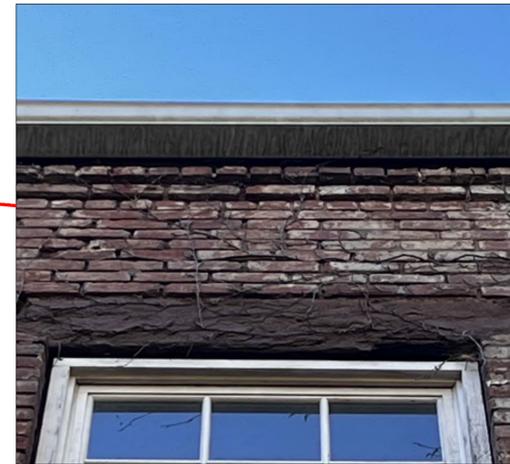
SPALLED BRICKS AND OPEN
JOINTS BELOW EXISTING
GUTTER

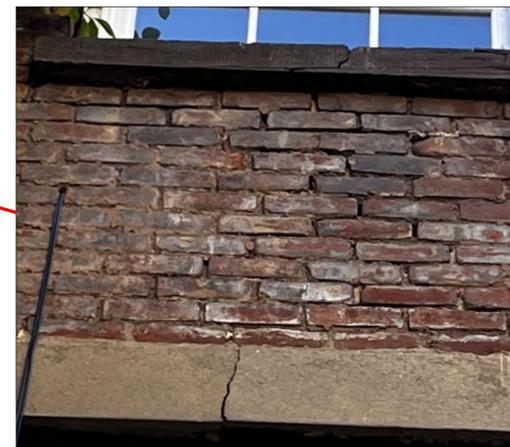
PARGED LINTEL CRACKED AT
MID-SPAN CAUSING STEP
CRACKING AT APRON WALL

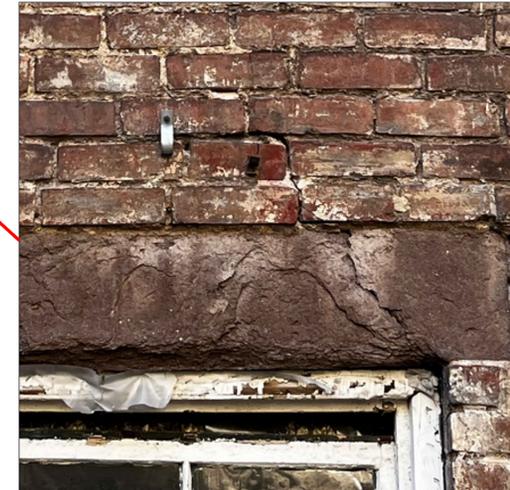
SPALLED AND ERODED
BROWNSTONE LINTELS & SILLS

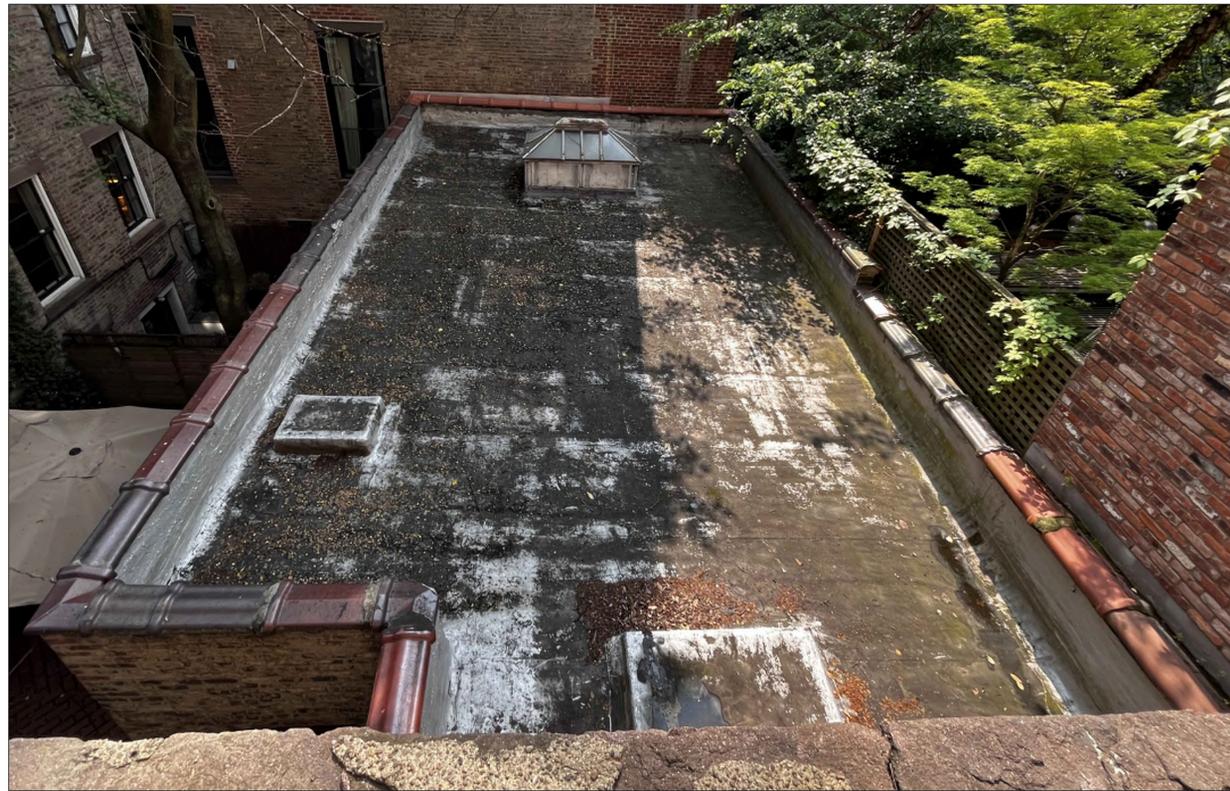
EXISTING SINGLE-STORY REAR
EXTENSION - NOTE DETERIORATED
ROOFING, INFILLED PENETRATIONS, &
CRACKED/VARYING COPINGS AS WELL
AS POSITION RELATIVE TO ADJACENT
REAR FACADE EXTENSION AT RIGHT

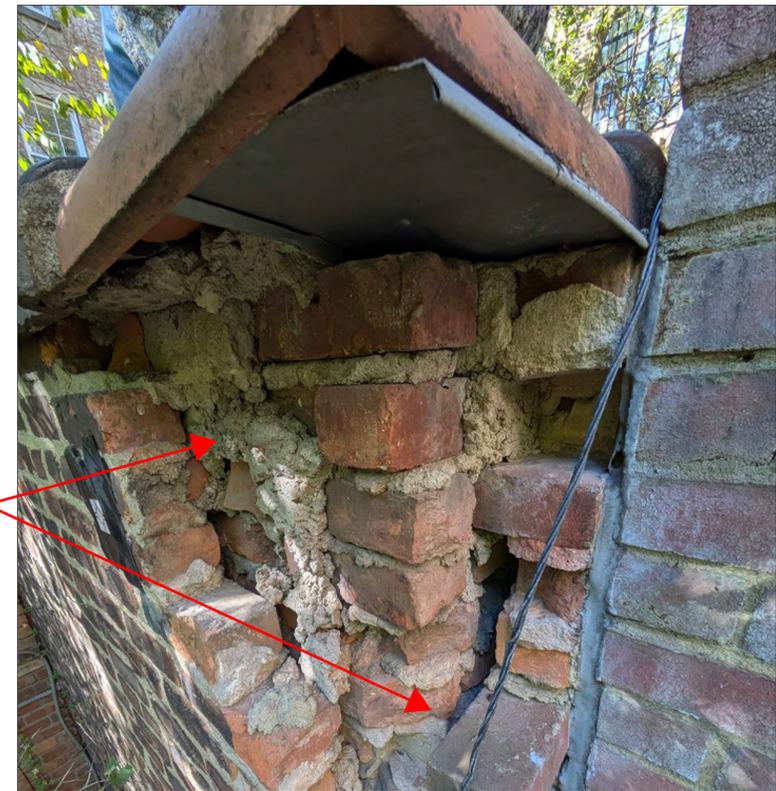
EXISTING DAMAGE AT SOUTHEAST
CORNER CAUSED BY A TREE IN THE
ADJACENT REAR YARD; NOTE
RUDIMENTARY TWO-WYTHE WALL
ASSEMBLY.

EXISTING AREAS OF REMOVAL AT EAST FACADE REVEAL A RUDIMENTARY
TWO WYTHE WALL ASSEMBLY WITH LARGE VOIDS AT THE SLUSH JOINTS.

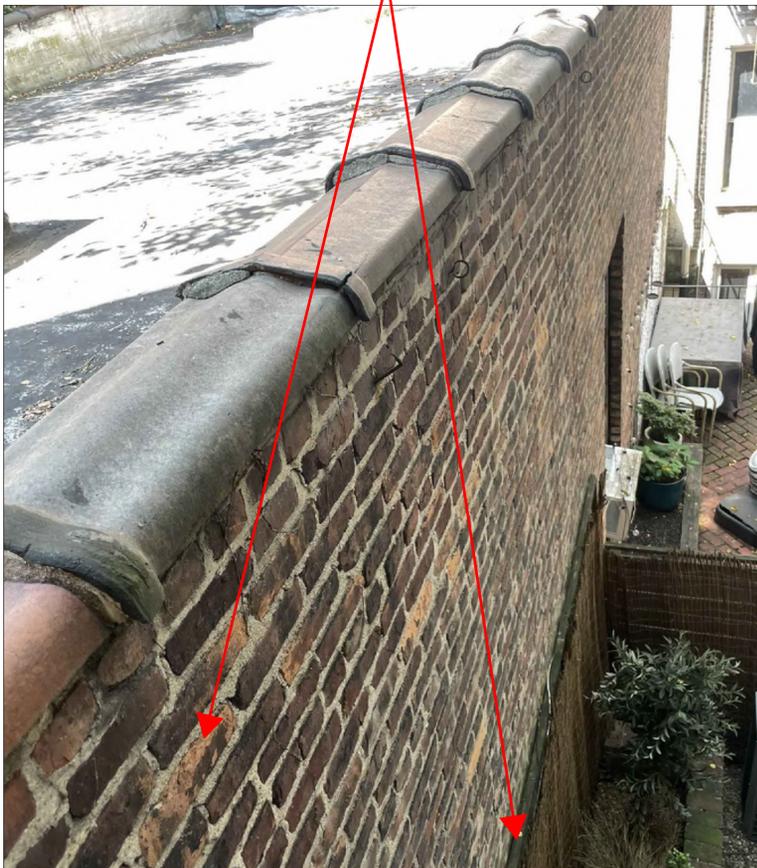
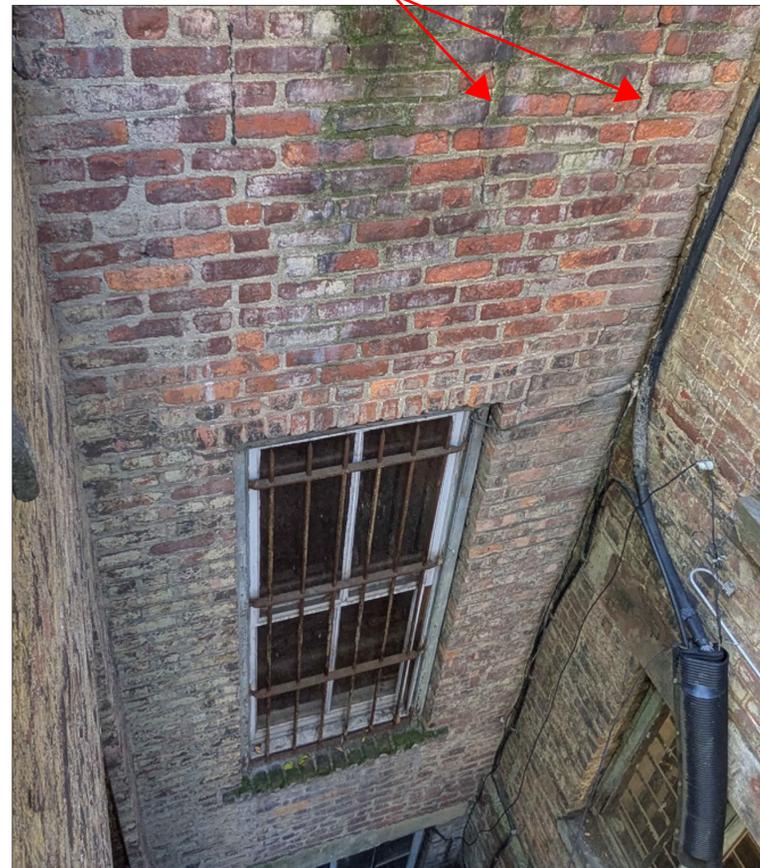
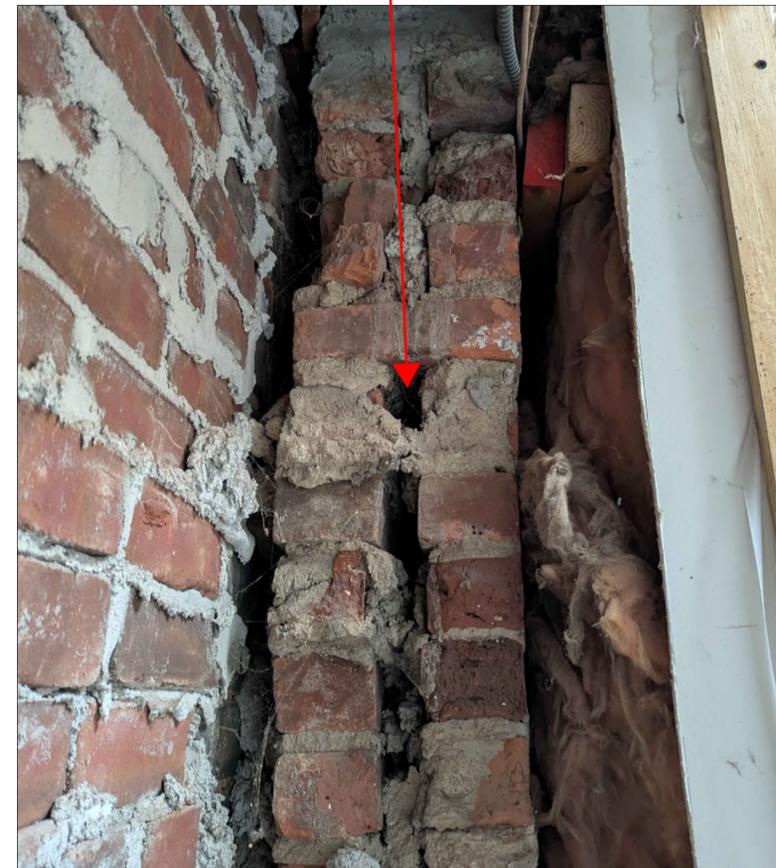
NORTH FACADE EXHIBITS LOSS OF FIRESKIN, BUCKLING AND
LONG-TERM WATER INFILTRATION ALONG THE WALL BASE.

LIGHTWELL ADJACENT TO ORIGINAL REAR FACADE; CONFIGURATION
DIRECTS STORM DRAINAGE INTO CELLAR AREAWAY - NOTE VERITCAL
CRACKING THROUGH SEVERAL COURSES OF BRICK
