Sullivan Thompson Historic District Map: LP-2590

139 Thompson Street Community Board Presentation January 12, 2026

CCD1 - Application of 2022 NYC Building Code

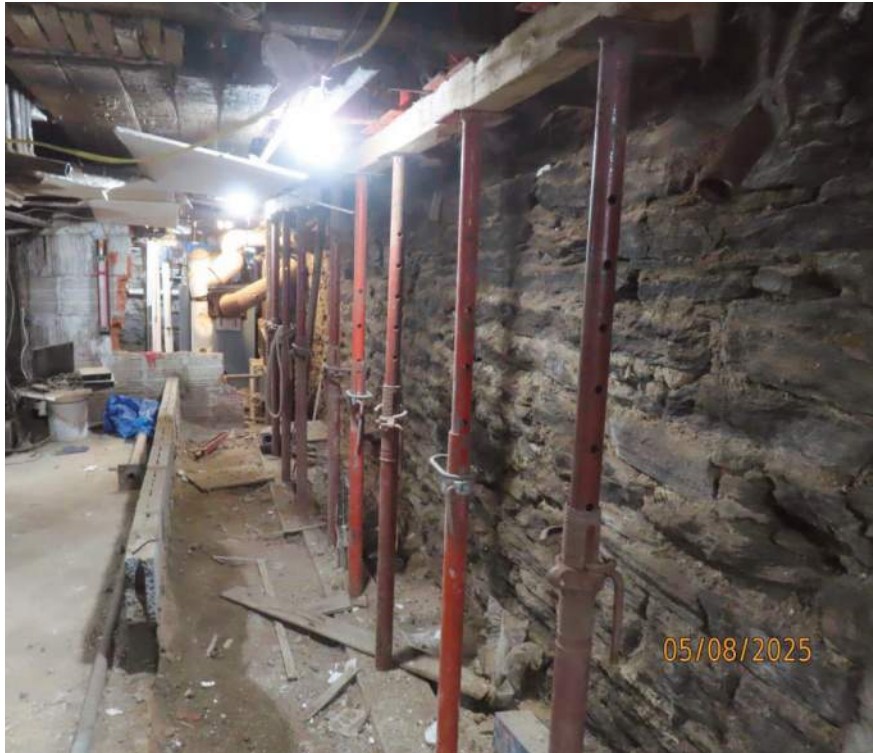
A. CURRENT CONDITION AT CELLAR

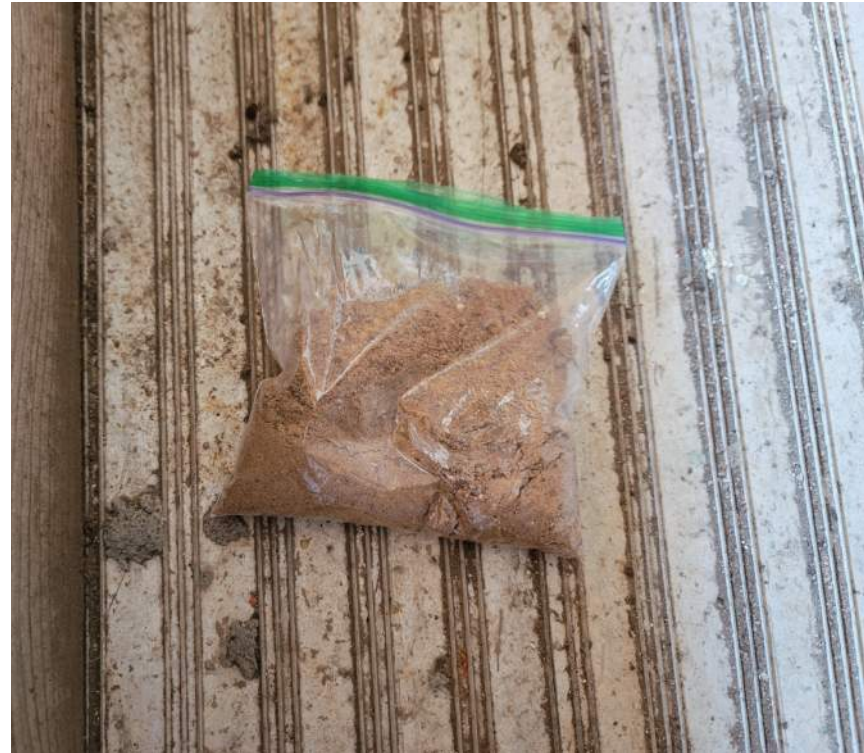
B. BRICK DUST COLLECTED FROM SCAFFOLD

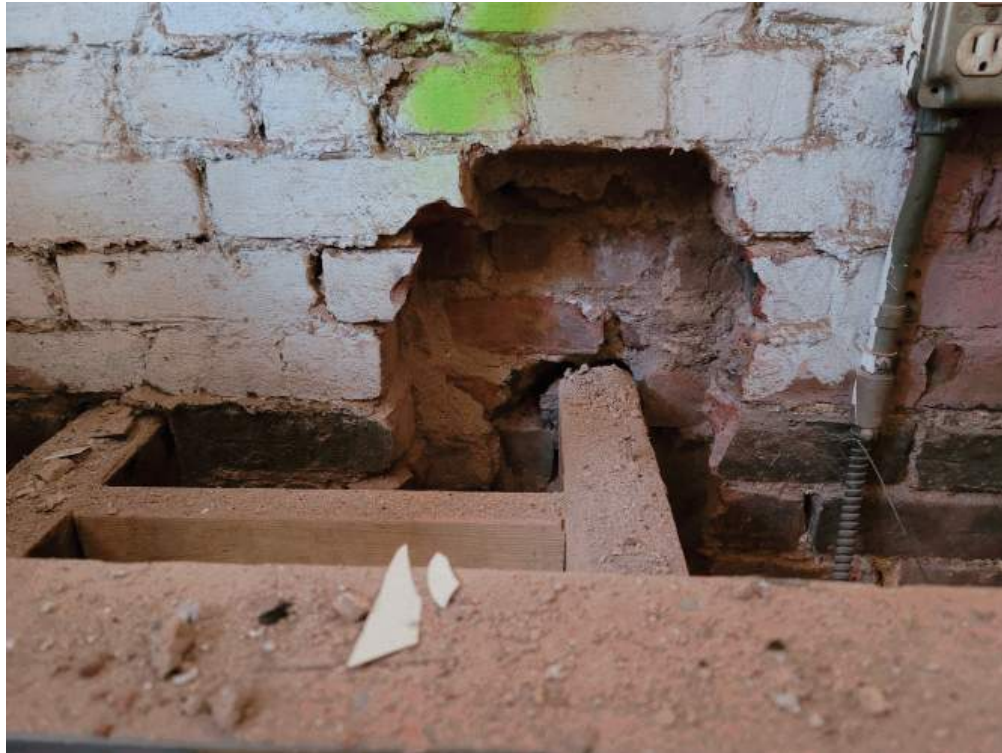
DEGRADED JOIST SLIPPING FROM POCKET

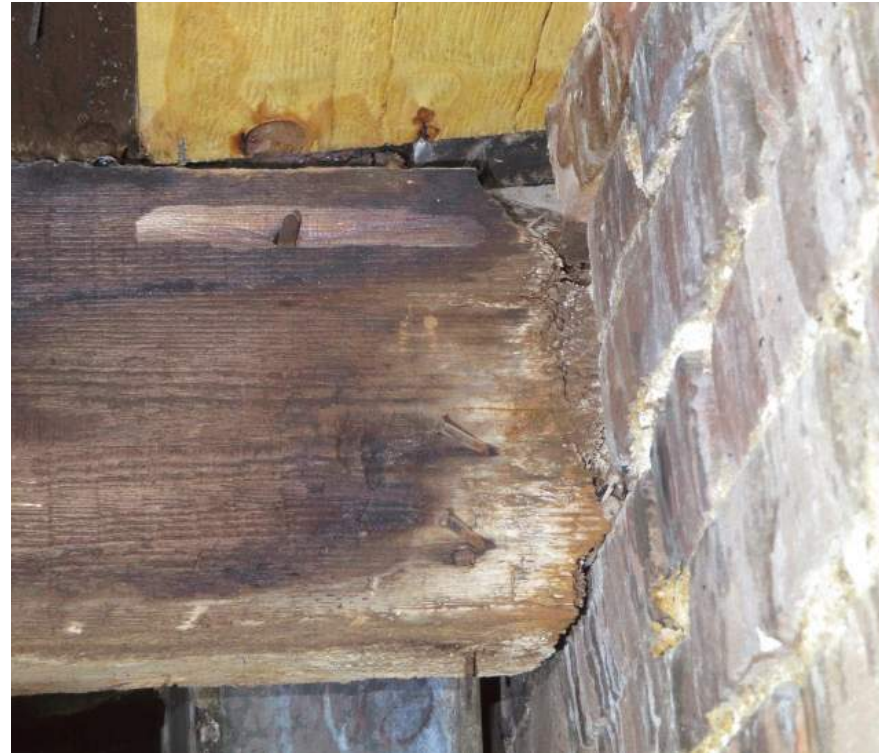
DEGRADED JOIST SLIPPING FROM POCKET

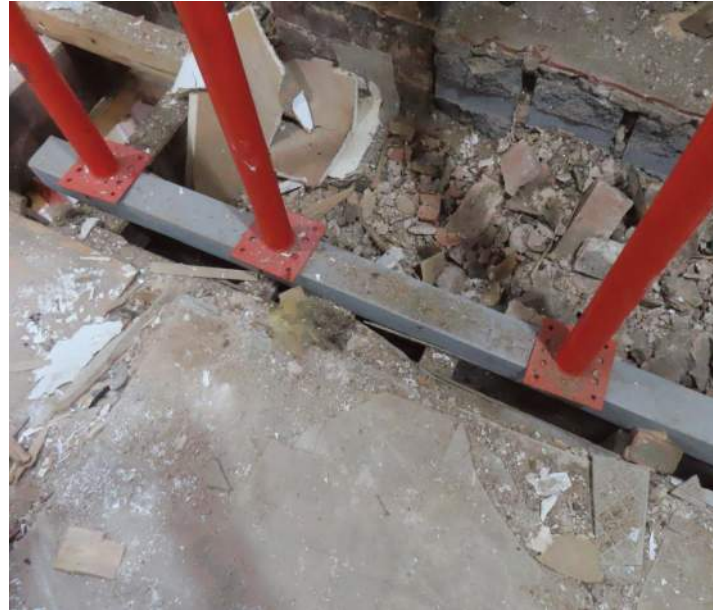
SHORING JACKS (DETAIL)

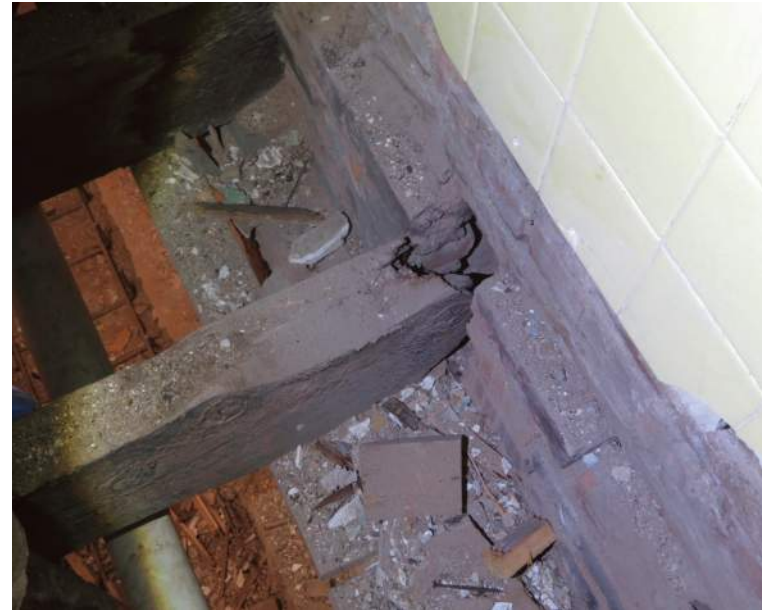
DEGRADED JOIST SLIPPING FROM POCKET

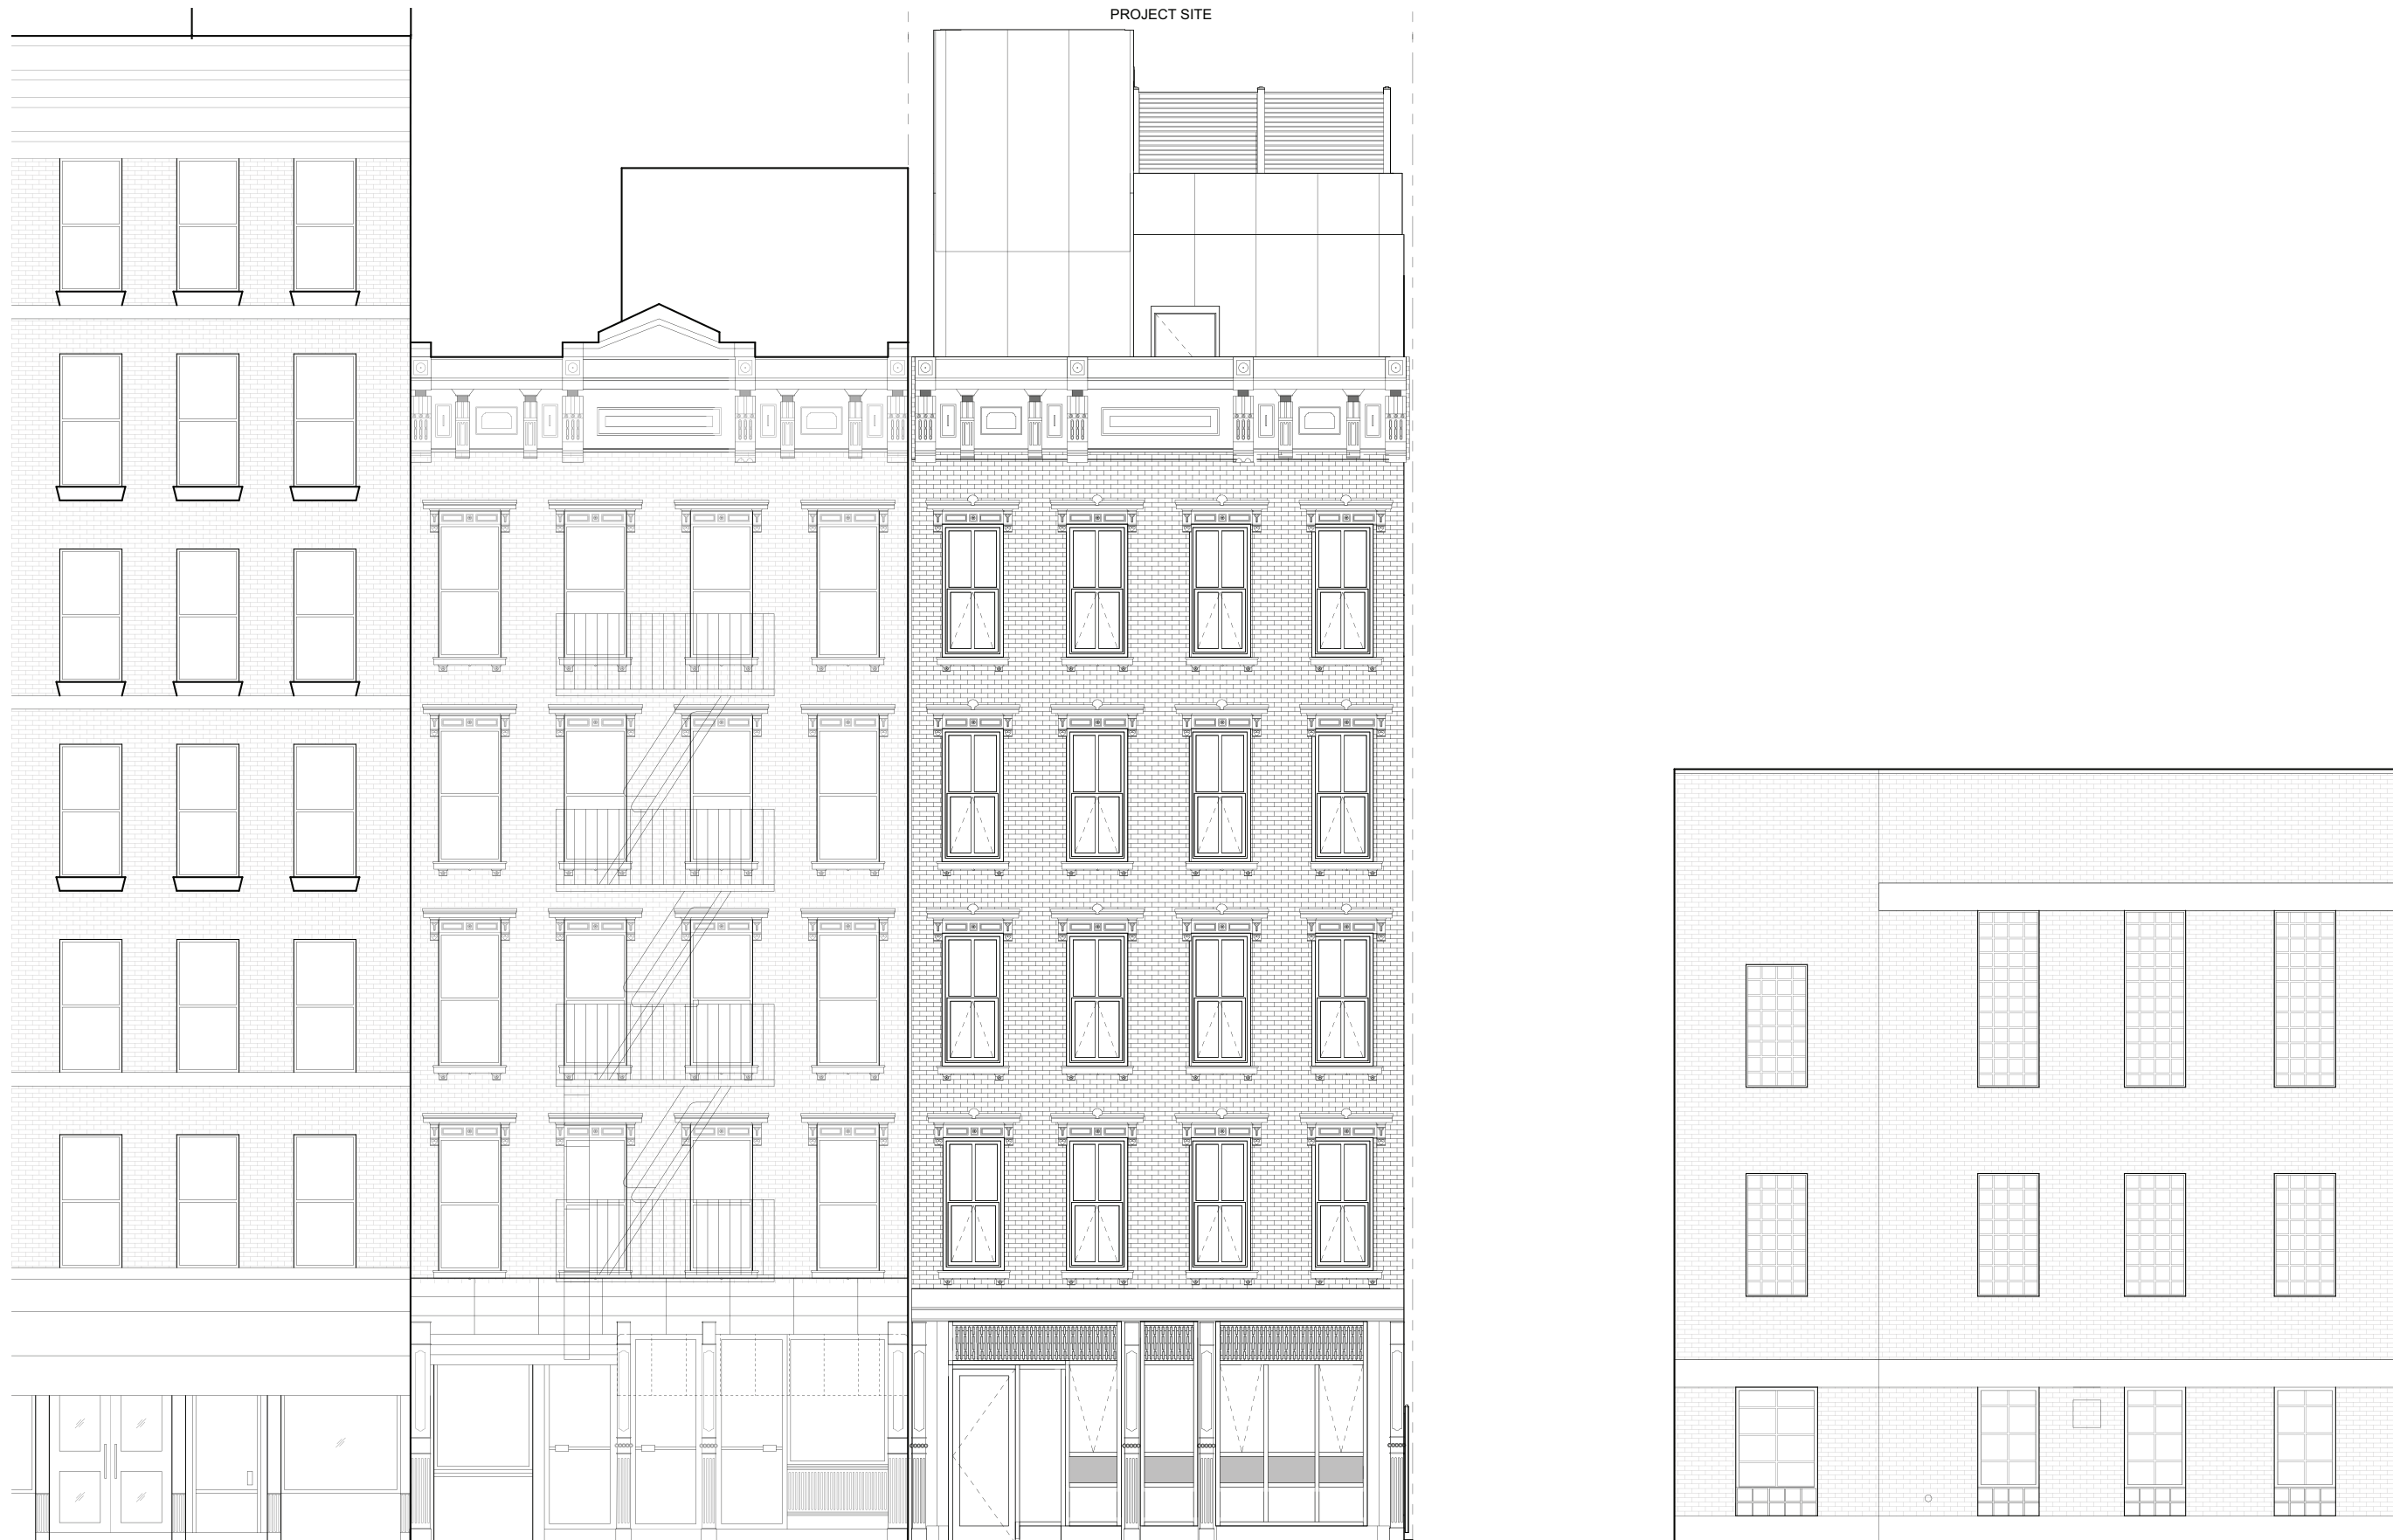
THOMPSON STREET ELEVATION - PROPOSED

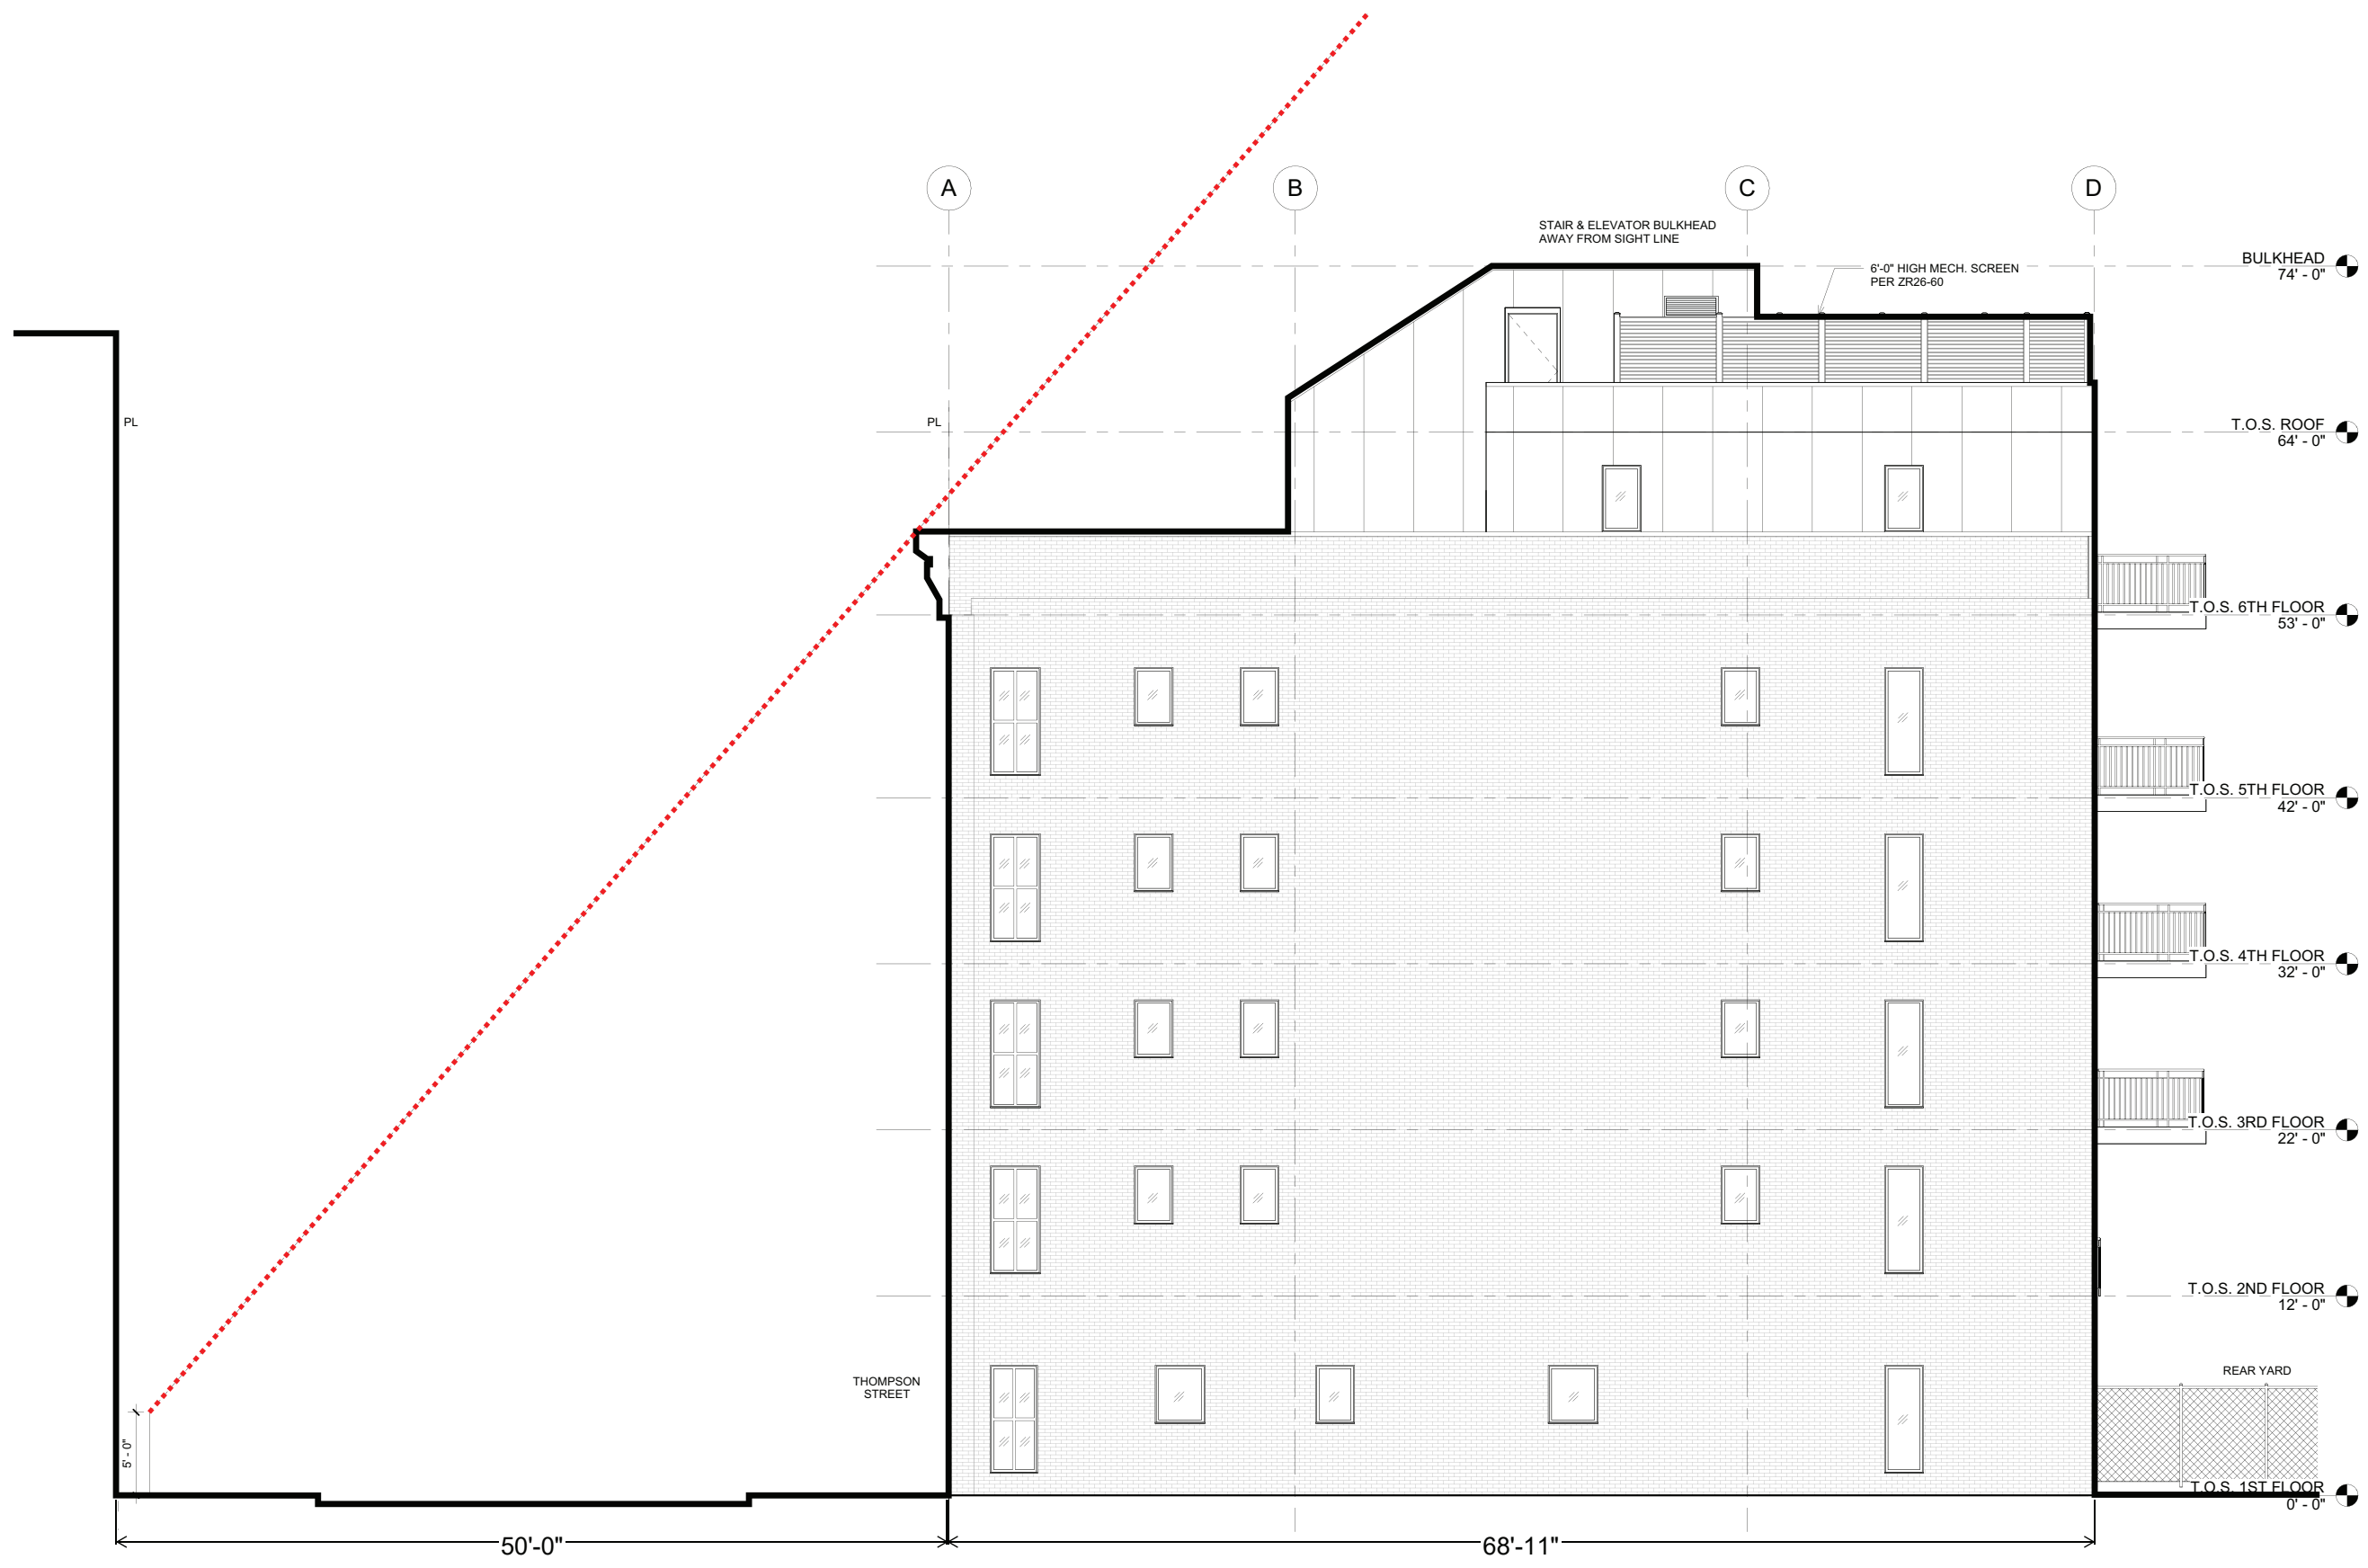
SIGHT LINE DIAGRAM @ THOMPSON STREET
 1 3/16" = 1'-0"

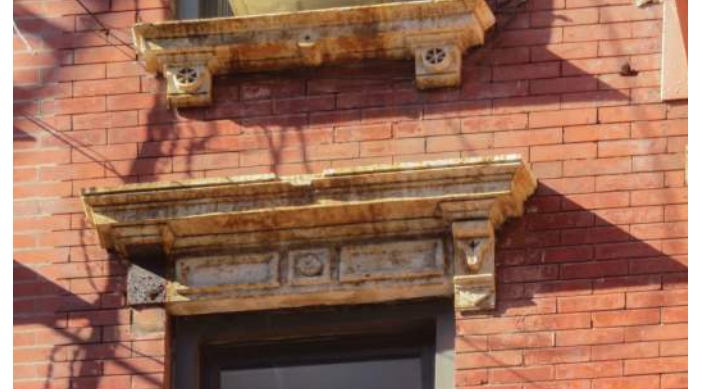
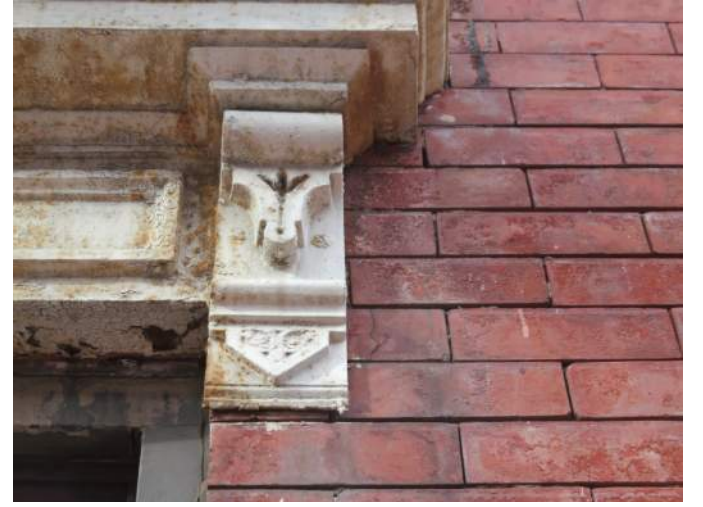
ALL CAST IRON FAÇADE ELEMENTS (WINDOW HEADERS, SILLS, 1ST FLOOR COLUMNS) WILL BE CAREFULLY REMOVED, STORED, AND REPAIRED FOR REINSTALLATION OR REPLICATION IF NOT SALVAGEABLE.

NOT SALVABLE DECORATIONS BE REPLICATED IN FIBERGLASS TO MATCH EXISTING PER DOCKET# LPC-19-29746 AND AS PART OF THE EMAIL CORRESPONDENCE AND CONFIRMATION RECEIVED ON 07/17/2019 VIA EMAIL THROUGH MARY B. DIERICKX AT HISTORIC PRESERVATION CONSULTING, UTILIZING THE STORED COMPONENTS.

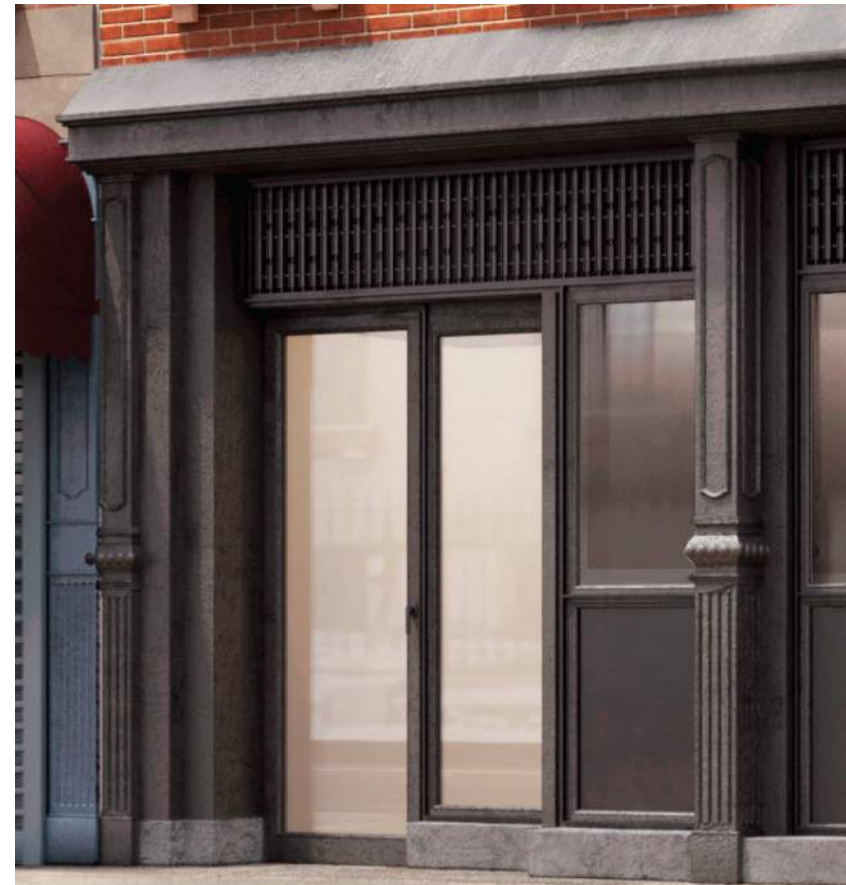
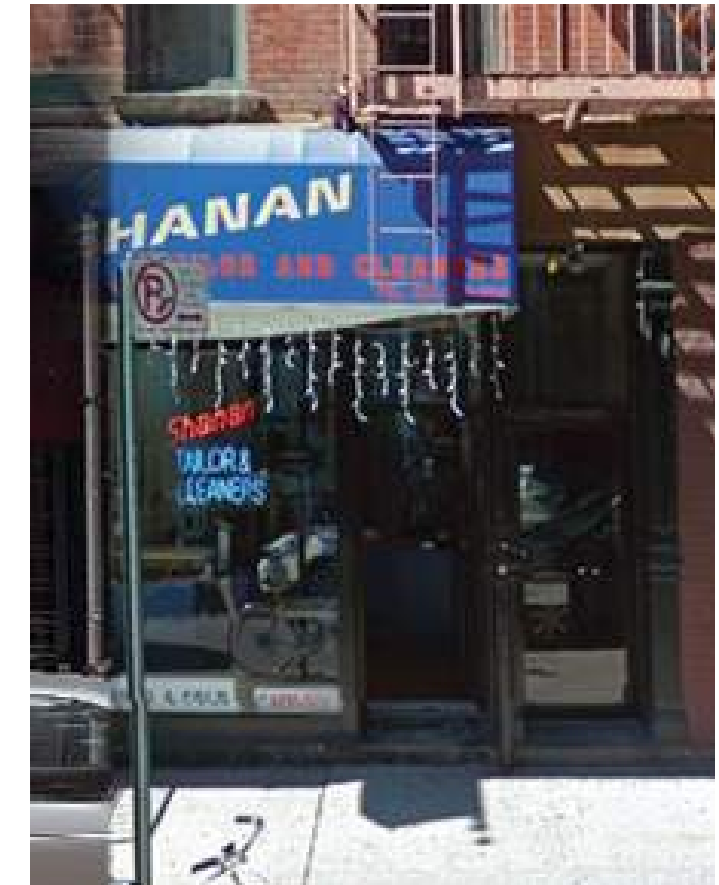
ALL CAST IRON FAÇADE ELEMENTS (WINDOW HEADERS, SILLS, 1ST FLOOR COLUMNS) WILL BE CAREFULLY REMOVED, STORED, AND REPAIRED FOR REINSTALLATION OR REPLICATION IF NOT SALVAGEABLE.

NOT SALVABLE DECORATIONS BE REPLICATED IN FIBERGLASS TO MATCH EXISTING PER DOCKET# LPC-19-29746 AND AS PART OF THE EMAIL CORRESPONDENCE AND CONFIRMATION RECEIVED ON 07/17/2019 VIA EMAIL THROUGH MARY B. DIERICKX AT HISTORIC PRESERVATION CONSULTING, UTILIZING THE STORED COMPONENTS.

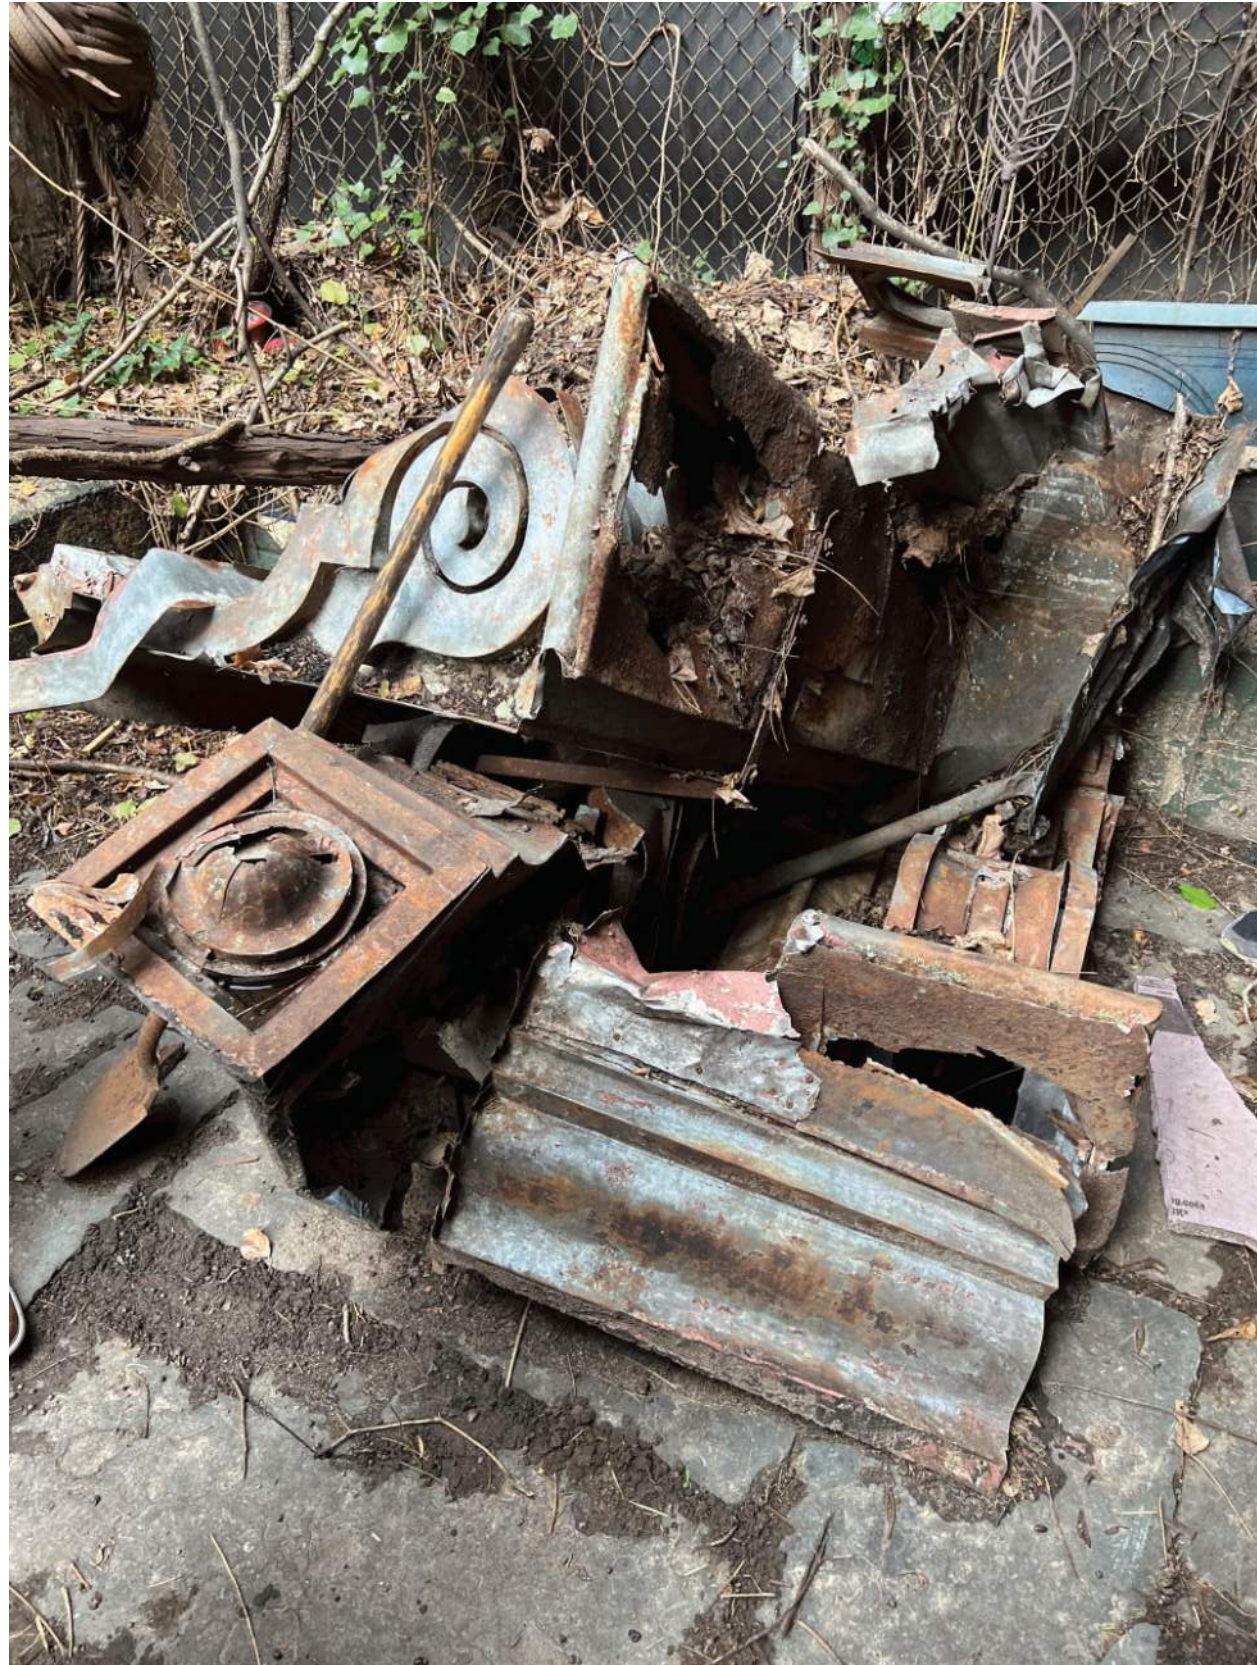
**RUBBLE PILE IN REAR YARD,
CONSISTING OF ORIGINAL FACADE**

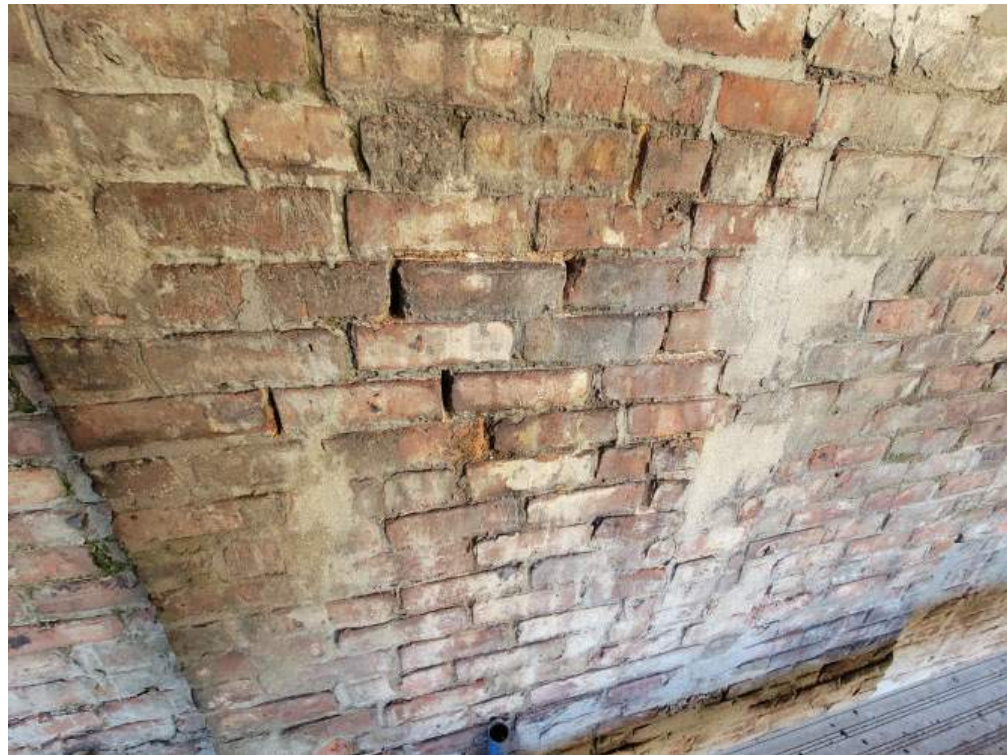
DEGRADATION OF FACADE BRICK (VISIBLE FROM SCAFFOLD)

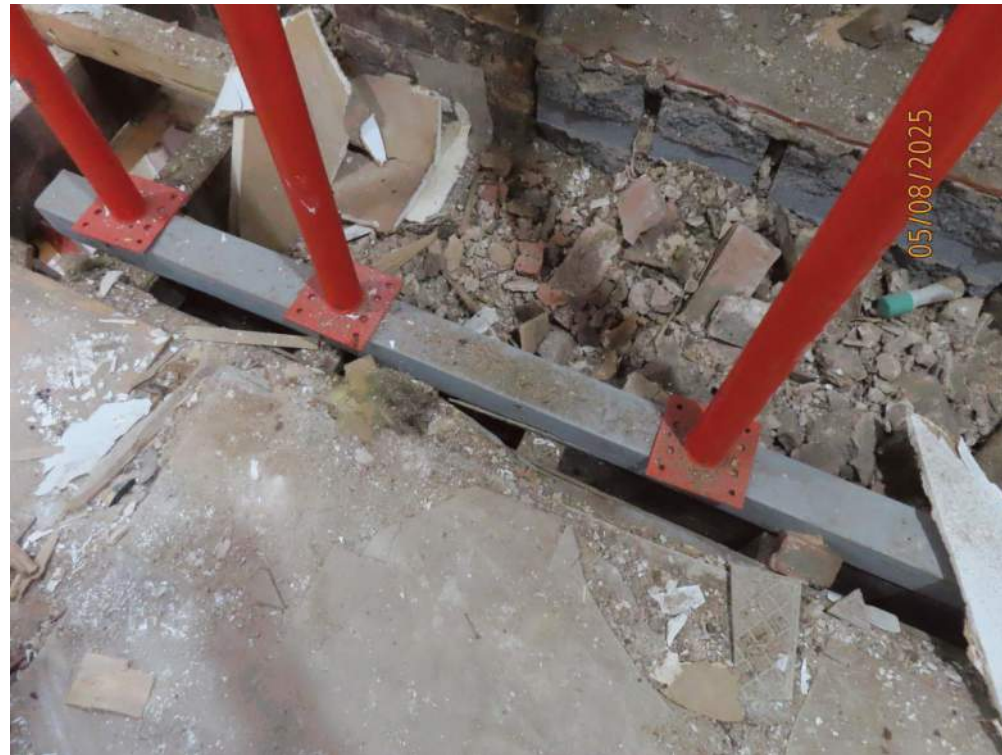
SHORING JACKS (DETAIL)

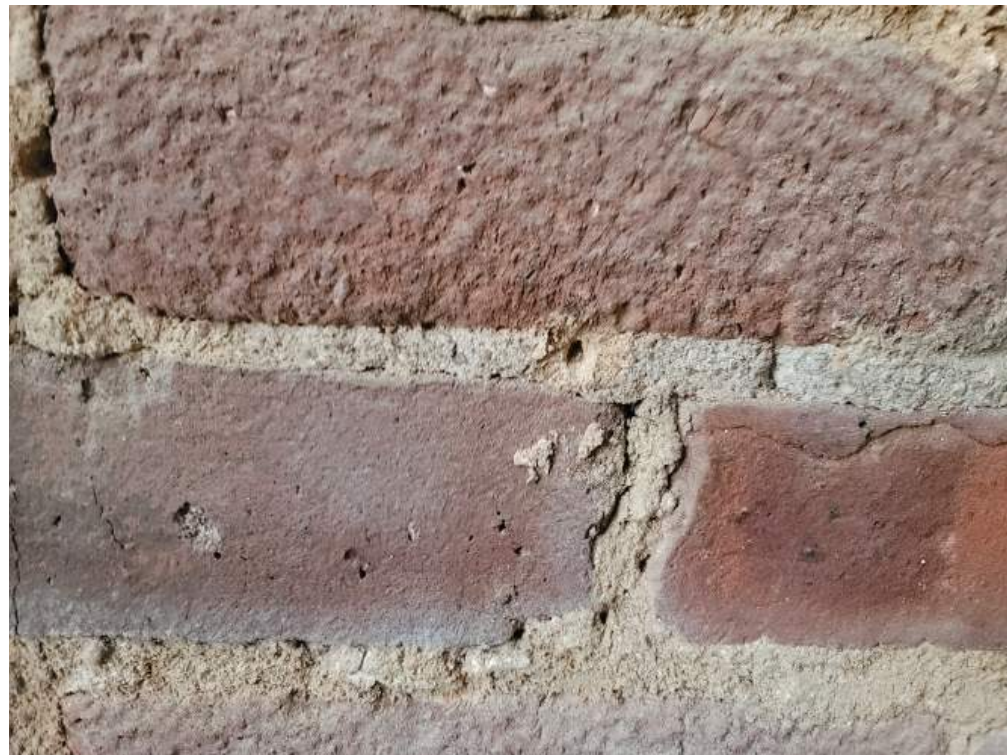
DETAIL OF MASONRY FOLLOWING PIN TEST

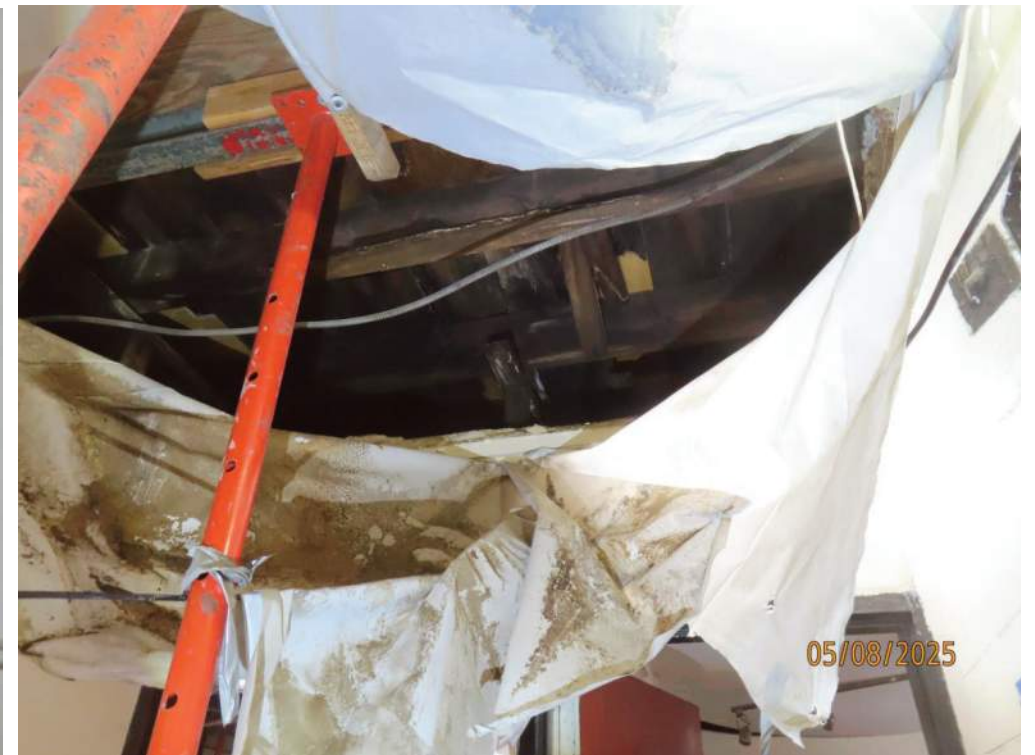
TYPICAL OVERHEAD CONDITION WITH SHORING JACK IN PLACE

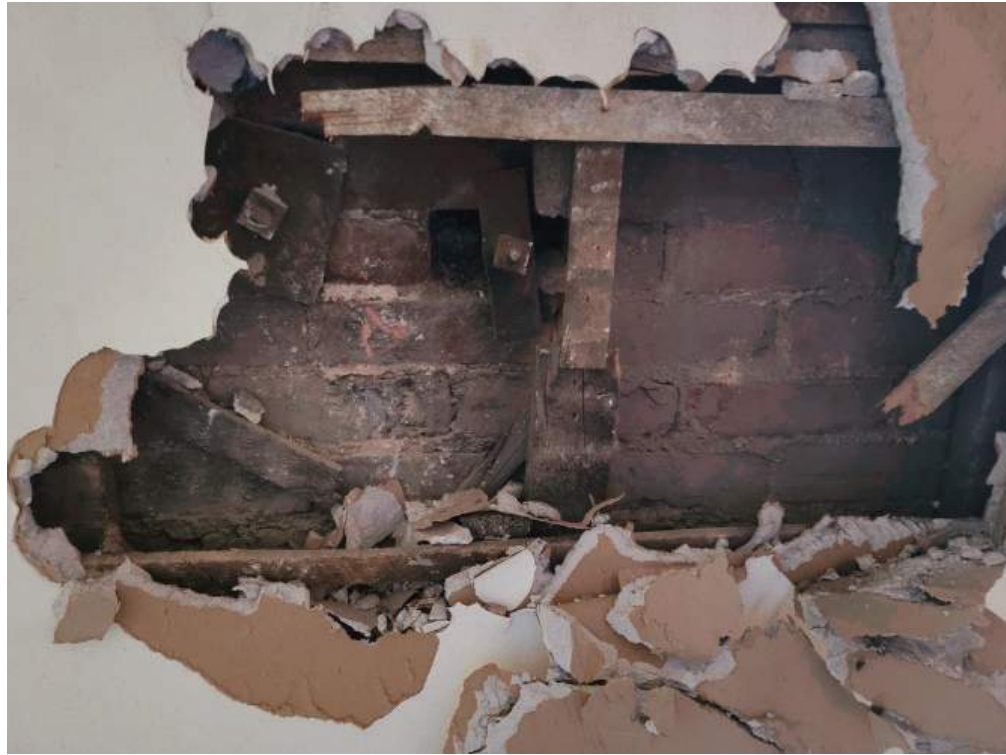
PROBE AT INTERIOR OF FACADE

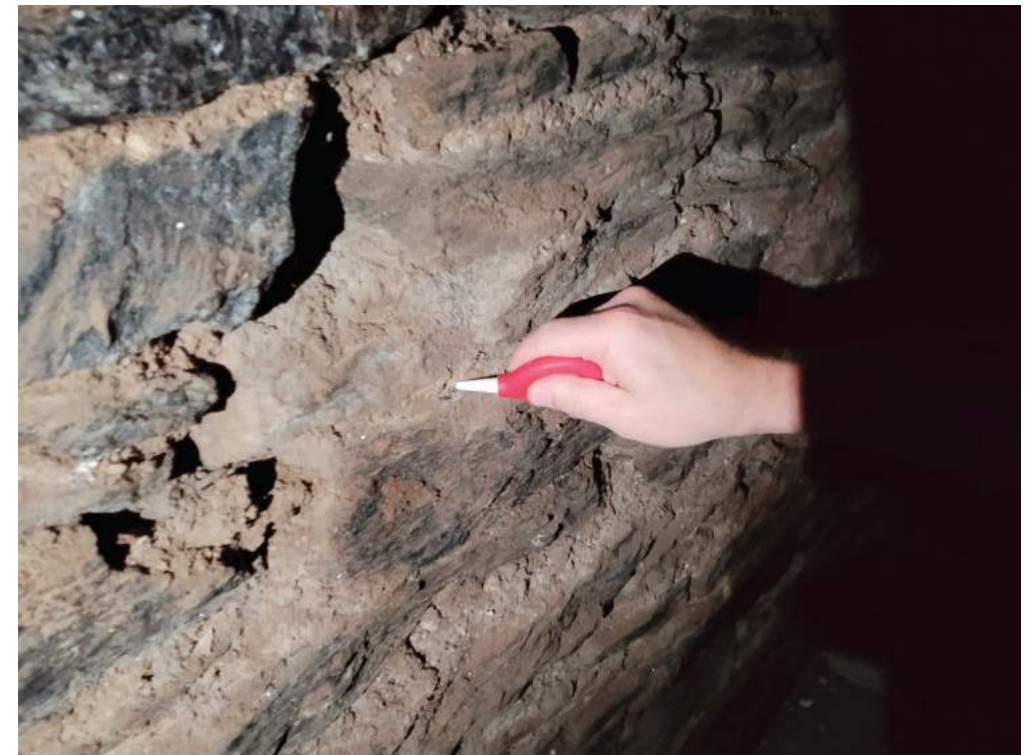
CLEARING DUST FROM TEST SITE

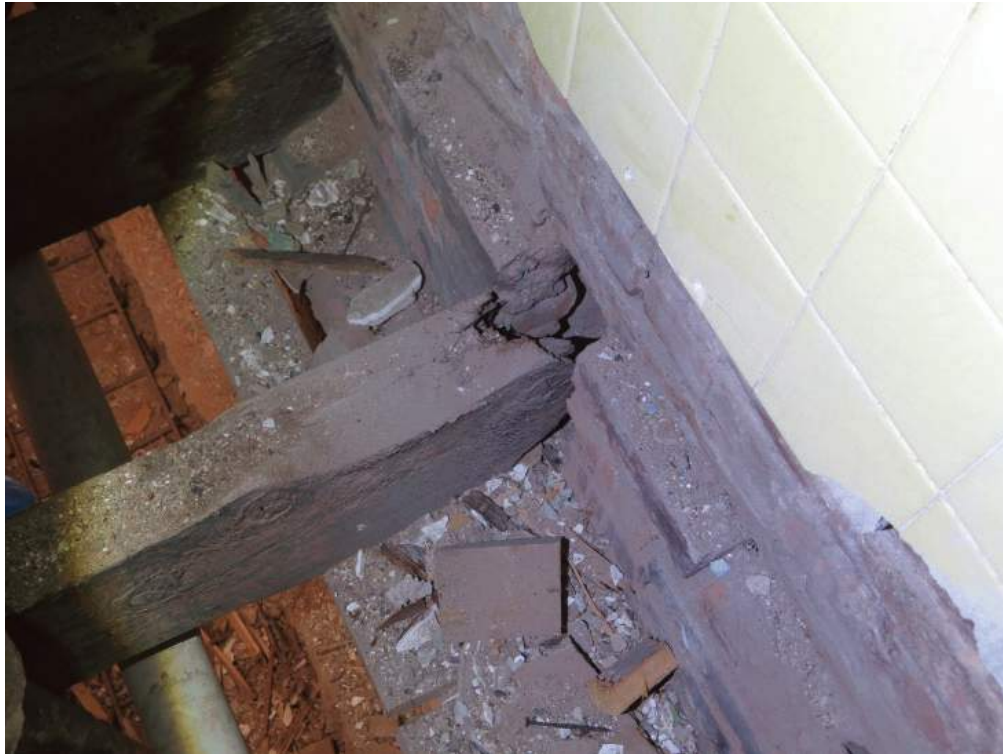
DEGRADED JOIST SLIPPING FROM POCKET

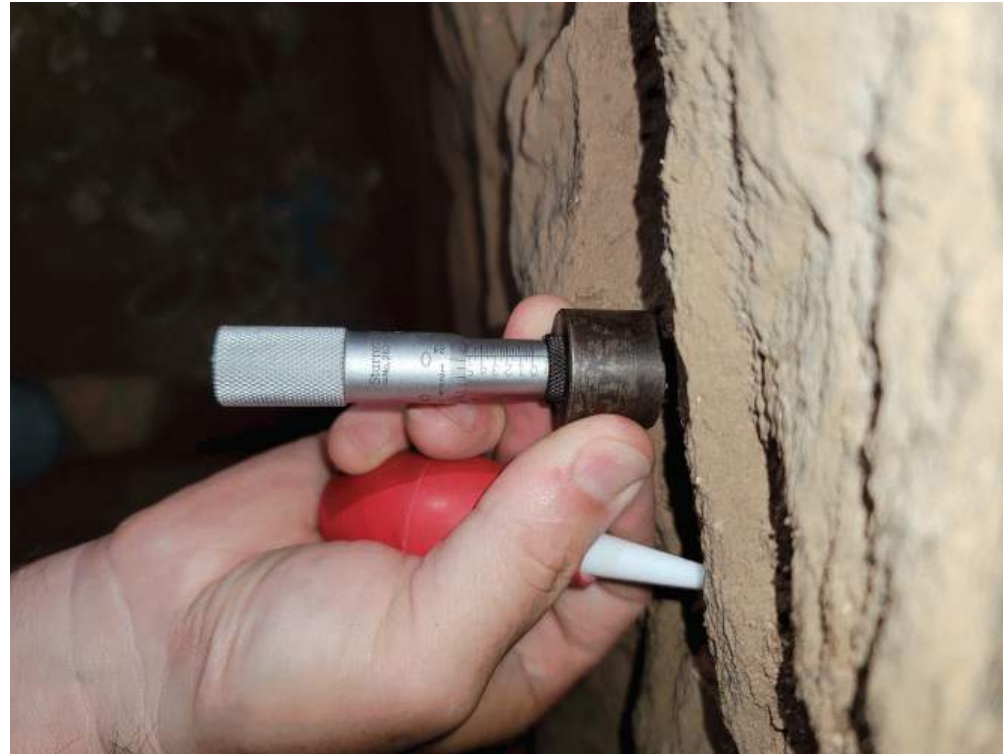
GAUGING DEPTH
