139 Thompson Street
Landmark Preservation Commission Public Hearing Presentation
March 17, 2026

Table of Contents

1. History of building up to repair work
2. Required stabilization and intervention
3. Observations & Analysis undertaken
4. CCD1 and its ramifications
5. New configuration and compliance
6. Facade conditions and assessment
7. Proposed reconstruction

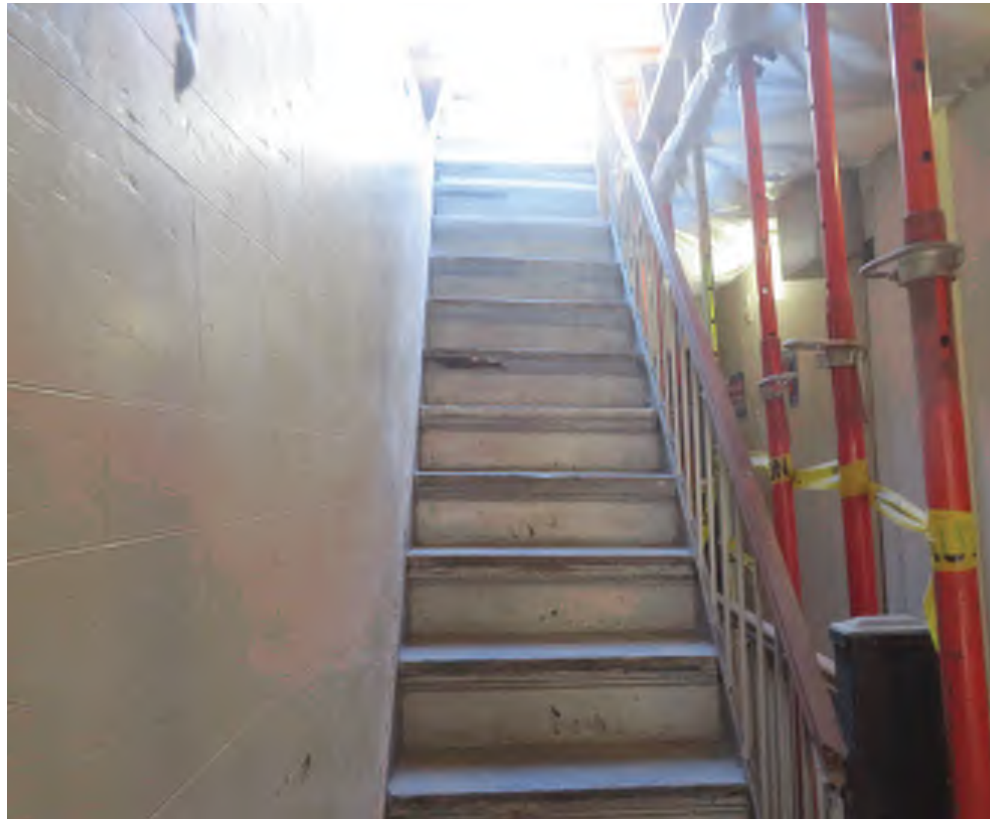
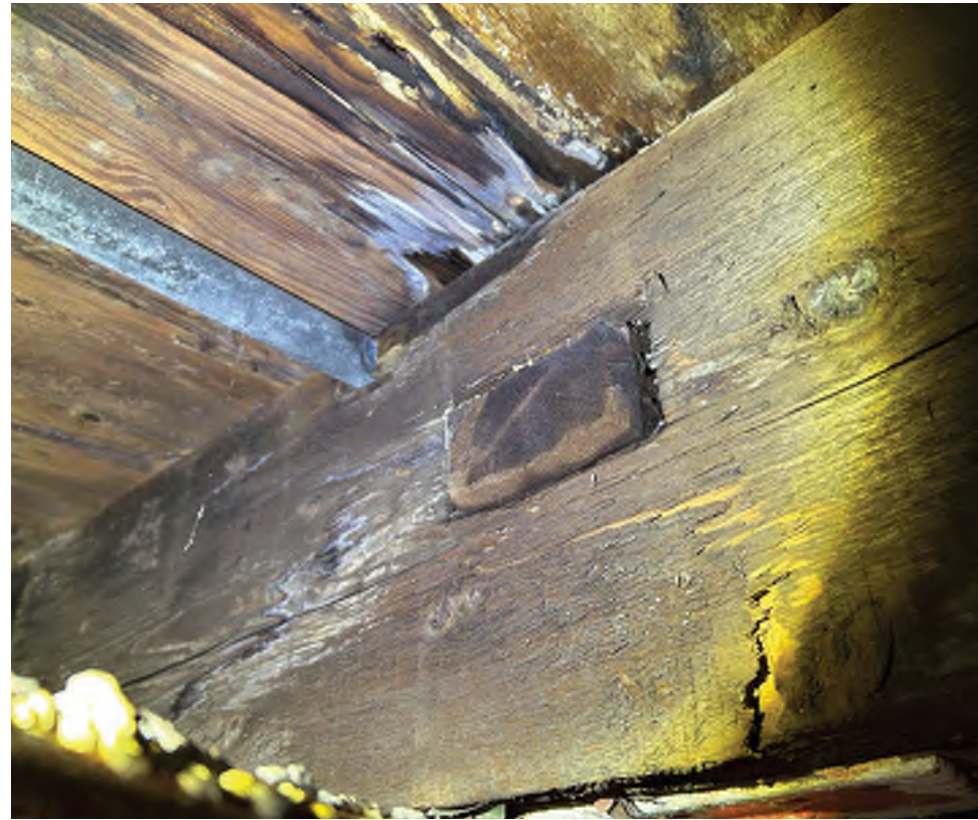
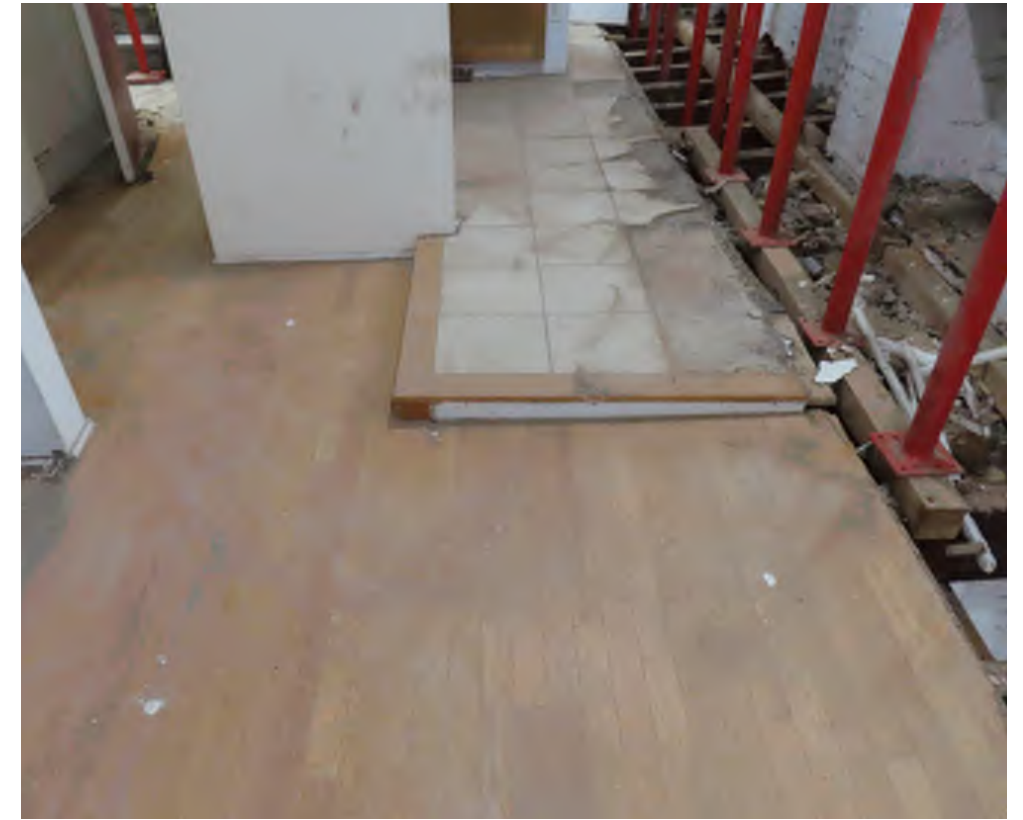
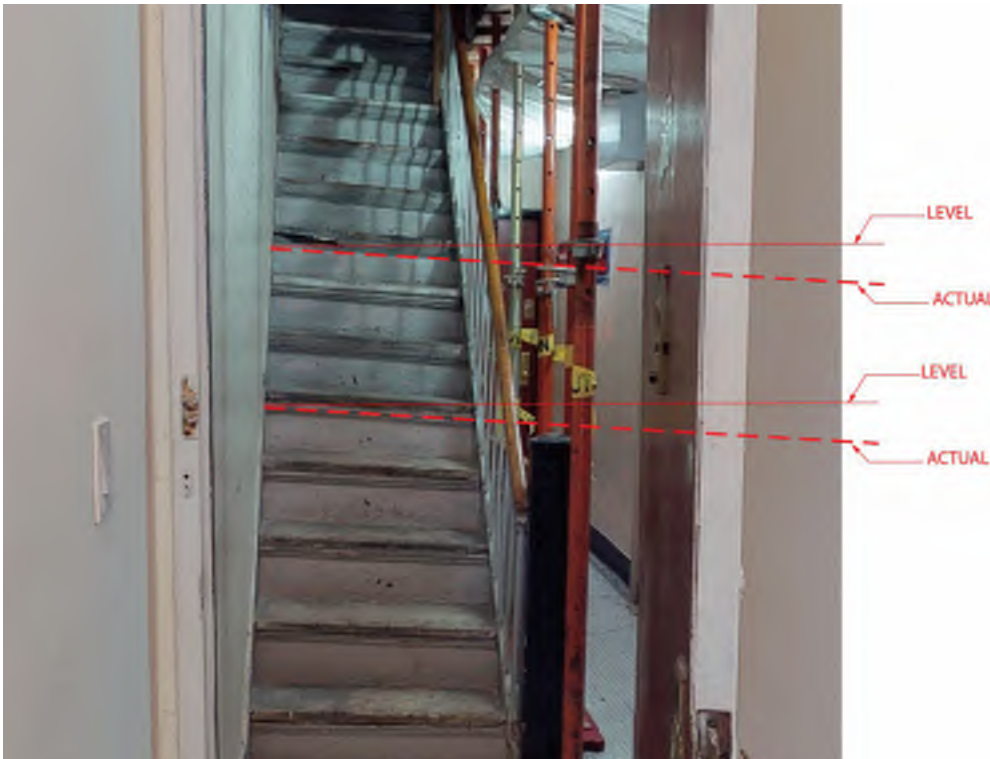
TILTED STAIRS DUE TO EXCESSIVE FLOOR JOIST DEFLECTIONS

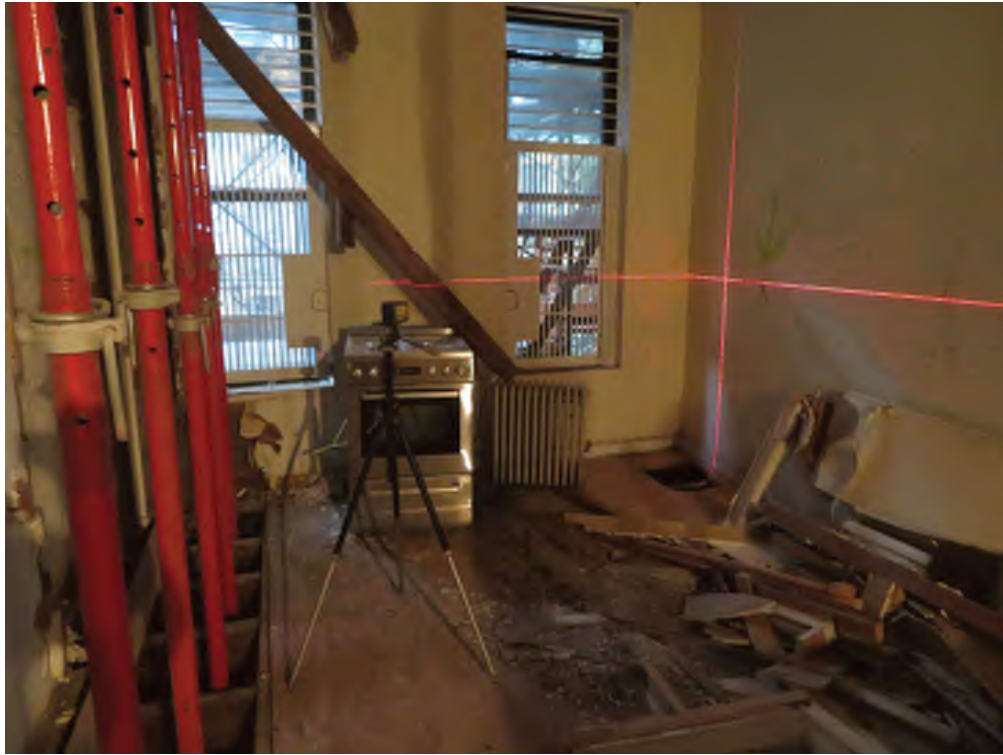
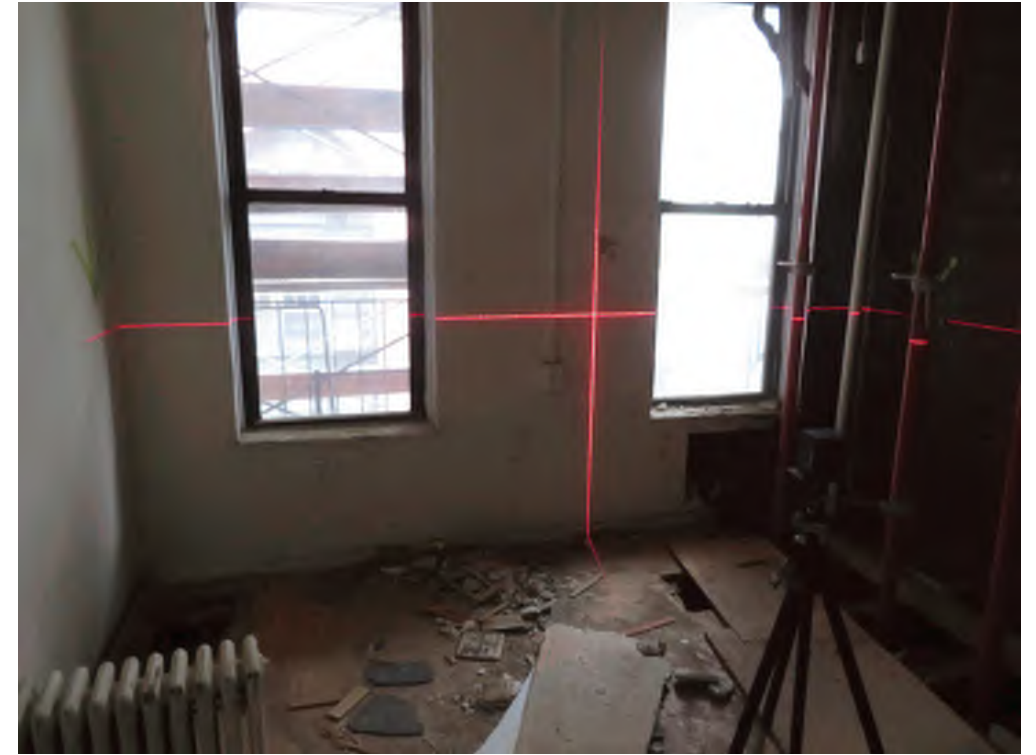
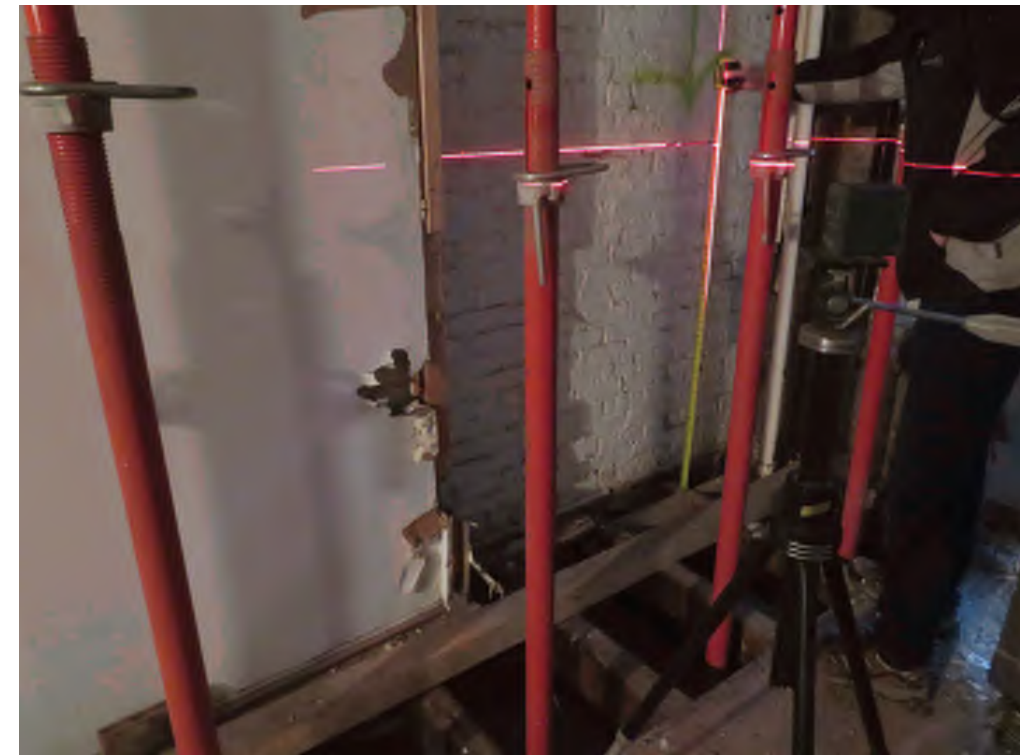
Joist Deflection and Measurement

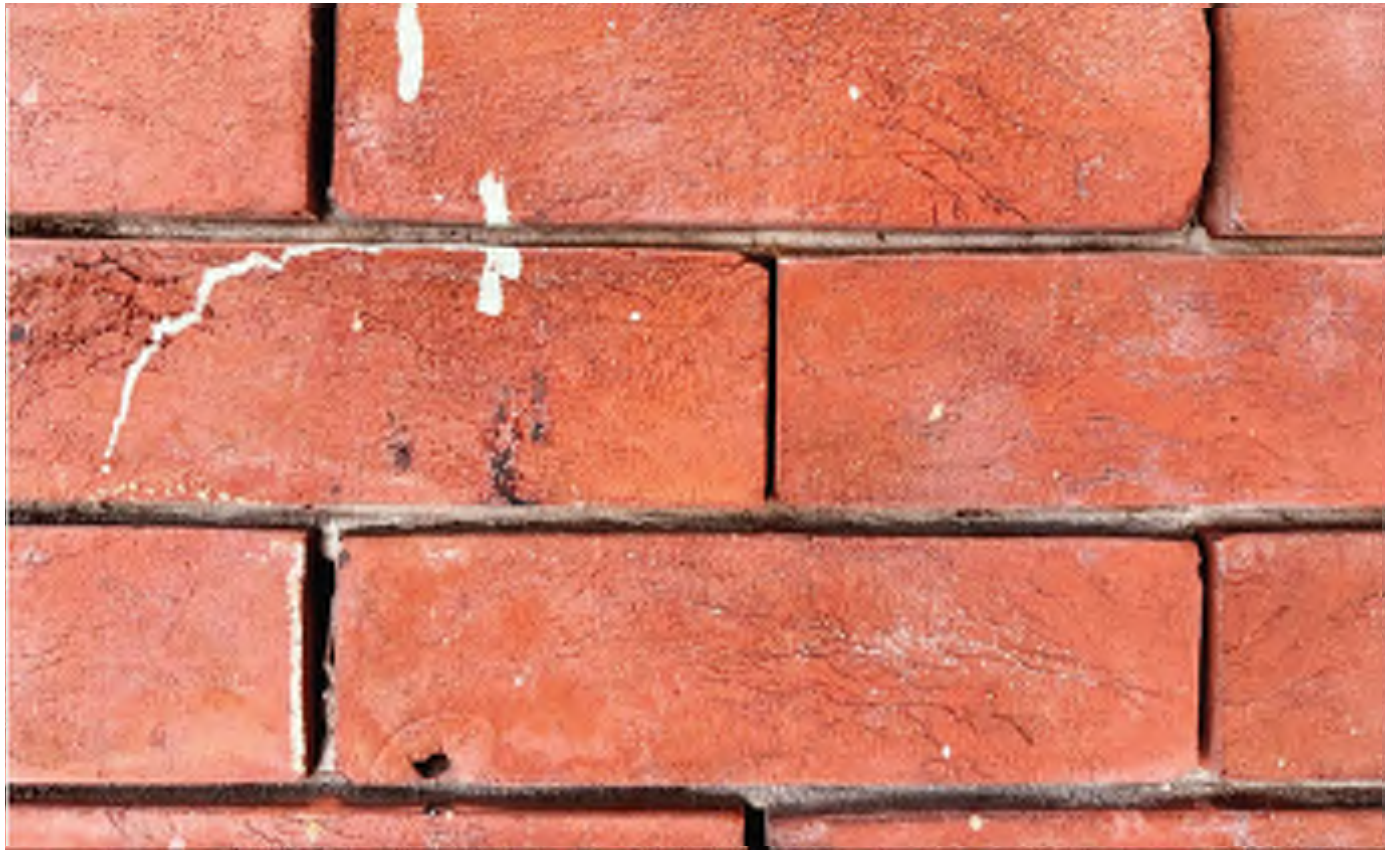
1 Heavy Crazing

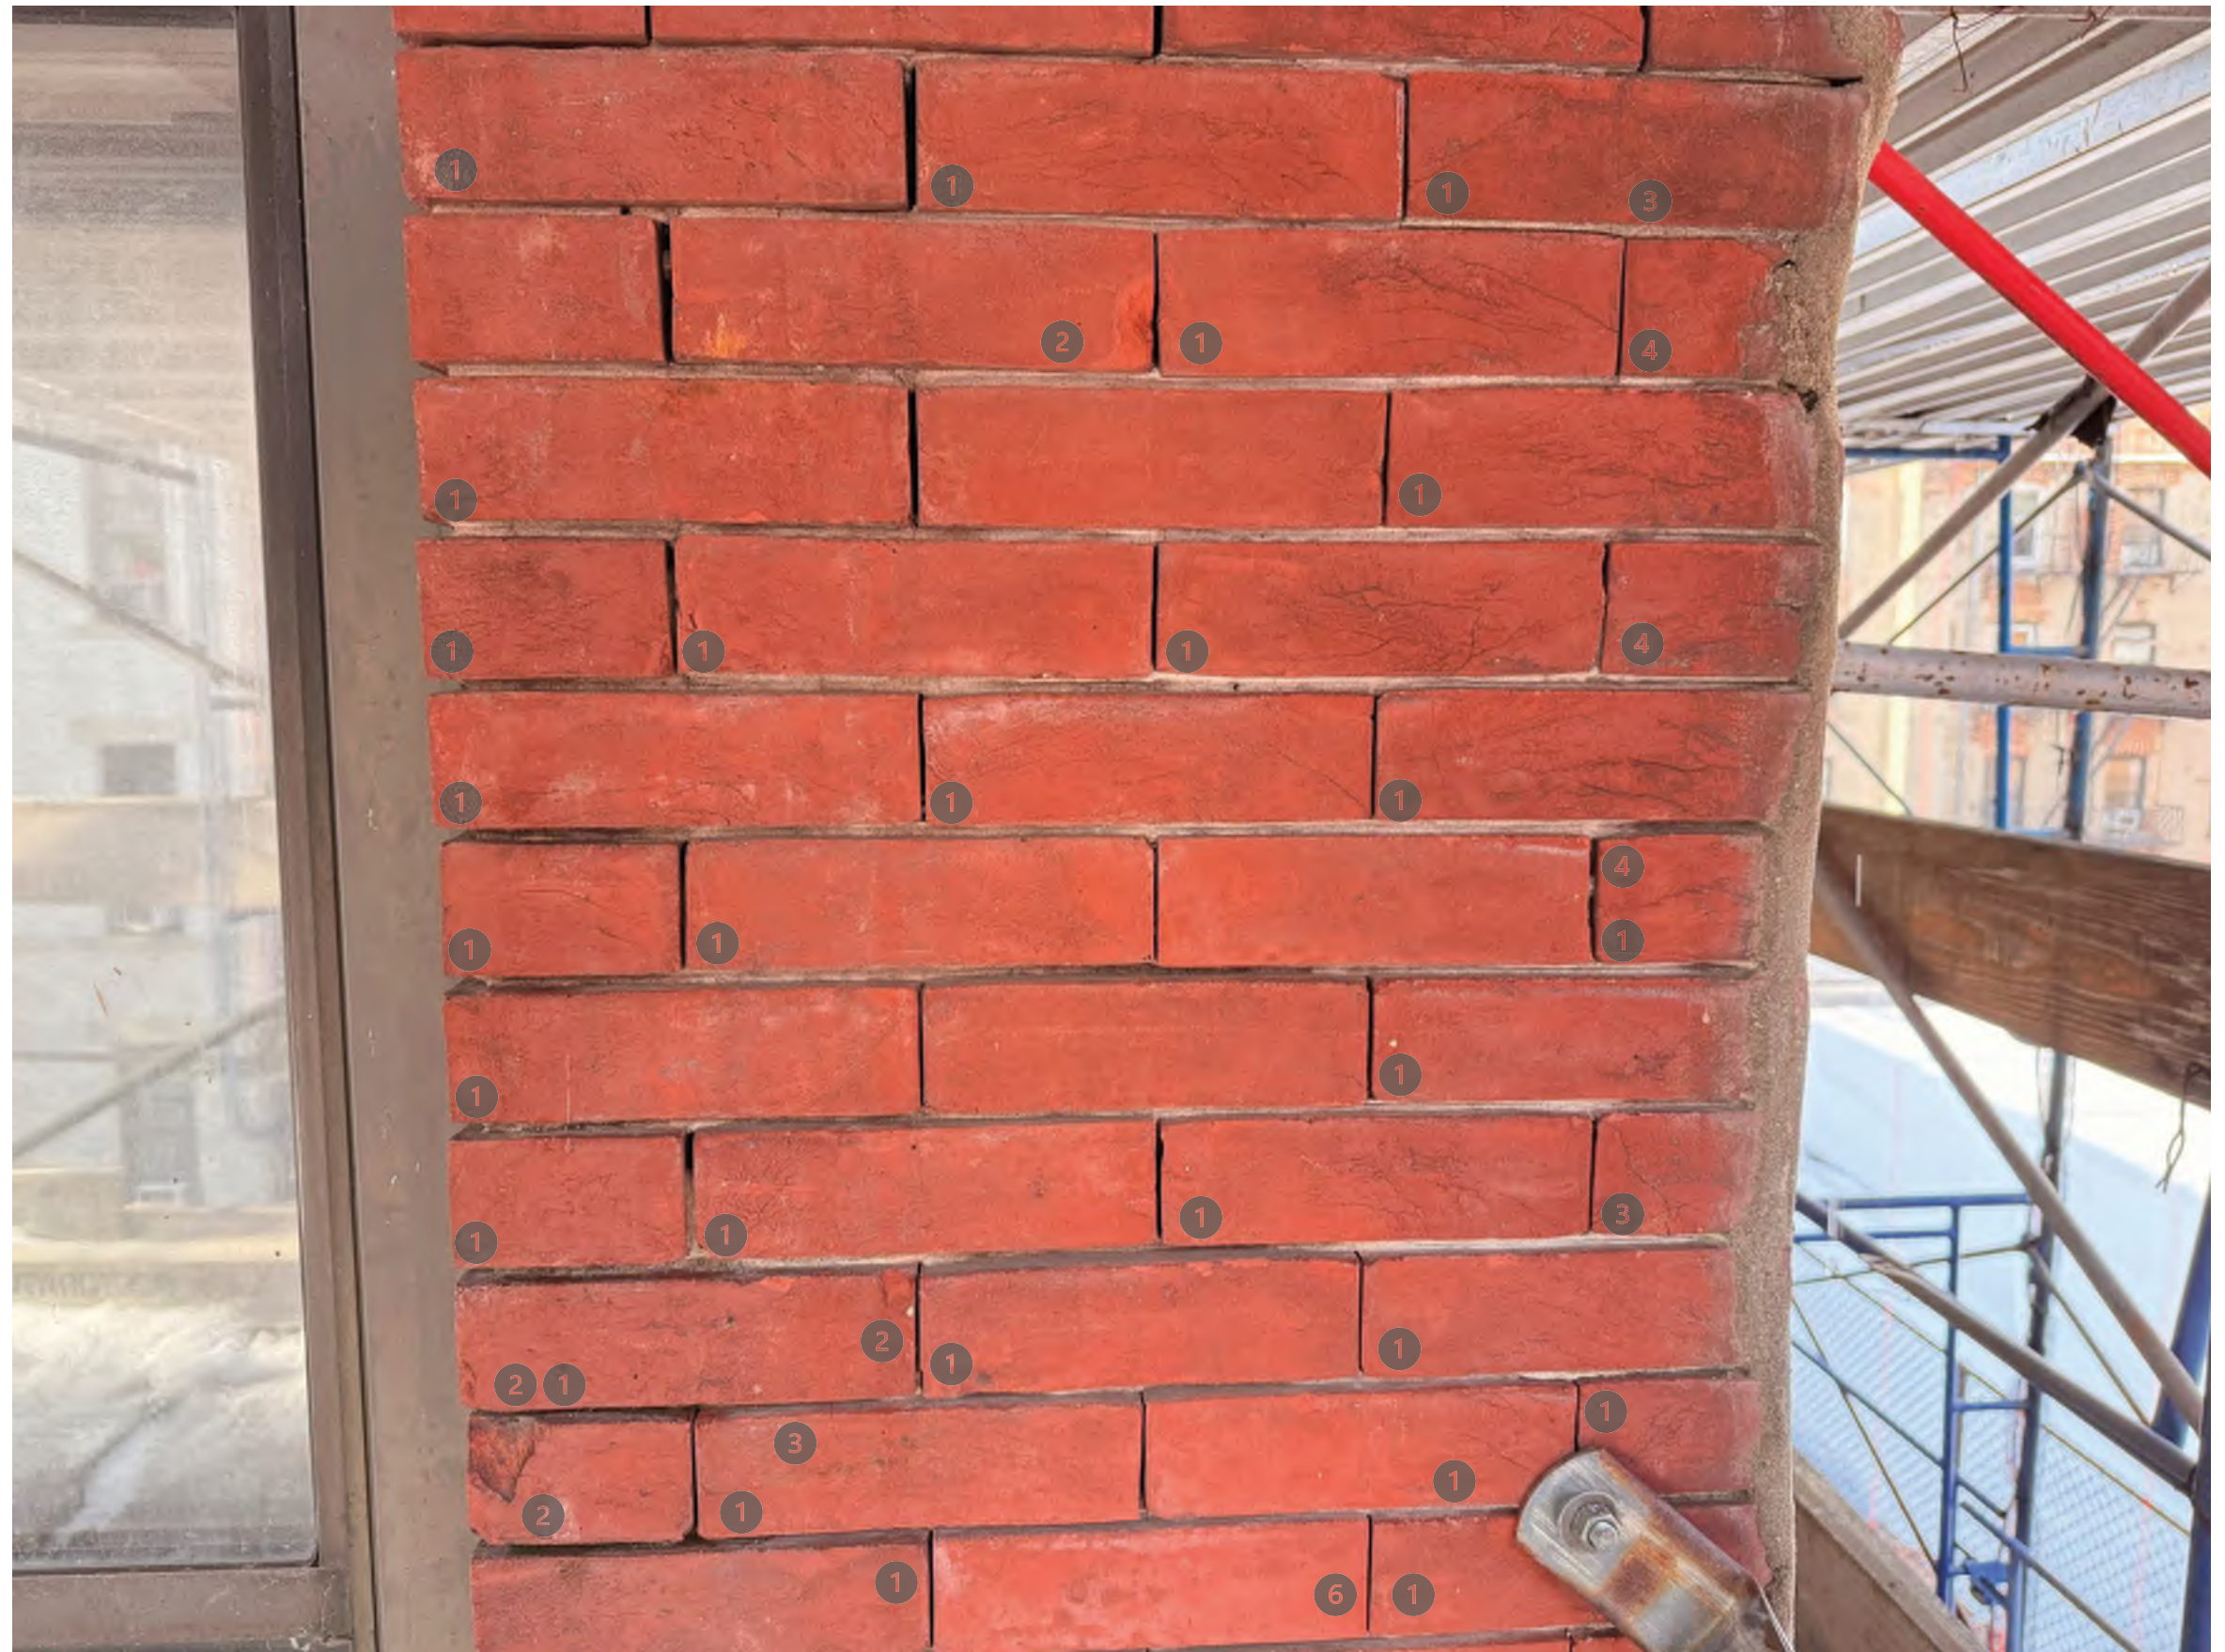
Front Facade Inspection - 5th Floor

- 1 Heavy Crazing
- 2 Brick Spall
- 3 Cracked Brick
- 4 Missing/Damaged Brick
- 5 Vertical Brick Crack
- 6 Discoloration/Non-Original Brick
- 7 Former Coating Damage
- 8 Organic Growth

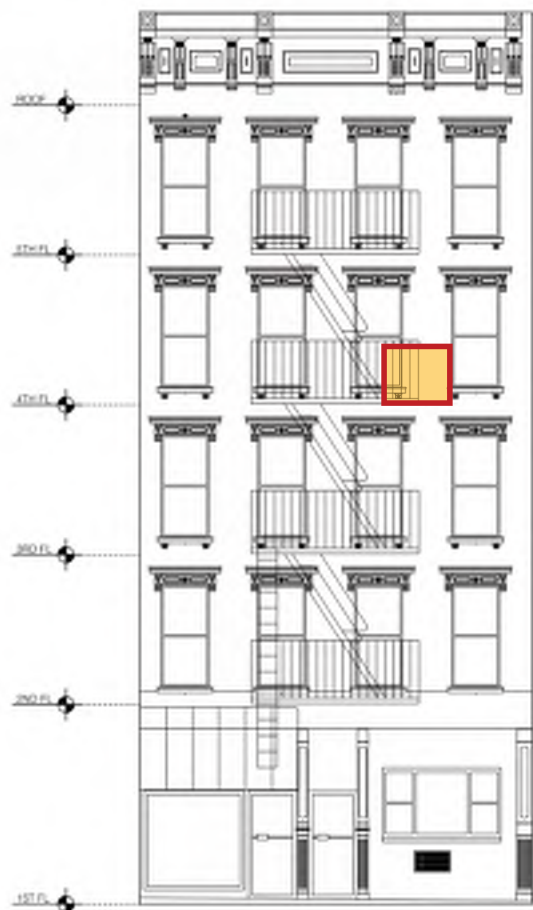
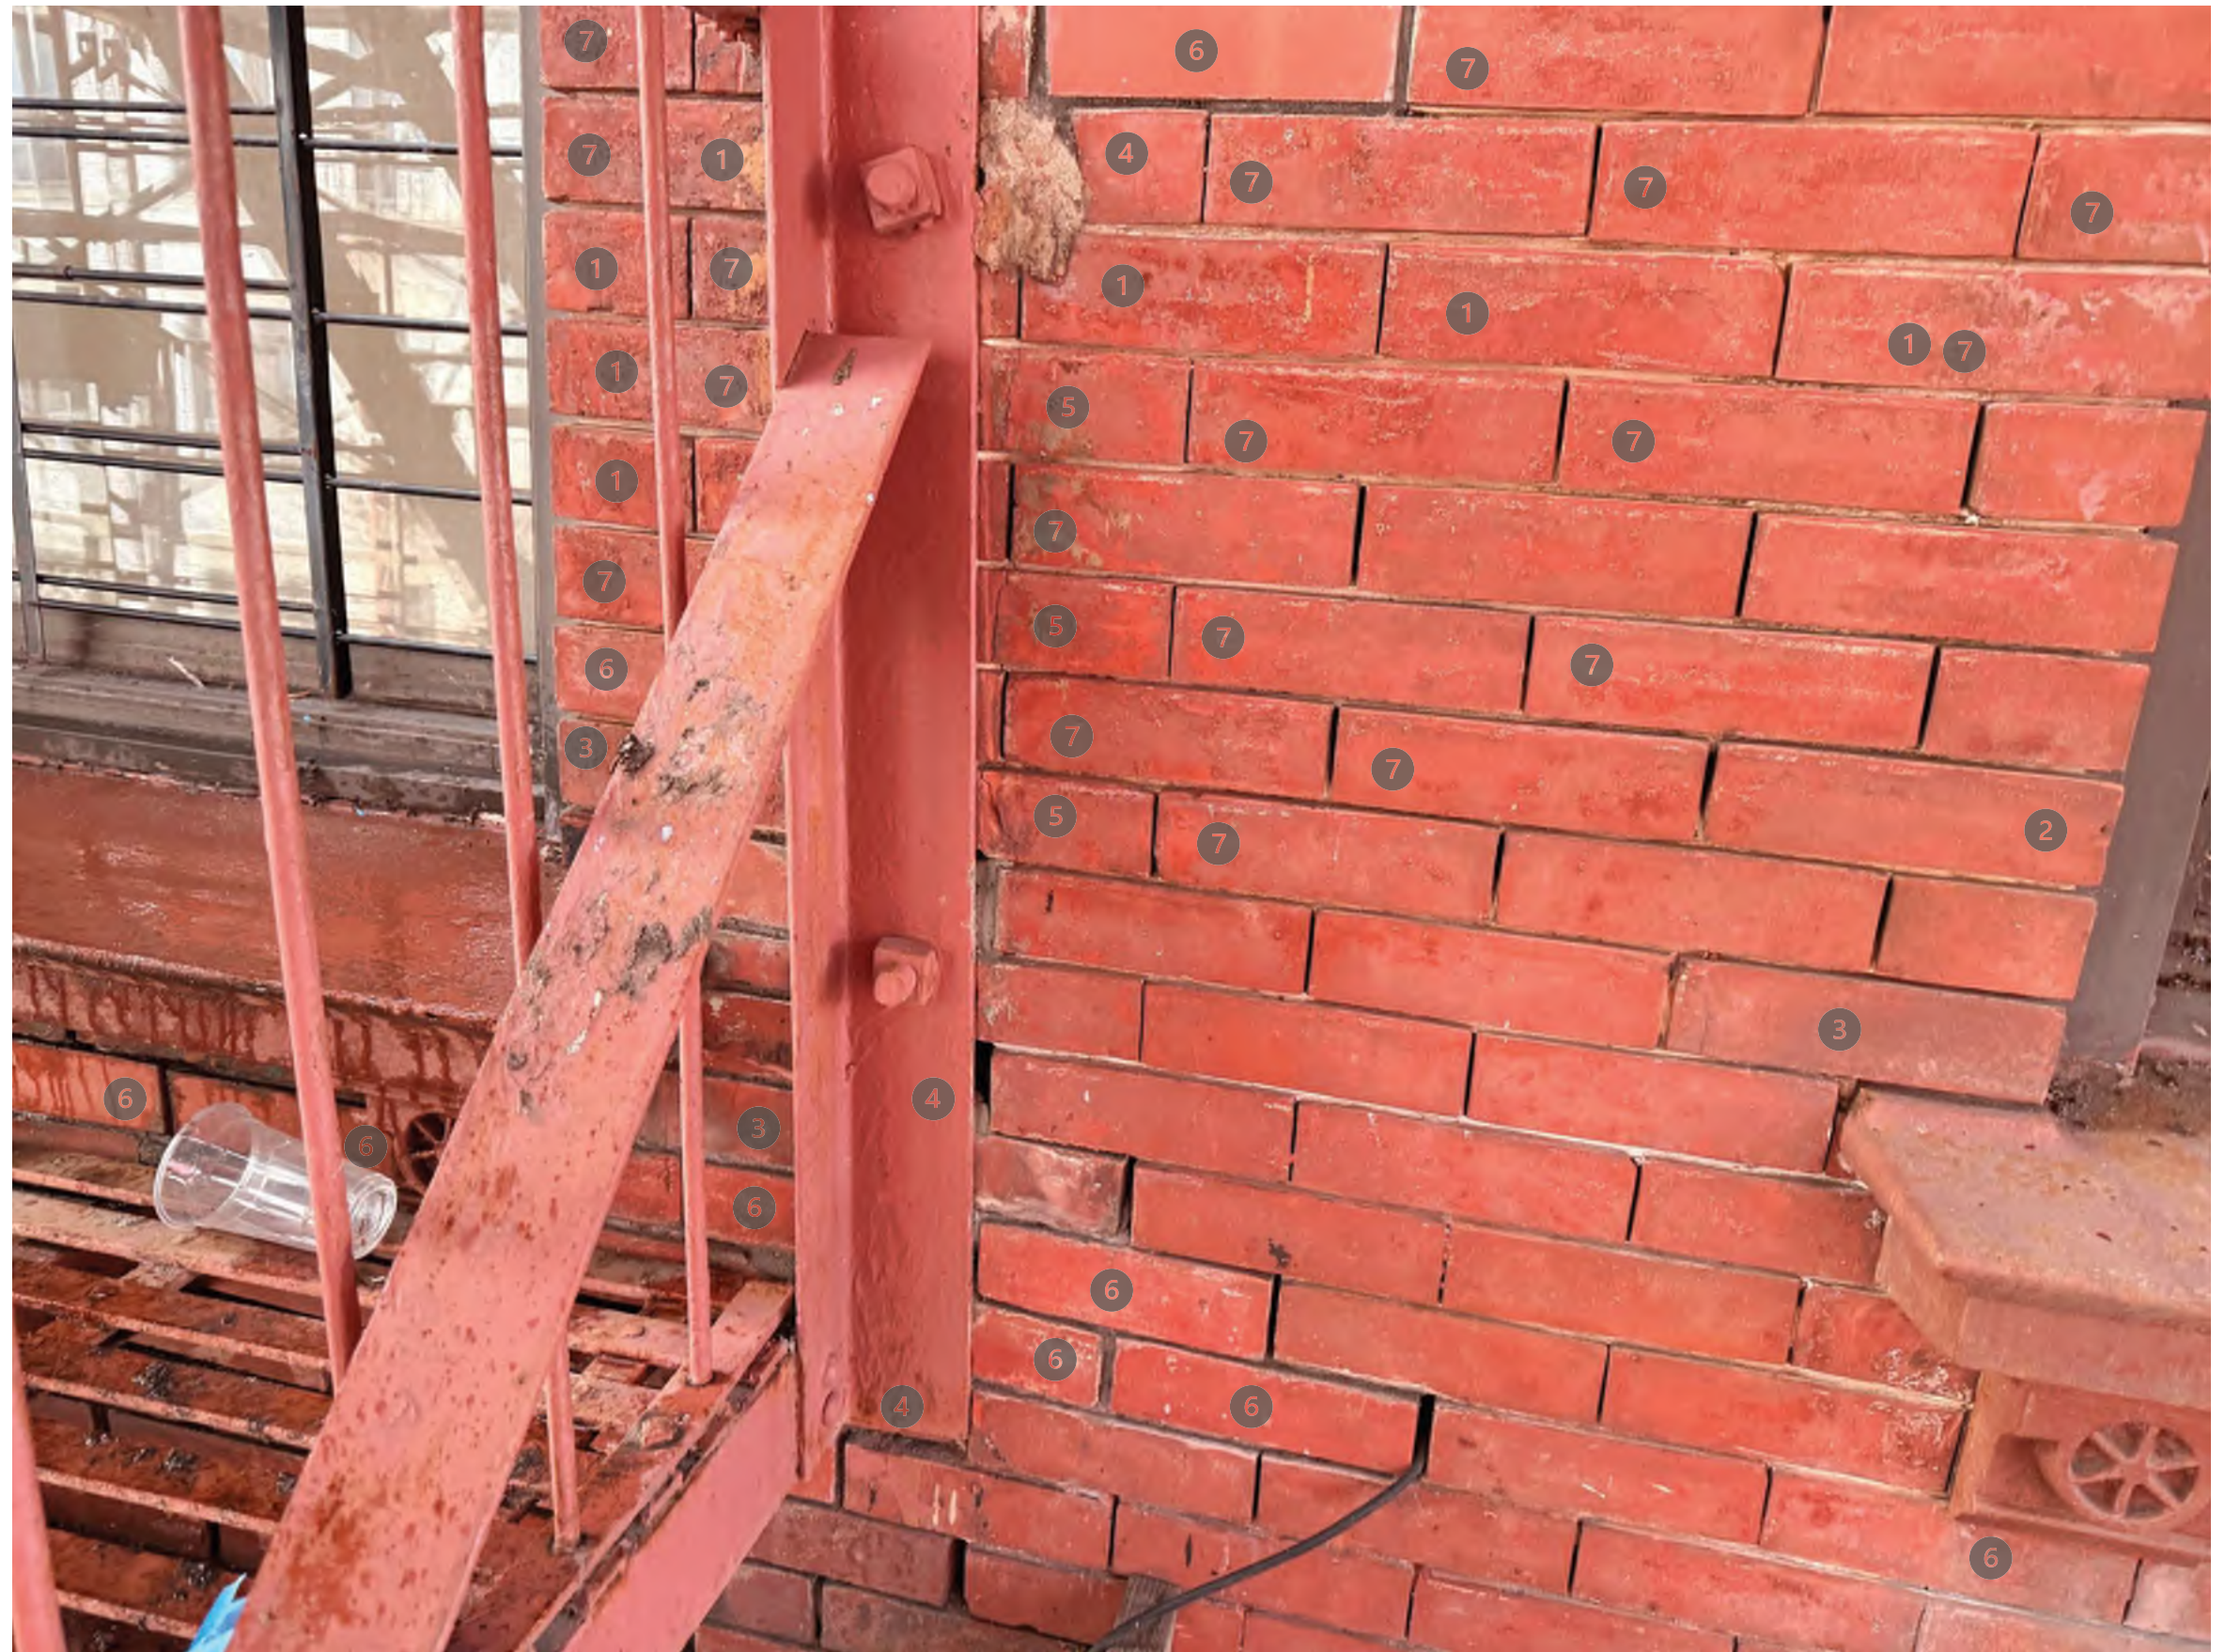
Front Facade Inspection - 4th Floor

- 1 Heavy Crazing
- 2 Brick Spall
- 3 Cracked Brick
- 4 Missing/Damaged Brick
- 5 Vertical Brick Crack
- 6 Discoloration/Non-Original Brick
- 7 Former Coating Damage
- 8 Organic Growth

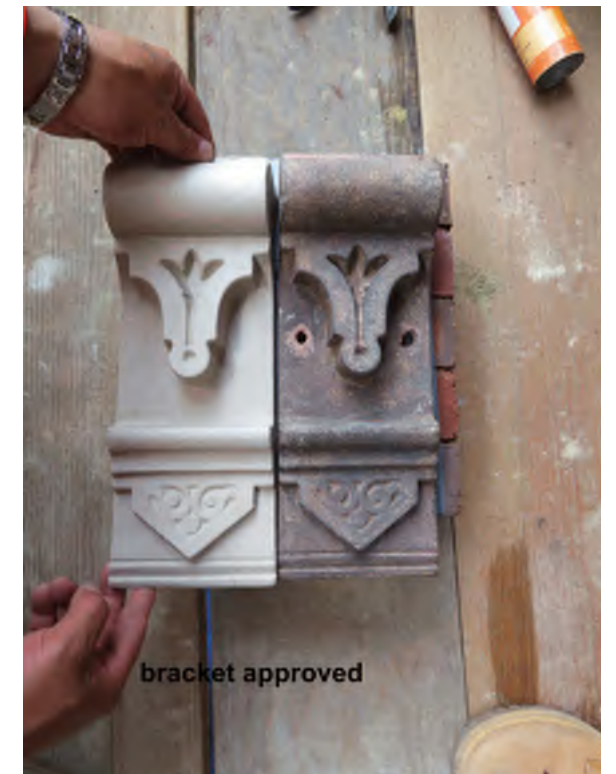
THE CORNICE HAS ALREADY BEEN CAREFULLY REMOVED AND RESTORED BUT IT IS NOT SALVAGEABLE. IT WILL BE REPLICATED IN FIBERGLASS TO MATCH EXISTING PER DOCKET# LPC-19-29746 AND AS PART OF THE EMAIL CORRESPONDENCE AND CONFIRMATION RECEIVED ON 07/17/2019 VIA EMAIL THROUGH MARY B. DIERICKX AT HISTORIC PRESERVATION CONSULTING, UTILIZING THE STORED COMPONENTS.

FIBERGLASS REPLICA OF BRACKET APPROVED

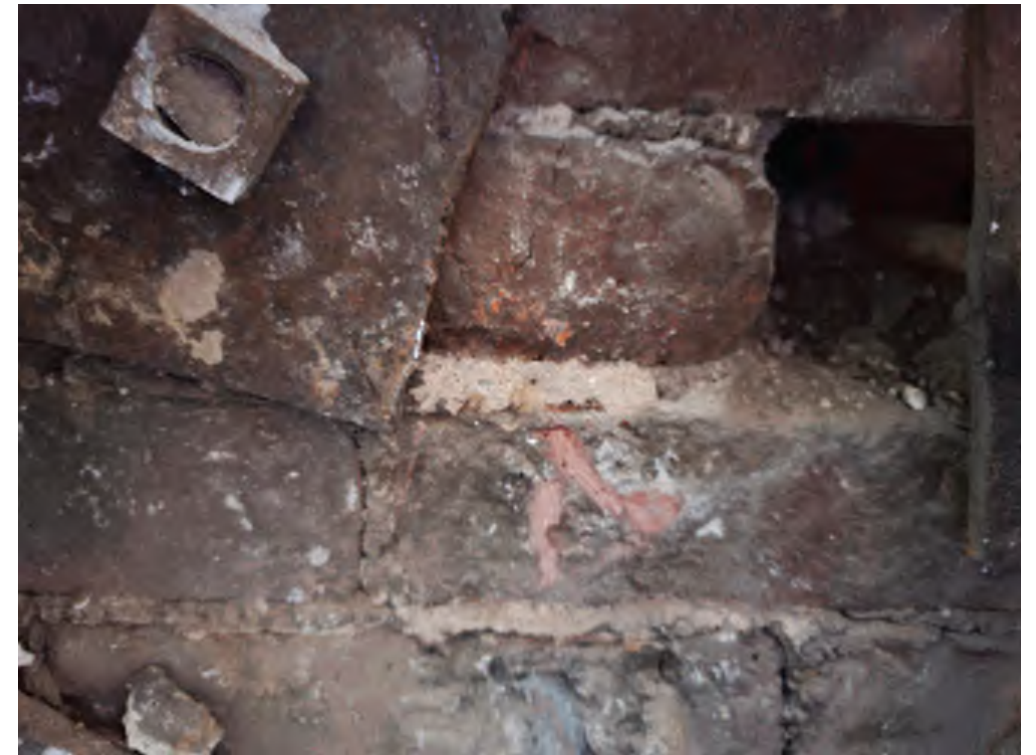
PROBE AT INTERIOR OF FACADE

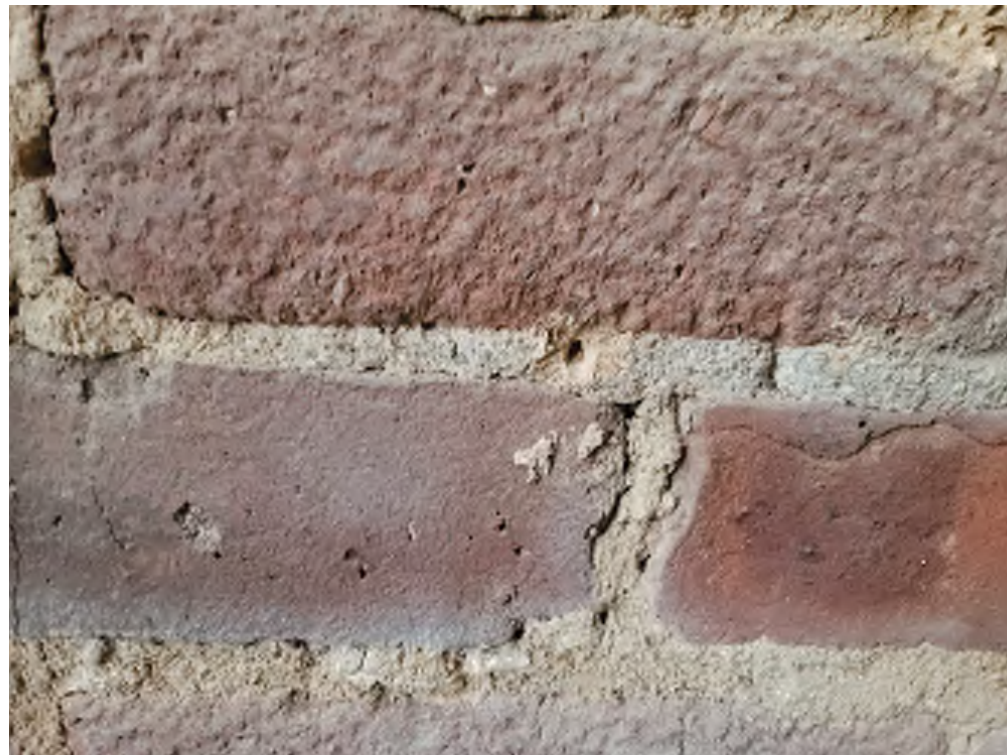
PROBE DETAIL

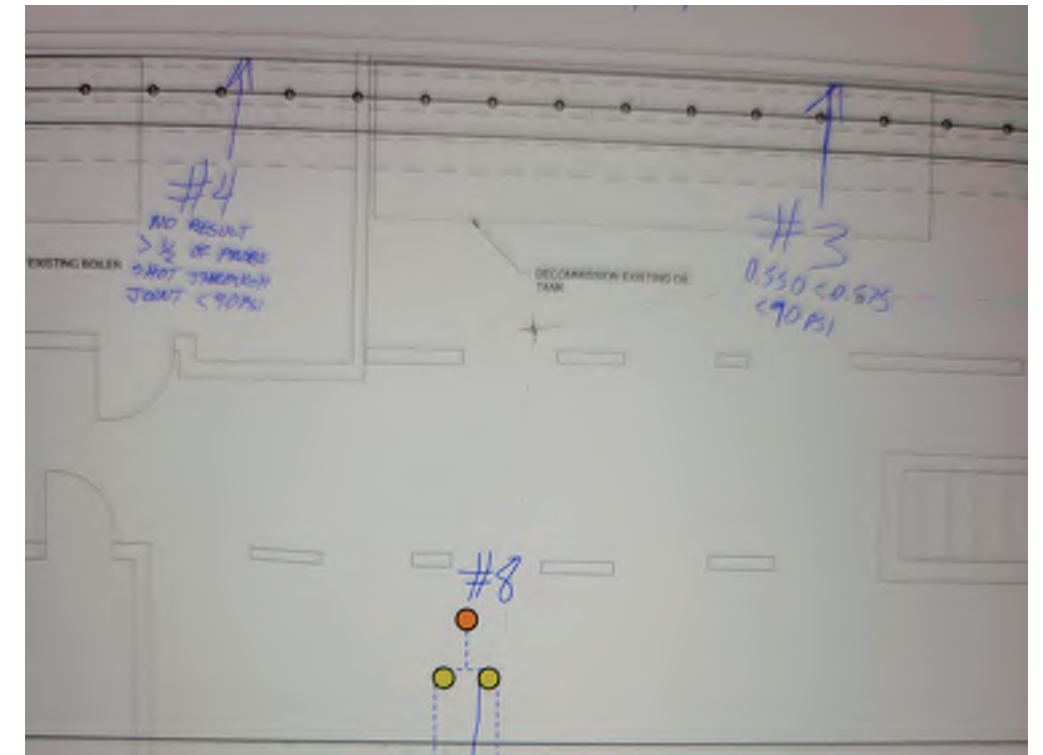
GAUGING DEPTH
