FACADE REPAIRS & STAIRWELL REINFORCING

139 THOMPSON STREET
 NEW YORK, NY

Front Facade Inspection

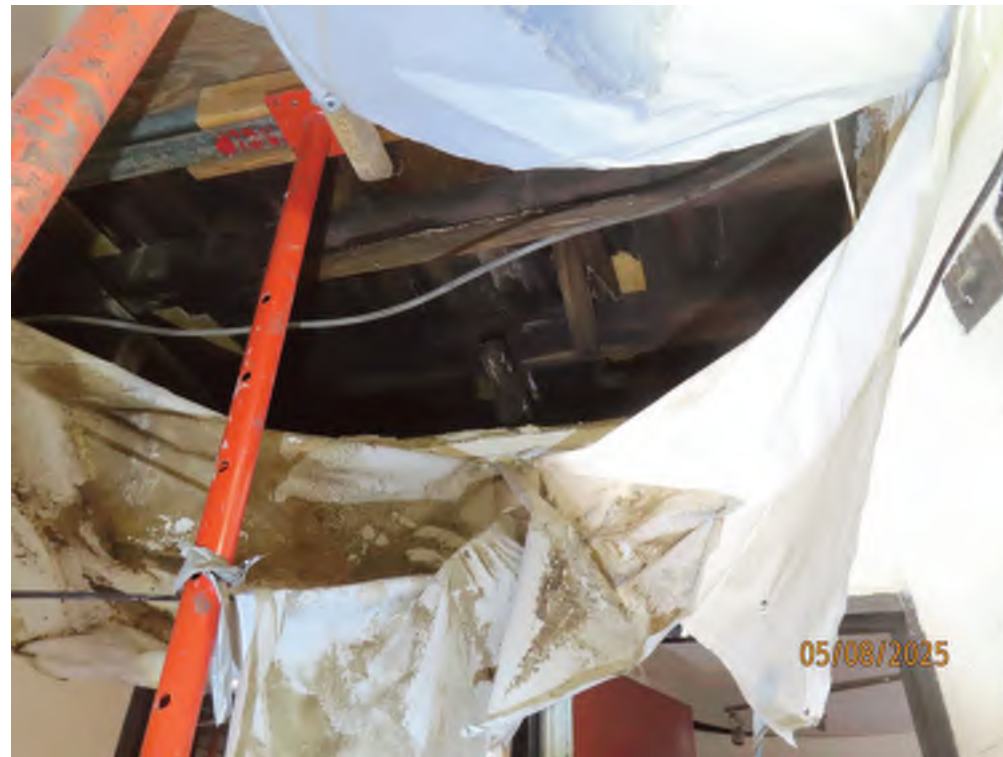
TYPICAL OVERHEAD CONDITION WITH SHORING JACK IN PLACE

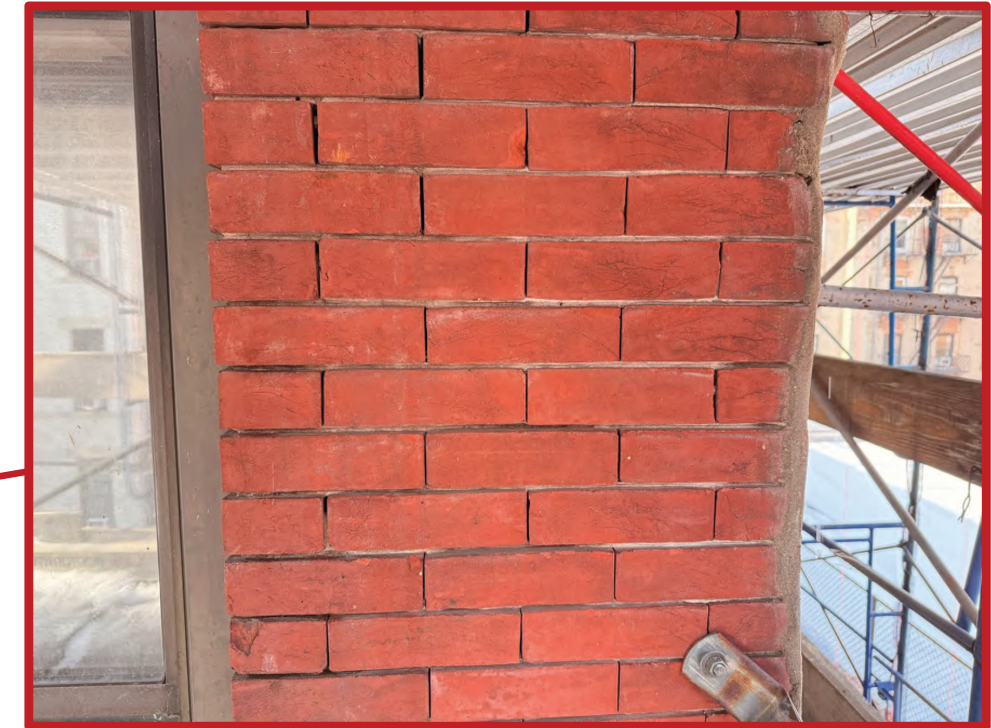
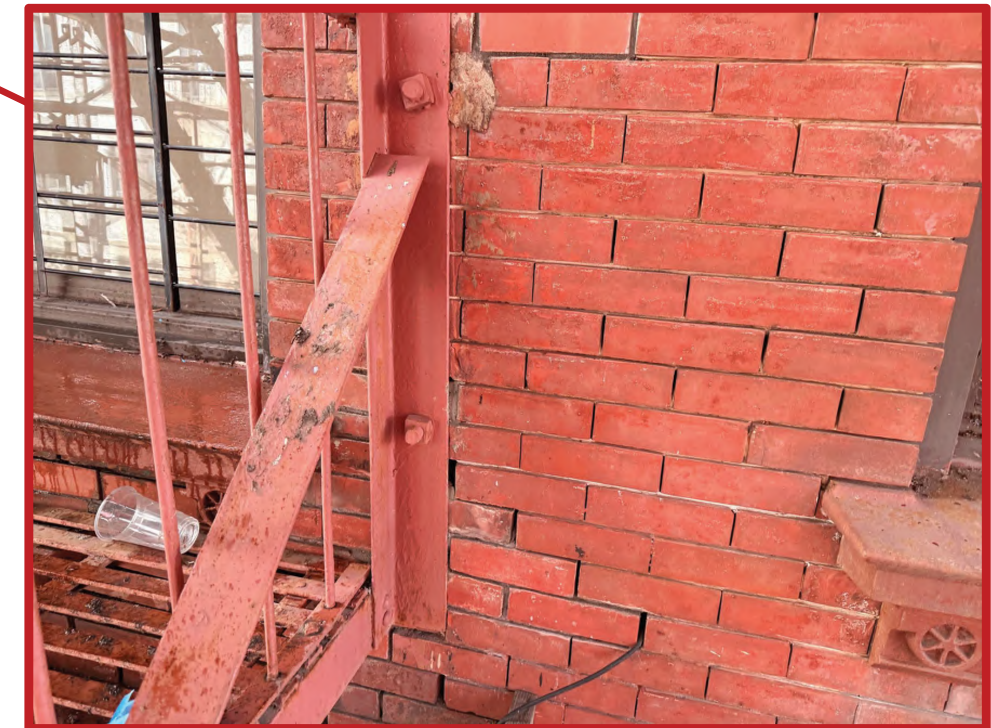
2. BRICK SPALL

3. BRICK CRACK

4. MISSING/
DAMAGED BRICK

5. VERTICAL BRICK
CRACK

7. FORMER COATING
DAMAGE

8. ORGANIC GROWTH

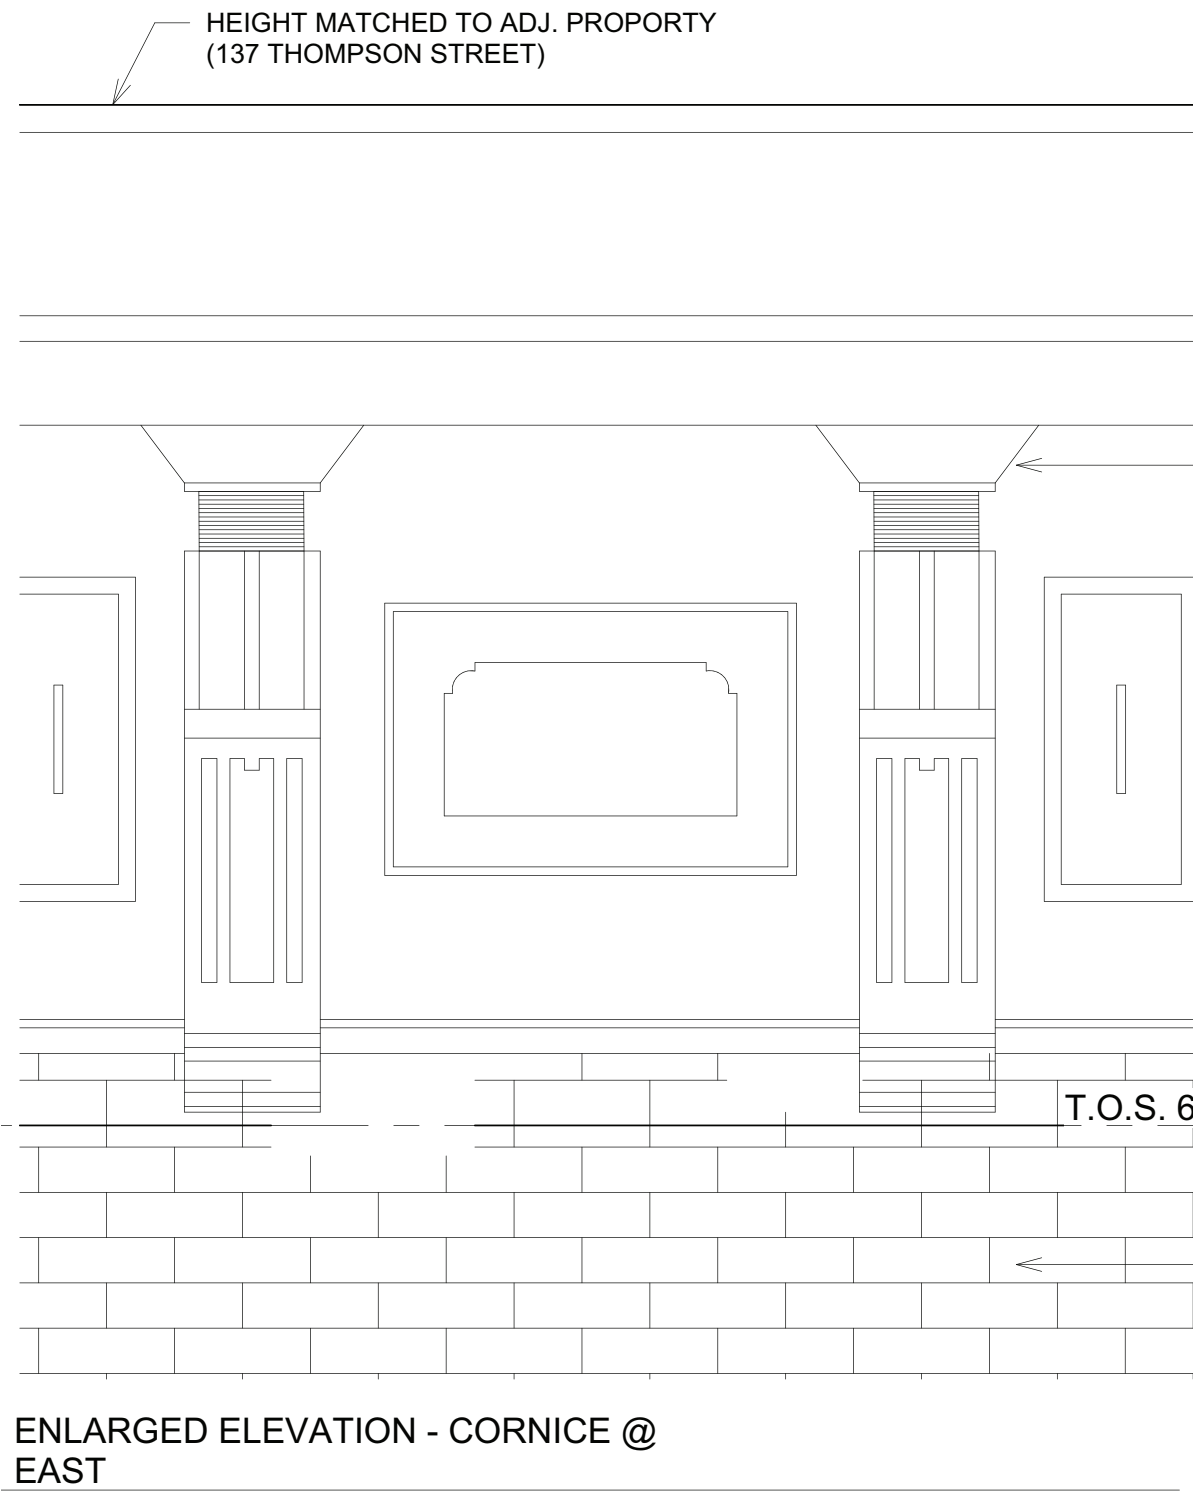
ENLARGED ELEVATION - CORNICE @ EAST
1" = 1'-0"

THE REPLICA OF EXT. CORNICE TO MATCH THE EXISTING HISTORIC ORNAMENTAL QUALITY, WHILE THE MATERIAL WILL BE FIBERGLASS. THE COLOR FOR THE HEADER/LINTEL AND SILL WILL MATCH THE NEIGHBORING 137 THOMPSON STREET BUILDING.

THE CORNICE HAS ALREADY BEEN CAREFULLY REMOVED AND RESTORED BUT IT IS NOT SALVAGEABLE. IT WILL BE REPLICATED IN FIBERGLASS TO MATCH EXISTING PER DOCKET# LPC-19-29746 AND AS PART OF THE EMAIL CORRESPONDENCE AND CONFIRMATION RECEIVED ON 07/17/2019 VIA EMAIL THROUGH MARY B. DIERICKX AT HISTORIC PRESERVATION CONSULTING, UTILIZING THE STORED COMPONENTS.

EXT. FACE BRICK TO BE REPLACED WITH LPC APPROVED GLEN GERY CROTON BRICK & #407 MORTAR
